RESIDENTIAL BUILDING SURVEY

Bedford, Bedfordshire. MK41

FOR

Mr K

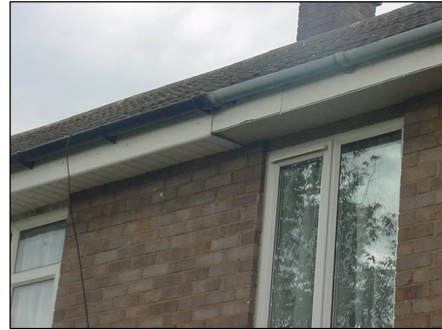
The fascias and soffits that we could see are finished in plastic. We believe this is over cladding, this is a system where plastic is put over the original timber, ironically it is often done because of rot in the timbers to make it more presentable and is always sold as never needing painting however unfortunately usually it traps in any dampness and causes the wood underneath it to rot even quicker.

Fascias and soffits – definitely looks like over cladding, plastic on left hand side and timber on right hand side.

ACTION REQUIRED: At some point you need to check whether the plastic is over cladding or has been replacement.

The easiest way we found to do this is either to remove some of the screw fixing points and check what they are screwed into or to drill into the plastic and see what residue you get from your drill. If you do find over cladding and if the timber beneath it is in poor condition we would recommend that it is replaced with proper cladding panels in plastic or timber, as long as it is done properly!

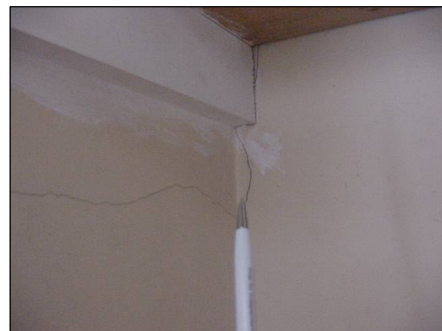
We find today that people are more and more concerned with regard to cracking in a property and rightly so as often in the Bedford area where clay is a major consideration. The cracks that we noted internally were we are pleased to say original settlement or drying out cracks. These are particularly prominent in areas that have not been redecorated recently that are hidden such as the cupboards.

Cracking

ACTION REQUIRED: Fill with a pliable mastic and redecorate in due course.

ANTICIPATED COST: A few hundred pounds dependent on your DIY skills; quotations required.

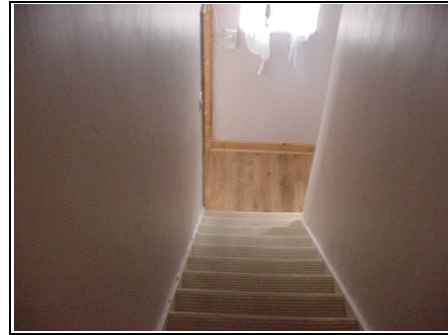
No hand rail on staircase

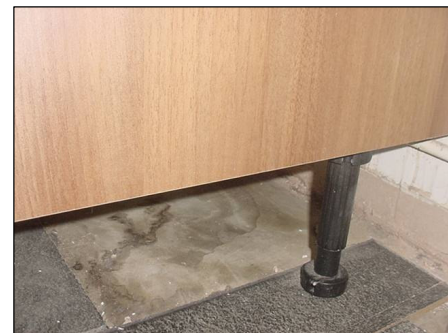
Missing flooring in kitchen

ANTICIPATED COST: A few hundred pounds for the resealing suggestion more if you are re-flooring; quotations required.

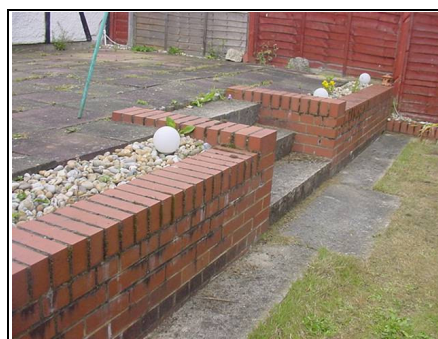
The garden is on a slope which has been stepped and has retaining walls. The retaining walls do not have any weep holes.

No weep holes present

ACTION REQUIRED: Cut weep holes into walls to stop the build up of water behind them which eventually pushes them over and/or causes spalling

ANTICIPATED COST: £100; quotations required.

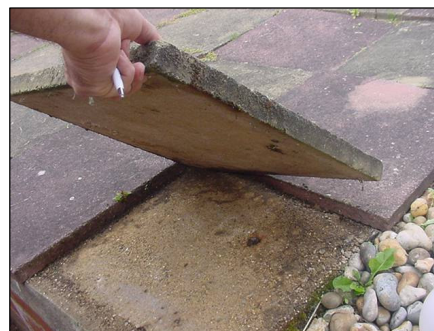
Loose paving slabs

ACTION REQUIRED: Lift and reposition paving slabs.

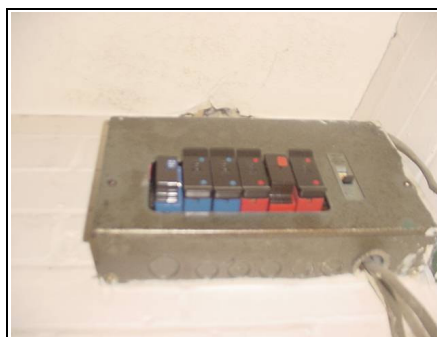
Out of date electrics

ACTION REQUIRED: We recommend that the fuse board is replaced.

ANTICIPATED COST: In the region of £300-£500; quotations required.

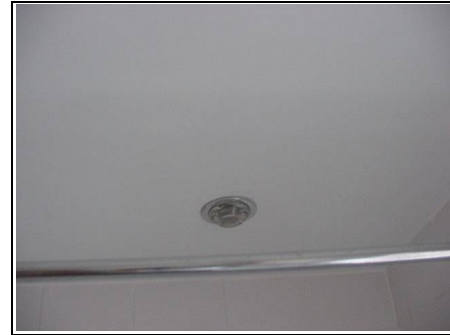
The older ceiling lights were renowned for causing fires where they let heat up into the fittings. You need to specifically request your electrician checks these when they do the NICEIC test. You may be OK and have a modern equivalent or you may not, you cannot tell when seeing them from the front.

Ceiling light

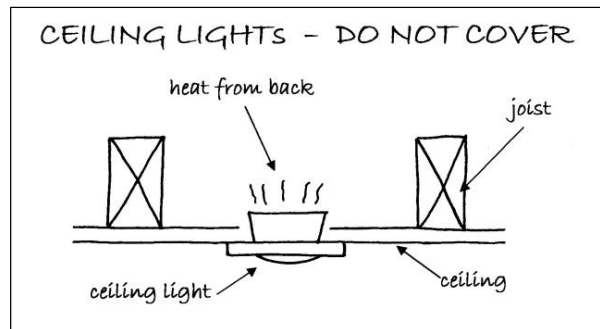
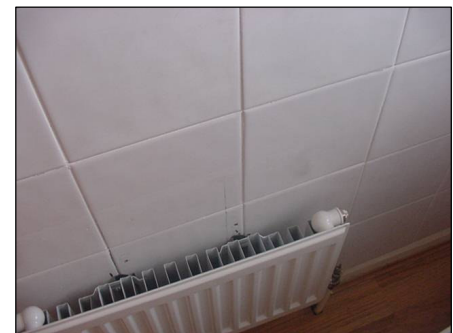
We noted that some of the radiators are single panelled so the property may not heat up as quickly as you are used to.

Single panelled radiator

ACTION REQUIRED: As heating is very subjective, particularly between males and females!, we would suggest that you live with the radiators for awhile and see if they warm up the rooms enough and if not replace the single panelled radiators.

ANTICIPATED COST: A few hundred pounds per radiator; quotations required.

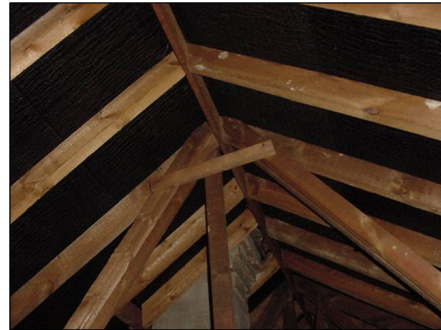
One is a Hessian base Bitumen membrane. This type of membrane has been used since the 1960s. We generally found it to be in average condition, average although it is damaged in a few places but this is not unusual considering its age.

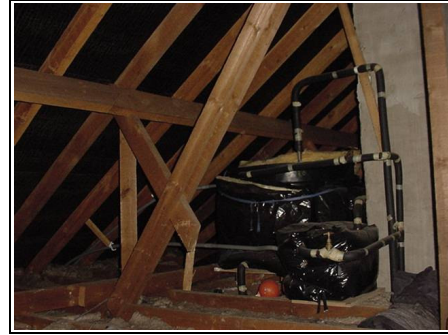
Water tanks

We would always recommend that water tanks be drained down and cleared of any debris etc. (we have seen dead birds and other unmentionable things in these tanks). As you are cleaning your teeth with this water it is best that it is as clean as possible!

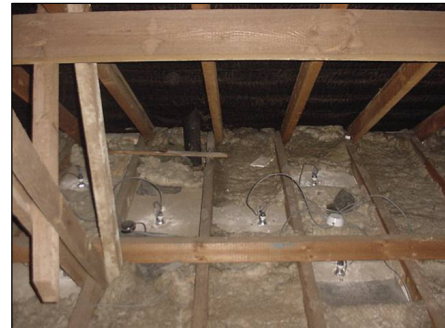
We can often identify the age of an electrical installation by the age of wiring found in the roof. In this case please see our comments in the Executive Summary regarding the wiring to the ceiling lights

Electric wiring in the roof to the ceiling lights

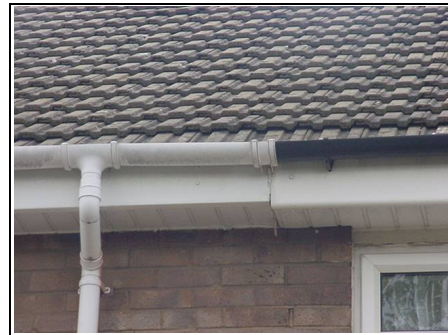
From ground level the gutters and downpipes looked to be plastic. Generally they appear in average condition, in this age of property the gutters are likely to have some minor leaks but most people can live with them.

Gutters and downpipes

ACTION REQUIRED: We would always recommend that the gutters and downpipes are cleaned out, the joints are checked and the alignment checked to ensure that the gutters fall towards the downpipes.

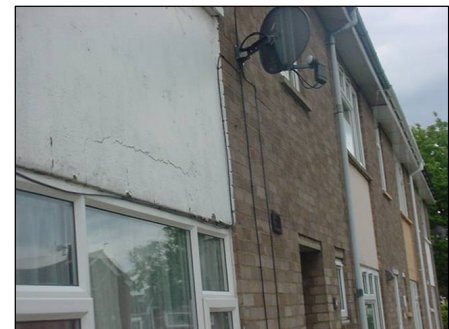
There is a render panel underneath the windows, this is in need of benefit from redecoration. Often the render panel areas can have a lower thermal efficiency than the brickwork and cause what is known as a cold bridge beneath the window.

Render panel

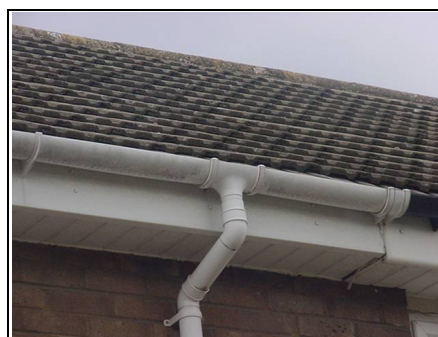
Fascias and Soffits

ACTION REQUIRED: We believe they are over cladding, please see our comments in the Executive Summary.

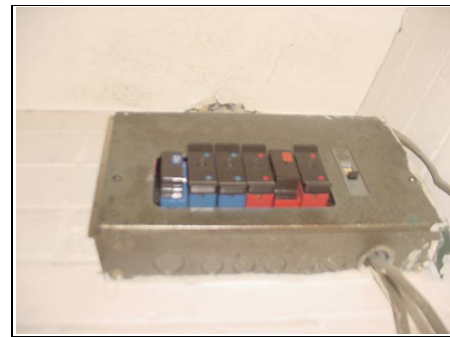
Fuse board

ACTION REQUIRED: Replace the fuse board as soon as possible.

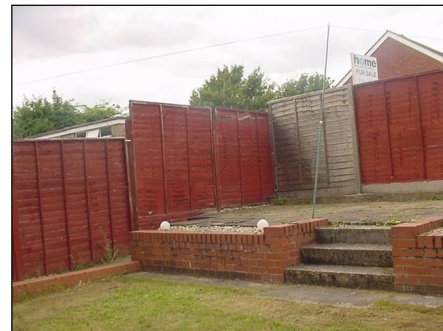
The rear garden is on a slope that is stepped.
Please see our comments about adding weep
holes to the retaining walls and also our
comments about staining the fencing.
