RESIDENTIAL BUILDING SURVEY

**Bedford,
Bedfordshire
MK41**

**FOR
Mrs S**

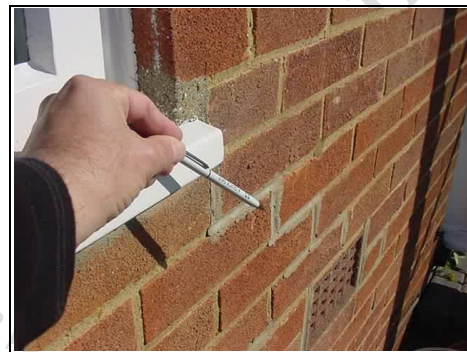
1.0) Cracking - rear right hand side

To the rear right hand corner we can see there has been cracking to the property which has been repaired in years gone by. This is possibly due to a leak in the nearby drains or possibly the clay soil in the area. There has been some very minor re-opening of this stepped crack.

External cracking to kitchen

With this age of property it could be argued that this is a characteristic of the building particularly as it is likely to sit on clay soil. As you are aware from our discussions and investigations the drains are slightly unusual.

ACTION REQUIRED: We would recommend a Closed Circuit TV camera report of the drains to check that they are not leaking.

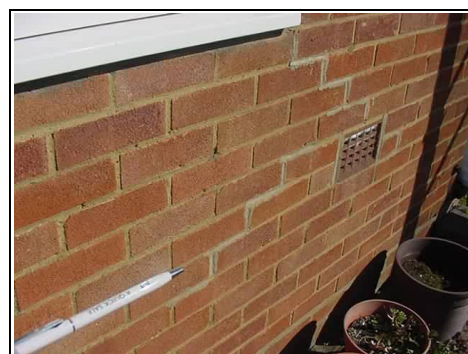
Cracking to external wall

ANTICIPATED COST: A few hundred pounds; please obtain quotations.

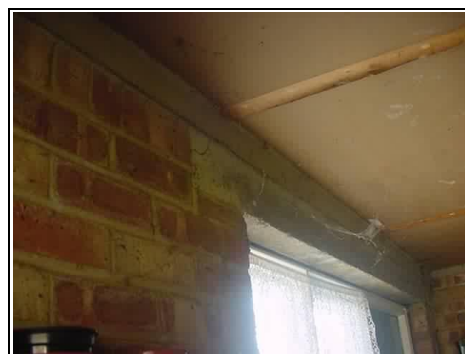
A characteristic of this age of property is cold bridging. This occurs when one material is generally colder than the rest of the materials. For example, this could relate to a concrete lintel.

Concrete lintel in the garage

ACTION REQUIRED: Have good quality humidity controlled extract fans fitted to the kitchen and bathroom. All radiators should be moved under windows. As we know you are looking to replace the existing

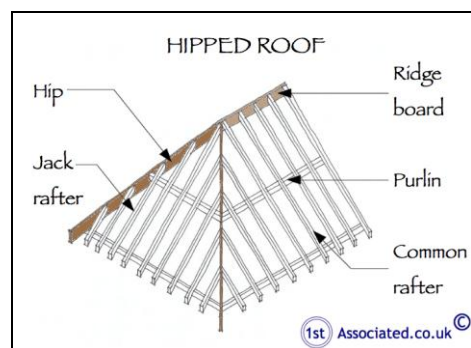
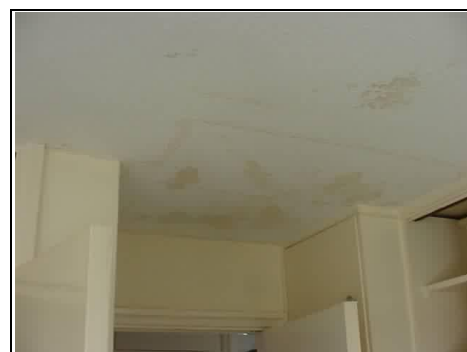
3.0) Staining to the ceiling

There is staining mainly to the ceiling in the kitchen but also in the bathroom to the ceiling and the wall particularly near the door.

This looks to have come from the water tank that is close by within the roof space. This is a plastic water tank and looks relatively new. Nevertheless these can crack particularly with its position within a hipped roof as these tend to get colder. The issue is whether the water tank problem has been resolved or not.

Staining to the ceiling in the kitchen

ACTION REQUIRED: The estate agent / sellers legal advisor to check and confirm if the problem has been resolved with the water tank having been replaced. Ideally they need to show you the property with the water turned back on. If this is not possible then you will have to allow from between £1,000 and £2,000 for testing, checking and possible replacement of the tank and associated parts.

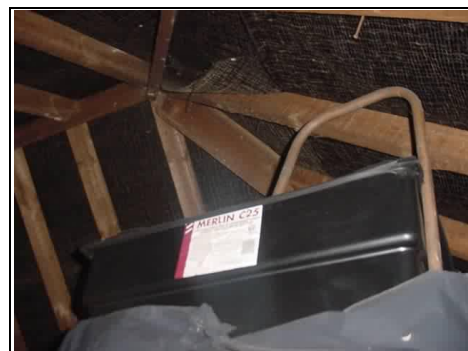
Water tank in roof space

ANTICIPATED COST: £1,000 - £2,000 (one thousand to two thousand pounds); Please obtain quotations.

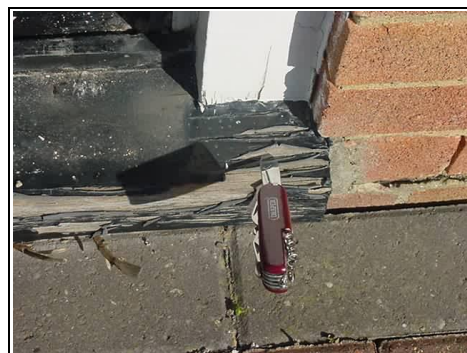
There is flaking to the windows and doors and some areas of rot. There is also some flaking to the fascias and soffits, although this is relatively minor.

Timber test. More solid than we were expecting!

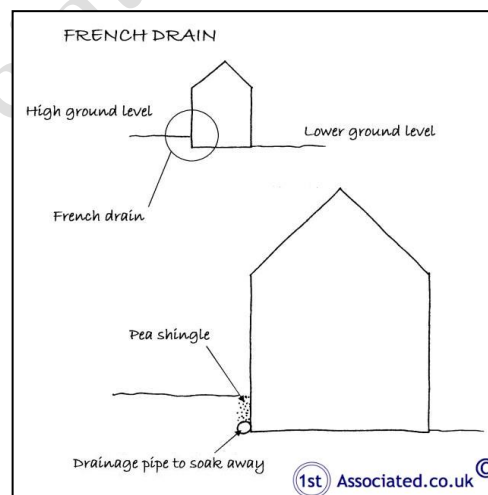
We believe this to be down to poor original construction and to not bedding the brick pavers properly. There is also not an ideal detail where the brick paves meet the main building. We would recommend a French drain here.

ACTION REQUIRED: Add a French drain and repair drive.

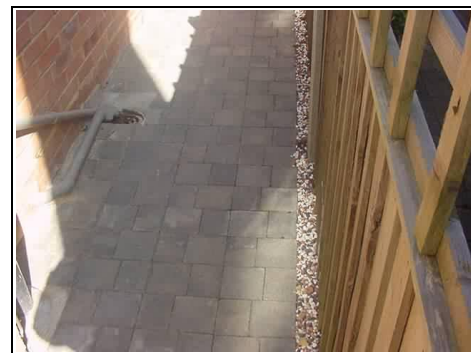
The neighbour on the right hand side has a path that is higher than yours. This means that water will discharge from their garden on the right hand side onto yours.

Your neighbours higher pavement

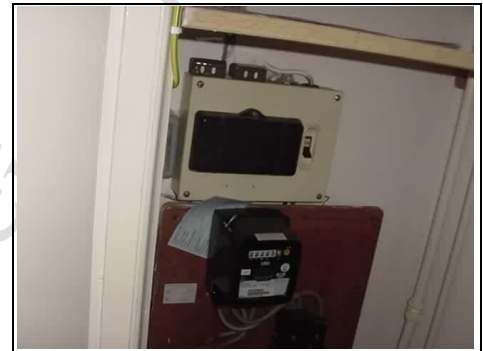
Dated electrics

ACTION REQUIRED: We would recommend a new earth board is installed and to replace all the single socket points with double socket points.

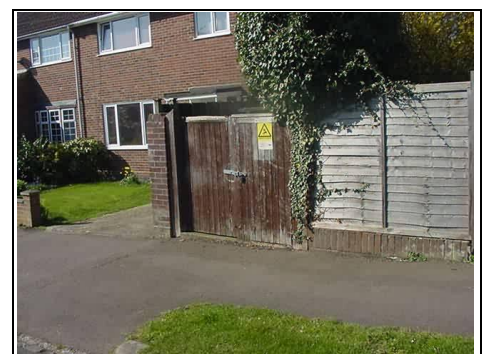
Over the years that we have been surveying there have been many different reports and thoughts on electric substations. It is probably fairest to say that the jury is still out as to whether they are a problem or not. We know there have been indications that they cause problems for the young and the elderly. This may put some buyers off.

Electric substation

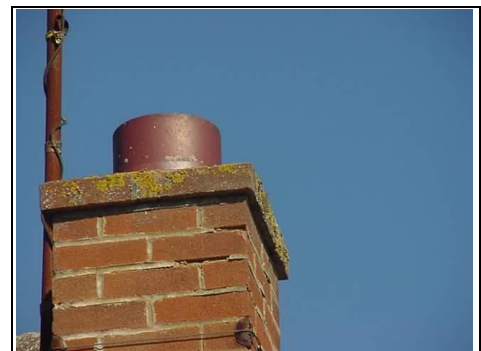
This chimney is brick /finished with a lead flashing and one chimney pot and is in need of some re-pointing. From what we could see from ground level it looked in average condition considering its age, type and style.

Needs re-pointing

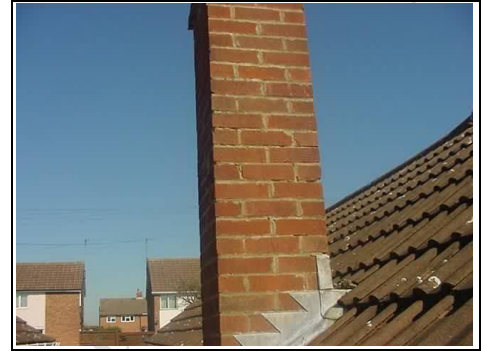
Chimney two

This is a much larger chimney and again is brick built with a stepped lead flashing and one chimney pot. From what we could see from ground level it looked in average condition considering its age, type and style.

ACTION REQUIRED: Again as with the first chimney it may need some re-pointing, please check in the next few years and then periodically inspect the chimney.

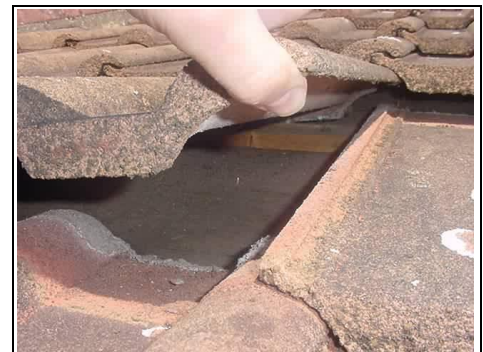
Lifting tiles

ACTION REQUIRED: Carry out periodic inspections and maintenance of the roof, as required.

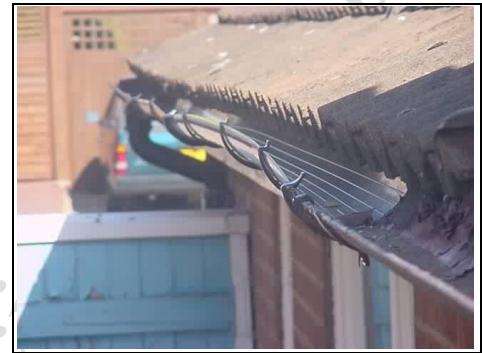
The property has a mixture of cast iron and plastic gutters and downpipes. The condition of both is fairly typical of what we see with the exception of the plastic guttering on the right hand side which undulates a little; they are in average condition for their age, type and style.

Plastic gutter tends to undulate when not fixed properly

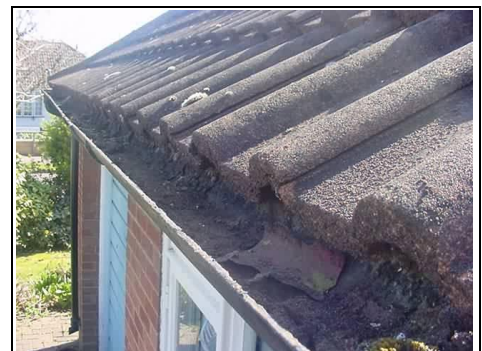
There may be some minor leaks with the existing system particularly where the cast iron joins the plastic. Most people would be happy to live with these providing repairs are carried out within the next six to twelve months.

Cast iron gutter needs minor maintenance

We would also recommend that the gutters and downpipes are cleaned out (particularly where there is minor moss on the roof), the joints are checked and the alignment checked to ensure that the gutters fall towards the downpipes.

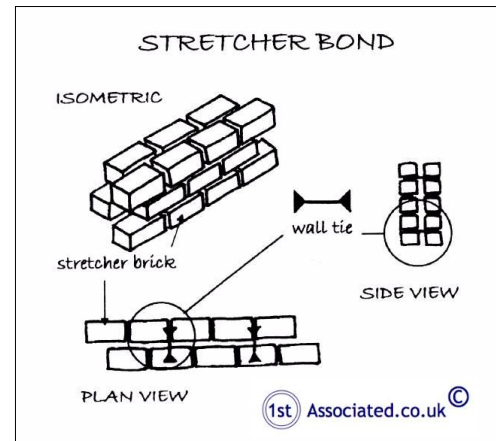
Cracking to brickwork

There is cracking to the kitchen external wall.

ACTION REQUIRED: Please see our comments within the Executive Summary.

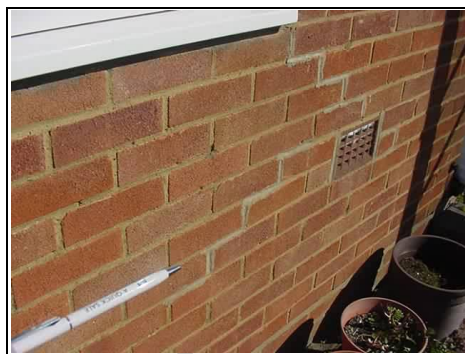
Cracking to brickwork

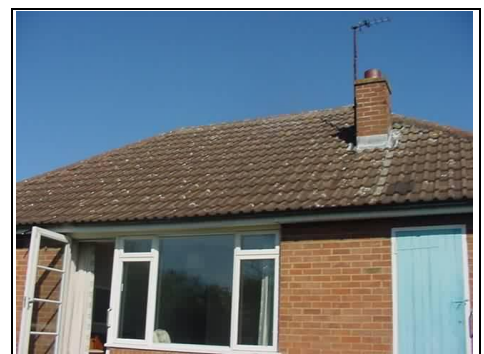
The property has single glazed timber windows, which generally look to be of slightly below average quality with paint flaking and some timber visible in some areas.

Single glazed timber windows

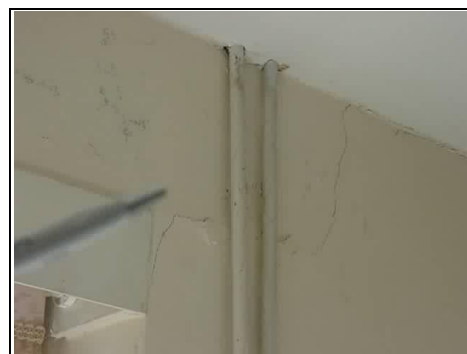
The walls are solid internally (as opposed to being dry lined). There is some cracking visible within the kitchen which relates to the cracking externally and which in turn could relate to the drains.

Crack in kitchen wall

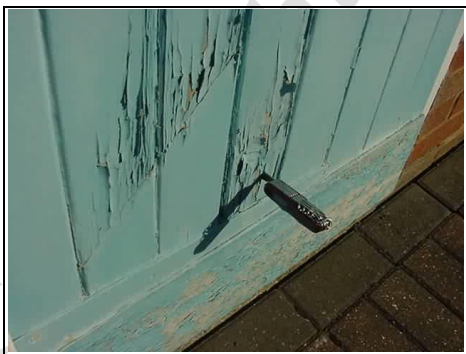
We found wet rot in one of the doors to the garden sheds. We were surprised in regard to the windows at how resilient they are. We knife tested these.

Wet rot knife test shows knife going straight the wood.

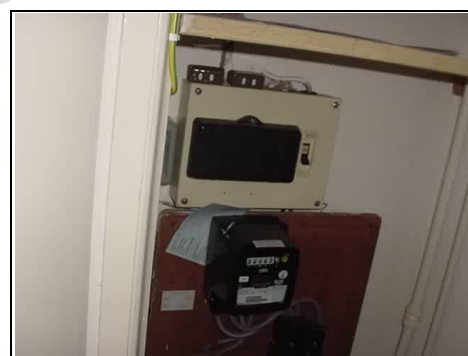
Dated Fuse Board

ACTION REQUIRED: We recommend upgrading. Please see our comments in the Executive Summary.

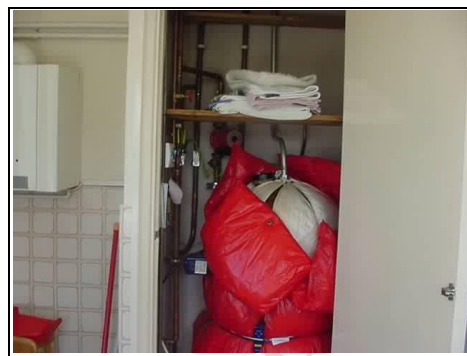
There is a hot water cylinder located in the kitchen. It has a loose insulation jacket which indicates that it is relatively old (in this case we mean the last 50 years). This cylinder will therefore not have the same thermal properties as a modern factory insulated cylinder. The problem with these dated cylinders is they can just leak at any time.

Hot water cylinder

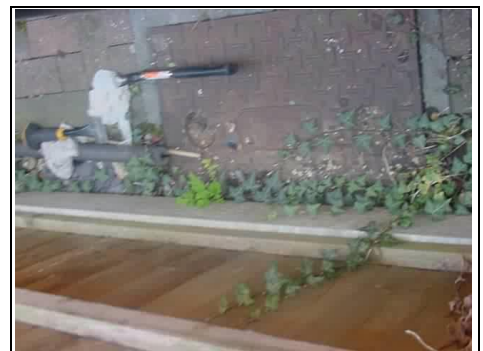
Manhole front right partly under the fence indicating that the fence line has changed.

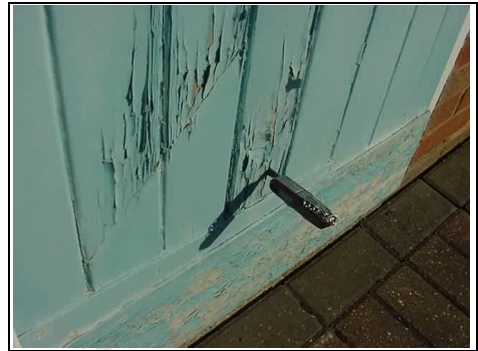
Shed has wet rot.
