**RESIDENTIAL BUILDING SURVEY
OF
Bexhill-on-Sea, East Sussex, TN39**

**FOR
Mr B**

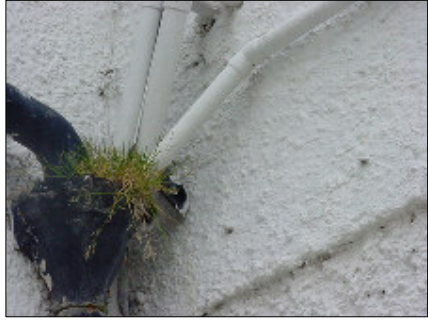
The rainwater goods require some work and attention such as clearing out the grass ...

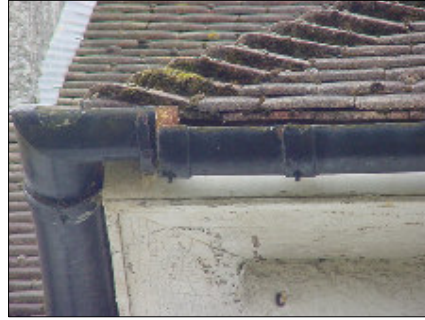
and replacing the rusting cast iron gutters and re-fixing the joints,

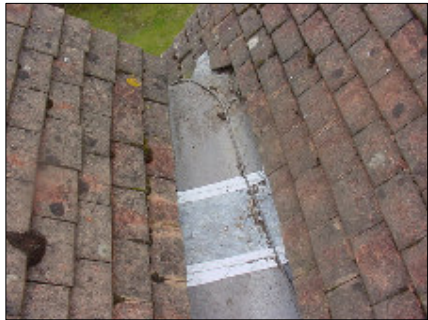
repairing the valley gutter properly and

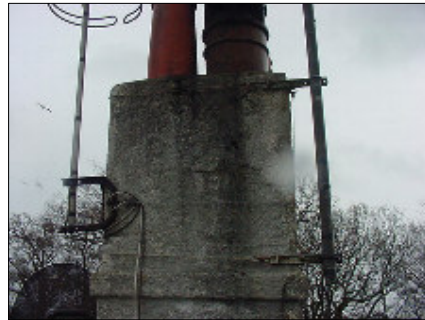
re-rendering the chimneys and redecoration to make them watertight.

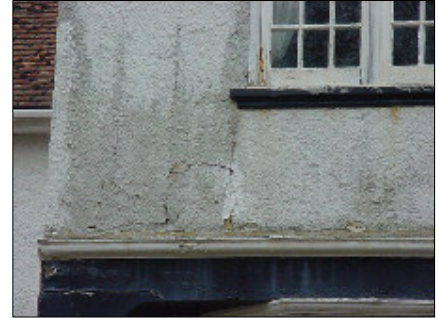
We could show lots of photos of the deteriorating render and the cracking

ACTION REQUIRED: We would expect the majority of the property to require re-rendering together with associated repairs beneath. You will have what we would term a domino affect, in that when you start one area this will then lead on to other areas of repair etc. etc. This also can often have pound's signs rolling in the eyes of any builder you use, so care should be taken to specify the work correctly, but more about this in the render section.

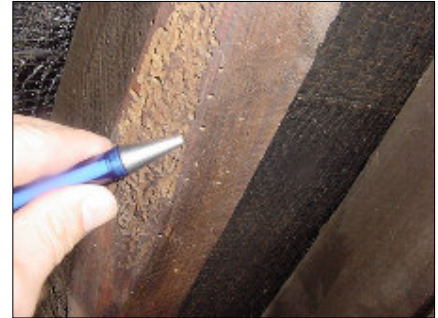
The worst area of woodworm that we could find.

The main risk areas are that the woodworm that we have seen on the structural timbers has affected the laths in the plasterwork, which in turn could result in new ceilings being required or that it has affected under the floor area to the front of the property, as this is an ideal breeding ground for it, i.e. damp.

ACTION REQUIRED: This is more a suck it and see situation, due to the sheer amount of insulation in the roof we were unable to establish the true condition of the ceilings and unfortunately we were also unable to gain access under the floor area.

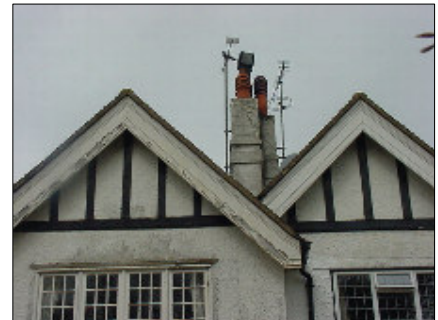
Rear Middle Chimney near the Roof Light

This is a rendered finished chimney with a lead flashing and has three chimney pots. This is the worst of the chimneys and will require a fair amount of re-rendering. There is a crack visible in the chimney and it goes without saying that it will need redecoration as well.

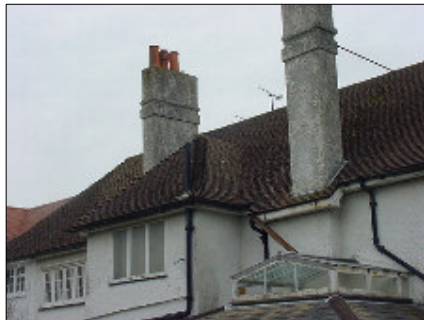
The two rear chimneys.

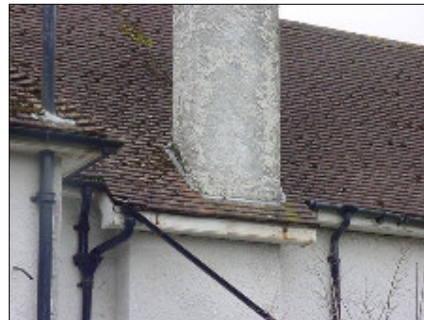
Looking more closely at the rear chimney, as this area is where the dampness is getting into the bedroom. You can see moss on the tiles indicating that water is sitting on the roof. There is a relatively small flashing and also the guttering has come away and is at 45 degrees in the photo. All of these, we believe, contribute towards the dampness in this area.

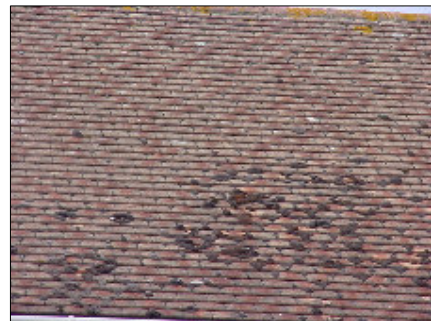
There is a very minor amount of moss growth growing on the slopes, this is not uncommon on concrete tiled roofs. This can, in extreme cases, impede the run-off of rainwater, lead to gutter blockages and cause water penetration, which in turn may lead to rot or other defects in nearby timbers. We suggest the roof is cleared of the moss periodically, in fact we would go so far as to say because this has not been done this is the reason why the gutters are blocked causing dampness.

ACTION REQUIRED: Clear the roofs and gutters of moss.

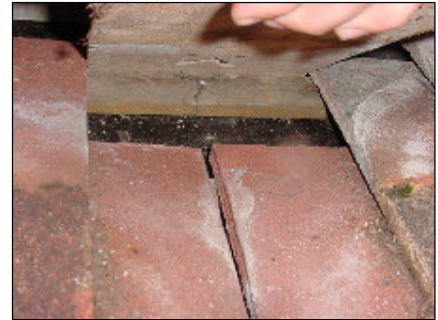
Valley gutters are generally considered to be weak areas on a roof. The valley gutter is used where a roof changes direction. In this case the valley gutters are formed in lead. The lead looks to be thinner than would normally be recommended for valley gutters (what is known as code 6 lead). The lead has split and the owner has carried out a repair to it, although in theory it is a jointly shared valley gutter. We spoke with the adjoining owners who advised that they had dampness coming into their property, we assume it was from this leak. Although, alternatively, when we did lift the tiles, as shown in the photo, there was no lead running under the first few courses, which is the detail we would recommend, as this stops water getting into the structure should it back up or should it snow.

ACTION REQUIRED: At some point in time (within the next few years) you will have to consider re-leading the valley gutter and taking it underneath the tiles to stop water finding its way in in this area. This should be a shared cost, from what we could see, with the adjoining owner.

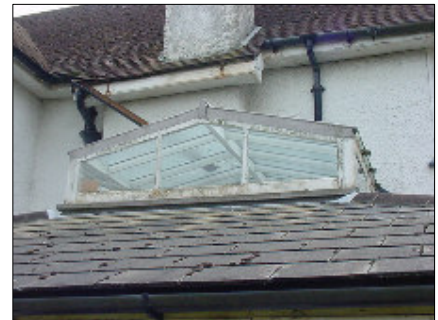
From within the room below we could see that leaks are coming through. Fibreboard has been used to line the underside so we could not identify if the structure was damaged internally. From our external inspection we would expect some repair and replacement to be required.

We note also that one of the cast iron gutters has fallen onto the roof and cracked some of the glass. Part of this is Georgian wire polish plated, as it should be to stop any tiles etc. coming through the glass, but some of the glass looks to be normal glass (although it could be strengthened glass but we could not see the British Standards Kite mark). During the refurbishment all this roof glazing will have to be changed to strengthened glass.

The way we suggest you tackle this area is to first of all make the roof light watertight by taking it off completely this summer (you can also use the opening left to put a ladder through and fix the gutter back in place, if you are happy to do this), cover the area with polythene, or something to protect it against any summer rain and, depending upon its condition, have a new one made or have the old one repaired.

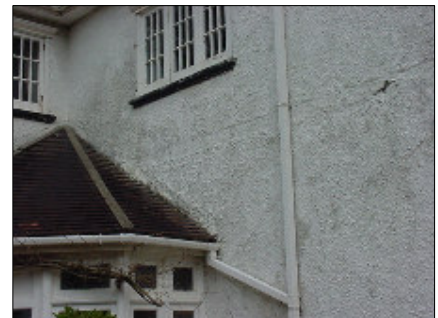
Entrance Porch Roof

This is a pitched tiled roof. Our main concern with this area is that it did not look to have a flashing, although there was some undulations to the render where the roof meets the main wall. If you look at the render there looks like there may even have been another structure in this area, as there is a horizontal band running across it.

With regards specifically to the roof we would expect some flashing work to be required.

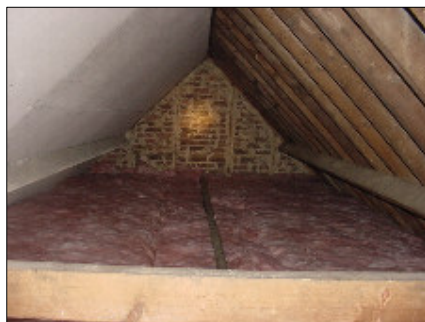
General view of the roof and the mass of insulation. You can see where the light from my torch is shining on the end wall, here you can see timbers in the wall, which is why this property will be a problem when taking the render off because some of these timbers will have rotted. To the left hand side you can see what we believe to be asbestos.

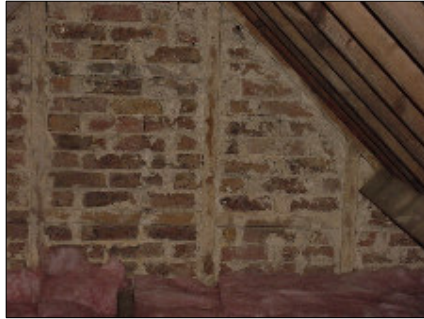
Close up of the timbers in the walls.

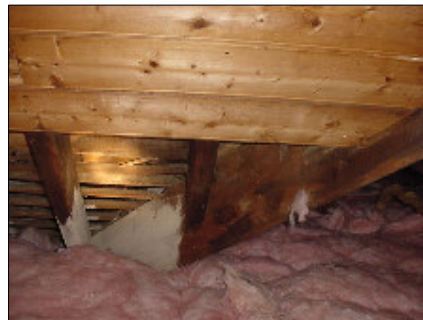
You can see the darker bits of timber, where there is some dampness getting in.

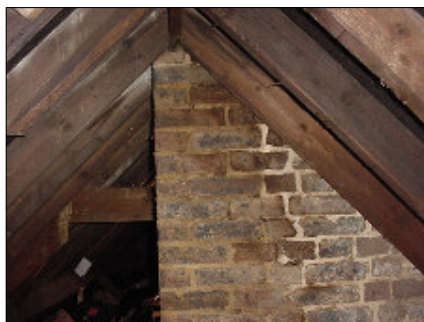
You can see the dampness here getting in from the middle chimney.

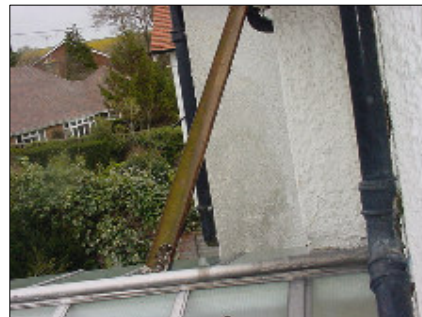
You have a mixture of the original cast iron rainwater goods and plastic and they are in a poor state. The cast iron ones are rusting away, which is a real shame and one has even come away from its fixing and smashed into the workshop roof. Grass can be seen growing from some of them and the plastic rainwater goods do not look to have been aligned correctly in some places.

The question is where do you start with these. The first thing we feel you need to decide is whether you should have all cast iron or all plastic rainwater goods. There are arguments for both.

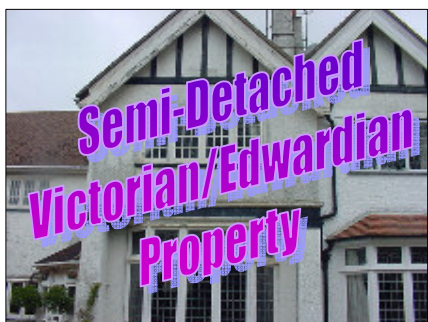
This elevation shows quite well where the deterioration has occurred to the render and also where there is likely to be deterioration in the structure itself (that is in the darker areas of the render).

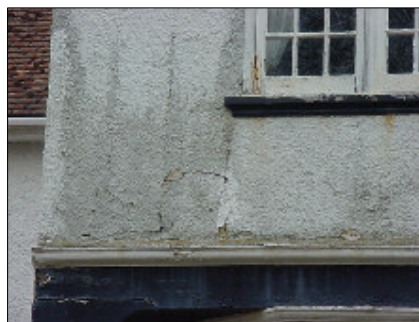
A close up shot showing cracking etc. We think the cracking is probably in line with where the timber is underneath the structure. Without opening it up we cannot be certain of course.

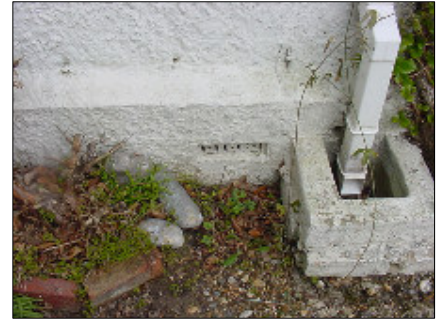
There are some suspended timber ground floors to this property. This means there should be an air flow beneath them. We noted airbricks to the front of the property but these were minimal and the air flow is then blocked by the concrete floors further on in the property. We therefore think it is likely that there could be wet rot in the floors due to the general dampness in the structure as a whole.

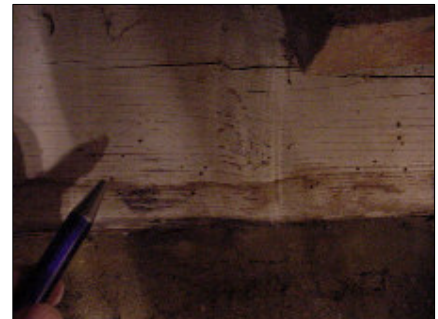
To the floor to the rear that we were able to inspect we found woodworm although relatively minor; however the front of the property would have more ideal conditions for woodworm i.e. dampness.

ACTION REQUIRED: We have suggested earlier within this report that the floor be lifted and checked or you need to negotiate a reduction in the price to allow for the risk that you are taking on.

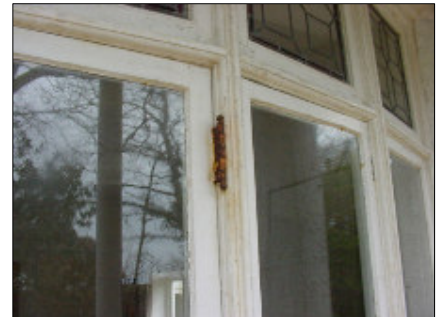
Redecorate and repair. Some of the ironmongery will need replacing as well, for example the hinges are rusting.

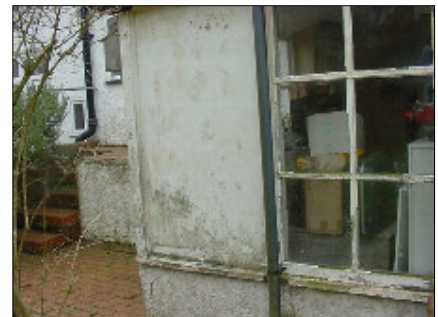
Probably the worst timber condition is to the rear workshop area (see photo), which is a new add-on and therefore the quality of the timber is not as good.

ACTION REQUIRED: Ironically whilst the flaking paint to the fascias and soffits, doors and windows looks terrible the quality of the timber used originally is good and therefore has survived quite well. You will need to redecorate in the next year or so.

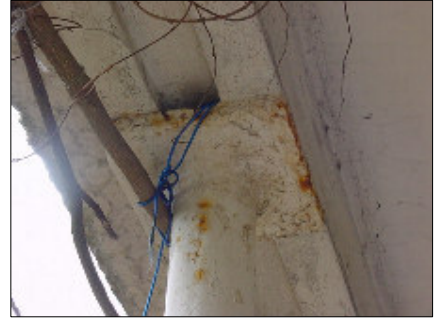
There are some supporting cast iron columns (or what we believe to be cast iron) to the left hand gable (outside the dance area). We noted some signs of rust in these areas.

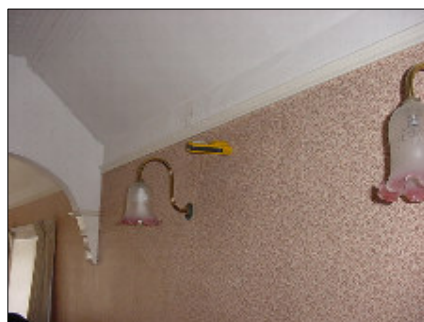
The yellow object is my damp meter, not that it was needed as dampness is visible. This is probably coming from a combination of leaking gutters, leaking render and possibly the chimney also is contributing to it.

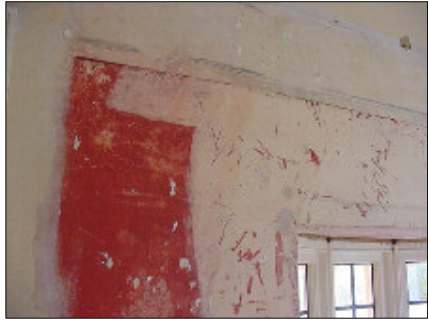
This photo is taken inside next doors property. We spoke specifically to the owner of your proposed purchase about this who said that he had not come across any problems, but we did not within his own study that the paper was coming away and this red paint was beneath.
