JOB REFERENCE: RBSM2/MH/MB

RESIDENTIAL BUILDING SURVEY

Hertfordshire

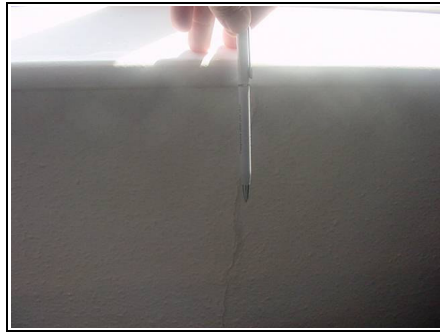
To the front wall we noted cracking in both the front right and front left hand bedrooms. As this is a cross wall construction effectively the front and rear walls shouldn't take any weight and as such the cracks to the walls shouldn't be considered a problem.

Crack in front left bedroom

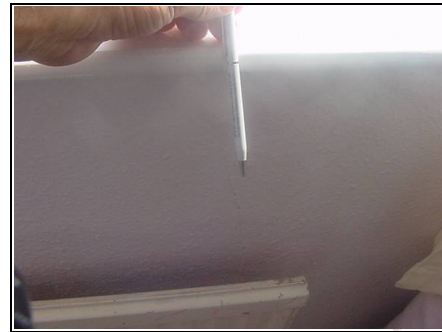
Crack in front right bedroom

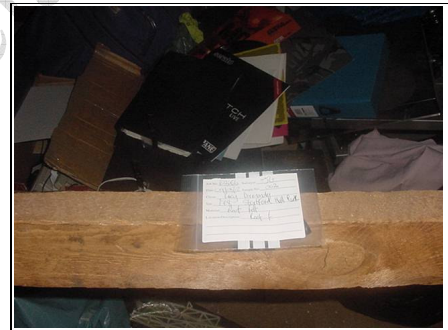
At the time the survey was carried out an asbestos report was also being carried out. We could see that there was what looks to be asbestos gutters, downpipes, water tank, flues, fascias and soffits, (although it is not possible to be 100% certain from a visual check). It is the condition these are in and whether they need removal that the asbestos company should be able to advise you of. The asbestos testing company took samples which they advised they would be analysing within their labs.

Example of sample taken for asbestos

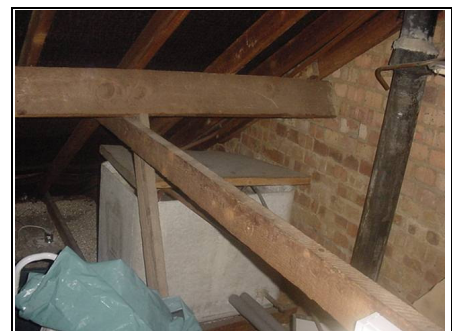
Asbestos flue and water tank in roof space

There is an asbestos water tank within the roof space which your asbestos company may recommend is removed. We would recommend, if it is staying, that you always drain down and clear of any debris etc. (we have seen dead birds and other unmentionable things in these tanks). As you are often cleaning your teeth with this water it is best that it is as clean as possible!

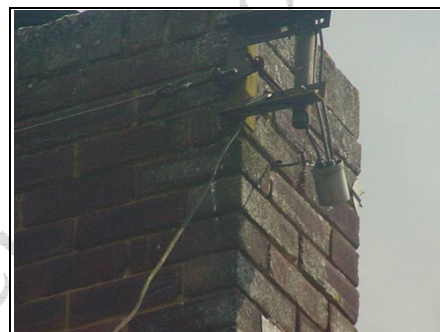
Chimney needs repointing

ACTION REQUIRED: We would recommend repointing in the summer of 2013, by 2014 at the latest, otherwise dampness will start to get in.

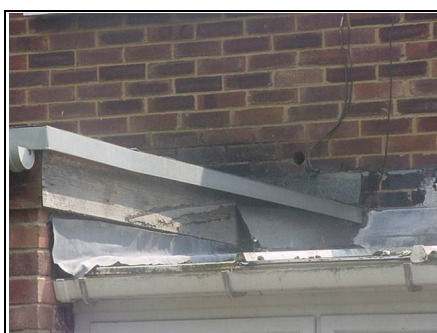
We can see that the right hand side of the rear conservatory (all directions given as you face the front of the property) has part of the flashing missing. Although it has some of the flashing remaining, work is required to renew this flashing to stop water getting in. Rain may also get into the joints and other similar weak areas.

Flashing missing to rear right hand side of conservatory

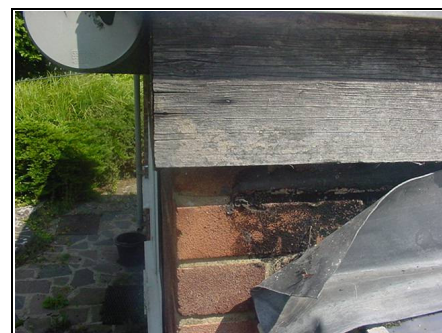
Close up of flashing coming away

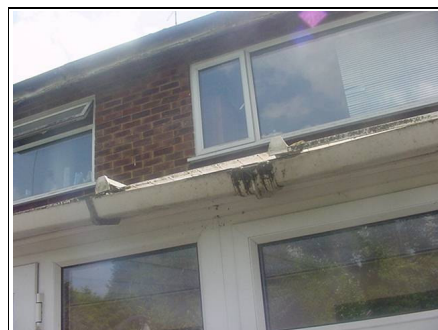
Leaking gutter to conservatory

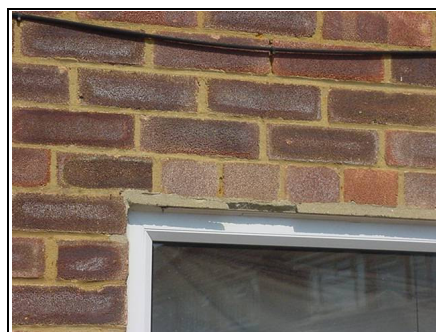
In this era and type of property we sometimes come across there being no lintels over the windows. We noted that some of the windows have a different brick pattern than we would expect, for example in the photo you can see a row of headers (the ends of the bricks) which indicates to us there may be a lintel in this area.

Window without a lintel

ACTION REQUIRED: You need to be aware that there aren't lintels over some of the windows and watch out for deflection. They have obviously stood the test of time to some extent (depending upon how old the windows are). Your legal advisor to check and confirm when the windows were put in and if they are subject to a guarantee and if the window company recommended the lintels being added (they would normally draw this to your attention).

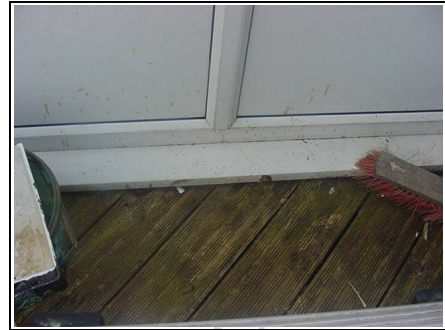
The decking to the rear comes right up to the property and as such can cause dampness by capillary action to the concrete floor.

Ideally there should be a gap between decking and building

ACTION REQUIRED: We would recommend a gap between the decking and the house which may be easier said than done. We would also recommend ensuring that you can lift the panel directly above the drain. Watch out for vermin and for the decking getting slippery.

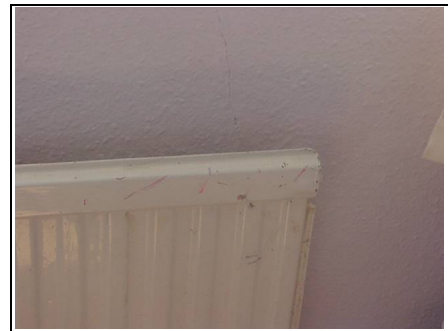
Marked radiator needs redecoration

ACTION REQUIRED: The house needs a good clean, preparation and redecoration. There is a lot of woodchip paper in the house which can be fairly difficult to remove.

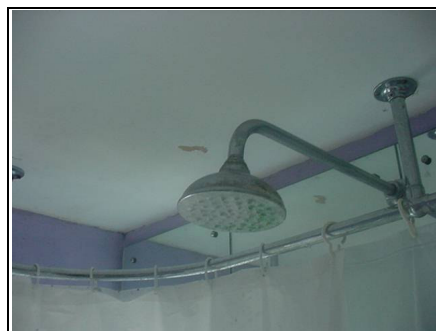
We noted condensation within the rear right hand bathroom.

Condensation and paint flaking – needs extract fan

ACTION REQUIRED: We would recommend an extract fan with humidity controlled thermostat is added to the bathroom and the kitchen.

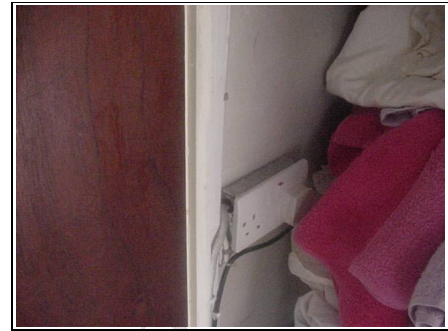
We noted DIY electrics within the airing cupboard.

DIY electrics in airing cupboard

ACTION REQUIRED: The Institute of Electrical Engineers standards (IEE) recommend a test and report be carried out by an NICEIC registered and approved electrical contractor or equivalent whenever a house changes occupants. We would recommend the same in this instance as there seems to be a lack of socket points and possibly some DIY electrics.

ANTICIPATED COST: A few hundred pounds for the test and then recommendations; please obtain quotations.

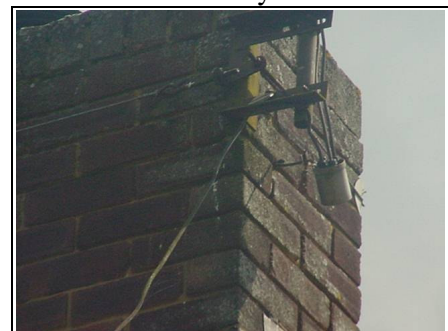
This chimney is brick finished with a lead flashing and two chimney pots. From what we could see from ground level it looked in slightly below average condition as it looks weathered considering its age, type and style.

Chimney needs repointing

ACTION REQUIRED: We would recommend repointing in the summer of 2013, by 2014 at the latest otherwise dampness will start to get in. Periodically inspect the chimney.

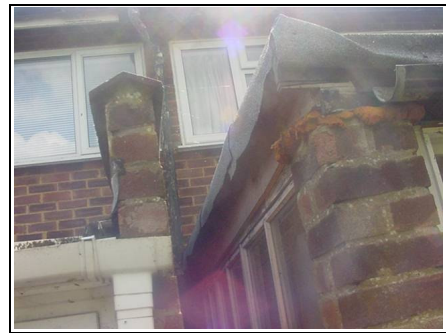
In this case there is a thin (one brick width) parapet wall to the rear of the property built from brick with a coping stone. We can comment that it is not the strongest and as you can see next door has a two brick wide pier which is more common. We assume it is not possible to re-build in this case because next doors extension is in the way. Where two extensions are built close together such as this, there should be a party wall agreement.

Thin rear parapet wall

ACTION REQUIRED: Obtain party wall notice and be aware that the party wall will deteriorate.

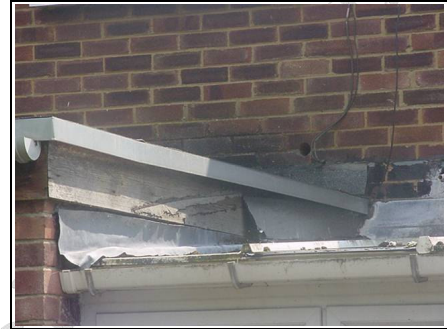
Flashing missing to conservatory

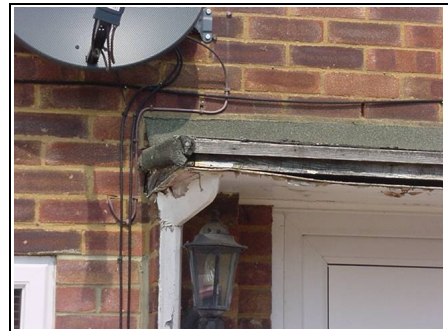
Entrance porch roof

The entrance porch to the front has a flat felt roof. It is in poor condition, we can see the timber underneath.

ACTION REQUIRED: Add felt to this area. Obviously as it is not inside it is not imperative but it would stop further damage to the structure.

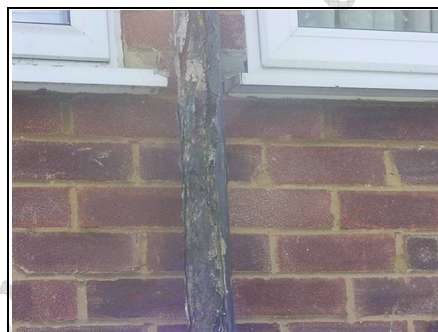
The property has asbestos gutters and downpipes which didn't look in the best condition. We are sure your asbestos company will comment upon these and whether they need removal or not.

Asbestos downpipe to rear

ACTION REQUIRED: Please see our comments in the Executive Summary with regards to asbestos. If the asbestos company doesn't recommend to remove them we would always recommend you stand outside the property next time it rains heavily and see how well the drains cope with the rainwater particularly looking at the guttering and the joints. We would also recommend that the gutters and downpipes are cleaned out, the joints are checked and the alignment checked to ensure that the gutters fall towards the downpipes particularly the gutters to the conservatory roof which will have a lot of moss in them.

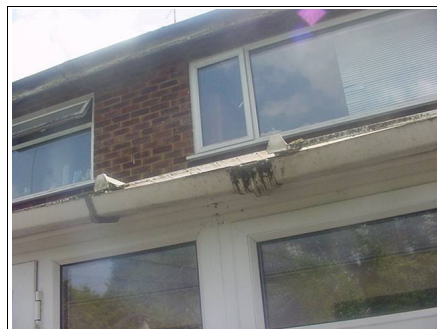
Leaking gutter to conservatory

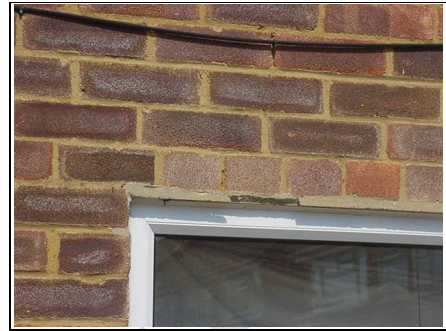
Window without lintel

ACTION REQUIRED: Please see our comments in the Executive Summary.

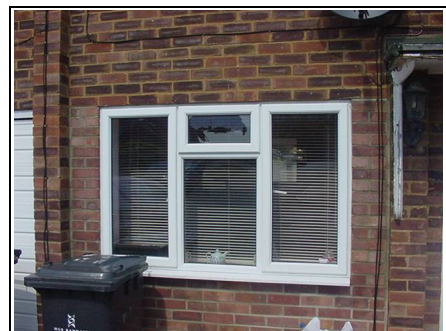
Garage room has double glazing without trickle vents

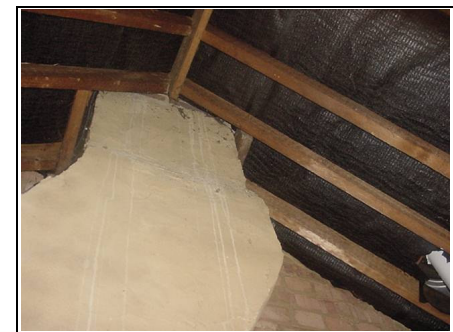
Within the roof we noted the chimney breast was rendered which we were slightly surprised about as this practice tends to have ended in the 1960's.

Rendered chimney breast within roof

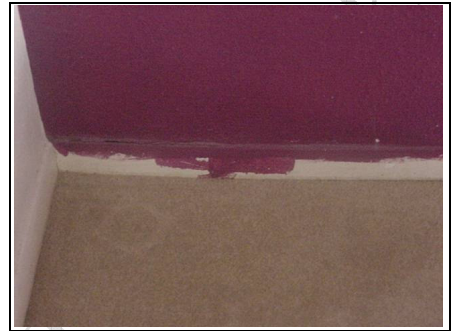
Internal decorations are in below average condition with marks to the walls and radiators and a poor standard of painting, for example to the top of the stairs the walls and skirtings have been painted. You may wish to redecorate to your own personal taste and standard.

Standard of painting at top of landing

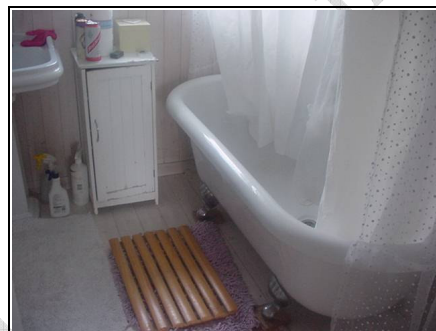
The property has a three piece bathroom suite, consisting of a bath, wash hand basin and WC, which looks in average condition although it did look slightly DIY, for example the pieces of wood wedged underneath the bath unit.

ACTION REQUIRED: We would recommend that a humidity controlled extract fan is added.
