RESIDENTIAL BUILDING SURVEY

**Bishops Stortford,
Hertfordshire
CM23**

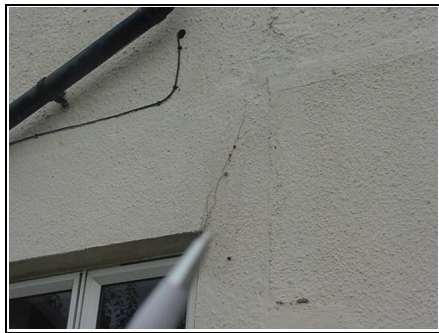
There are numerous cracks to the render, indicating to us that there has either been some settlement or the render has too a cement content, or alternatively it has been maintained poorly, i.e. not painted regularly. Either way, cracks do put people off properties.

Close up of a crack

ACTION REQUIRED: The present owner needs to put a claim in with regard to insurance and say that cracks have been noted during the course of a building survey. The insurance company needs to agree to carry out investigations and you need to insure with the existing insurance company. This will limit any possible liability to the amount of the excess (your legal adviser needs to check and confirm you have this in writing before you proceed with the purchase).

In addition to this you need to seal the cracks as soon as possible, then in the summer of 2013 (subject of course to what the insurance company's finding have been) you need to carry out patch repairs to the render and make good and fill any cracks and then redecorate the entirety of the property.

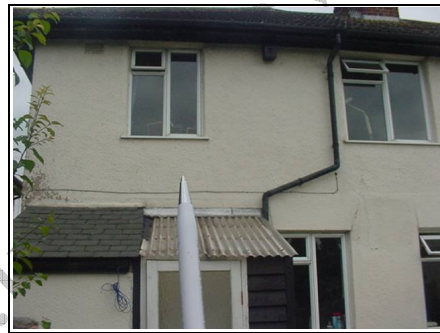
High level crack to rear

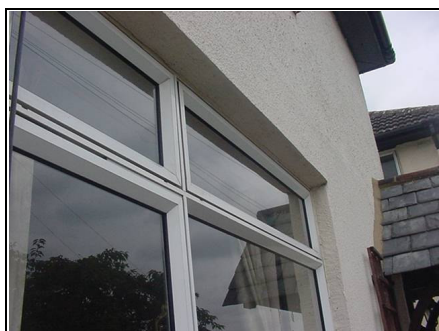
The windows are from the cheaper end of the market. Some of them have missing seals to the windows, etc and we feel they may allow rain in. We also noted there were no trickle vents, meaning that this age of property is more susceptible to condensation.

Looks like the seals are missing to the window

ACTION REQUIRED: We recommend that you live in the property and see how draughty the windows are. However, we do feel you would be better off with new windows and recommend you look to replace the windows, depending upon how bad the winter of 2012 is, in the summer of 2013.

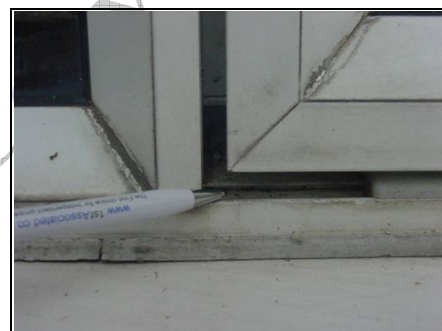
Close up of missing seal

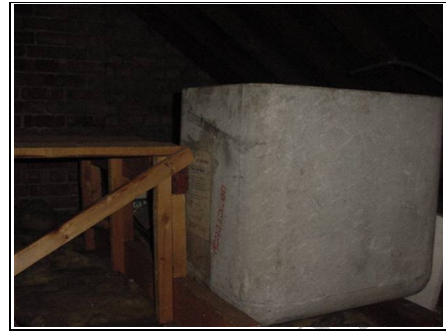
In this age of property asbestos was commonly used. We noted an asbestos tank in the roof space. This does indicate that there may be asbestos elsewhere; we thought possibly to the fascias and soffit boards, but also would typically be used in any ducting and flues.

Asbestos water tank – no longer used

ACTION REQUIRED: Your solicitor to specifically ask the present owners if they are aware of any asbestos and ideally have an asbestos report carried out.

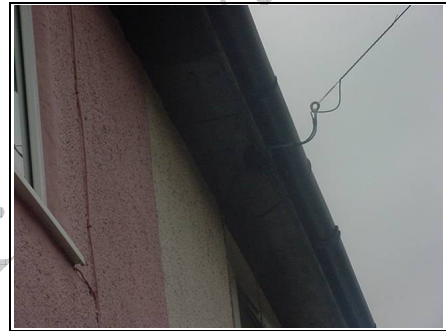
We also noted what could be possible asbestos soffits.

Possible asbestos to soffit

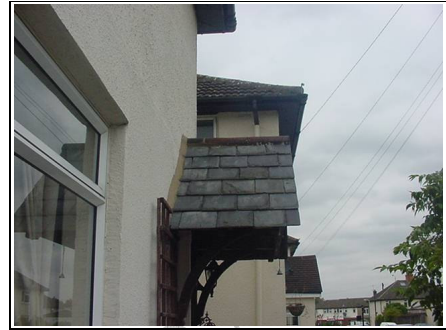
There is a low level pitched porch roof to the front of the property. It is covered with slates, which is probably what was originally on the main roof, and as you can appreciate slates are a lot lighter than concrete tiles. The roof is in average condition but we would prefer to see a lead flashing where it meets the main building.

Pitched porch roof

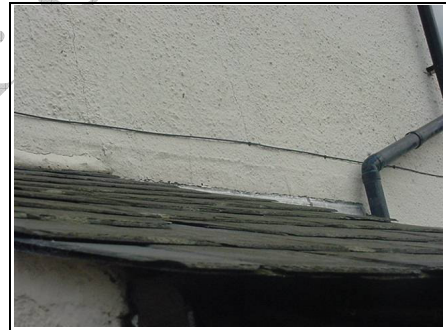
The rear low level pitched roof is also clad with slates. Again, we would have preferred to have seen a lead flashing.

Rear low level pitched roof

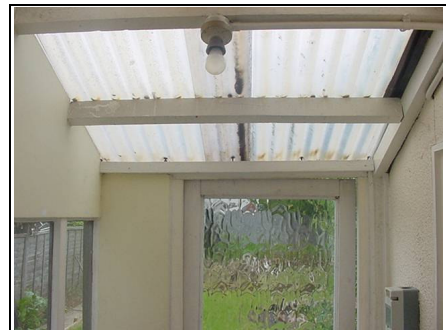
The other part of the roof is in a corrugated plastic and this type of roof will need replacement from time to time. A stronger, modern equivalent is a polycarbonate roof that is normally double lined which you may wish to replace this roof with. It really depends upon how you intend to use this area as to how much money you spend on it, in our opinion.

Polycarbonate roof

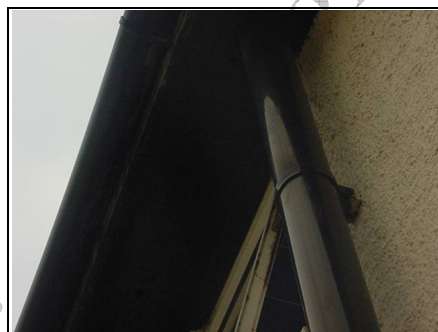
The gutters and downpipes are plastic. There may be some minor leaks but most people would be happy to live with these providing repairs are carried out within the next six to twelve months.

Gutters and downpipe

ACTION REQUIRED: We would always recommend you stand outside the property next time it rains heavily and see how well the drains cope with the rainwater particularly looking at the guttering and the joints. We would always recommend that the gutters and downpipes are cleaned out, the joints are checked and the alignment checked to ensure that the gutters fall towards the downpipes.

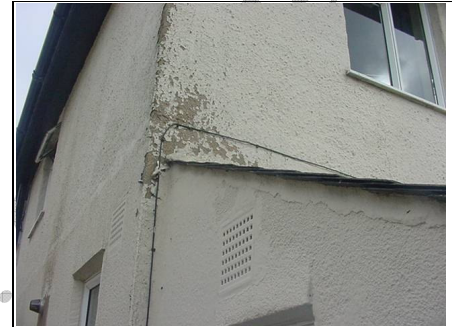
Paint coming off rear wall

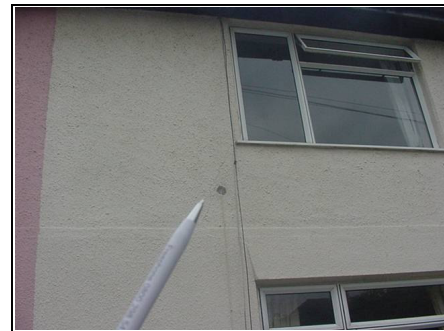
We were surprised at the amount of cracking to the render. Please see our comments in the Executive Summary about an insurance claim being made by the existing owners. It is not possible from a one off inspection to give you a 100% certain answer. Normally this type of thing would be monitored, as recommended by the Building Research Establishment for at least a year.

Pen indicates vertical crack to front of property

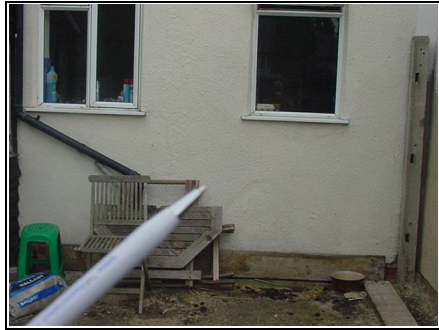
Crack to rear of property

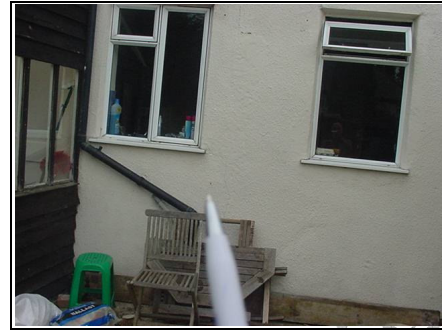
Crack below window

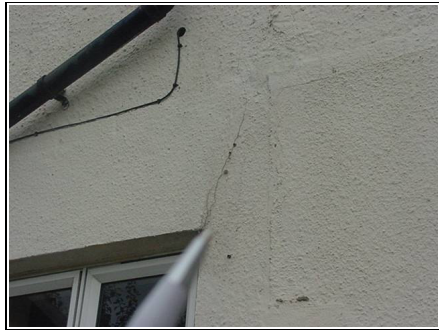
Close up of crack

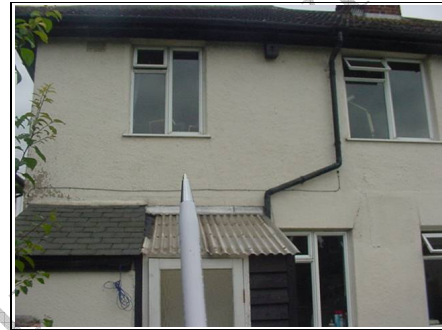
High level crack to rear

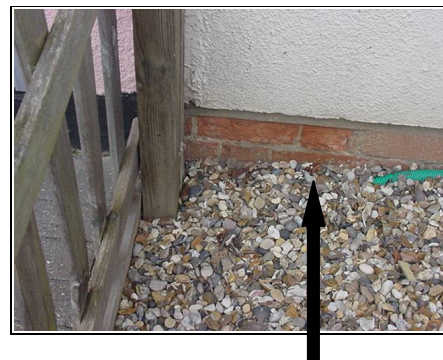
We can see a course of brickwork to the base of the property, which is a softer red brick. Please ensure that the shingle is moved back to allow the brickwork to breathe and not affect the floor timbers.

Spalling brickwork

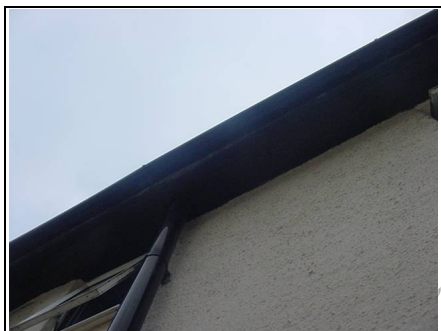
The fascias and soffits are timber or possibly asbestos. We would comment they look in average to slightly below average condition for their age, type and style.

Fascias and soffits

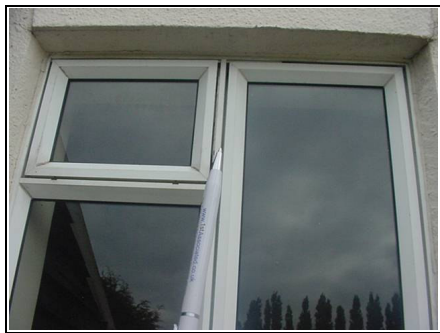
Pen indicates missing window seal

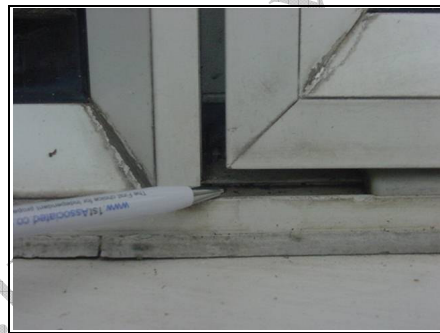
Close up of missing seal

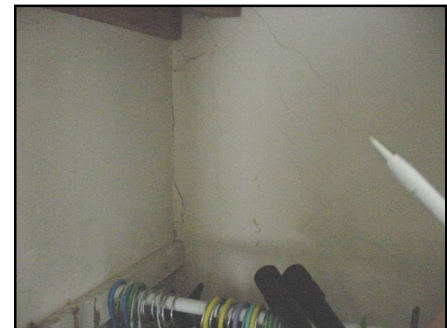
Cracking in cupboard

ACTION REQUIRED: Please see our comments with regard to the cracking externally. It is too risky to proceed with this property without having an insurance company looking into it, which limits your liability to the excess.

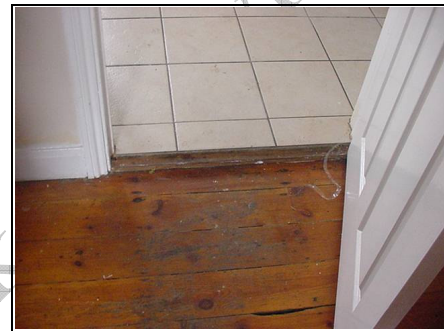
Floor very worn in lounge

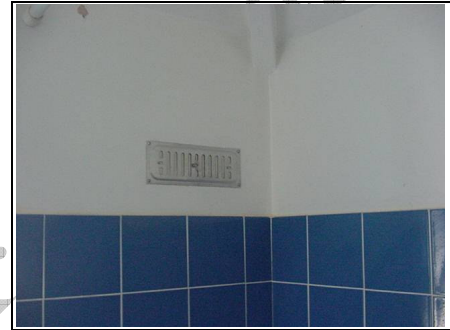
Vent in bathroom but no extract fan here or in kitchen

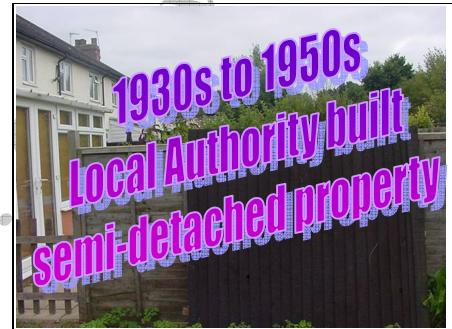
The missing panel propped up
