# RESIDENTIAL BUILDING SURVEY

## Hertfordshire

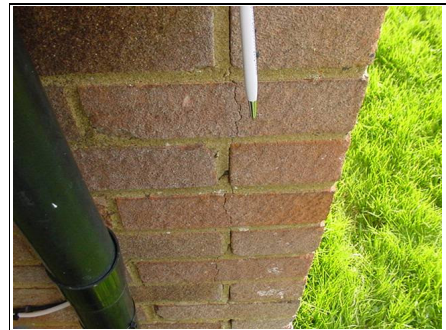
We noted cracking externally both in the form of raking cracks at the front of the property and vertical cracks to the front and rear on your property and adjoining properties which does indicate movement. We have been advised that the adjoining block was underpinned in 1981. This apartment block has not been underpinned.

Vertical cracking to rear of property

**ACTION REQUIRED:** It certainly needs investigation and probably long term monitoring. The Building Research Establishment recommend a year of monitoring to establish what to do. We would also like to have a drainage check to see if these have been affected and/or are causing or adding to the problem.

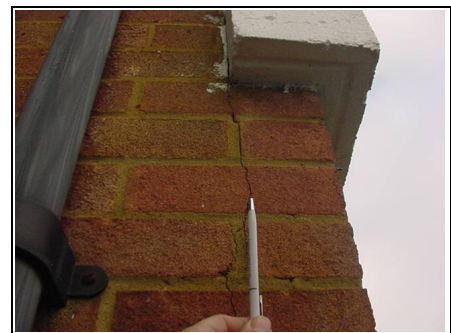
Vertical crack below concrete lintel

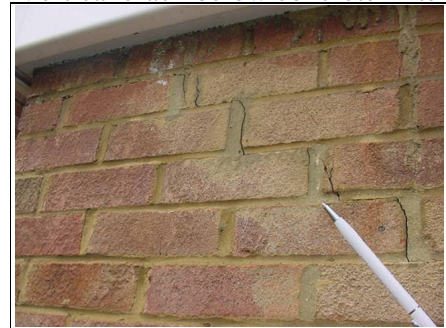
Diagonal cracking to adjoining property

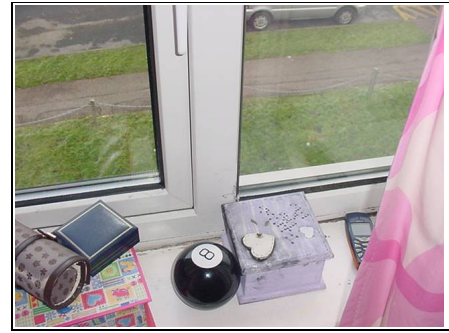
Note condensation to the sill

In addition to this you also get condensation caused by cold bridging where the cold concrete allows coldness to come through, this meets with the warm inside air and causes condensation which was visible.

**ACTION REQUIRED:** Very difficult if not impossible to solve without major alterations to the property. We have found that condensation is becoming a very big problem in this type of property and we feel does affect the value and certainly affects how nice they are to live in.

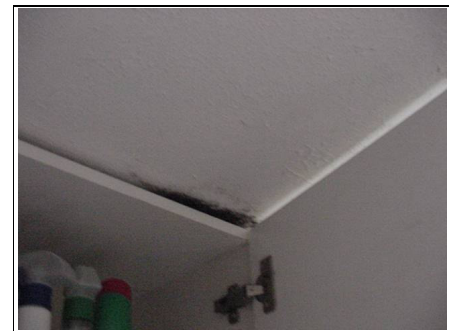
Note condensation above the cupboard in the bathroom

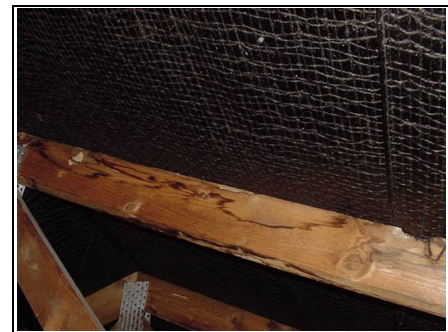
We noted staining to the timbers within the roof which to us indicates that there is the relatively common problem in shallow roofs of condensation occurring. Ventilation needs to be added to avoid this.

Staining to timbers

**ACTION REQUIRED:** The roof can be vented however please see our earlier comments with regards to condensation in the property.

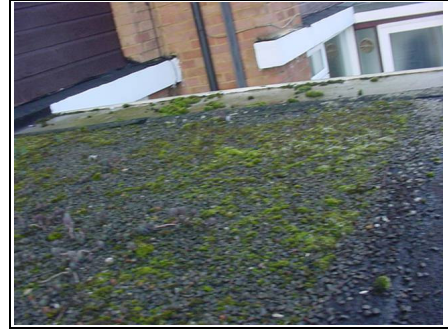
There is a felt flat roof to the front of the property which is in poor condition. There are plants growing on the roof because it is flat (a flat roof typically should have a fall of approximately fifteen degrees). There are areas where the roof has deteriorated completely.

Flat roof to front

**ACTION REQUIRED:** We would recommend some patch repairs to it.

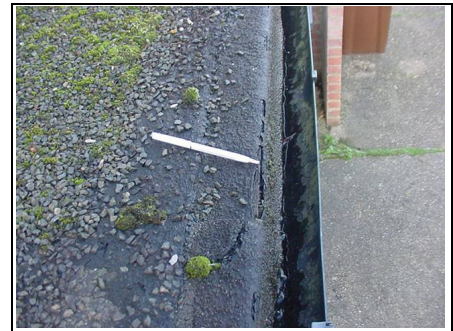
Please see the Roof Coverings Section of this Report. Defective felt

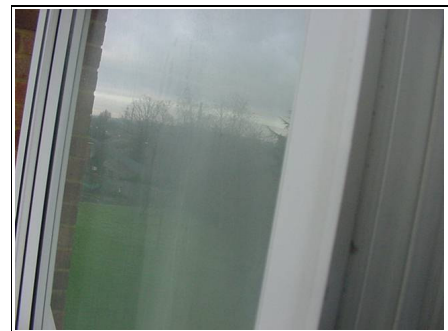
The plastic double glazed windows that have been installed don't have trickle vents therefore there is very little fresh air coming into the property and this results in condensation.

Rear bedroom window misting over

**ACTION REQUIRED:** It is very difficult to completely resolve this type of problem but a start would be to add new windows with trickle vents in and to ensure the property is aired. You need to examine other properties and surrounding properties to establish fully how to resolve this problem.

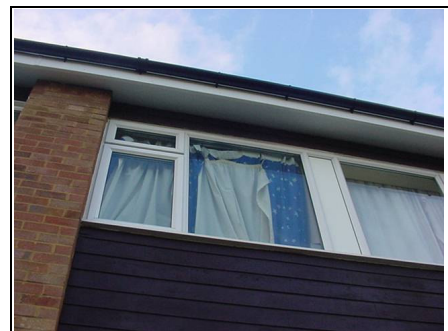
No trickle vents

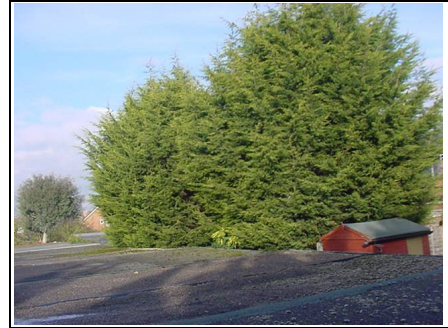
Conifers that have overgrown around the garages that need cutting back

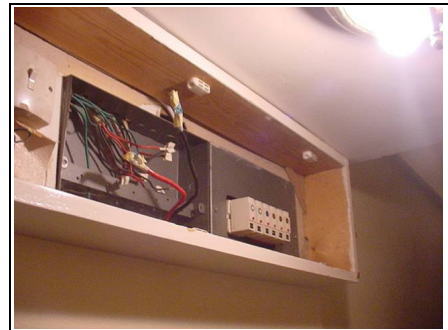
The electrics are dated, these are located in the ground floor and whilst they have a fire resistant box we would still recommend they are updated.

Dated electrics

**ACTION REQUIRED:** Update the electrics.

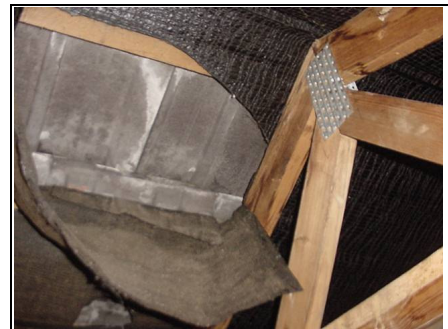
The roof is pitched and clad in a concrete tile. From ground level it was very difficult to see it however we could see it from within the roof space. We had a very limited view although we did note that the pitch of the roof is shallow. When we have come across this type of roof before it is prone to condensation which is what we found in this case. We therefore recommend that vents are added.

Underside of concrete tile

**ACTION REQUIRED:** Add vents.

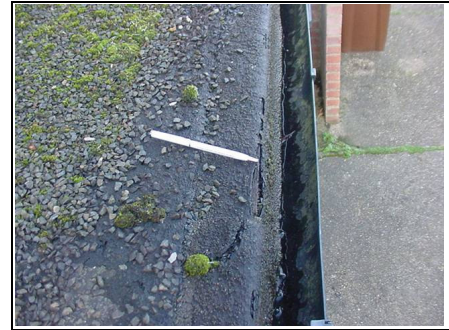
To the front of the property over the entrance area is a flat felt roof, typically this type of roof has a life of between 20 and 30 years, depending upon the quality of workmanship, materials and decking, although some roof manufacturers do claim longer. In this case we think it is coming to the end of its natural life, we noted cracks in the felt.

Defective felt

**ACTION REQUIRED:** We would recommend ad hoc repairs.

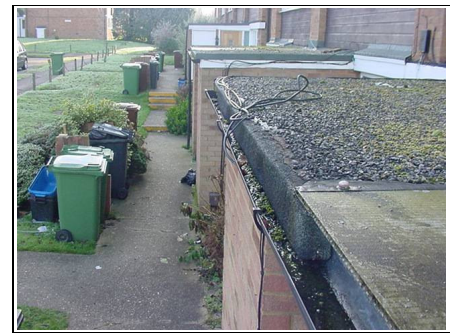
Polycarbonate at the front of this photo which needs cleaning

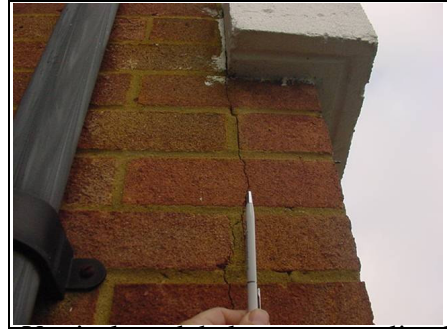
With regards to the brick walls we believe it is a cavity construction. We would comment that in earlier types of property such as these built in the 1970's wall ties can rust, however we did not see any tell-tale signs such as horizontal cracking. We did however see vertical cracking and raking cracking. Please see our comments in the Executive Summary.

Vertical crack below concrete lintel

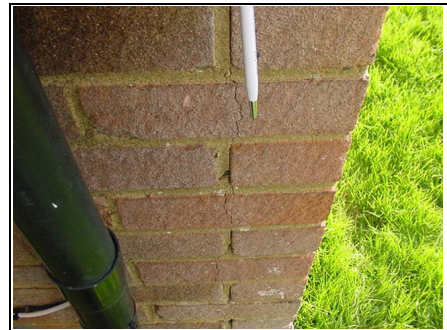
Vertical cracking to rear of property

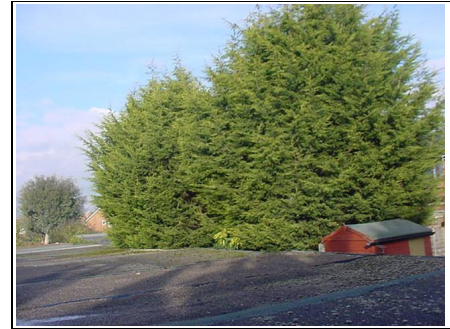
Conifers that have overgrown around the garages that need cutting back

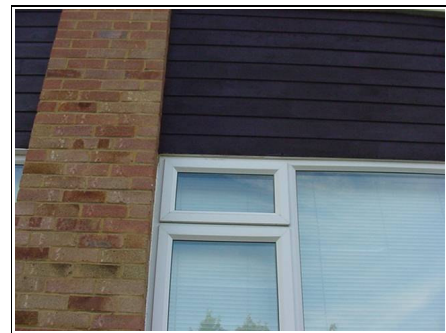
The property has plastic, double glazed windows which don't have trickle vents and we would say come from the economical end of the market. Unfortunately not having trickle vents in this property will increase the likelihood of condensation considerably.

No trickle vents to windows

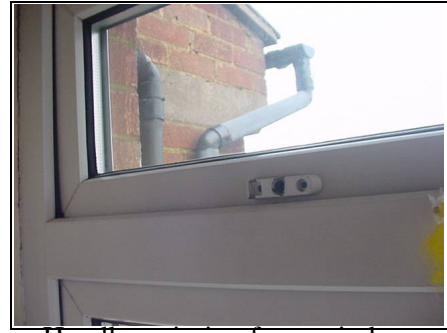
Handles missing from windows

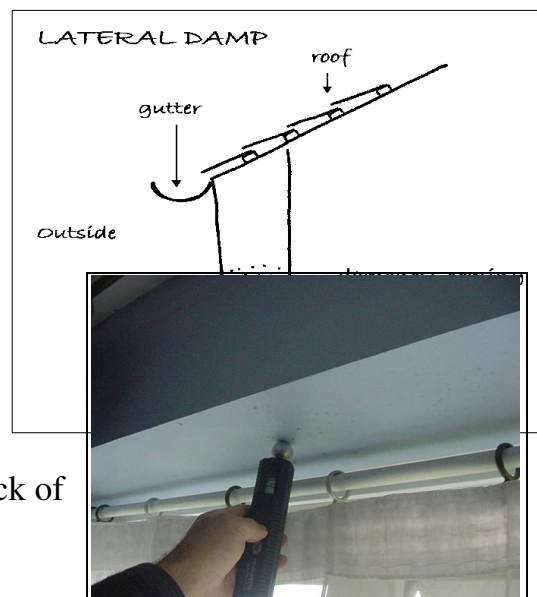
We found higher readings than we would normally find around the lintel areas. This we believe relates to cold bridging causing condensation rather than lateral dampness although there may be an element of this caused by a lack of a cavity tray.

Checking dampness to lintels

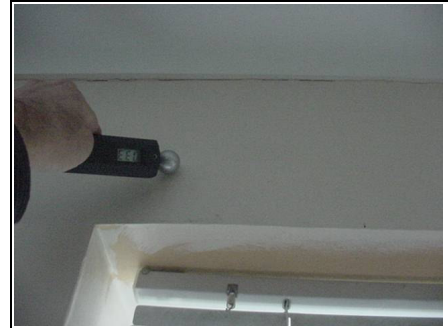
The decoration is average to poor, with minor marks as you would expect in a property that's been lived in. We would draw your attention once again to the areas around the windows where we believe the black mould has been present and has been cleaned. There are also areas which have been part painted and not completed, we don't know whether this is painting over the black mould or whether it is where blinds, etc may have been removed.

Painting not completed around windows

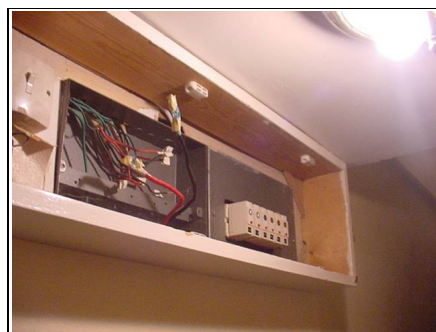
Fuse board

**ACTION REQUIRED:** Replace the fuse board ASAP.

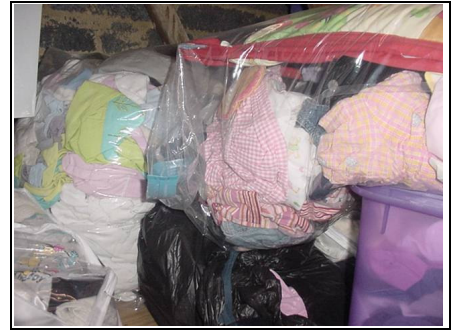
Unfortunately in this instance our inspection has been very limited due to the mass of stored items in the roof space and lots of stored items in the property.

Mass of stored items in the roof space
