# **RESIDENTIAL BUILDING SURVEY**

**Bury St Edmunds, Suffolk. IP33**

**FOR**

**Mr M**

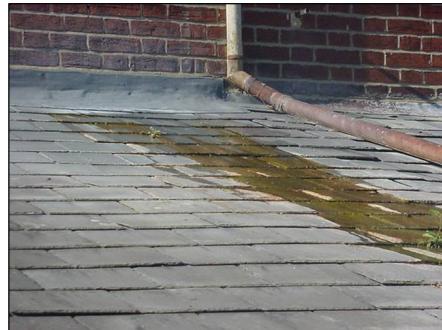
We noted to the rear of the property that you have some aluminium downpipes, these are rusting, although it is literally on your neighbours property it will affect yours as well. It may be worth having a ‘cup of tea’ discussion with your next door neighbours to get it replaced.

Leaking aluminium downpipes

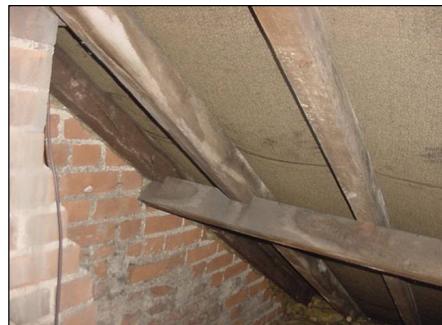
Condensation dampness getting in roof

**ACTION REQUIRED:** We would recommend that the roof in the kitchen is vented – by putting side vents in the wall, it would be best to do this in conjunction with your neighbour also venting their roof which is part of the same roof. We would also recommend adding of an extract fan next to the light switch within the bathroom, ideally 150mm in diameter with a humidity thermostat control. We also recommend that the roof is vented.

**ANTICIPATED COST:** In the region of £1000 - £3000; quotations required.

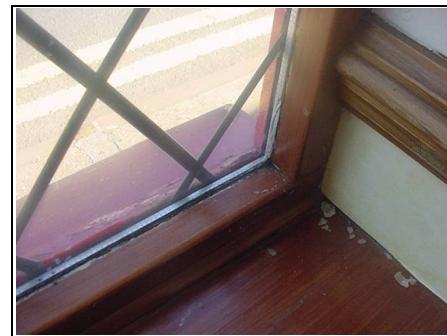
Thin double glazing

**ACTION REQUIRED:** You may wish to look at replacing these with a modern double glazed window which has a combination of thermal properties and sound insulation, particularly important for the front windows which are adjacent to the road.

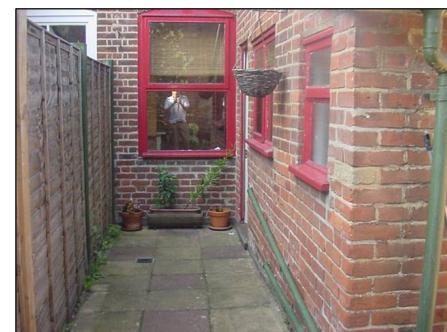
To the rear of the property we believe that whenever it rains it discharges to the rear of the property which can cause dampness.

Slope needing a running gulley

**ACTION REQUIRED:** Next time it rains you need to stand outside the property and check how bad this is, if it is bad add a running gulley.

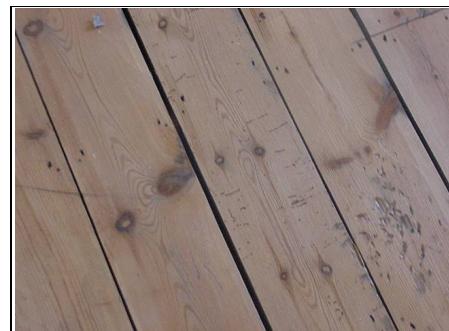
Signs of woodworm in front bedroom floor

**ACTION REQUIRED:** We suggest both the ground floor and first floor are opened up and checked for active woodworm. We would be more than happy to return to comment further.

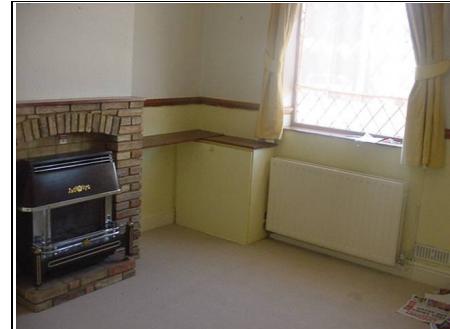
The property has an old style back boiler these are not as efficient as modern boilers however we find that due to being less technical they tend to be easier to repair by plumbers however the jury is still out as to how efficient the modern boiler really is when you take into consideration they need to be run at specific temperatures and maintained regularly.

Back boiler in front reception room

**ACTION REQUIRED:** We do feel you need to budget for a new boiler which we would suggest is relocated from the front room to either the kitchen or as the kitchen is small the roof space. A combination boiler would mean that in turn you would be able to remove the hot water cylinder. You need confirmation and assurance that the heating is working or you need to budget if it is not and allow the sum of £3500 for a new boiler and heating system and due to having micro-bored pipes we would recommend that these are replaced as well.

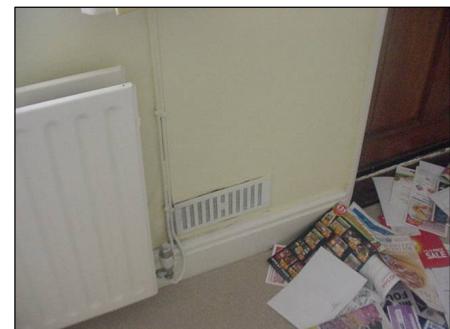
Our major concern is the heating system has micro-bored pipes, these tend to block. We did not have the benefit of turning the heat on in this case (we do not turn it on unless there is an owner present) to ensure one, that the heating is working and two, we would suggest you need to add normal pipes before the winter of 2010.

Micro-bored pipework

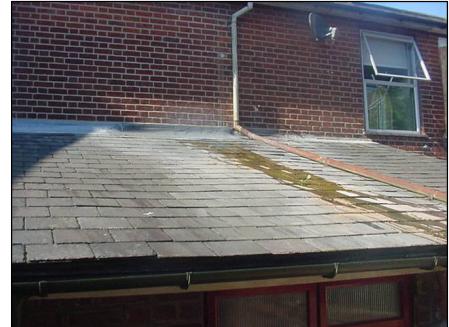
The overflow pipes are overflowing which is likely to be minor however we can see from the staining to the roof it has been going on a long, long time. This needs to be resolved as quickly as possible. It is likely to be a ball valve problem as discussed.

Staining to roof from  
overflow pipes

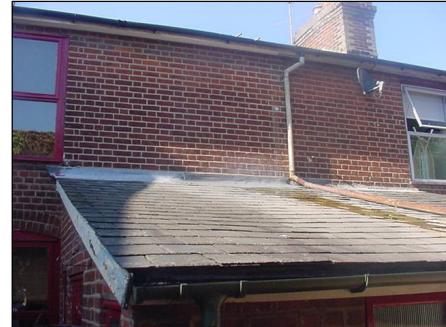
Low level roof

Generally we would comment it is in reasonable condition, obviously the water that has been landing on it from the overflow for a long time is not ideal and has caused some deterioration.

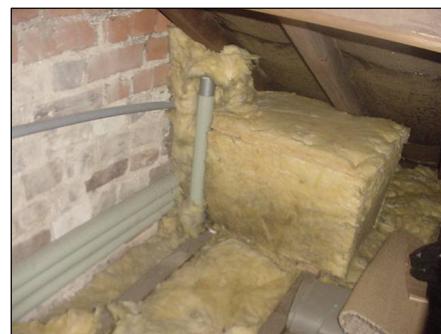
The water tank is heavily insulated, far more insulation than we have seen for a long time, this may be a problem in the winter months which may lead to it freezing over as there is no heat from the house getting to it. We recommend draining down the tank and cleaning it

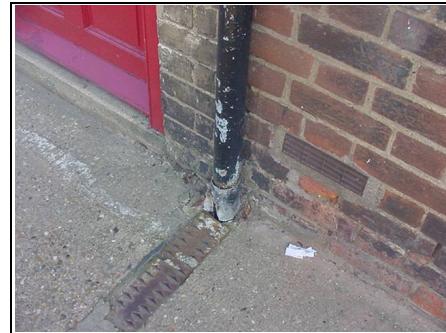
Guttering to front

We noted a mixture of aluminium and plastic, gutters and down pipes. Aluminium of this age can cracked and rusting, and presently needs some work. The aluminium is corroded to the rear of the property and probably requires replacement.

**ACTION REQUIRED:** The guttering and down pipes, needs reviewing and rationalising. We would always recommend that the rear guttering is repaired or replaced. We always recommend that gutters and downpipes are cleaned out, the joints are checked and the alignment checked to ensure that the gutters fall towards the downpipes.

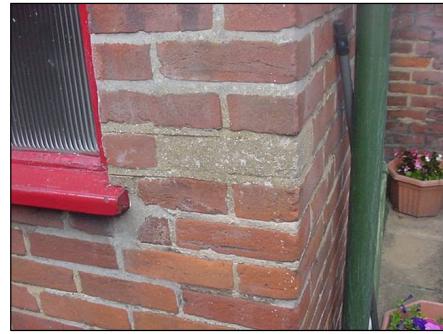
Generally Flemish Bond brickwork is liable to penetrating dampness internally, dependent upon the condition of the brickwork and the exposure to the weather. In this case there is some deterioration occurring where the cement mortar has allowed the wearing away of the brick.

Deterioration being cause to the bricks by the cement mortar.

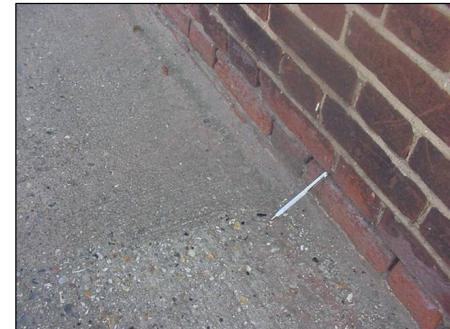
Repointing needed to front brickwork

**ACTION REQUIRED:** Repoint in a like for like mortar.

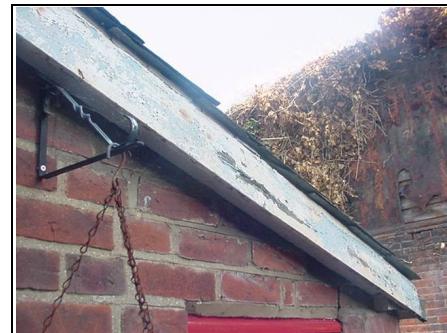
You have a painted timber fascia and soffit board to the rear of the property you can see it is in need of redecoration - it is just about saveable.

Fascia showing signs of age

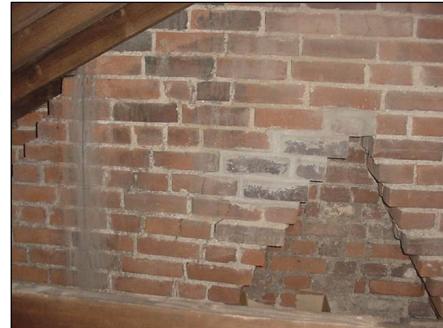
The chimney breast internally within the roof has a stepped crack in it therefore if you do want to use the fires as proper wall fires you need to get the linings checked and tested as you otherwise may put smoke into the roof and/or worse still cause a fire within the roof.

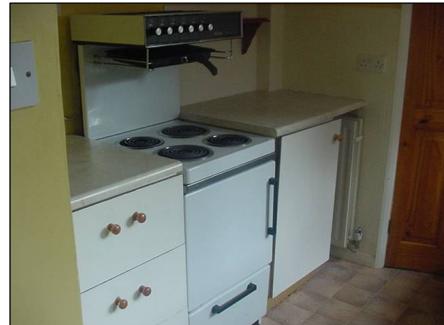
From our cursory visual inspection the kitchen looked dated, although it has suffered from some general day-to-day marks. We have not tested any of the kitchen appliances. It is not to the standard of the rest of the property.

Dated kitchen

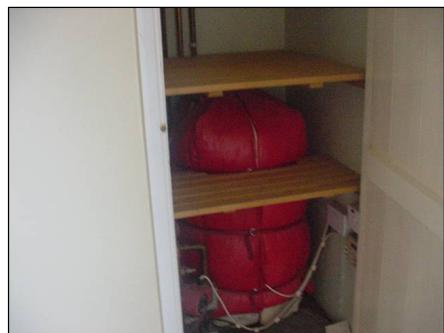
The hot water cylinder is dated (in this case we would estimate over 30 years). In our experience, in this age of hot water cylinder defects can start to occur and, unfortunately, hot water cylinders rarely give any proper warning before they leak/bust!

Hot water cylinder

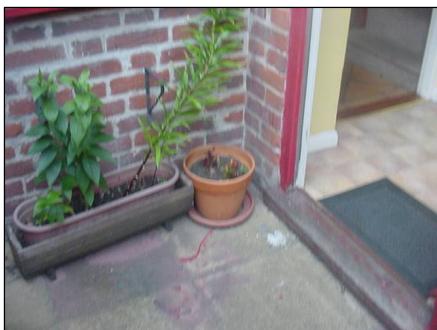
The paving runs towards the house, we have recommended a running gulley.

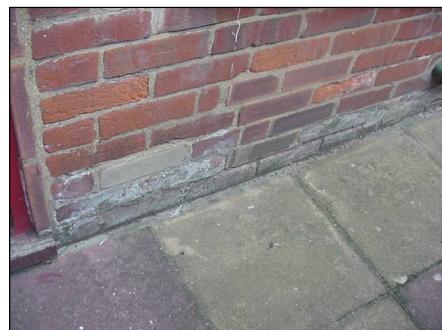
Here you can see the side to the brickwork which have been damaged over the years with water or rainwater from an overflowing waste pipe, you will soon discover which when it next rains.
