JOB REFERENCE: xxxxxxxxxxxxxx

RESIDENTIAL BUILDING SURVEY

Camden,
NW3

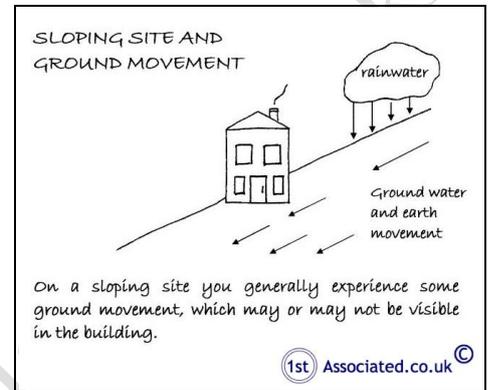
We can see what we believe to be a French Drain has been added to the side of the property and partly to the rear. We do not know when this was added (as the occupier could speak little English) or if it is a true French Drain.

ACTION REQUIRED: To check the French Drain that you have is a proper French Drain. We would also say that as an overall concept the French Drain should be added around the entirety of the property and not just to parts of it.

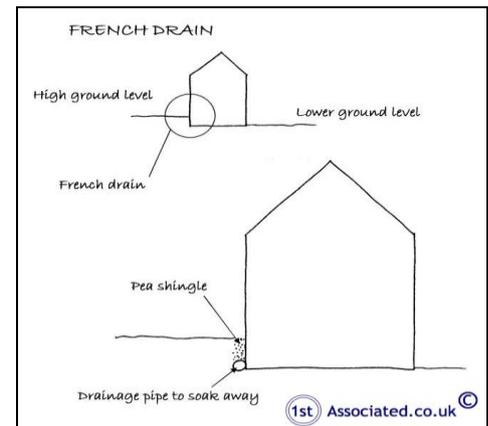
Is this a proper French Drain?

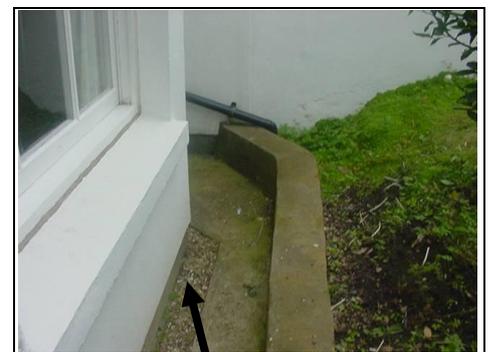
Is this a proper French Drain?

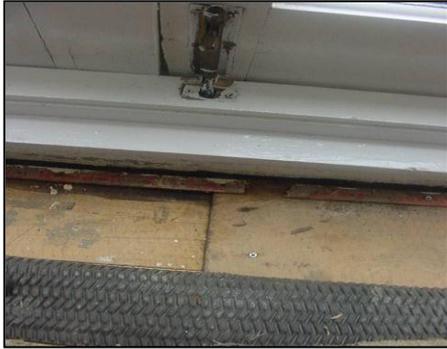
We can feel deflection in the floor that indicates deterioration has taken place and we could see that, when we lifted the carpet to the rear master bedroom, there is a problem with rotting floors beneath.

Deterioration in the floor

The main problem here is that the property sits on a sloping site and the ground levels are low. So you do need to resolve the dampness getting into the property as what we have discussed here with regards to the suspended timber floor is the effect. The cause is the dampness getting in.

ACTION REQUIRED: You need to open up the entirety of the suspended timber floor areas and check for wet rot, dry etc. ideally this should be carried out before you purchase the property.

ANTICIPATED COST: Best case scenario is a few hundred pounds and the worst case scenario could be a major replacement of the floor which could range from £5,000 to £15,000 (five thousand to fifteen thousand pounds). This is dependent on how easy or difficult it is to replace the joists particularly bearing in mind the concrete floor; please obtain quotations.

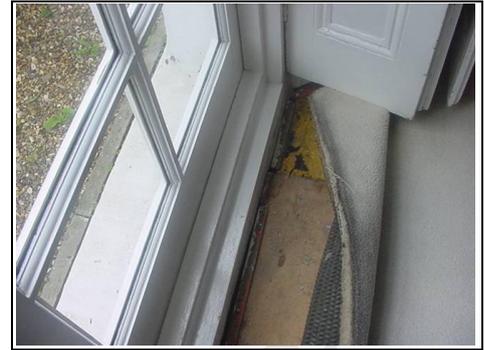
Deterioration in the floor

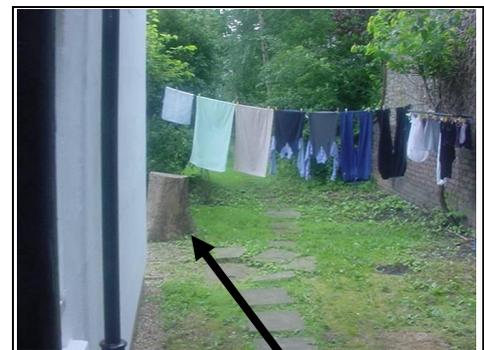
We believe the tree has had quite an effect on the property as we could see hairline cracking to the walls (this is partly due to age of the plaster) and we could also see movement to the doors and windows where they are out of square.

Tree stump is very close to the property

ACTION REQUIRED: We feel the best way to deal with this is for the landlord to put in an insurance claim with regard to movement on the property. This would then allow for monitoring for a year, which is what is recommended by the Building Research Establishment, rather than a one off inspection that you have had today.

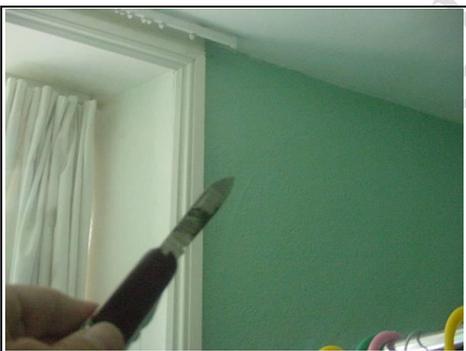
Cracking to rear bedroom adjacent to where the tree was

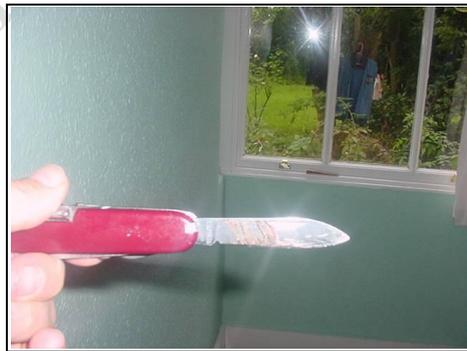
Further cracking to rear bedroom

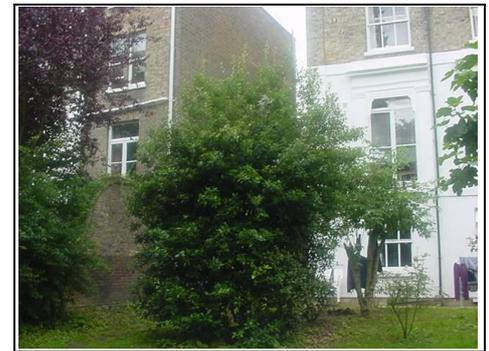
Remaining trees are close to the rear of the property

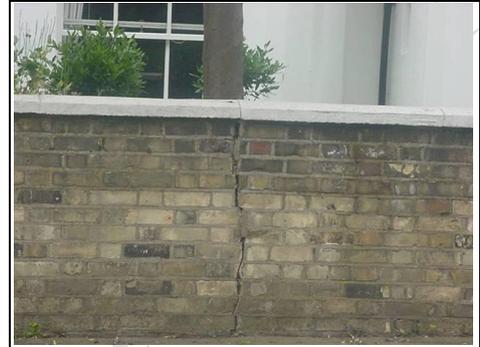
Whilst we are on the subject of trees we would just comment that the trees to the front of the property have caused cracking to the boundary wall. This will be a shared item and a shared cost to repair.

Crack in the boundary wall caused by the trees

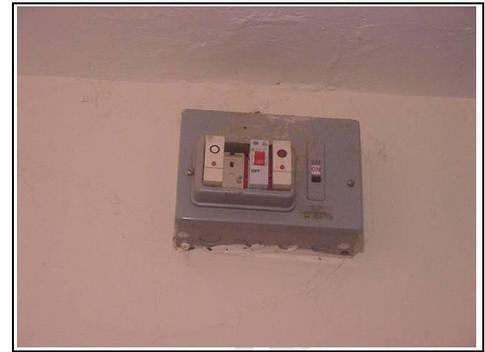
Dated Fuse board

ACTION REQUIRED: We would recommend replacement.

ANTICIPATED COST: As it is likely to need re-wiring as well we would expect costs to be in the region of £2,500 (two thousand five hundred pounds) plus, even just to carry out minimum work. From our survey we would also say that additional socket points are required. You can combine this sort of work with the work we have recommended to the floors; please obtain quotations.

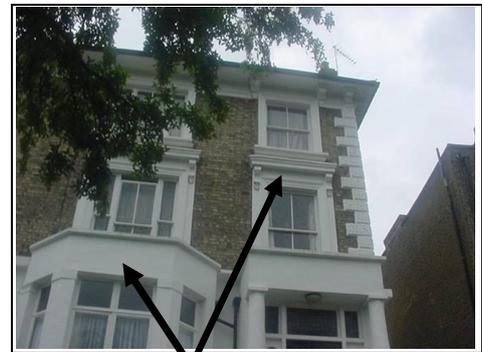
A good landlord would have a planned maintenance programme in place for such things as roof replacement, replacement of timber lintel (beams) over the bay windows etc. as these are often a problem. There may still be many timber lintels in the property.

Timber lintel over bay window

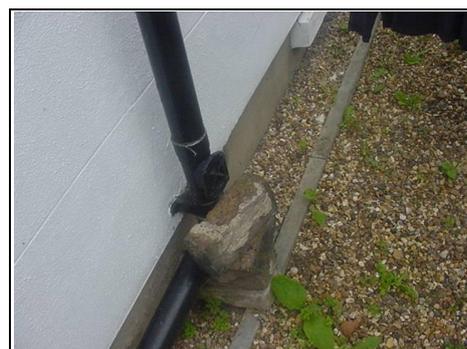
Bricks supporting the downpipe

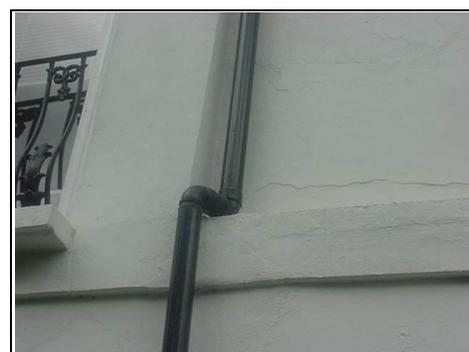
There may be some minor leaks to the gutters and downpipes but most people would be happy to live with these providing repairs are carried out within the next six to twelve months.

Awkward swan neck downpipe is leaking slightly

ACTION REQUIRED: We would always recommend you stand outside the property next time it rains heavily and see how well the drains cope with the rainwater particularly looking at the guttering and the joints.

We would also recommend that the gutters and downpipes are cleaned out, the joints are checked and the alignment checked to ensure that the gutters fall towards the downpipes.

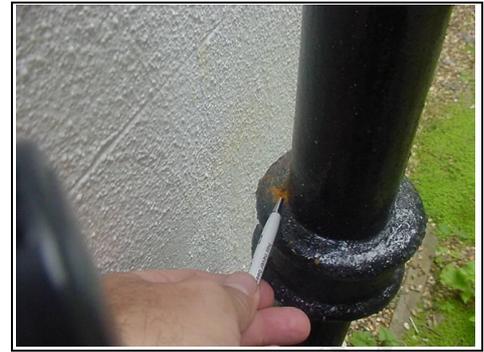
Some rusting to the downpipe

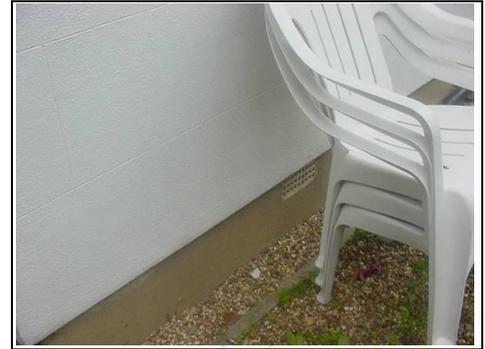
New render

ACTION REQUIRED: As the render looks relatively new we would recommend that you ask the owners / landlords when it was replaced and how?

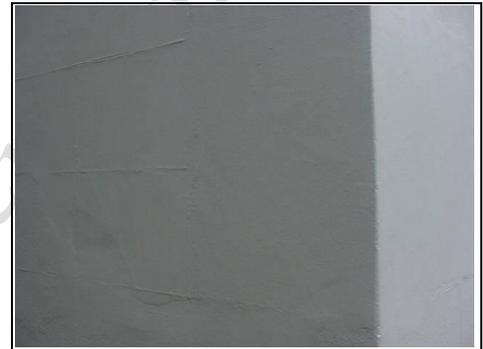
Stucco plaster has been repaired over the years. The lines are missing

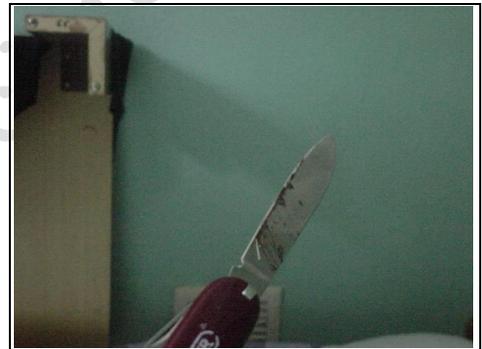
Hairline cracks in rear right hand bedroom

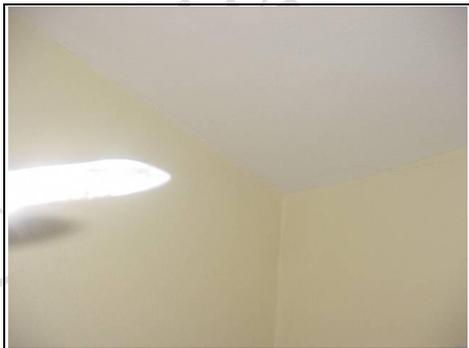
Cracking in the kitchen

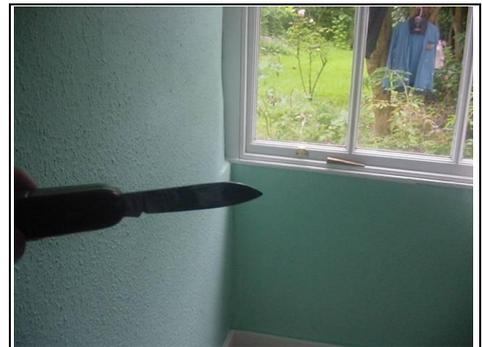
Window out of alignment

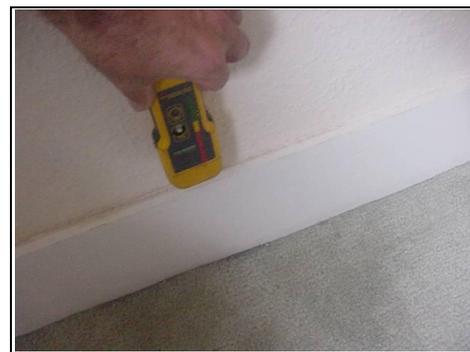
A random visual inspection and tests with a moisture meter have been taken to the perimeter walls. In this particular case we have found minor rising damp in the property.

Testing for rising damp

ACTION REQUIRED: Please see our comments within the Executive Summary.

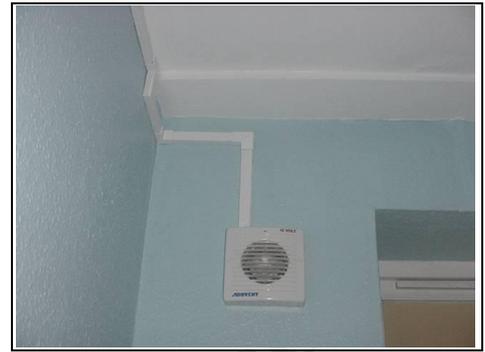
We would replace this extract fan in the bathroom with a larger humidity controlled extract fan

ACTION REQUIRED: We would recommend humidity controlled extract fans be added to kitchens and bathrooms.

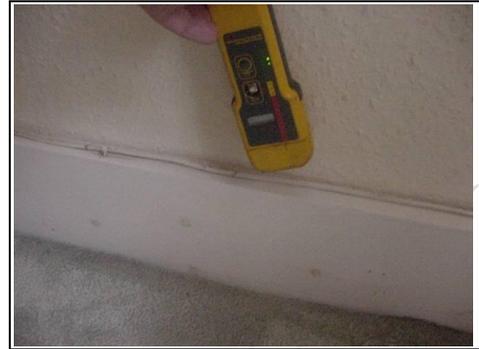
These look to be a modern replacement skirting as we can see the knots grinning (showing) through. This does indicate that dampness is coming in or the original skirtings were not treated properly.

Knots in skirting grinning through in bay window and testing for damp

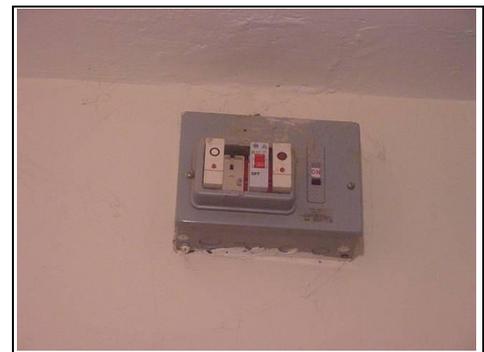
The electric fuses and consumer units were located in the central larder/storage room. The fuse board looked dated, circa 1960's – 1980's and better are now available. In multi occupied properties a defective fuse board can be particularly dangerous.

Fuse Board

We would recommend an Institute of Electrical Engineers standards (IEE) test and report carried out by an NICEIC registered and approved electrical contractor or equivalent.

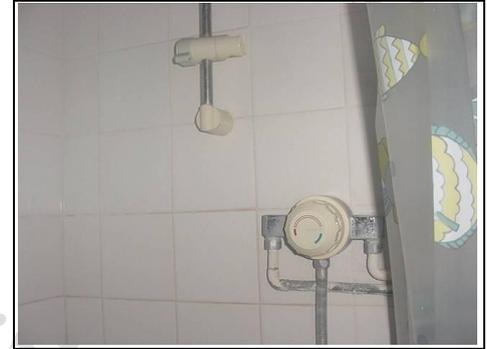
The property has a two piece bathroom suite, consisting of a bath and wash hand basin. There is also a shower within the bath. This looks in below average condition. Please note our earlier comments with regards to having a thermostatic controlled shower installed as water pressure is affected by taps being used and flushing toilets etc.

Shower in the bath.
The tiles have seen better days

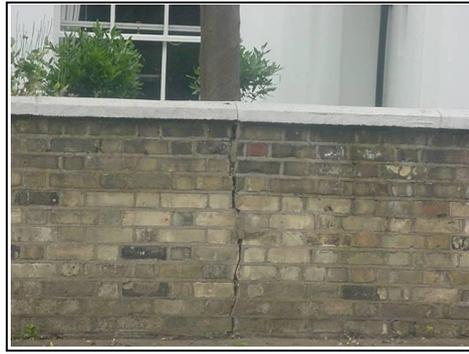
Crack in the boundary wall
