RESIDENTIAL BUILDING SURVEY

Monmouthshire

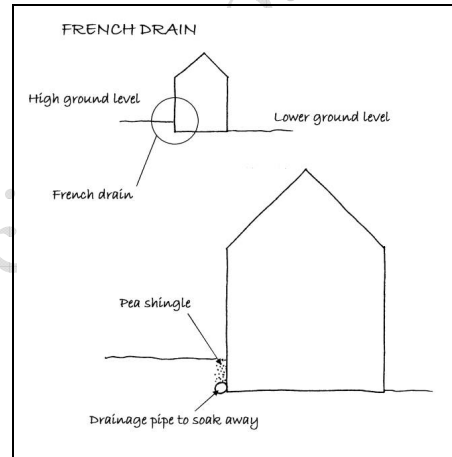
Please see the Walls Section of this Report.

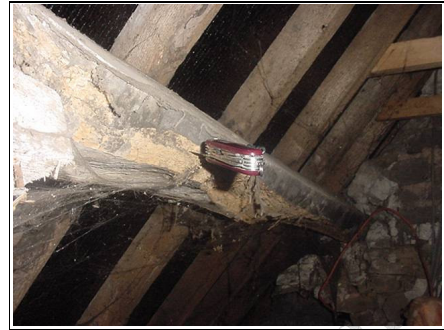
Utility/services room roof which is in a poor structural condition due to woodworm

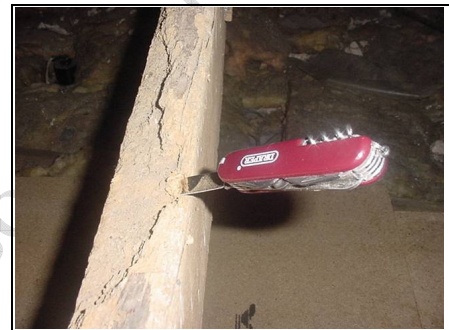
Woodworm in roof over right hand bedroom

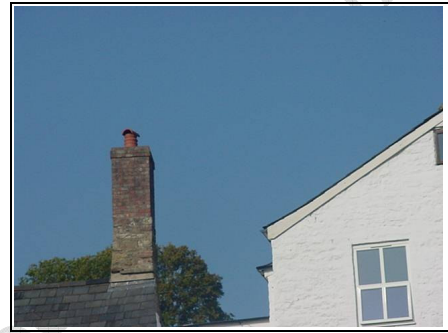
Badly repaired chimney

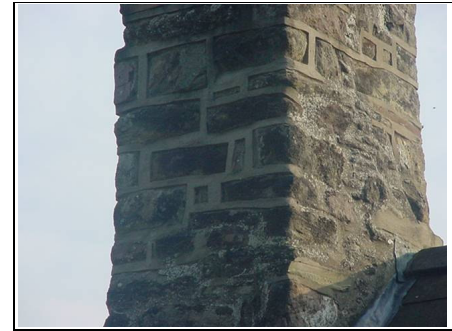
Close up of cement repair to main central chimney

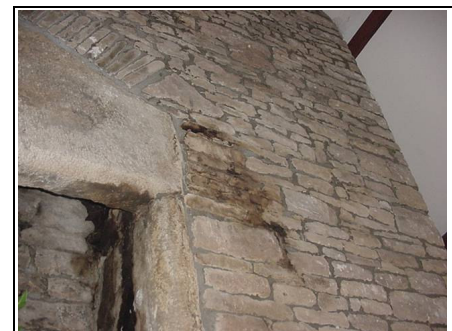
Likely to be sulphate attack

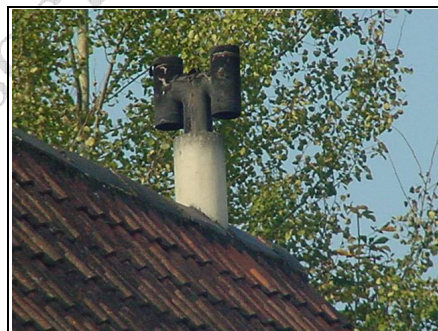
We can see an asbestos flue at roof level and also in the roof above the kitchen and no doubt it carries on down into the building. Asbestos was quite a common material to be used in older properties particularly around the 1960/1970's.

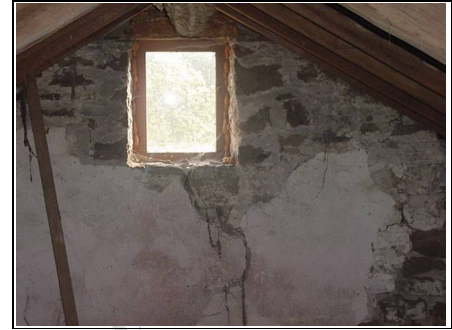
Crack to front right hand gable

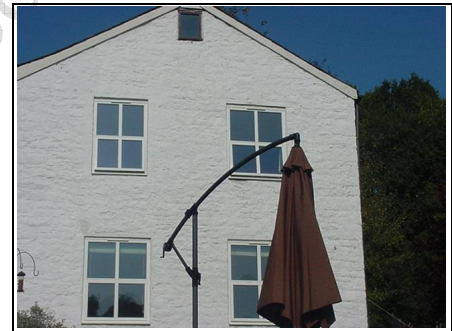
Crack not visible to outside of property due to paintwork

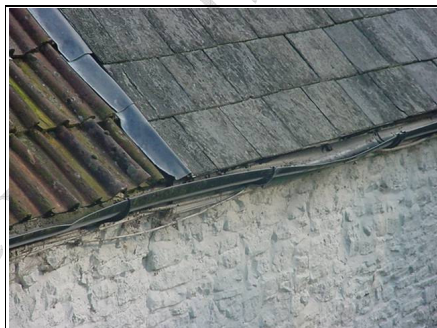
Defective guttering and downpipe

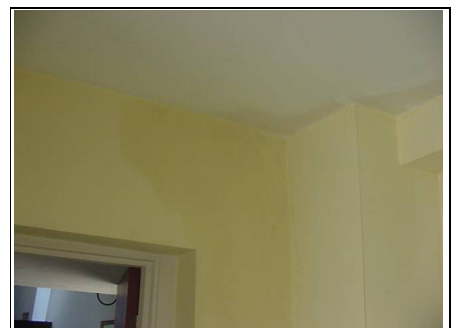
Damp staining to right hand side of property which we believe is coming from a leaking roof or leaking soil pipes

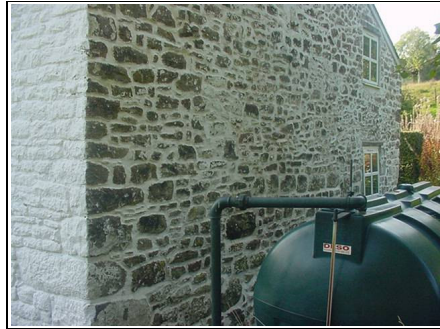
Defective wall coating

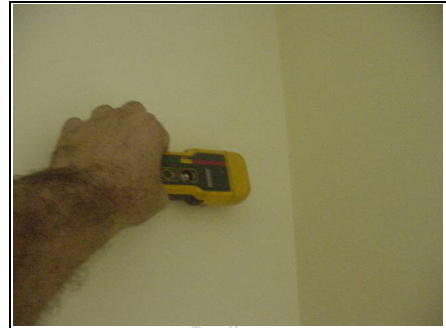
Dampness found to chimney breast in right hand side of property

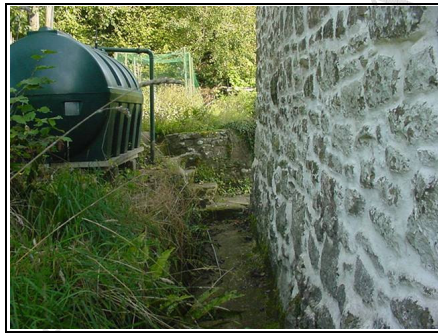
Dampness coming in through the rear wall at ground level where you can see the moss and due to the lack of a protective coating to the walls

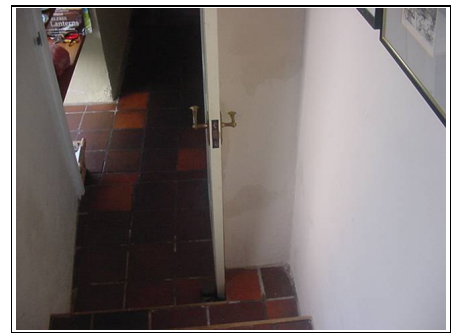
Dampness found around the steps down into the kitchen area

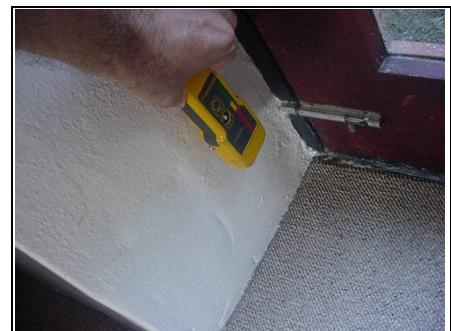
Dampness found by door in lounge with feature chimney

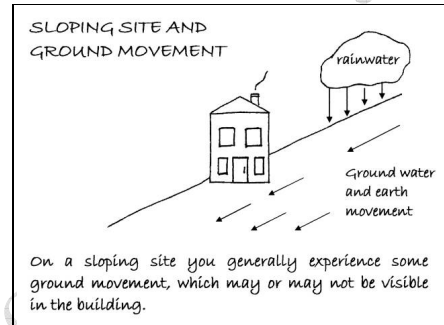
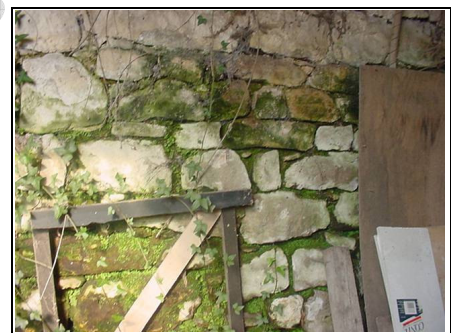
Single storey height barn

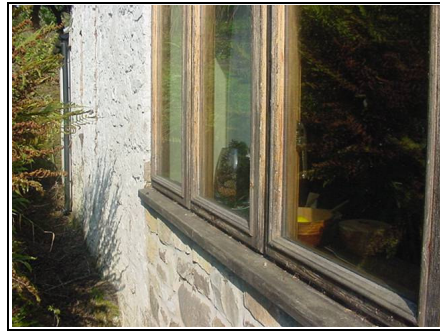
Window in need of repair and redecoration

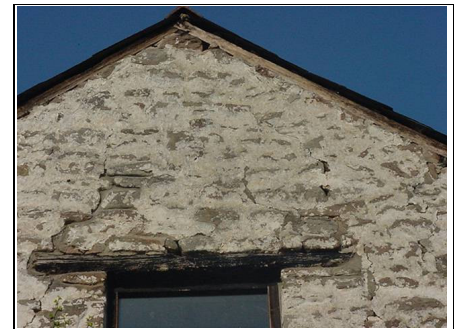
Timber lintel to barn

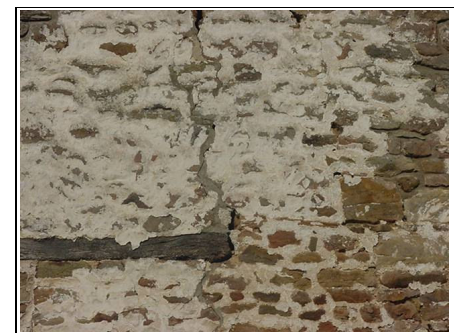
Barn – where you can see bearing or bonding timbers

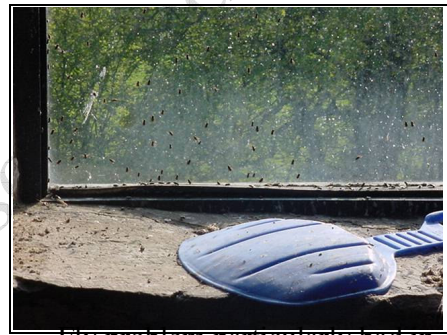
Fly problem particularly bad in outbuilding two

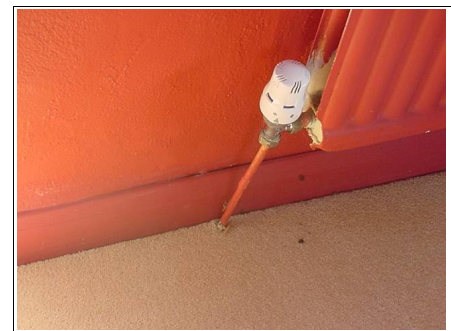
Whilst the property has two boilers, it is also the thermal efficiency of this type of construction that dictates how warm the property will be. There can be a considerable chilling effect caused when properties are higher up a valley (such as wind chill causing hypothermia). We also noted that the radiators use a system of micro bore pipes which were common in the 1970's however the only people that seem to like them are the plumbers that use them in an installation as they allow central heating to be put in quickly however in our experience they do block up and are not that efficient. We have recently replaced lots of these pipes in our own house.

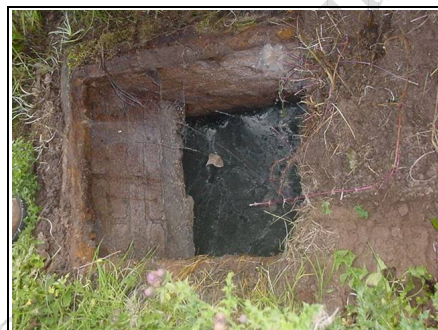
We spoke to the owners about this during our question and answer session; they advised that it was emptied about once a year. This tends to indicate that it is a brick manhole which is leaking into the ground to some extent although water usage is very low (or a very large tank).

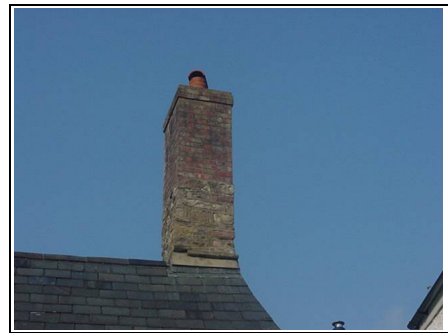
This chimney is predominantly stone finished with a brick top section and a chimney pot. From what we could see from ground level it looked in below average condition considering its age, type and style. Unfortunately we were unable to see the flaunching, we therefore cannot comment upon them. We believe there is sulphate attack to the base of the chimney.

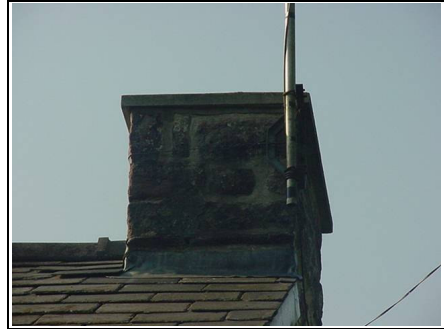
This chimney is also built in stone, it looks to have been dropped (lowered), and capped. We found some dampness coming into it, we much prefer these chimneys to be well ventilated with a cap as this also reduces the chances of staining/sulphate attack.

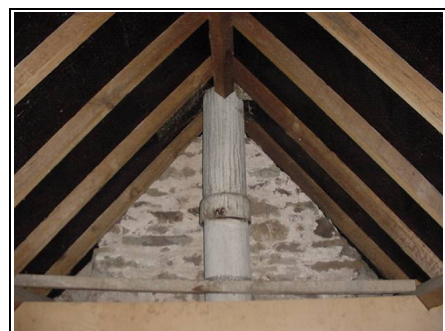
Water staining on flue indicating dampness is getting in

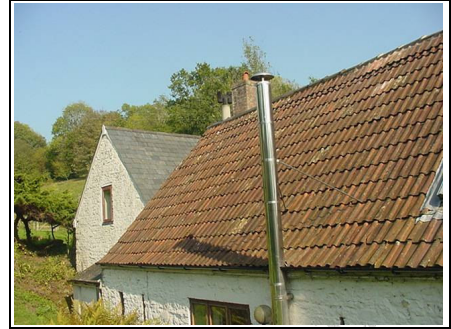
- iii) Flue on right hand side of property – we believe relates to the boiler below.

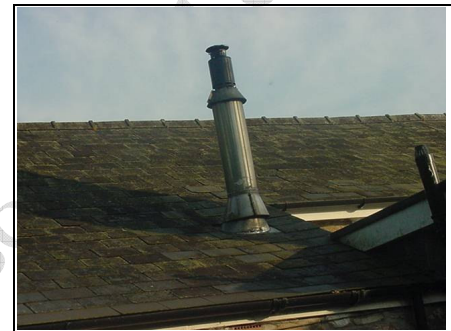
Please note we haven't tested any of these flues or chimneys.

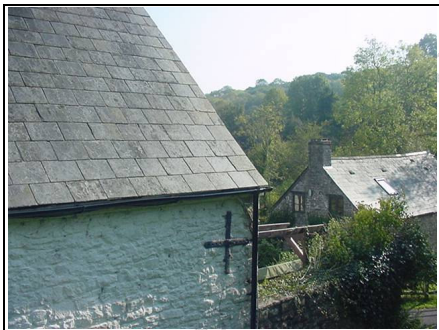
Slate roof left hand side front

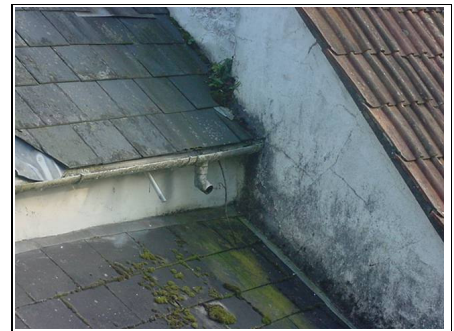
Rear left hand side slate roof – in worst of conditions which looks to have some man made slates

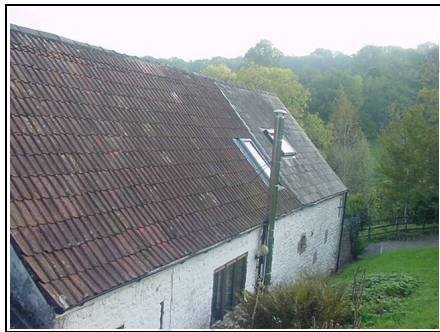
General view of tiles

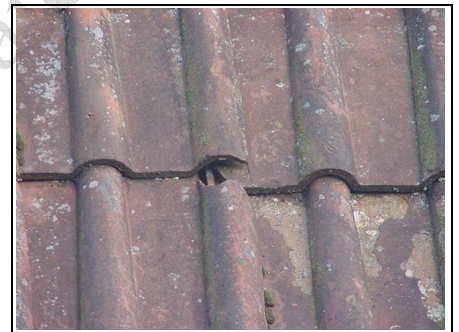
Damage in tile of roof

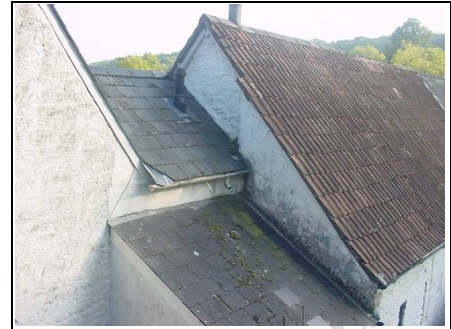
To reiterate and advise further we find that the junctions on properties are the areas where rainwater gets in. In this case we can find damp patches within the property, for example to the rear left hand side where there is an upstand also coincides with the steps into the kitchen and we believe that water is getting into this area. We would recommend a flashing detail is added and improved in this area. In the same way where the flat roof meets the pitched roof on the right hand side, again we found dampness at ground floor level which we believe may relate to this or a leaking service pipe within the boxed in section.

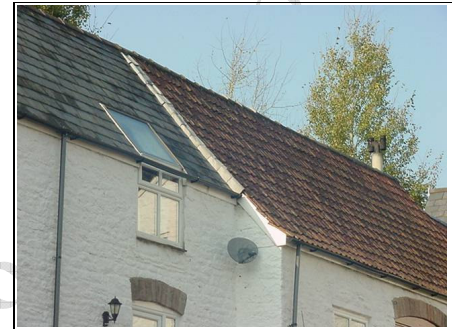
Slate and tile roof meet

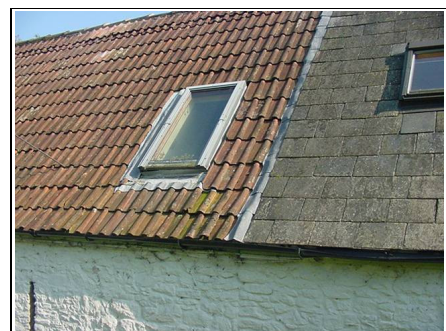
Protective Underlayer (Often known as the sarking felt or underfelt)

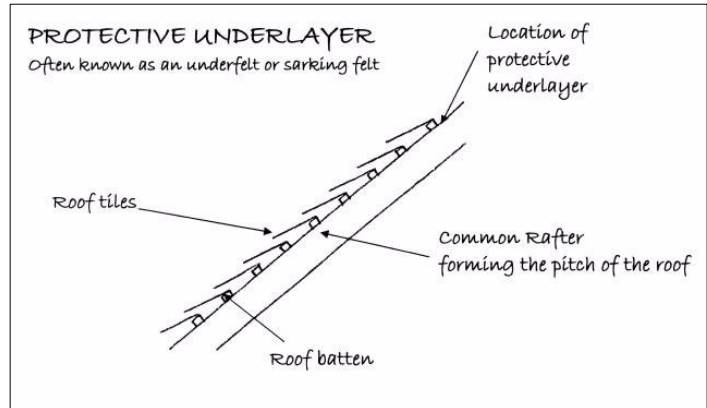
We gained access to three roofs. In each of the roofs there was a protective underlayer indicating that they have been re-roofed since the 1960's.

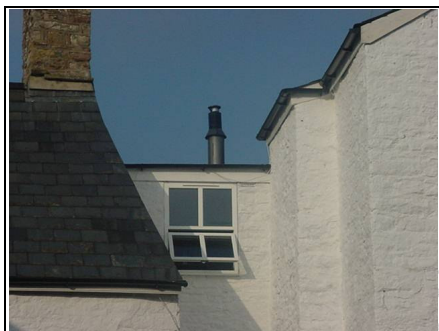
The flat roof was difficult to see as it is jammed in for want of a better term, between the middle chimney and the corridor to the front bedroom and the stairway area. As mentioned we were given limited access to this area so we weren't able to check properly whether the roof was leaking. We would however say that flat roofs do tend to leak sooner or later.

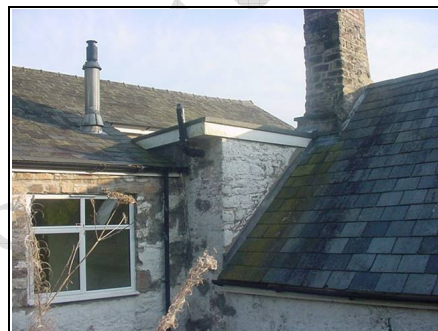
Close up of flat roof

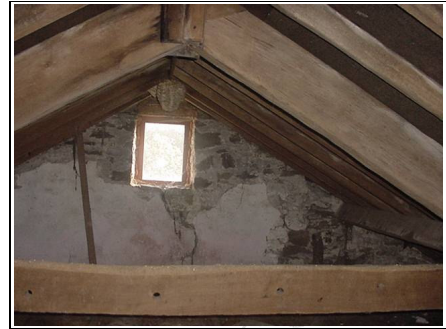
Roof over bedrooms right hand side

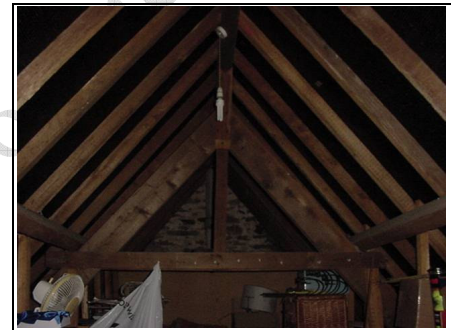
Our examination was limited by the general configuration of the roof, the insulation, boarding and wasps nest in the right hand roof, however we would comment that we generally found the roofs in below average to poor condition due to extensive woodworm.

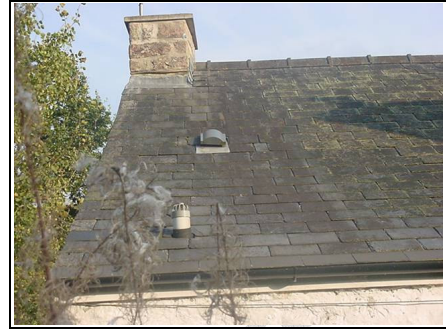
ACTION REQUIRED: You need to have ventilation to the roofs added. This will help reduce the activity of the woodworm as they are not particularly keen on a colder, dryer environment rather than the warm moist environment that they have at the moment.

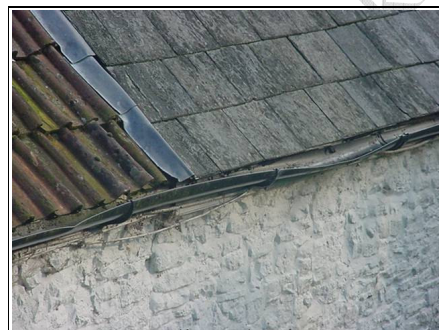
Bending plastic gutter

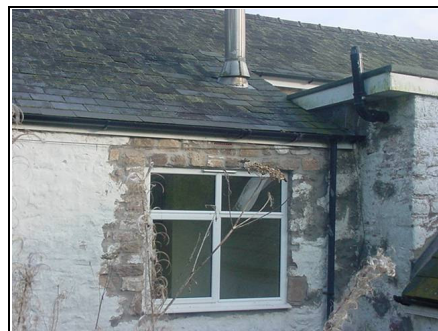
We can only see soil and vent pipes at roof level. As they are internal we can't comment upon their condition other than to say that it does look like there is a leak from a service pipe to the right hand side of the property near the stairway; you need to open up the property.

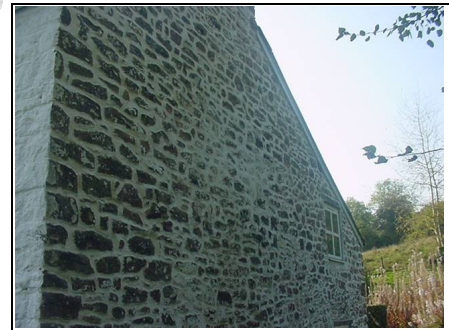
Rear of the property

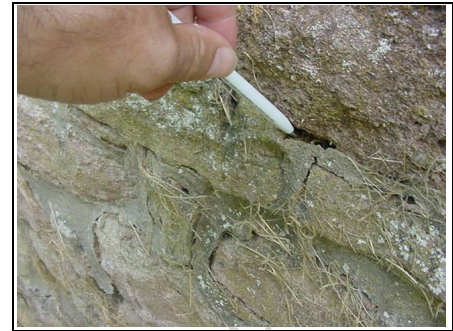
Wall with cement mortar

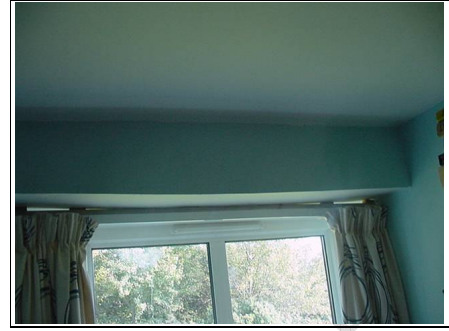
This property will probably have timber lintels as we can see timber beams internally and given its age. However these have been painted over and we note that some have been replaced in concrete. As you work via each elevation that we have spoken about earlier in this section you will need to also check the condition of the lintels and any bonding timbers or bearing timbers.

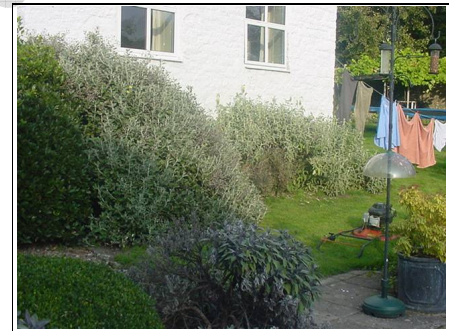
Plants growing around base of property

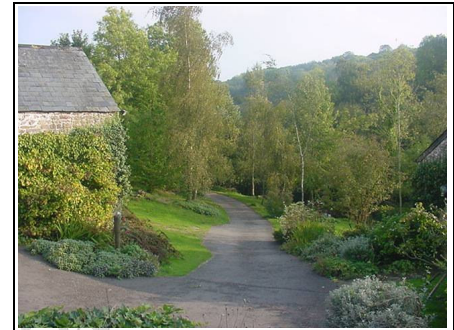
There are trees surrounding the property within what we would term as influencing distance of the outbuildings. As mentioned earlier it depends on what you wish to use the outbuildings for and how important these are to you. Some are closer than most insurance companies would like! We feel that generally where trees and the buildings have lived together for some time there aren't any problems as long as the trees are maintained and not allow to literally grow next to the buildings.

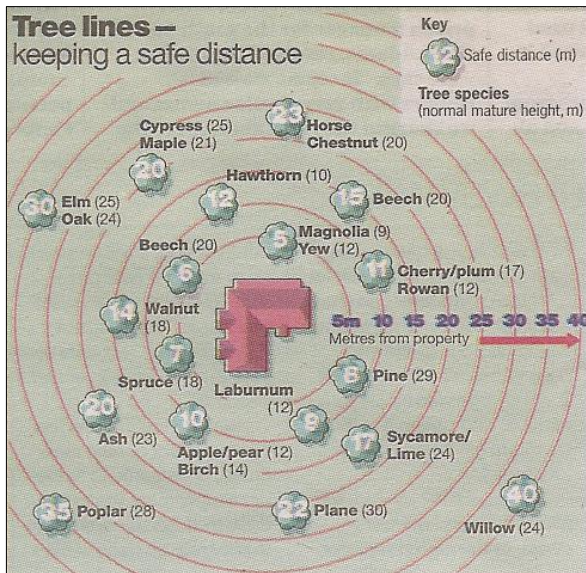
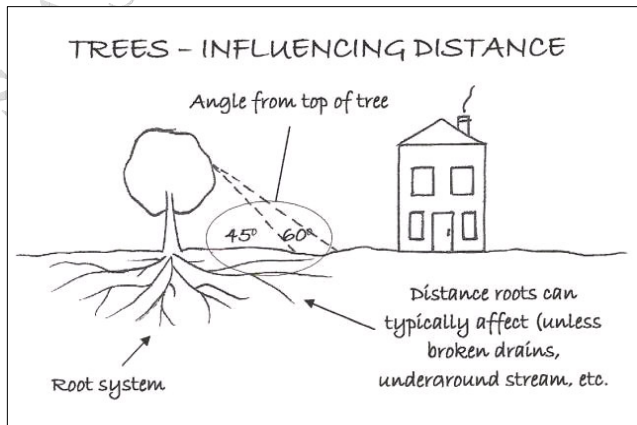
Influencing Distance Defined

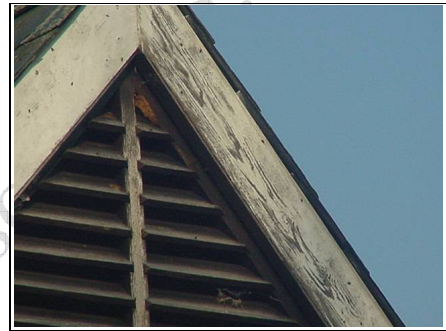
ACTION REQUIRED: We would recommend redecoration in the summer of 2012.

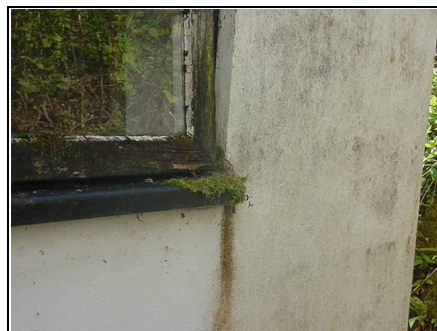
Windows in need of repair and
re-decoration

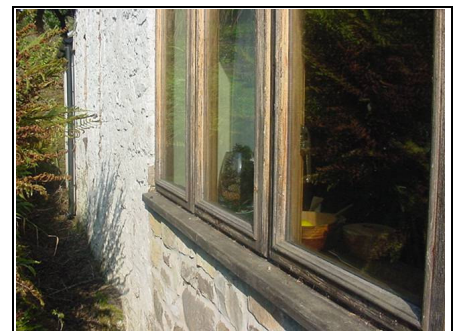
The property has plastic double glazed windows, which generally look to be of a reasonable quality. We would draw your attention to the fact that sealed double glazed units can fail, particularly as a result of poor workmanship during installation. Failure of the seal leads to condensation between the two panes of glass and simply replacing the affected units may not provide a satisfactory long-term solution.

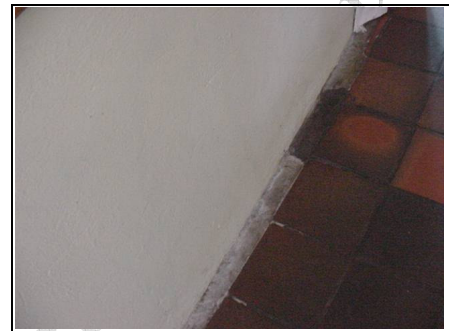
Poorly finished kitchen tiles

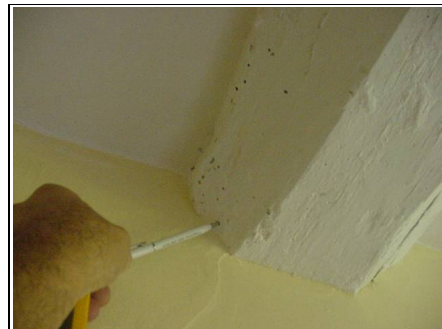
Rear bedroom right hand side

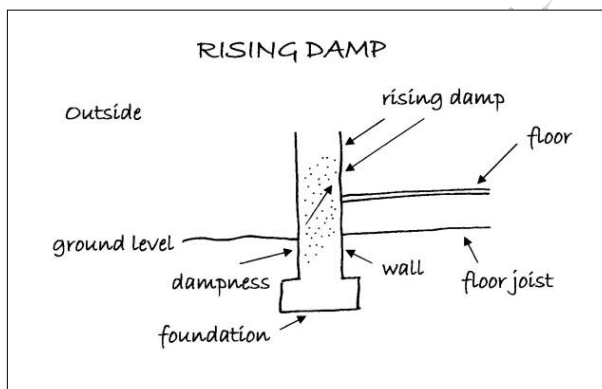
A visual inspection and tests with a moisture meter have been taken to the perimeter walls and some internal walls.

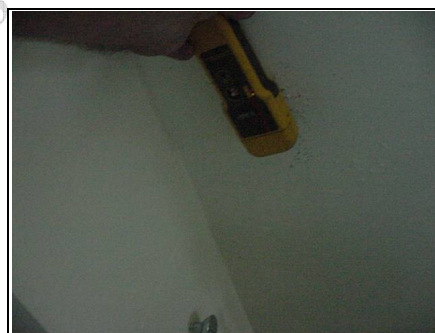
Rising damp in rear shower room

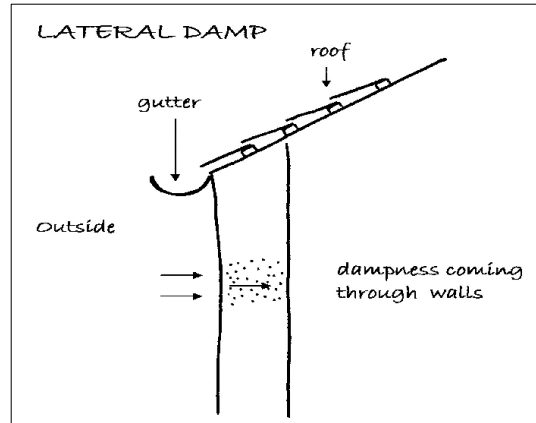
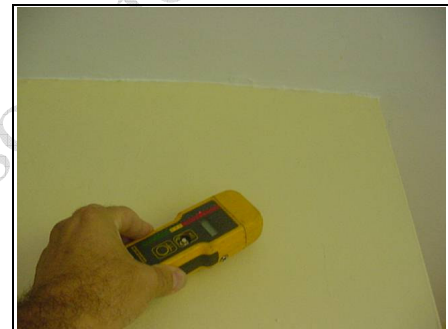
High level damp internally in far end of property

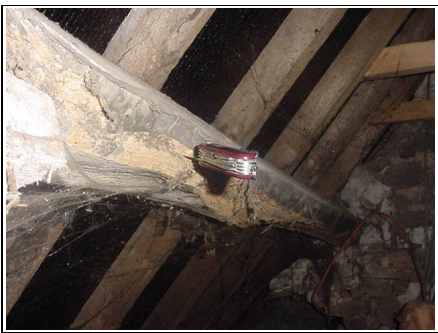
Third roof where there is the worst woodworm

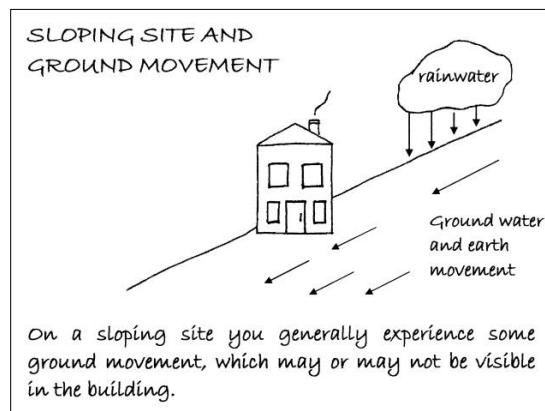
Any property on a sloping site is more susceptible than one on a flat site; it is simply the laws of gravity. Foundations normally allow for such occurrences, particularly in new properties. There can still be some minor movement.

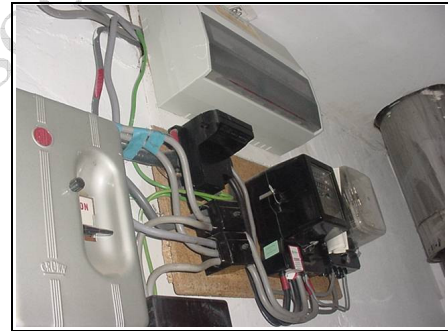
The electric fuses and consumer units were located in the utility/services room. The fuse board looked dated. In an older property a defective fuse board can be particularly dangerous.

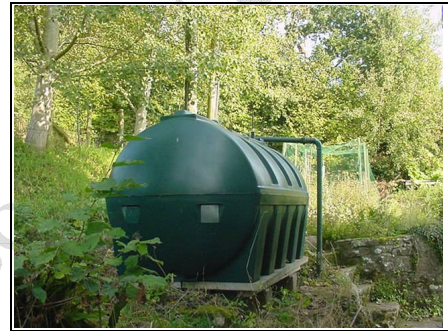
We were pleased to see that the oil tanks are plastic. These usually replace the older metal tanks that can rust and they typically have a double lining, meaning that if they leak they leak into the outer lining. We didn't check to see if the tank was full or not, in our experience most people leave them empty.

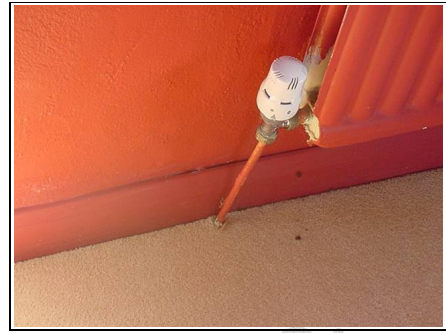
We are using this term to refer to supply pipes, wash hand basins, sinks, etc. Where visible it comprises of micro bore pipes. No significant leakage was noted on the surface, although most of the pipework is concealed in floors, walls and ducts. Please see our comments within the Executive Summary.

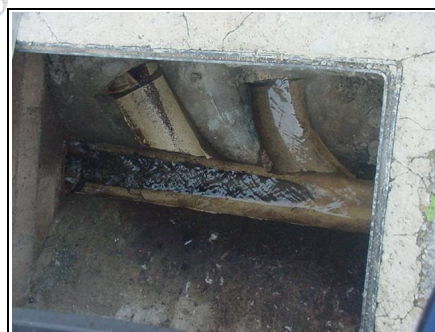
We duly lifted the cover and found it to be fairly clear and free flowing at the time of our inspection although it was relatively shallow.

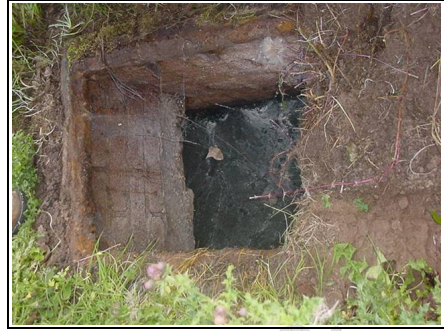
We have been unable to determine the adequacy of treatment or the effectiveness of the disposal arrangements.

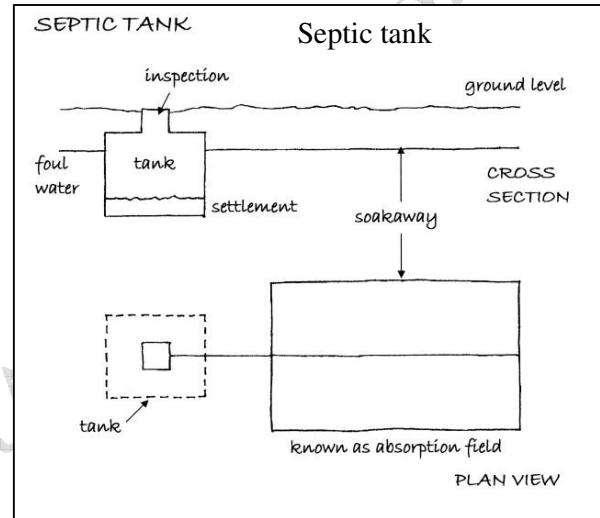
Finally, it must be emphasised that the condition of the property's foul drains can only be ascertained by the carrying out of a test; such a test has not been undertaken. Should there be leaks in the vicinity of the building then problems could occur, particularly with respect to the stability of the building's foundations. Drainage repairs are inevitably costly and may result in damage being caused to those areas of the property beneath, or adjacent to, which the drains have been run.

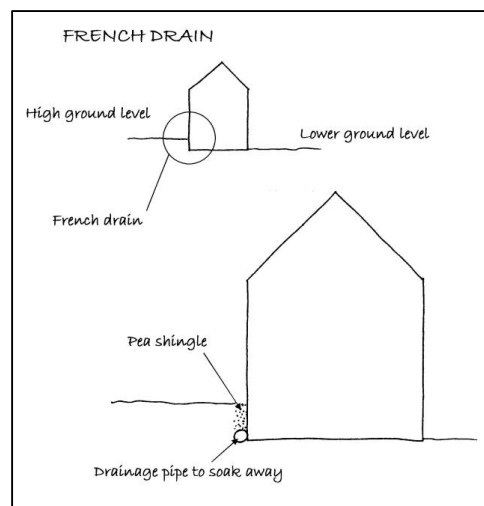
French drains must be on a slope
