# **RESIDENTIAL BUILDING SURVEY**

**Clophill, Bedfordshire, MK45**

**FOR  
Mr C**

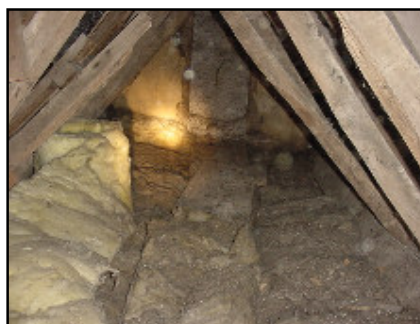
The clay roof to the front of the property undulates, as one would expect in a property of this age. When we were inspecting the roof structure we noted that one of the common rafters (these are the rafters that form the pitch of the roof) has moved. We suggest that this is repositioned. Do not get overly concerned about this, from our inspection we note that this type of work has previously been carried out.

Just to the left of the torchlight is the broken timber – sorry it is a poor photo but I was literally on my knees at the time.

**ACTION REQUIRED:** A competent carpenter should be able to resolve this problem and check the other timbers. Approximately one day's work. Our main concern would be that the carpenter, if he is not careful, will cause more damage than good – the roof is fairly delicate.

**ANTICIPATED COST:** £250.

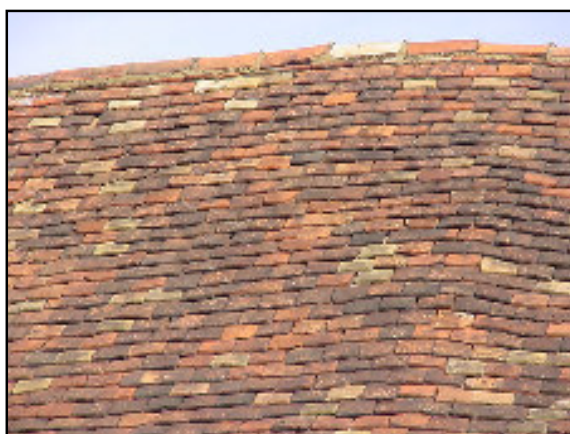
General view of the roof, you can see that the tiles are spalling and that they have opened up slightly, leaving gaps between them, which is why we have recommended a general overhaul of the roof.

**ACTION REQUIRED:** We expect that most of the work/time will be spent replacing deteriorating tiles as they are in a fairly poor condition and it looks like little more than gravity is holding them in place. If care is not taken then a domino effect could occur. Again, a good quality contractor is required.

**ANTICIPATED COST:** £2,500 - £5,000 – this very much depends upon the amount of tiles that are replaced. We suggest a quote is obtained for this prior to making a final offer on the property.

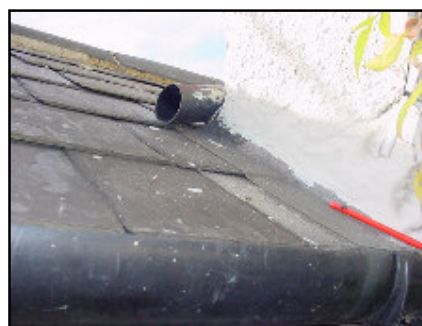
Following on from the above, the roof would benefit from a general check over once the roof structure repairs have been made. The cement flashings and various other bodged flashings, particularly to the valley gutter at the front of the property, should be replaced in lead.

The red pencil here indicates where a flashing has been added in a temporary material known as Flashband. This should be replaced in lead.

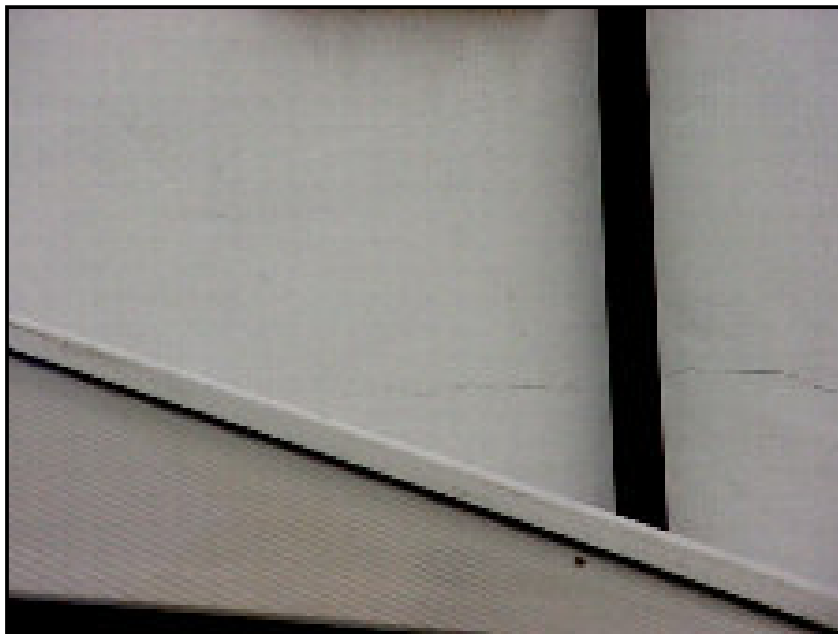
Possibly due to the various types of materials beneath the render there is hairline cracking in the structure. This sort of cracking needs sealing instantly. We always describe the render as being like a raincoat, and any cracks as being like leaks through that raincoat, which can and will cause damage to the structure below.

This horizontal hairline crack is an example of the sort of cracking that is being caused by differential movement in the structure.

**ACTION REQUIRED:** We would also suggest you go around the property with a mastic gun sealing any hairline cracks. You will also note hollow areas, which we identify later on within the report, that we suggest are hacked off, but not until the summer of 2004, and you will also note areas that have been repaired poorly, as they do not match in with the existing render.

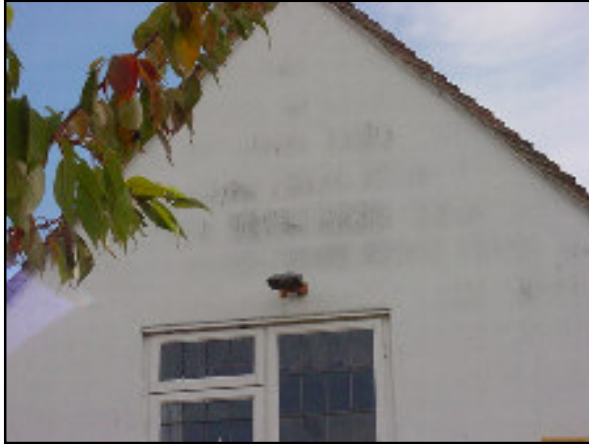
Here on the rear gable, if you look closely you can see pattern staining, indicating the structure beneath in a noughts and crosses type pattern above the window.

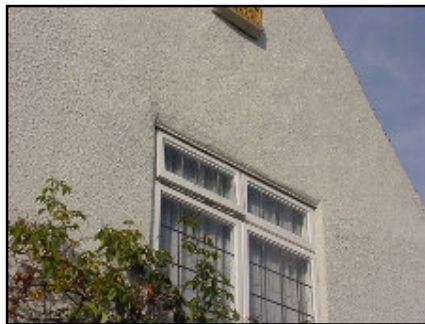
We would also comment that the quality of render can usually be determined by the quality of detailing upon it. In this case they are generally very poor. An example of this would be the presence of drip details (see photo below).

Above the window there should be a drip detail to throw the water away from the window.

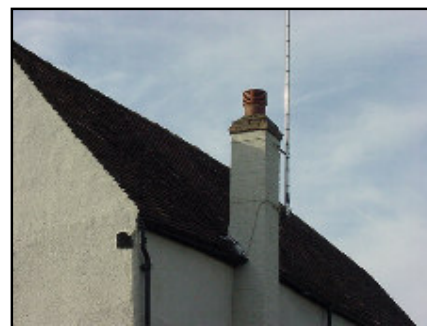
Our only proviso or additional comment would be to check the flashings when you are having the roof work carried out as the general standard of flashings on the property is not very good.

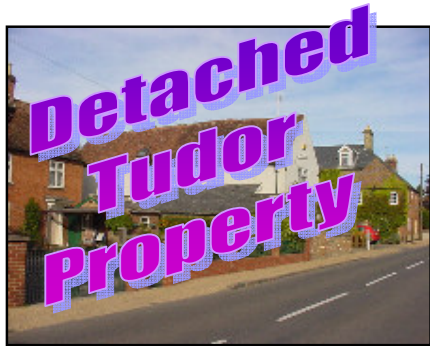
Here you can perhaps see the darker front roof, which is the original roof to the property.

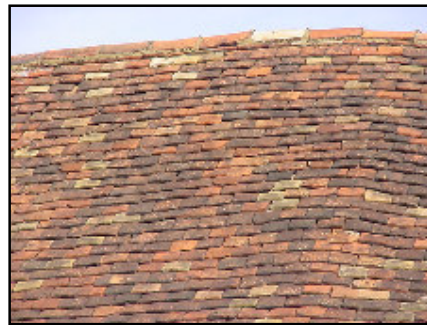
We believe from the angle/pitch of this roof that it was once thatched. Acts required thatched roofs to be removed from habitable buildings (although we are advised that at one point this was the hayloft to the adjoining farmhouse). Clay tiles were the common material used to replace thatch and these would have been hand made at the time, which you can see from the general undulation of the roof and the way they sit. However, the clay tiles are spalling and opening up and are coming to the end of their useful life.

We know we have already used this photo, but it does demonstrate well the tile issues.

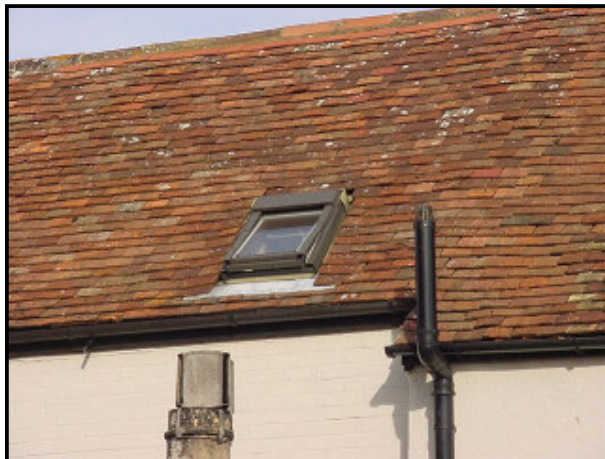
Here you can see the fairly flat look of the roof. We mentioned that there may be concrete tiles mixed with clay tiles. We have made this comment due to the moss that is present, which is a common feature with concrete tiles.

**ACTION REQUIRED:** The roofer to have a general look at this roof. We do not expect that many tiles will need replacing, but you never know until you have a close look. Due to the plastic sarking felt (see below) we suggest that venting is added in this area. There is a discrete vent that can now be added at the ridge and also underneath some of the tiles.

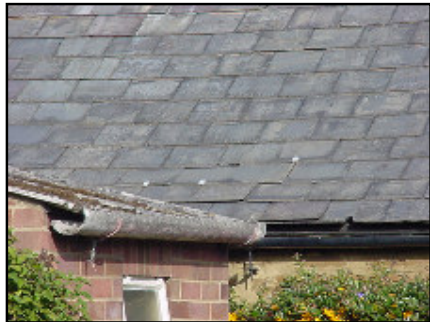
There is a slate roof to the left hand side of the property. This is in reasonable condition, although we did note some lead tingles. This can only really be viewed if you stand within the curtilage of the adjoining property on the left hand side (the old farm). Normally as a rule of thumb in surveying once you have a dozen tingles you feel that the roof is coming to the end of its natural life.

If you look closely in the centre of the photo you can see the lead tingles. We have not been able to access the inside of this roof.

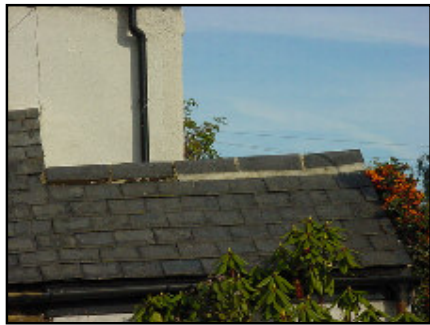
You can see that some of the ridge tiles have been displaced in this photo. This is to the front of the property, but the area obviously suffers from a fair amount of windy weather.

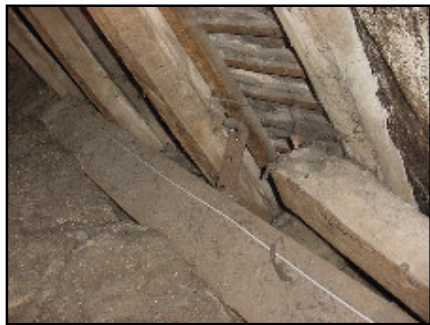
A general view of the roof. If you look between the joists you can just see the old peg tiles and some pegs, although we do not think the pegs are original and the battens look fairly new (the battens are the timbers going across horizontally). You can also see a metal tie that has been added at some point to pull the structure together.

**ACTION REQUIRED:** A carpenter should be able to resolve the rafter that has moved by using what is known as an 'A' frame and we would also suggest that he checks and secures any other timbers at the same time. Great care should be taken or else he could cause more damage than good.

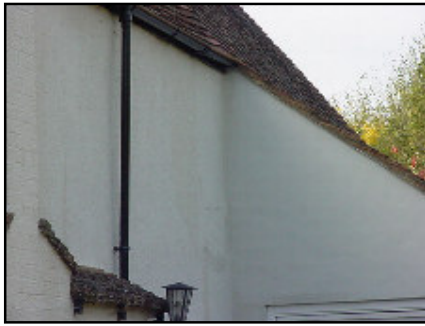
There is an end cap missing on the right hand side (all directions given facing the property). This has allowed water to cascade down the render, which has in turn formed hollow areas in the render.

You can just about see the gutter here, the end cap to this is missing.

**ACTION REQUIRED:** Fix an end cap on the rainwater goods.

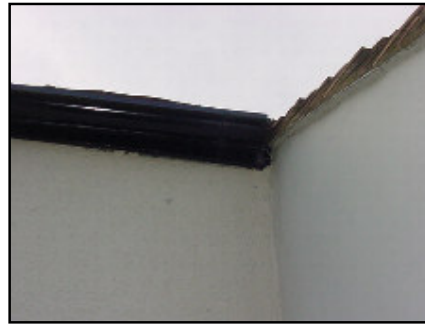
Close up of missing end cap.

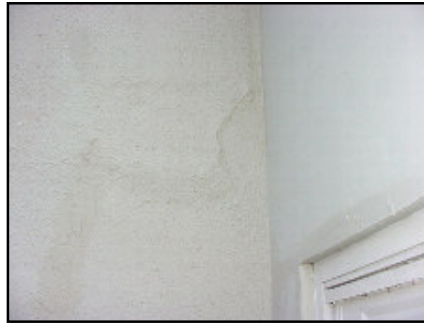
The blown render beneath the gutter. This is typical of the problems that can occur from the most minor piece of lack of maintenance.

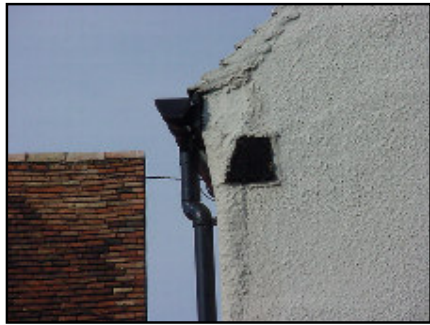
There is only a fascia to this property and this is hidden behind the rainwater goods. Given the age of the property we believe it is likely to need replacing/repairs. This should be checked when you are having the roof work carried out.

The fascia board is behind the rainwater goods.

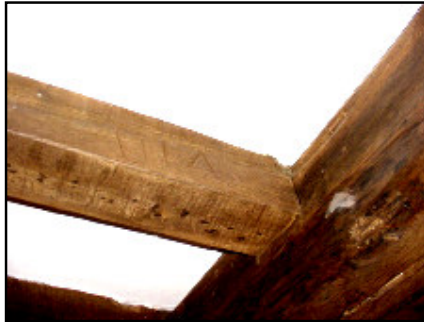
We would add that there is something that does not quite ring true about the numbering of these timbers, which we cannot quite put our finger upon. In our experience the numbers are neater than we would normally find, but we are really not certain.

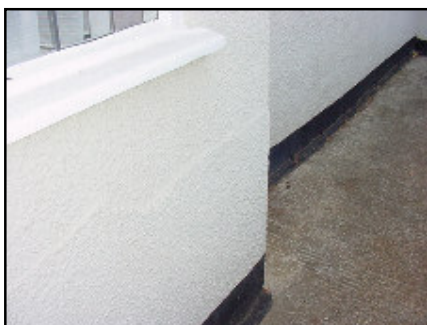
The sole plate would be at the very base of the wall, in this case where the black paint is.

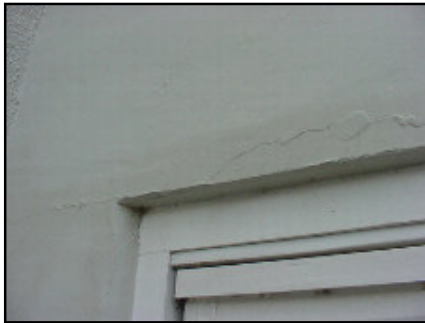
We noted similar problems with the render as those mentioned on the main house, such as no drip details over the door of the garage, which is causing cracking to the render.

Cracking above garage door.
