JOB REFERENCE: XXXX

RESIDENTIAL BUILDING SURVEY

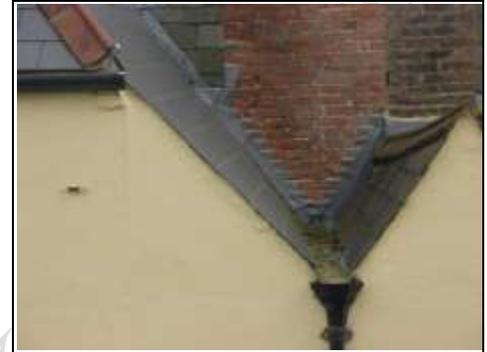
Valley gutter to rear of property at high level

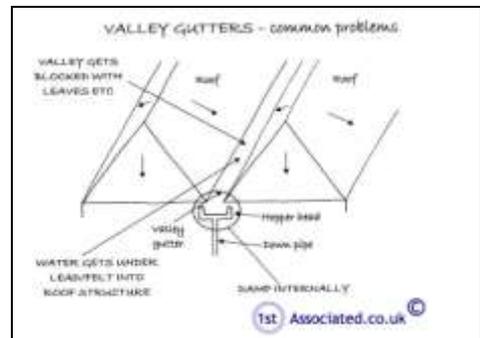
ACTION REQUIRED: Access needs to be gained to the rear roof section of the property. We would recommend a roof window is formed to the roof, (subject to Local Authority Approval) as access needs to be gained to

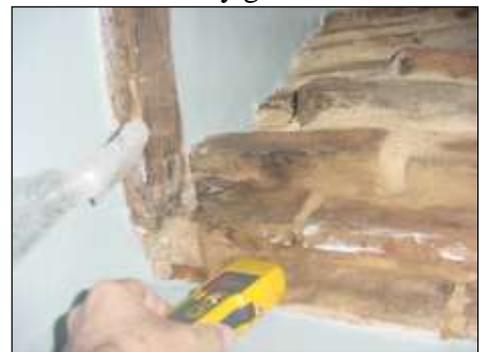
Found a combined dampness problem coming in from the rear left hand chimney (all directions given as you face the property).

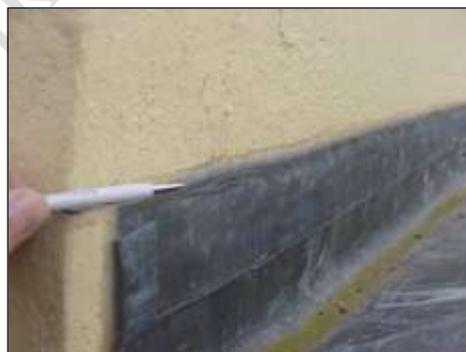
Mastic seal to the lead flashing indicating problems

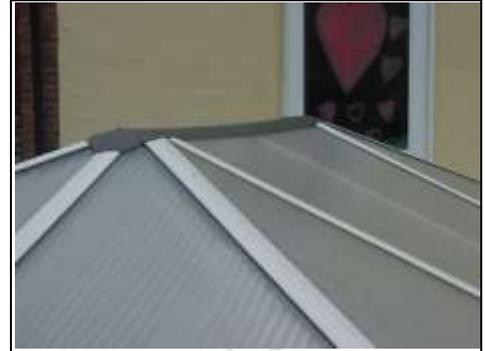
Poor quality repair to the ridge in Flashband that needs replacing

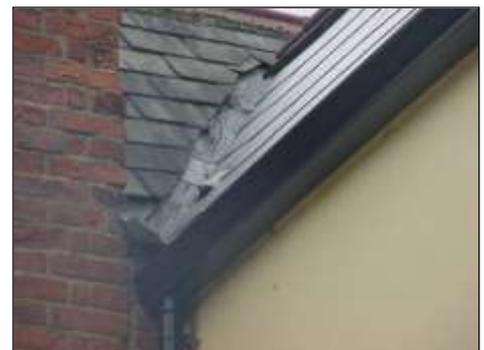
Natural slate to the left hand side and manmade slate to the right hand side and a lead valley gutter that has been tarred indicating that it has leaked

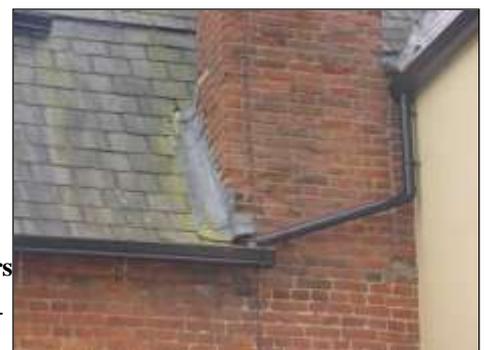
Unusual downpipe detail

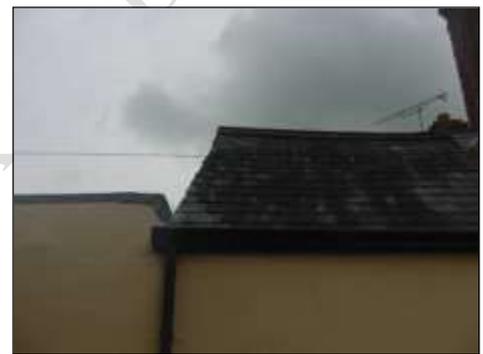
ACTION REQUIRED: We never recommend that a natural slate roof is replaced by a manmade slate in

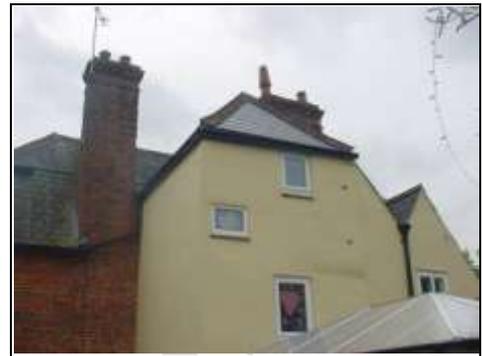
Repair work required to render

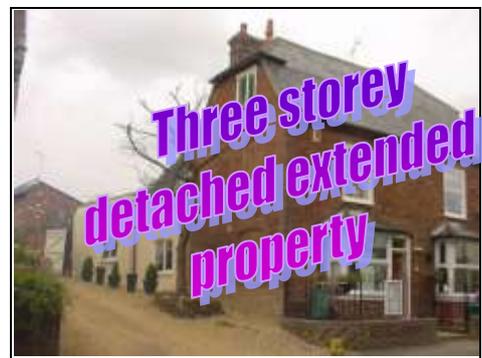
Property on a sloping site

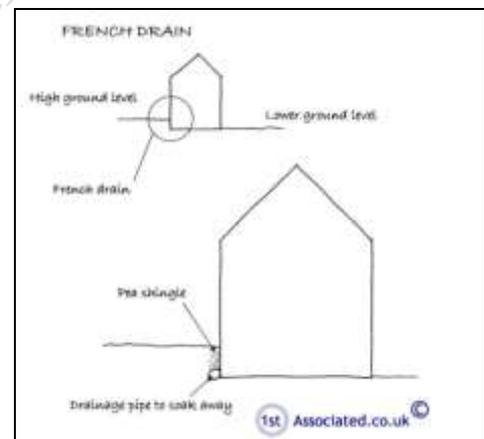
ACTION REQUIRED: Add French drain to reduce dampness in the property.

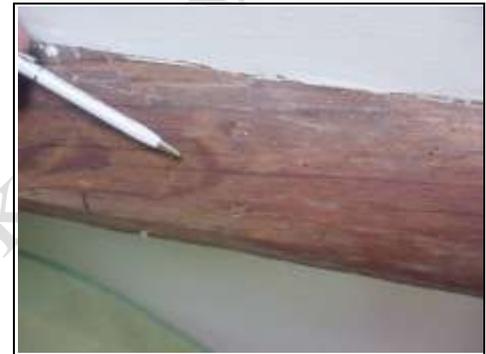
Signs of woodworm in rear building

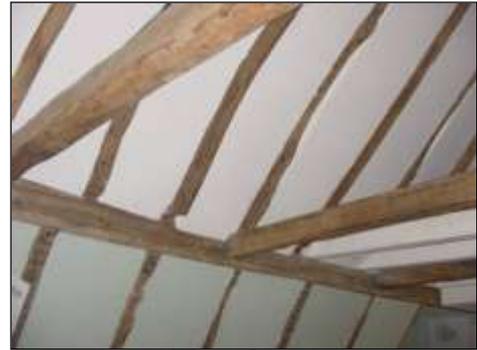
Timber frame structure.

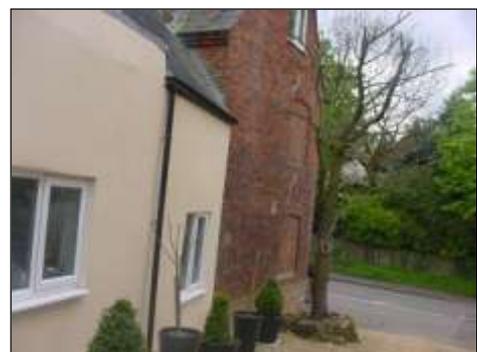
ACTION REQUIRED: As mentioned we would recommend some opening up to be carried out to investigate the hidden areas of the property to ensure that you carry out work long term for the correct repair of this building.

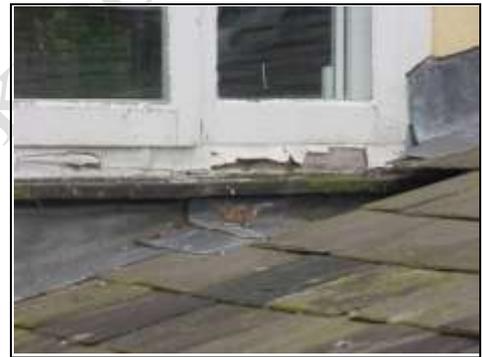
Timber window degrading

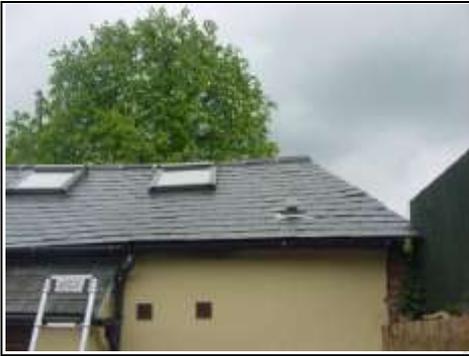
Undulation to rear building roof

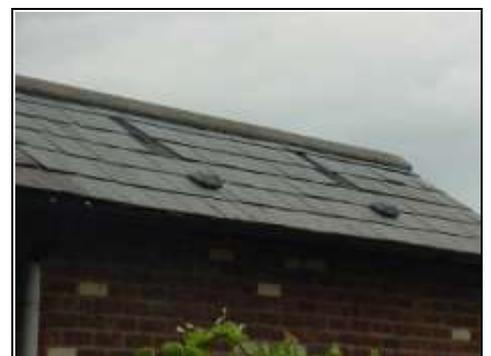
Rear of roof with missing slates

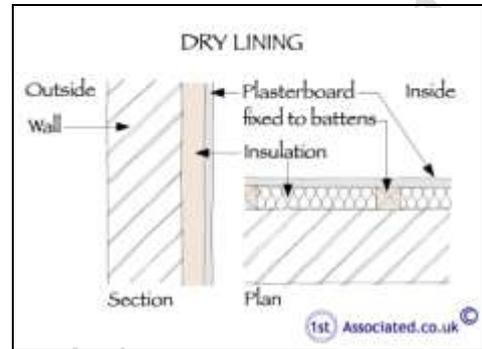
12.0.1) We suspect there is dampness to the rear walls due to the high level of the ground outside on this general sloping site. We are unable to check the walls due to the dry lining. We also noted there is sandstone to the base of the walls which could be contributing to the dampness.

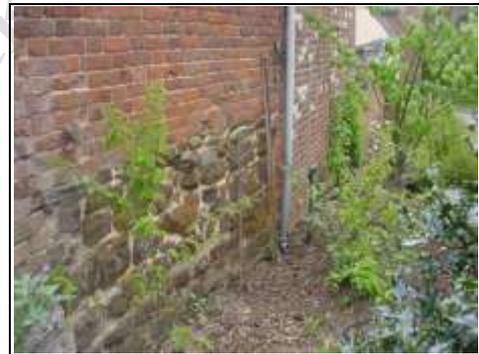
Please see the Walls Section of this Report.

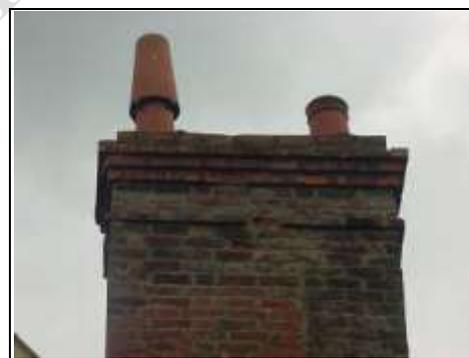
This chimney is built in brick with we believe a lead flashing (we literally could not see most of it) and two chimney pots/flues. From what we could see the chimney needs some ad hoc re-pointing and the flashing needs checking/replacing as there is dampness inside. We were unable to see the very top of the chimney know as the flaunching, we therefore cannot comment upon it.

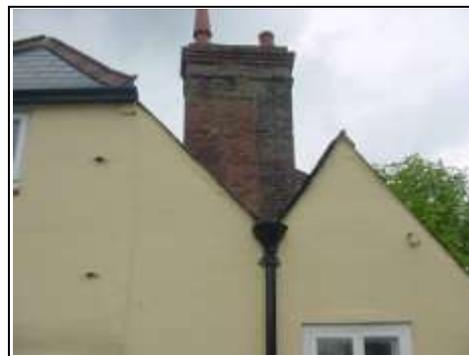
ACTION REQUIRED: Please see our comments in the Executive Summary with regard to adding a roof window to allow closer examination of the chimney and also the dampness that is being caused by the condition of this chimney.

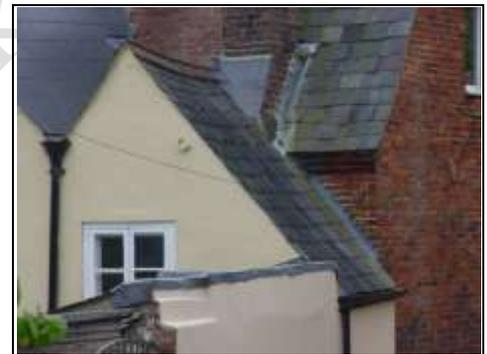
Lead tingles to rear of main roof

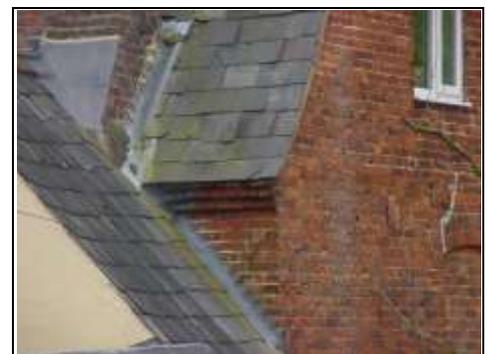
Lead tingles to left hand side of the roof and displaced slates to the right hand side

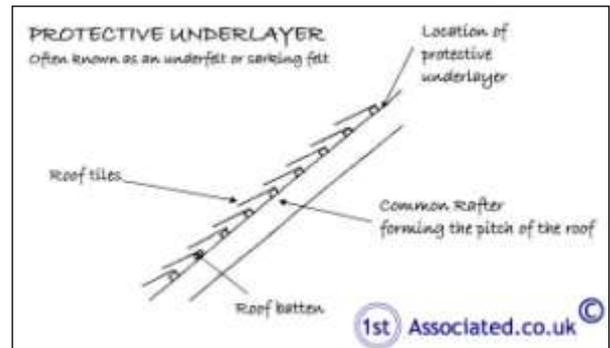
Protective underlayer

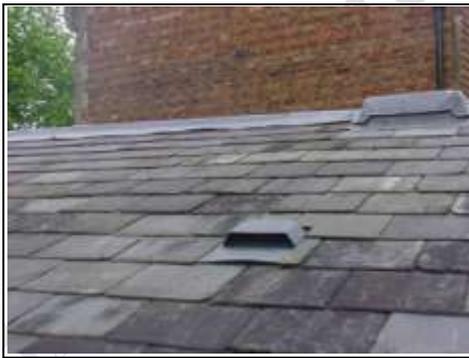
Rear slate roof in average condition

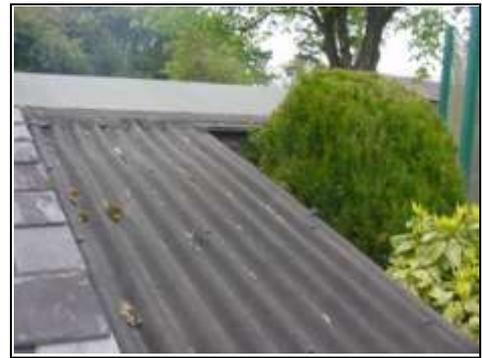
Fibre roof, also to the rear, we would replace with a slate roof in keeping with the rest of the property

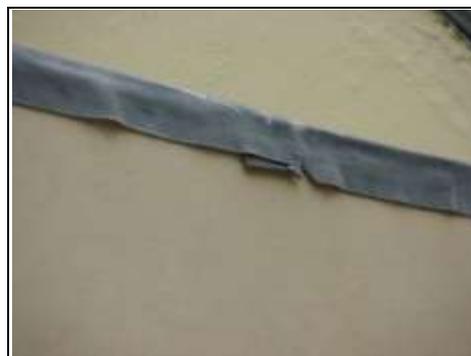
Detail to the top of the single pitched roof is awkward, the lead turns. As far as we could see this will allow water to drip down this side of the wall and may well lead to dampness getting in.

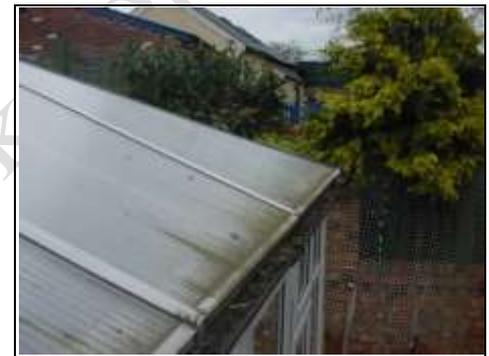
We were surprised to see the deeper metal gutters have been used at high level nevertheless we feel that some of them will overflow and there is also a need for repairs in some areas and there are some awkward gutter detailing. Please see our comments in the Executive Summary.

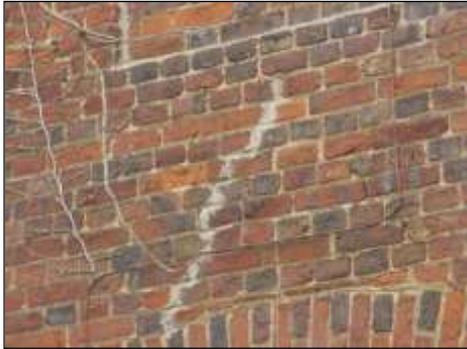
Cracking we believe this relates to gable end movement

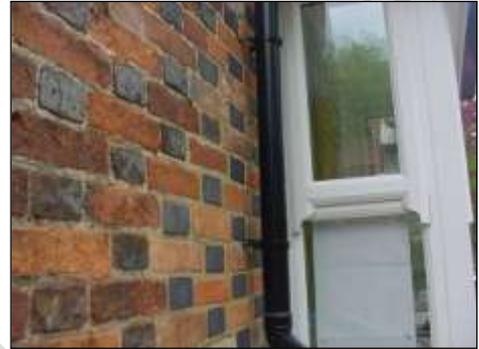
Replacement repaired brickwork at front of main building

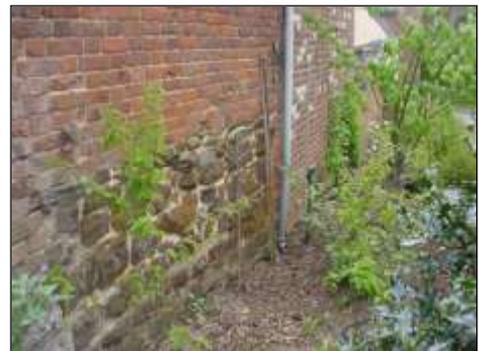
Rear of main building left hand side original sandstone

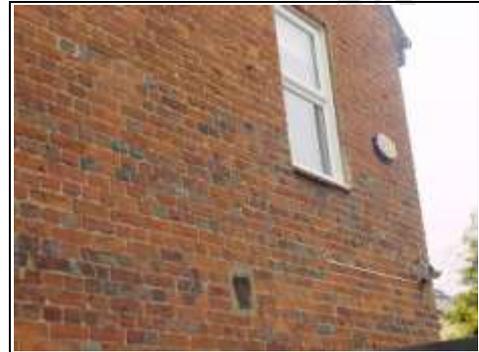
To the bottom centre of this photo is a timber end

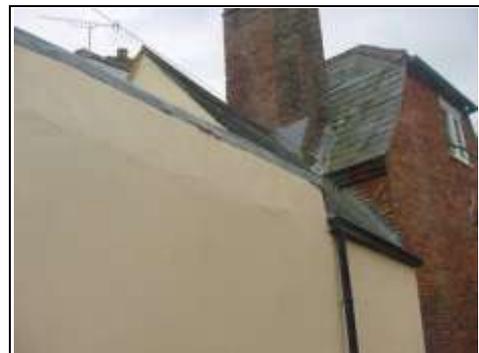
Render to main building

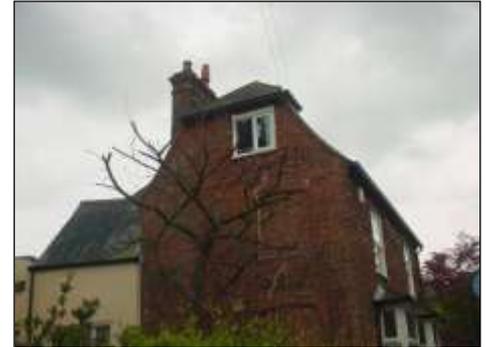
Tree to side of the main building

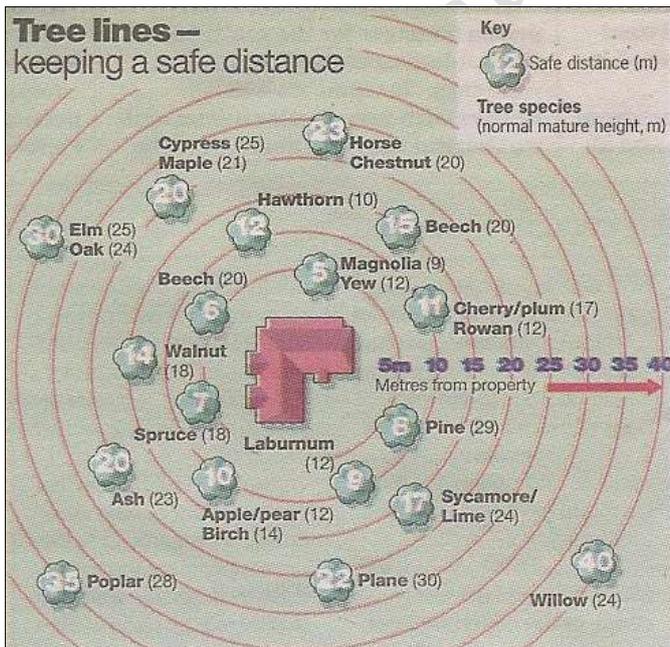
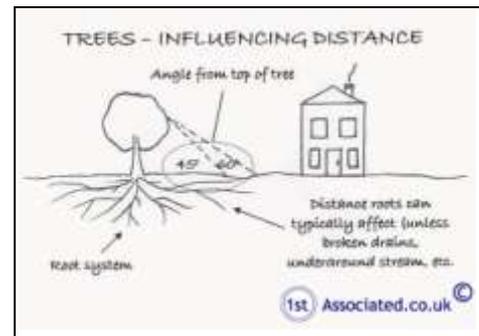
Influencing distance

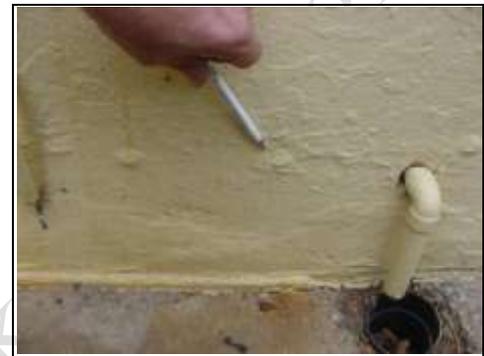
Old inserted damp proof course to right hand side main building

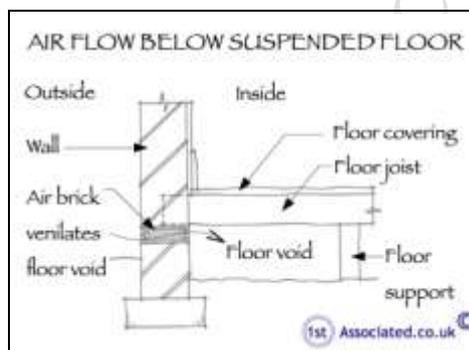
Air flow beneath suspended floor

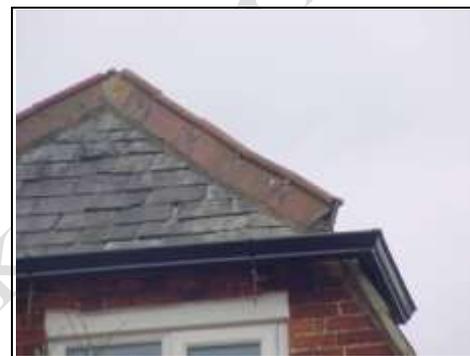
Guttering hiding fascias and soffits

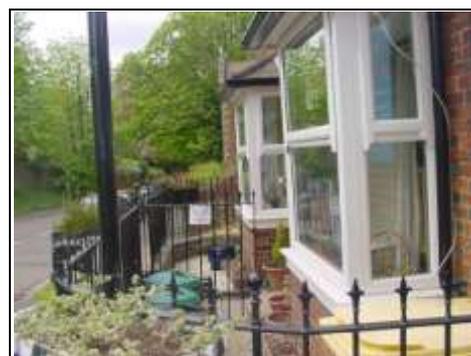
Plastic windows to front of main building

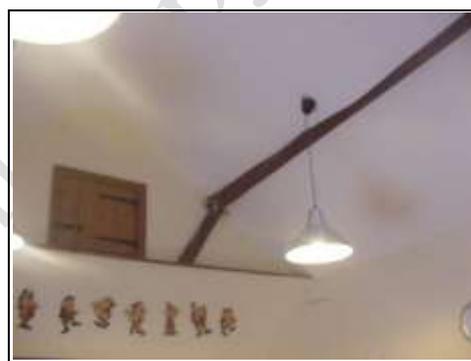
Lath and plaster ceiling

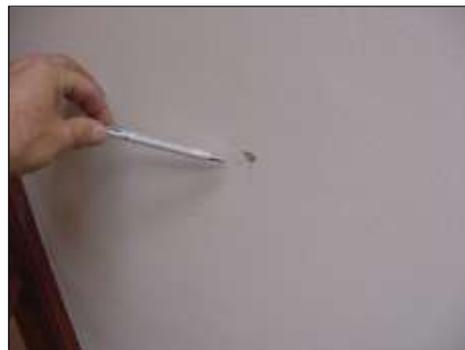
Plasterboard ceiling
top floor degrading

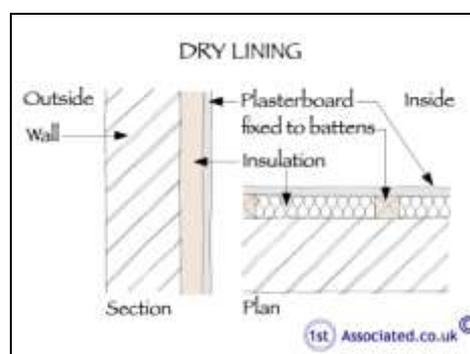
These are everything from plaster walls to dry lined walls and given the mixture of ages in this property this is not unusual. We would comment with regard to dry lining that it can be hiding dampness and this is what we found in the rear building.

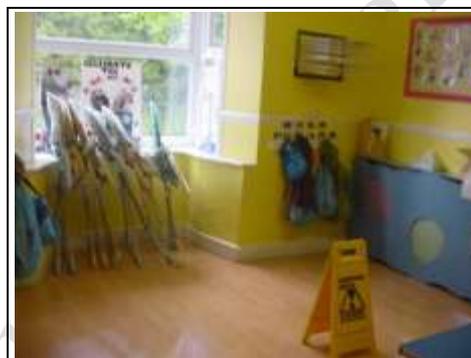
The floor covering hides the floor in many instances, we believe there is a timber floor to the ground floor and in turn it is a suspended timber floor. We can only be certain of this in the cellar area which is where we can see the timbers when we go into the basement.

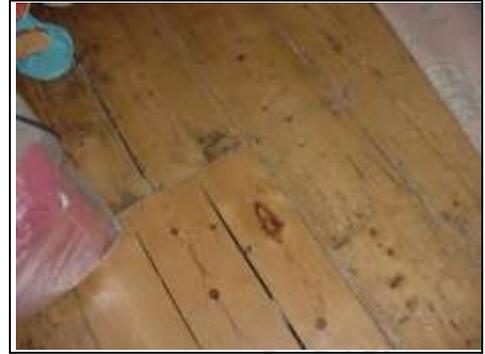
Top Floor: Older timbers have woodworm and there are new replacement timbers

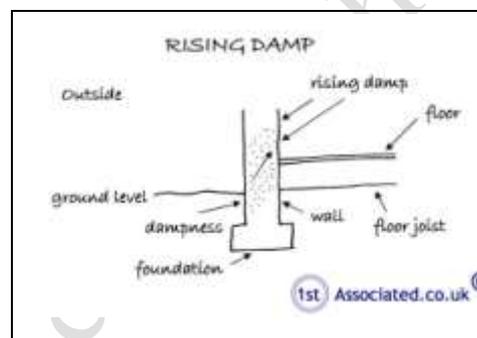
This is where water ingress occurs through the walls. This can be for various reasons such as poor pointing or wall materials or inadequate gutters and downpipes, such as poorly jointed gutters.

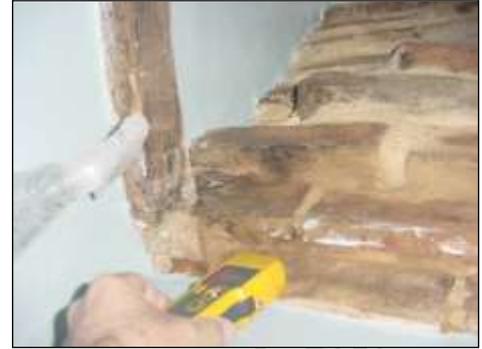
Dampness coming in from chimney one

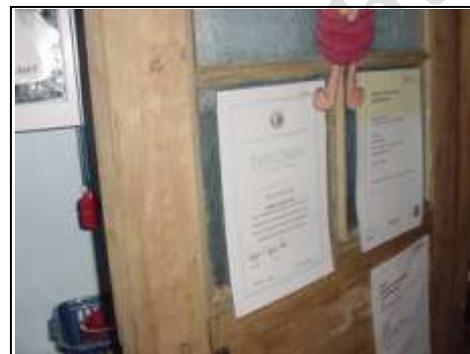
Timber and glass door

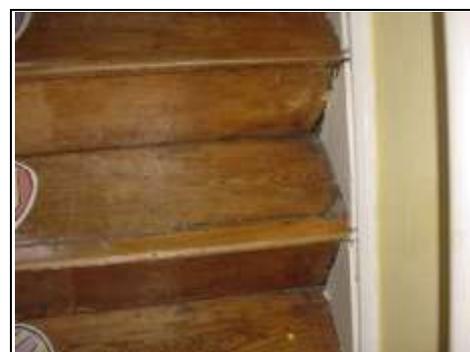
We noted that some nosings were deteriorating and would benefit from repair. There is relatively high usage as the property is being used as a nursery.

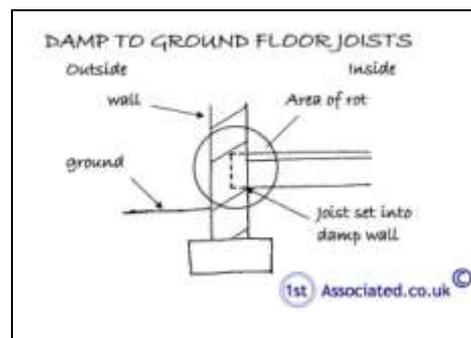
Damp to ground floor joists

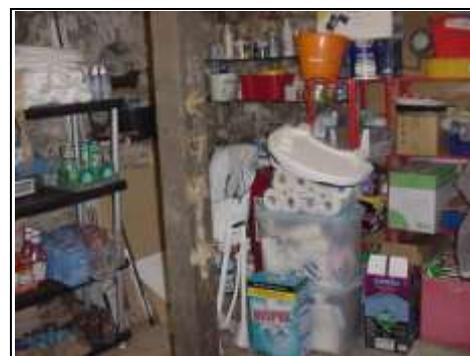
Stored items in the cellar

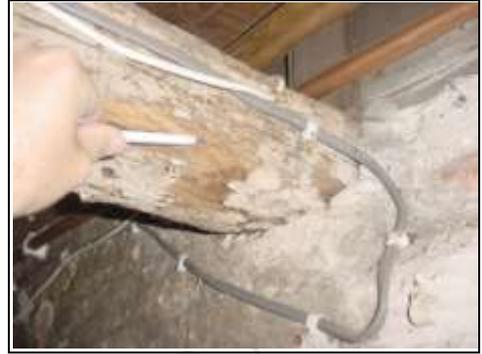
Woodworm was visible within the cellar probably the worst visible area in the entire property.

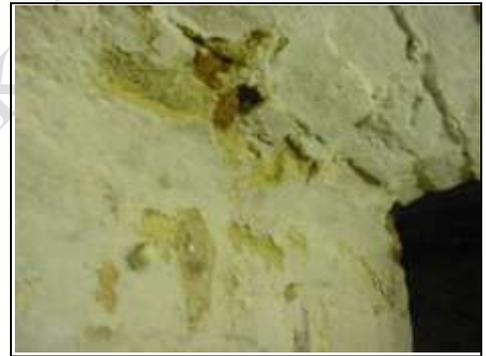
We also noted spalling to the brick chimney (right hand side chimney) that is in the cellar area.

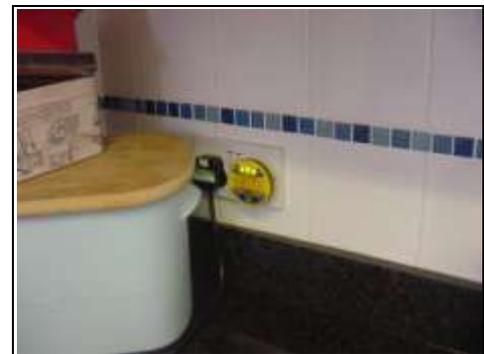
Neither of these indicators can give certainty as to the condition of the rest of the wiring.

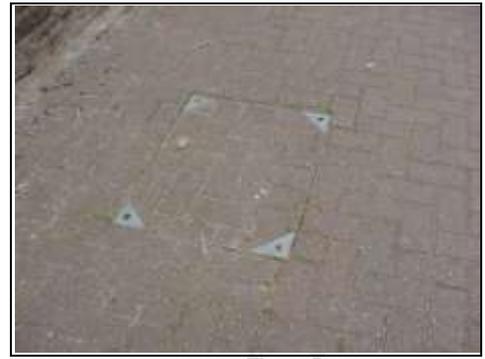
Finally, it must be emphasised that the condition of the property's foul drains can only be ascertained by the carrying out of a test; such a test has not been undertaken. Should there be leaks in the vicinity of the building then problems could occur, particularly with respect to the stability of the building's foundations. Drainage repairs are inevitably costly and may result in damage being caused to those areas of the property beneath, or adjacent to, which the drains have been run.

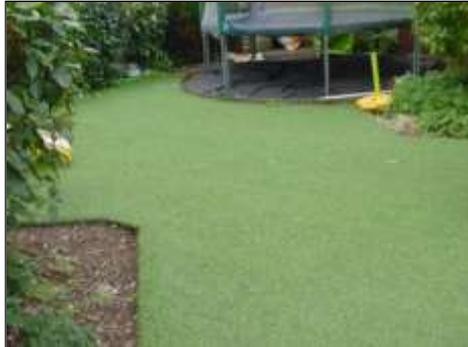
This has been taken over and redesigned for the nursery and is on a sloping site so it does have steps within the area. We recommend that weep holes are added to the retaining walls.

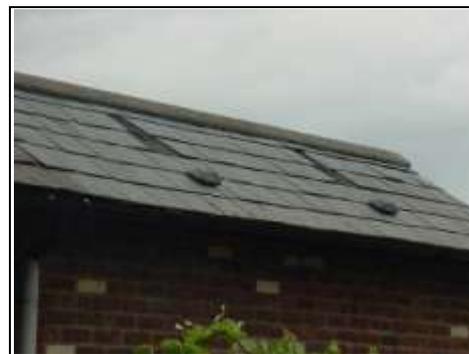
ACTION REQUIRED: Please see our comments in the Executive Summary.

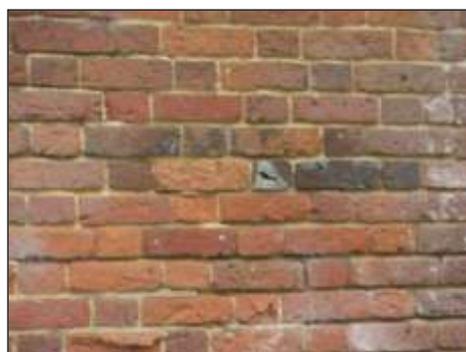
Brickwork in need of re-pointing

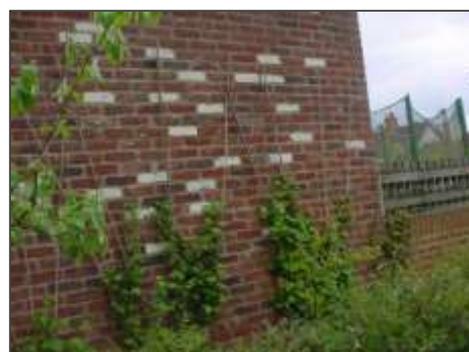
Plants on the brickwork

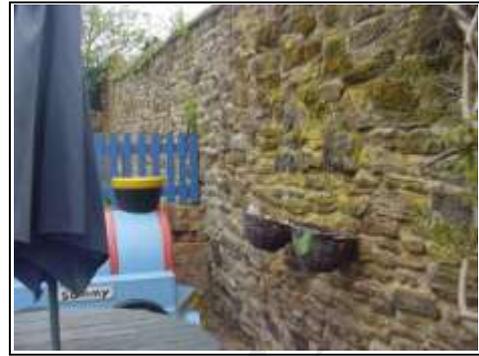
Bulging Boundary wall

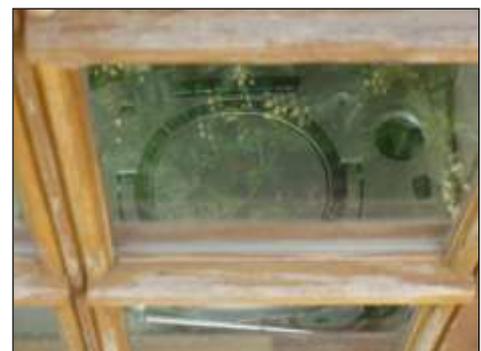
Window starting to deteriorate.

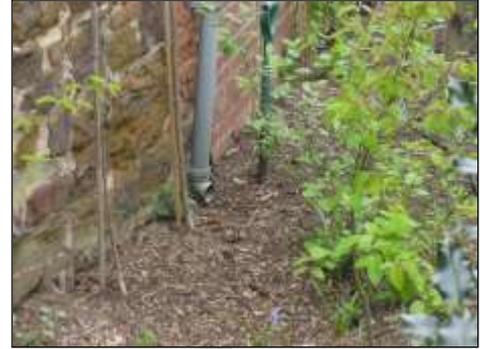
Rainwater discharges directly to the base of the property
