RESIDENTIAL BUILDING SURVEY

Norfolk

INTRODUCTION

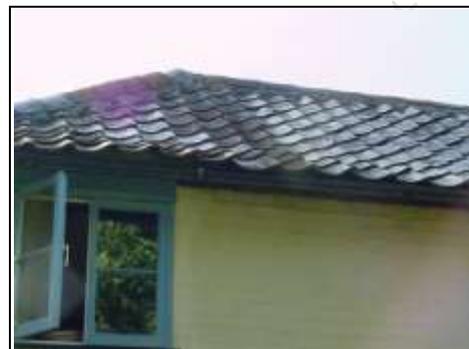
The roof is covered with Pantiles. Pantiles of this age will be susceptible to rain particularly wind driven rain which means that some dampness can get in. Unfortunately there is very little you can do about it other than ensure any displaced pantiles are replaced and rebedded. In the area of the roof we could see there is a protective underlayer which will help .

Pantile roof

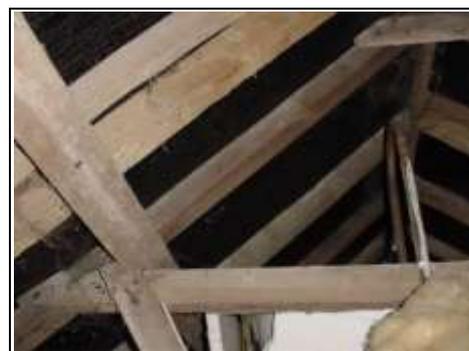
The property has an old timber roof that has been repaired over the years with the addition of new timbers. We can see that many of the timbers have signs of woodworm activity. It is difficult to tell whether this woodworm was active or not due in part to the live wasp nest limiting the time we wished to spend in the roof!

Woodworm in roof

And also the general difficulty of identifying if woodworm is active. The timbers we could see to the left hand side of the roof had what we would term as structurally significant woodworm damage. We didn't wish to access the right hand side of the roof due to the chimney and the thought of being trapped in there with the wasps wasn't a pleasant one!

ACTION REQUIRED: We are unhappy that we were unable to access part of the roof given other things that we noted within the property. We feel it is best to look at a worst case scenario with regards to the roof.

ANTICIPATED COST: From the other things we seen in the property and our experience and knowledge of older properties we feel it is best to set aside a sum for repair. We recommend that you set aside the sum of £5,000 to carry out work to the roof starting with the addition of a further loft hatch at the right hand side of the property; quotations required. We would be happy to come back and comment further. This does need to be carried out in the summer/autumn of 2010.

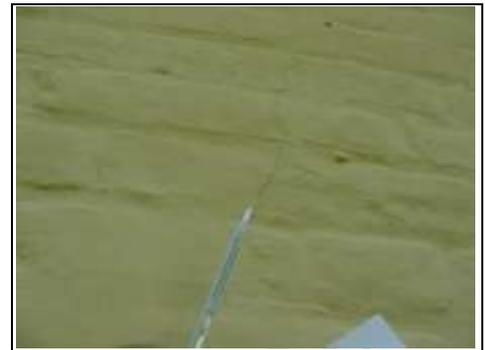
We can see from the cracking in the property and the different bricks that have been used that there has been some movement in the property. Having discussed this with the owner during the question and answer session he advised that the property was underpinned to the

Unfortunately in the 1970's lots of properties were underpinned we consider unnecessarily. In addition to this they used too much concrete, often therefore adding unnecessary weight to the property. In many cases we would comment causing as many problems as they solved.

Cracking to walls

ACTION REQUIRED: The existing owner to place an insurance claim for the cracks that have been identified in this report. This will then allow the insurance company to carry out monitoring over a year which is the Building Research Establishment's recommendation rather than a one off inspection such as we have just made. It will also enable you to take on the insurance claim and limit your liability to the excess only. We consider this to be a requirement of purchasing the property.

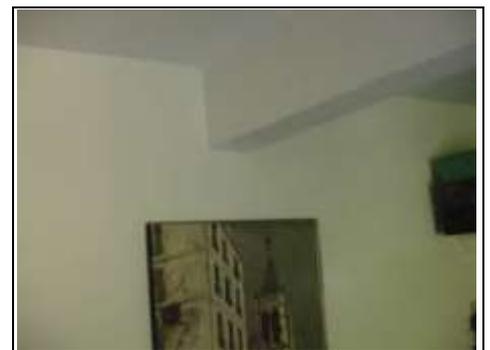
To add to our thoughts and concerns with regards to the structure if you can read this section and the next section about the deflection to the floors and the tie bars. We did note what looks to be additional structural support that has been added within the bedroom as you can see in the adjoining photo. The owner wasn't aware about this happening in their time.

Additional structural support boxed in

ACTION REQUIRED: A way of improving this which we would recommend is to add extra timber supports; quotations required.

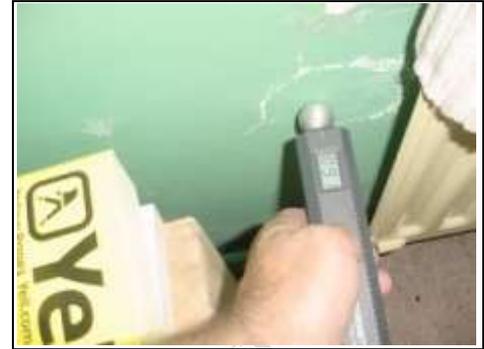
We found damp throughout the property particularly the front and right hand side elevation.

Rising damp

ACTION REQUIRED: In this age of property we would recommend a French gully.

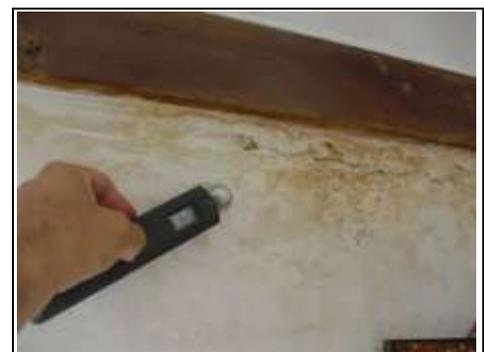
We can see staining within the master bedroom indicating lateral dampness is getting in. We also suspect from the different colours of yellow paint externally that there have been areas of paint deterioration over the years that have let in dampness.

Lateral damp

It should be noted when you do repaint that a paint that allows the property to breath should be used, not a plastic based paint.

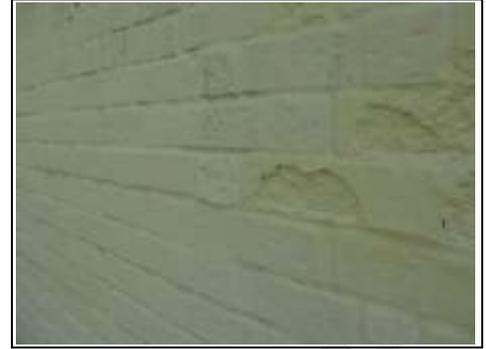
Repainted yellow sections of the property

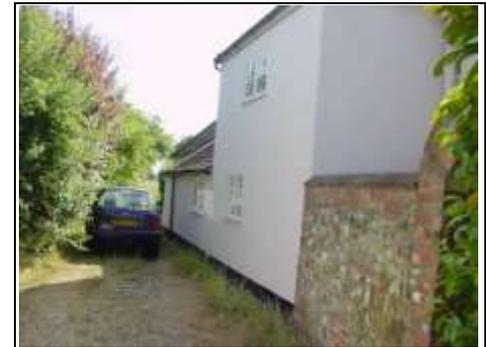
Your legal advisor needs to check and advise who owns the road and the land and whether the road has been adopted and maintained by the local council or whether you have to maintain it and also repair it and have liability for it.

Ownership of this driveway needs to be confirmed

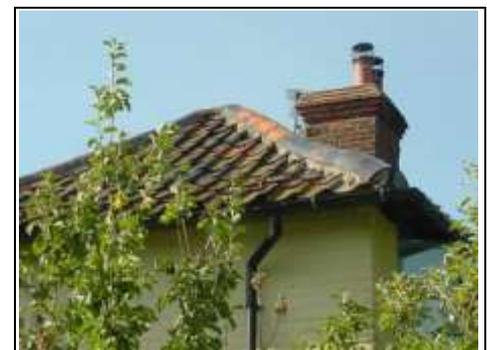
The roof has a pantile roof covering, considering the age of the pantiles we believe they are in slightly below average condition. Some of the ridge tiles are starting to spall if you look at the photo these are ones that are a brighter red colour. You should watch the ridge for deterioration and also exposed areas such as the eaves.

Some of the ridge tiles are starting to spall

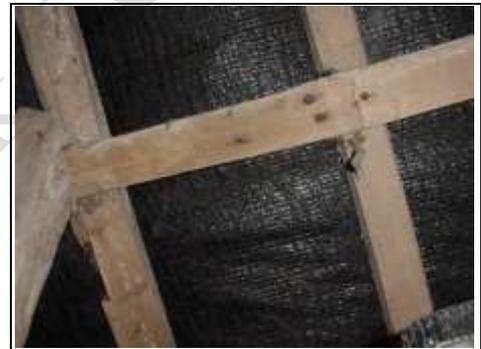
When we inspected the loft space we found a Hessian base Bitumen membrane. This type of membrane has been used since the 1960s. We generally found it to be in average condition, its damaged in a few more places than we normally find.

This photo shows the common rafters (the ones that form the pitch of the roof) and the dark area between is the underlayer.

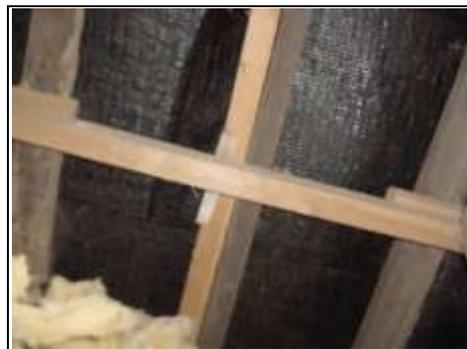
We found the area of the roof timbers that we could see generally in average condition considering their age albeit that it had woodworm as we would expect. We have inspected the roof structure for:

Repairs to the timbers

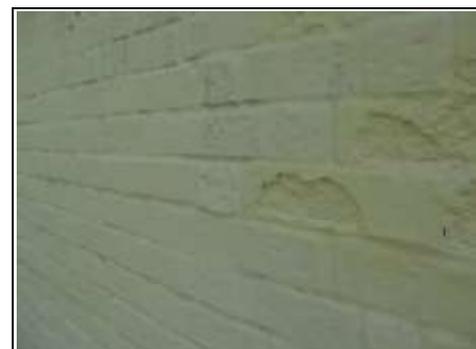
Close up of spalling painted brickwork

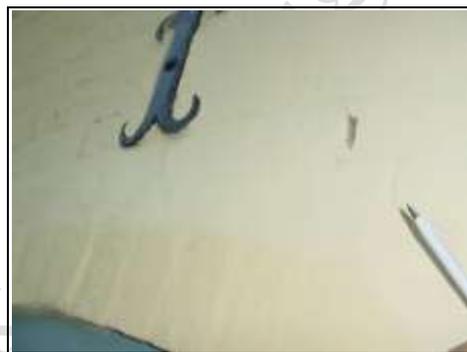
Cracking to brickwork

ACTION REQUIRED: Please see our comments in the Executive Summary.

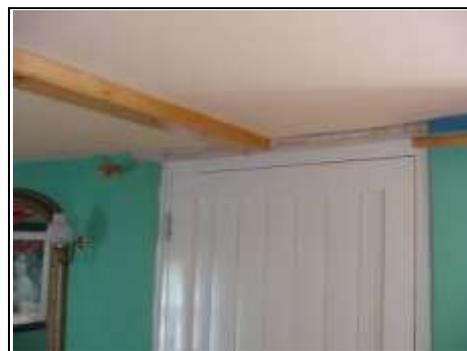
We noted timber lintels in some areas.

Timber lintel

ACTION REQUIRED: If the walls are damp these will in turn be susceptible to rot and will need checking when the floors are opened up where possible.

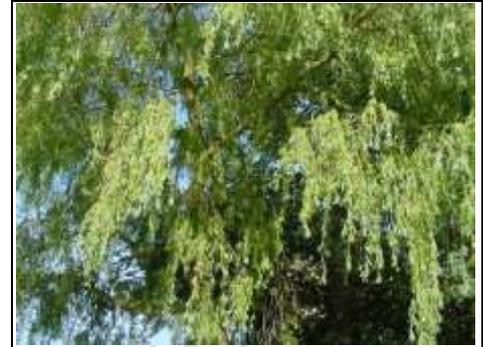
The trees and the property have obviously sat together happily for many years. However if trees are not maintained then they can cause problems. Damage to foundations and underground services can be caused by trees and shrubs. There are a number of trees in the vicinity of the building, what we term within influencing distance, and we believe that these trees may be affecting the property. Properties with trees nearby will always be more susceptible to movement.

Nearby weeping willow tree

ANTICIPATED COST: A few hundred pounds; quotations required. Please see our comments within the executive summary.

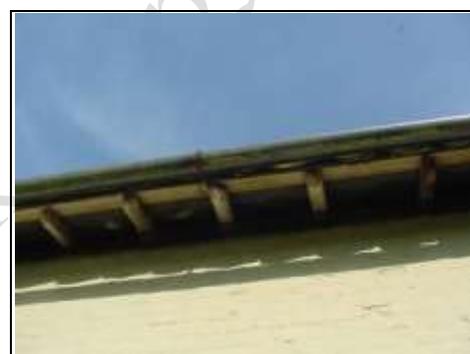
Rafter feet

ACTION REQUIRED: Re- Stain.

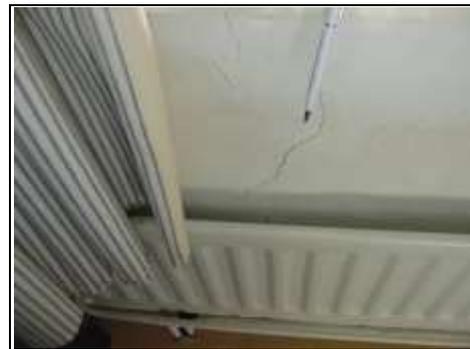
Crack in main bedroom

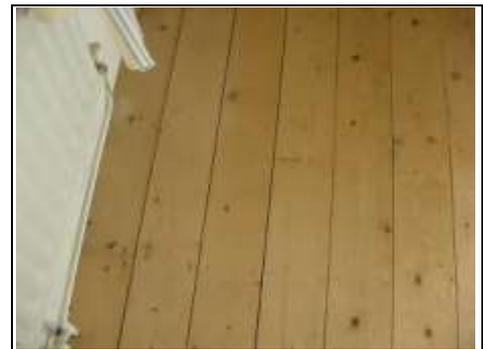
We have not opened up the floor, but we do feel that it has an above average level of deflection - it is certainly more than we typically see (bearing in mind we are seeing old properties all of the time). This can be for many reasons, from under sized timbers to lack of lateral restraint, to wet rot and wood worm. In this instance we would like to open up the floor as we note there is modern floorboards we believe there is likely to be older floor joists which are embedded into the walls.

Modern floorboards
which are embedded into the walls.

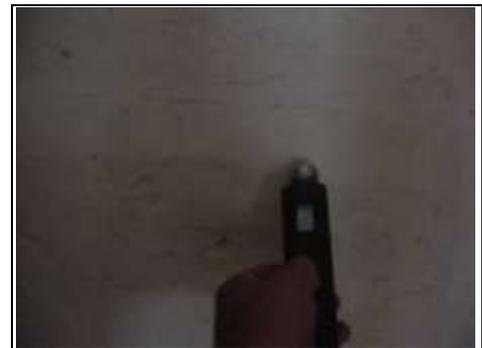
The readings we obtained indicated that there is some dampness in the property. It is located throughout but we had higher readings towards the front of the property in the right hand side. You should bear in mind that these readings have been taken during warm weather so it is only likely to get worse in the colder, wetter months.

Checking for rising damp

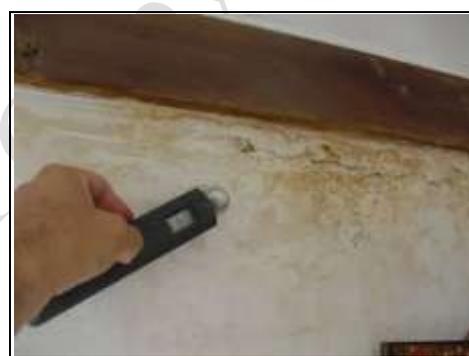
Tests were taken with a moisture meter at random points to internal walls, floors and other surfaces. Whilst we got damp readings these were in line with what was expected for this type of construction. The area of staining within the main bedroom we think is due to a leaking gutter or tiles above.

Checking for lateral damp

ACTION REQUIRED: You need to check the gutter, the tiles above and also the painted brickwork in this area.

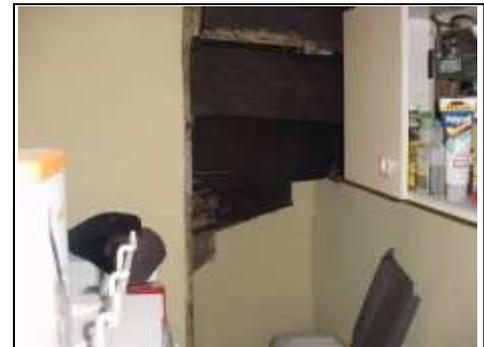
Underside of stairs not lined

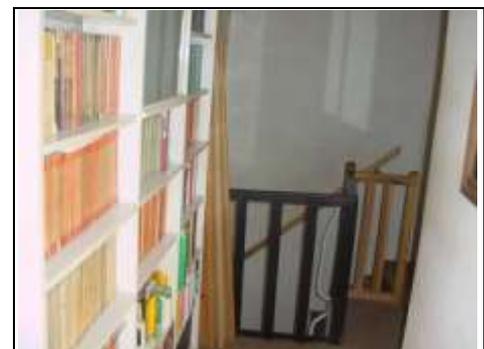
Awkward steep stairs

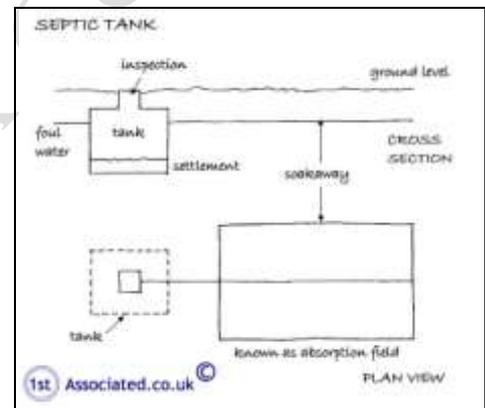
We have been unable to determine the adequacy of treatment or the effectiveness of the disposal arrangements. We asked to be shown the lid of the septic tank. The owner advised that he has only had it emptied three or so times in the time he has been at the property (28 years) therefore highly likely that it is leaking which is a common problem with brick.

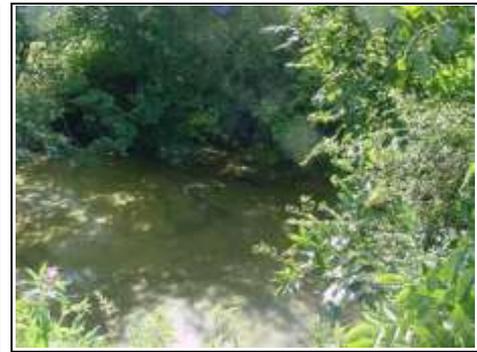
The pond was dark and murky on the day of our visit
