# RESIDENTIAL BUILDING SURVEY

xxxxxxxxxx,  
Cricklewood,  
London,  
NW2 xxx

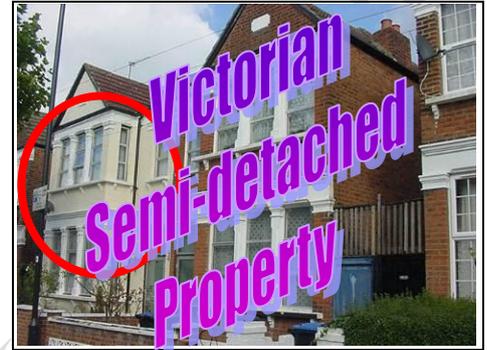
The neighbouring property was underpinned in 1992/1993. From what we understand the re-enforcement was very deep, over three metres and involved partial underpinning of the external walls. We are advised that the total cost including re-decoration etc. was £55,000 (fifty five thousand pounds) in 1992. xxxxx, your neighbour, may be able to advise you further with regard to exact details of this work. He believes it related to problems with the tree adjacent to his property.

The circled house has been underpinned

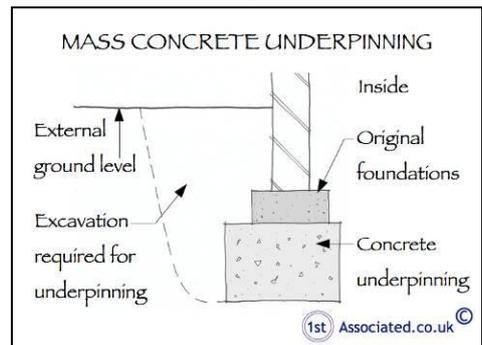
Concrete underpinning

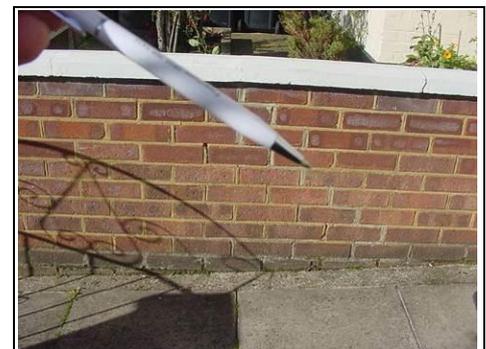
Step crack visible to boundary wall

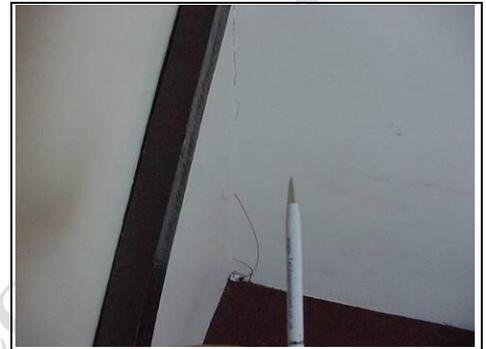
1.1.1) We can see cracking internally between the front and middle bedroom and cracking to the room in the roof space.

Cracking in the room in the roof  
This shows it is moving to the left

**ACTION REQUIRED:** Ideally we would like the owner to specifically advise how long the cracking has been in the property and provide any photographic evidence they have to back up their comments. Your Legal Advisor to specifically ask in writing if they were aware of the cracks and how long have they been present.

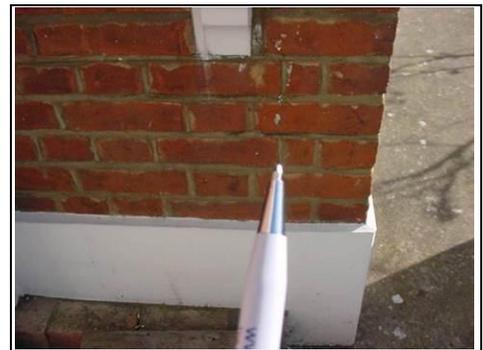
1.1.2) We can see some hairline cracking to the front bay window through the brickwork. The majority of cracks that we would expect to see would be in the mortar/pointing. However this property has been re-pointed and as such we would not expect to see them.

Hairline crack to the front bay window

Re-pointing is carried out where the existing mortar has failed and broken away to stop damp penetration and further deterioration. The mortar should be raked out to approximately 20mm and then replaced with a mortar of a similar type, therefore, stopping damp occurring.

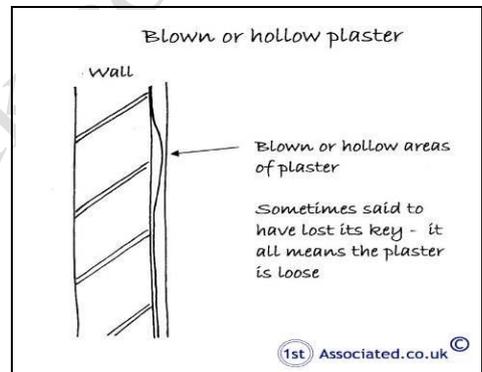
We also noted a number of hollow areas in the plaster to the rear wall when we carried out the survey. This may mean that there is some movement in the property or it may mean just that the plaster is coming to the end of its natural life. What it will mean is that re-plastering will be necessary and we would recommend this is carried out with a lime based plaster

Blown or hollow plaster

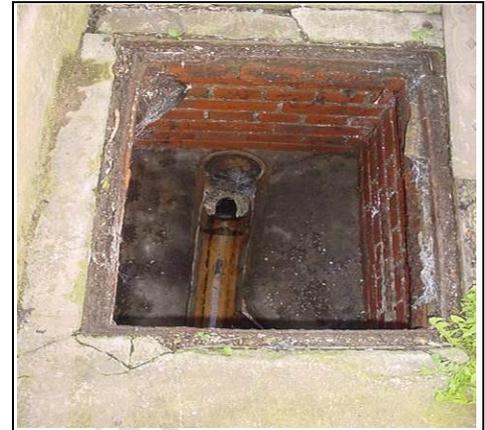
Drain front right

**ACTION REQUIRED:** We would recommend a closed circuit TV camera report of the drains is carried out to establish the condition of them.

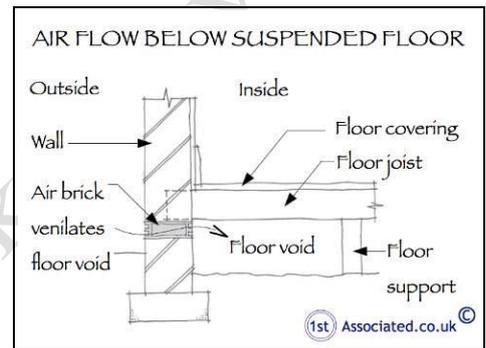
There is a suspended timber floor to the ground floor of the property. We can see to the rear room of the property that part of the floor has been replaced with concrete. This then stops a free flow of air underneath the floor which is needed to minimise wet rot and dry rot. This in turn is why, we believe, we are getting high damp meter readings in this area as any dampness under the floor cannot go anywhere and is simply using the concrete floor slab like a large piece of blotting paper and absorbing into it. This then gets into the adjoining walls.

Airflow under suspended floor

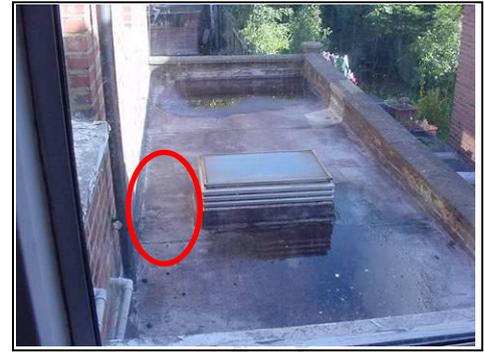
We also cannot discount the adjacent flat roof that may have leaks and that are manifesting in this wall. With flat roofs we find that when they leak we very rarely find the dampness at the point of the leak.

Rear flat roof

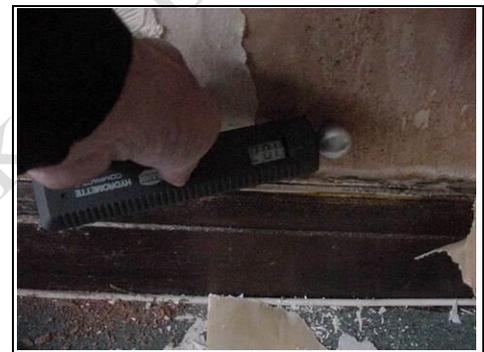
We noted rising damp in the kitchen and the adjoining rear lounge area which again we believe relates to the concrete floor issues mentioned previously.

Rising damp

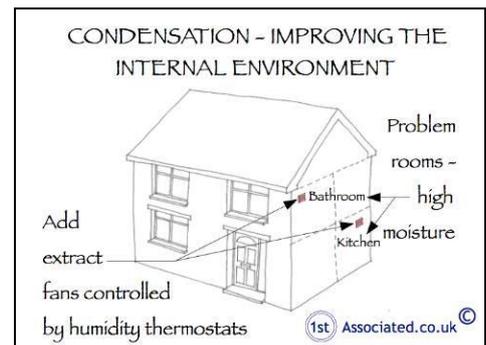
Cold bridging is caused by a colder element in the structure allowing coldness to pass through the structure much quicker when warm moist air is present in the property.

Condensation

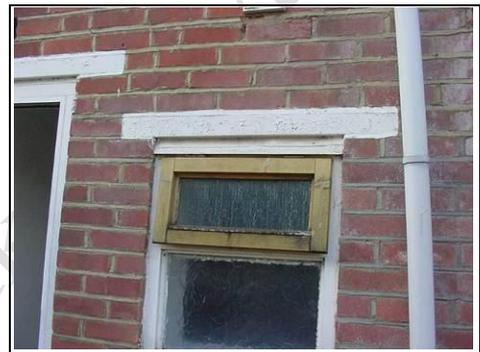
Concrete lintels to the rear of the right extension

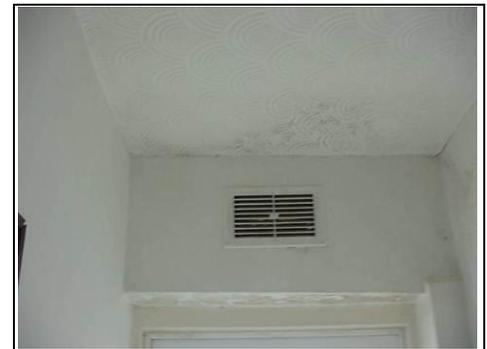
The extension is a humidity creating area and with the kitchen and shower room located in there this needs to be controlled and managed by adding large humidity controlled extract fans.

The area is vented but not enough. We would recommend a large humidity controlled extract fan is added

**ANTICIPATED COST:** Large humidity controlled extract fans £200- £400 (two hundred to four hundred pounds); please obtain quotations.

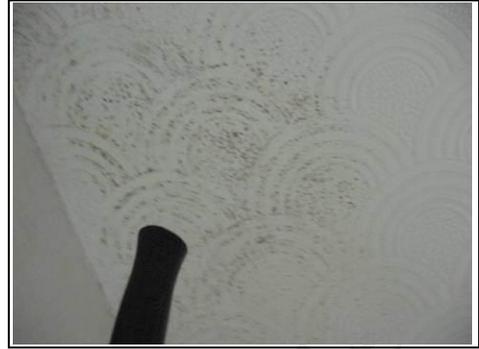
Cold bridging causes mould to the ceiling

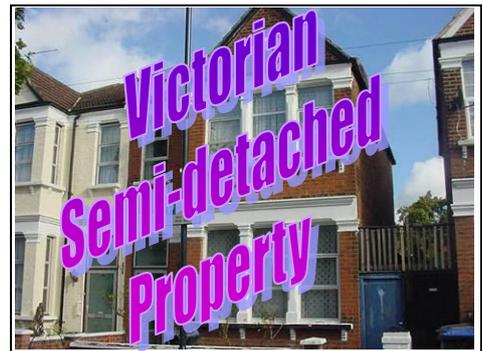
The property has large rooms and large glazed areas and will therefore need good heating to make it a warm house as we suspect at the moment it is a cold house. Whilst the house has two boilers it is very much down to how efficiently they are running and also the size of the radiators in the rooms. There is a British thermal calculation known as BTU that can assess the size of the radiators recommended. We personally have one similar large house that we actually used double the British Thermal Units recommended to allow the house to warm up quickly.

Large areas of glazing

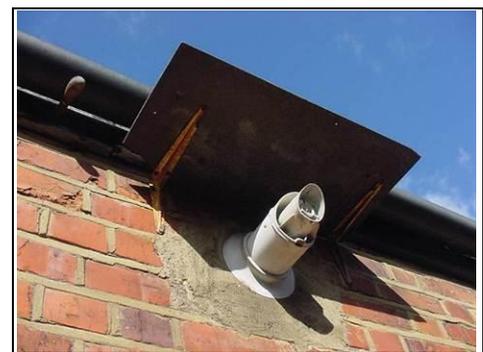
Asbestos board above flue?  
Used to deflect heat away from the plastic pipes above

We are not asbestos Surveyors. Our insurance requires us to recommend that you have a separate asbestos survey.

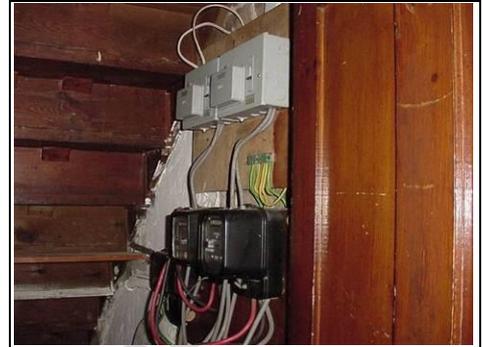
Dated fuse board

**ACTION REQUIRED:** We would recommend a new fuse board as these are much more efficient and cut out much quicker particularly if you have young people in the house with small fingers that play with sockets!

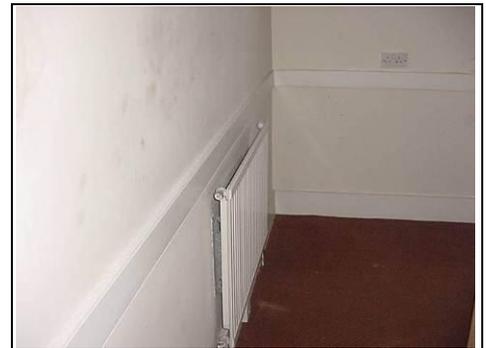
Single panel radiator

**ACTION REQUIRED:** We recommend replacing the single panels with double panel convection radiators and increasing the size as remember there are some very large rooms. It is best to live in the property for a while and establish if it is warm enough for you before you carry out any work as warmth and coldness is very subjective.

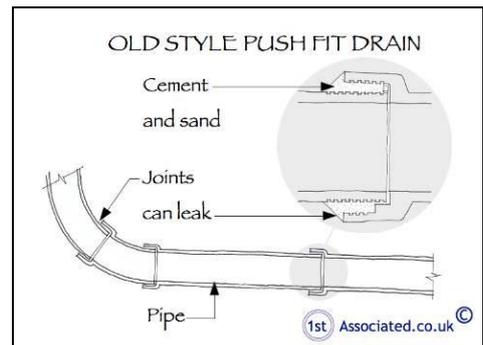
We would also comment that there is a possibility that the drains are leaking to the right hand side which is why we recommend the closed circuit TV report is carried out.

Old style drain

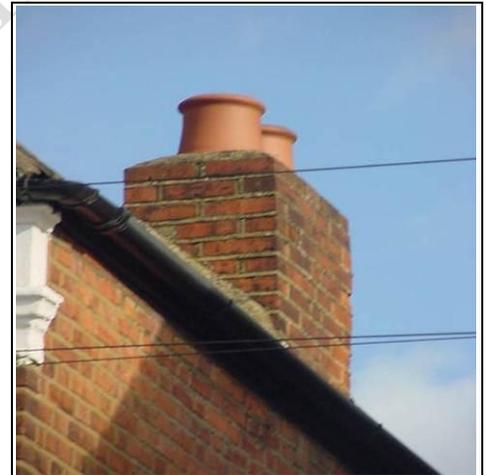
Chimney – front right

This chimney is brick finished with a cement flashing with lead underneath and two chimney pots. From what we could see from ground level it looked in average condition considering its age, type and style.

Our concern is the cement flashing although it does appear to have a lead or metal underneath it. We do find that cement does crack over time and allow dampness in.

Cement flashing needs repairs

**ACTION REQUIRED:** Repair the flashing and periodically inspect the chimney.

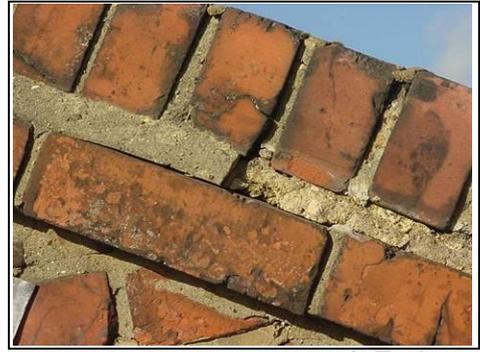
In this case there is a parapet wall to the left hand side built from brick with a lead flashing. From what we could see we would comment that generally it is in average condition. We were pleased to see that the lead work was stepped. We can see some cement mortar is coming away. In a perfect world this would be repointed.

Cement mortar is coming away

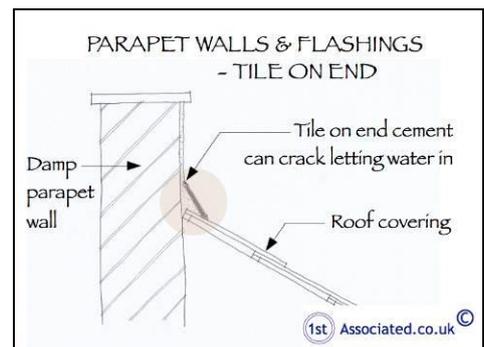
We noted that a section of the parapet wall has a tile on edge which in our experience leads to dampness getting in the property. In fact we could see dampness getting in that area.

A tile sitting sideways, bedded in cement mortar which has been utilised as a flashing. Due to the cement mortar it is bedded in being brittle and prone to cracking, this is not an ideal material. We would always recommend the use of lead flashings.

Tiles on edge

**ACTION REQUIRED:** We recommend re-pointing before the winter of 2014.

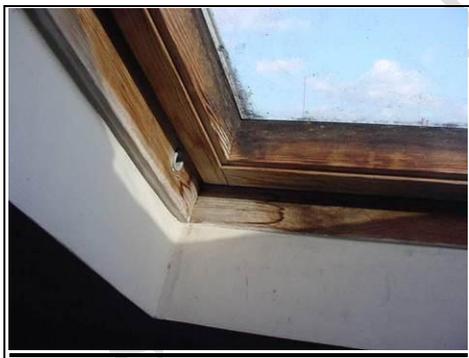
There is condensation occurring on the roof window in the room in the roof as this is probably the coldest room in the house during the winter months. Humid air is drawn towards it. We have mentioned having large humidity controlled extract fans added in the property to reduce the travel of moisture within the property.

Condensation on roof window

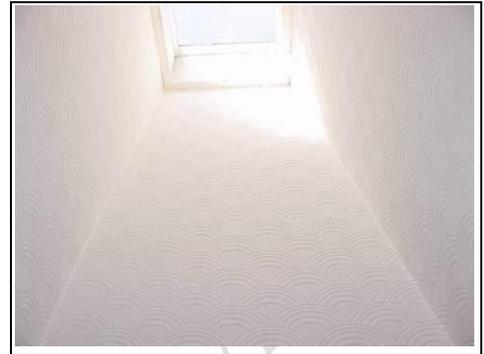
This purpose made roof window looks to have been repaired over the years with what appears to be Flashband. We could not see any damp staining inside.

No damp staining visible internally

**ACTION REQUIRED:** A replacement window may be the easiest way to make this watertight.

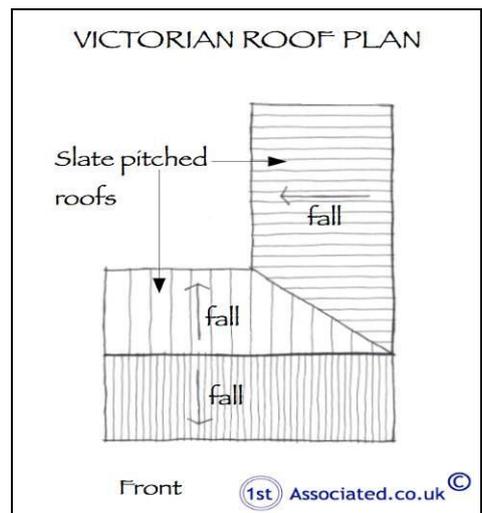
Roof plan similar to this property the slates have been replaced with concrete tiles

**ACTION REQUIRED:** Carry out periodic inspections and maintenance of the roof, as required.

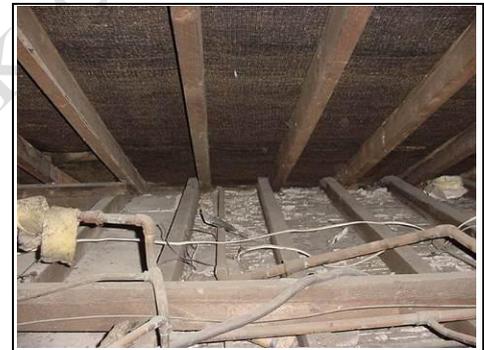
When we inspected the loft space we found a Hessian base Bitumen membrane. This type of membrane has been used since the 1960s. We generally found it to be in average condition, with damage in some areas which is what we typically find.

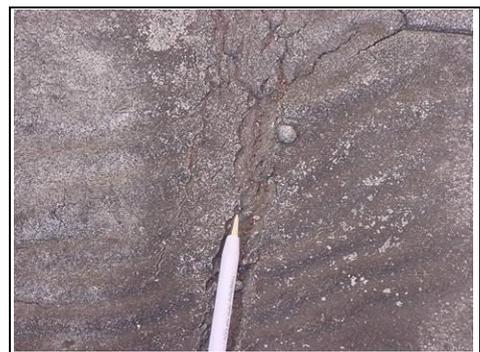
The asphalt is ageing. We can see this by the cracking in the asphalt.

More cracking in the asphalt

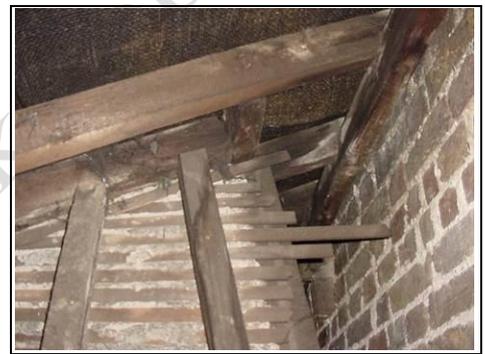
Our examination was limited by the general configuration of the roof, the old water tanks and an old boiler. What we could see was generally found to be in below average condition, because of the dampness, for its age, type and style. It is, however, feasible that there are problems in the roof that are hidden and we are concerned we could not view main roof properly.

Dampness getting in via the parapet wall

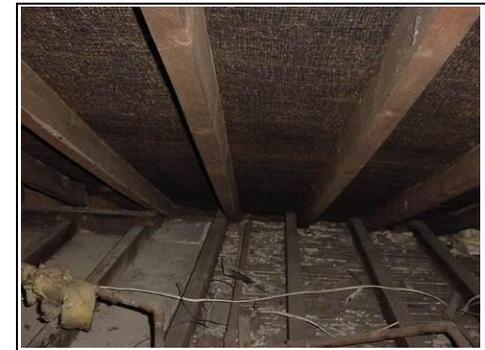
The photo shows the ceilings. Plasterboard on the left and lath and plaster on the right meaning the ceilings have been partly replaced

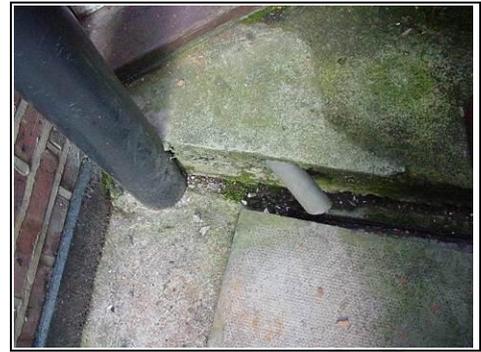
We also saw a similar arrangement to the middle of the property where clearly drains have been utilised. In both cases they would not meet Building Regulations and does give an indication of work that has been carried out to the house without getting proper Building Regulation approval. These are not major issues but we think if someone carries out this type of work without getting approval, what is hidden that we can 't see?

Unusual drain -middle

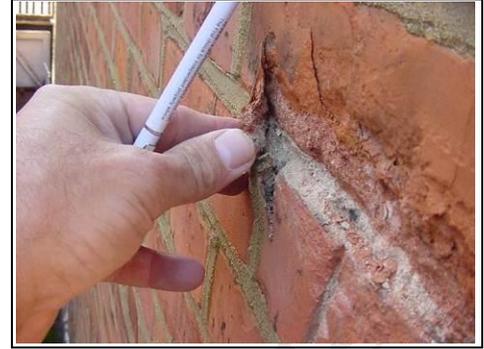
Spalling occurs to brick or stone when water penetrates the surface and via freezing and thawing starts to cause deterioration to the surface. This in turn allows further water penetration and the surface breaks up further. This ultimately can lead to water damage or structural damage to the area.

Soft red brick starting to deteriorate exposing the lime below

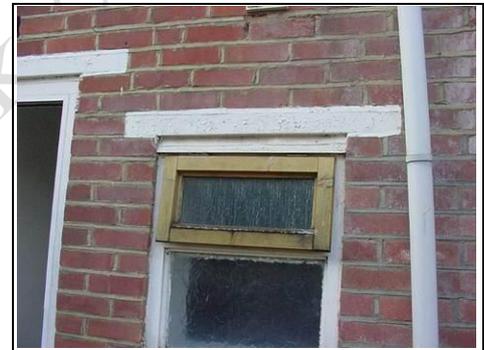
Please see our comments about the concrete lintels and cold bridging in the Executive Summary

Concrete lintels

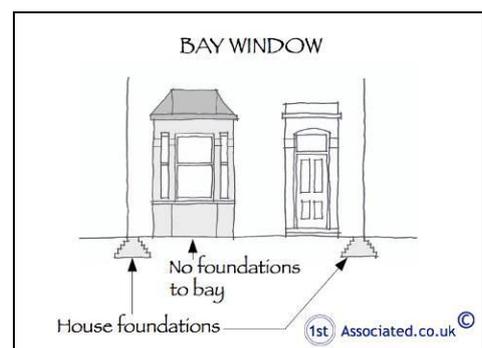
Bay windows in this era of property typically do not have foundations underneath them and have been subject to movement. We are aware that some insurance companies underpin bay windows with a modern foundation. We think this is excessive and unnecessary.

No foundations to bay window

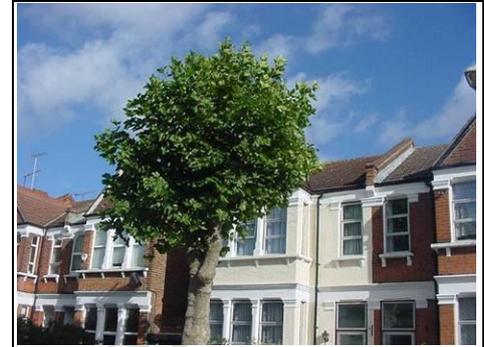
There is a tree within what insurance companies would term as influencing distance of the property. You do need to ring and check with your insurer if this affects your premium. You do also need to advise your insurer that the neighbouring property has been underpinned. The danger here is that the tree is so close to the property that its roots will affect how the property reacts particularly during drought/excessive dry weather and persistent excessive periods of rain.

Tree in front of neighbour's property

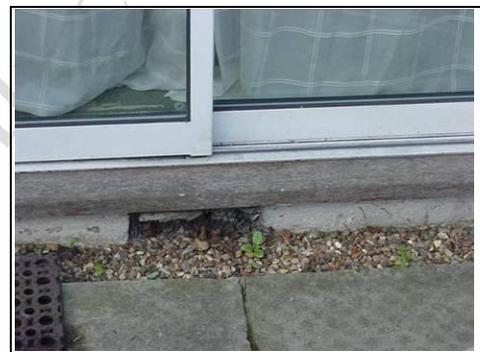
The property has a suspended timber floor which is blocked in part. Air bricks are essential to have a through flow of air as this helps to reduce the chances of wet rot, dry rot and woodworm.

Air brick to the rear of the property acting as a gutter

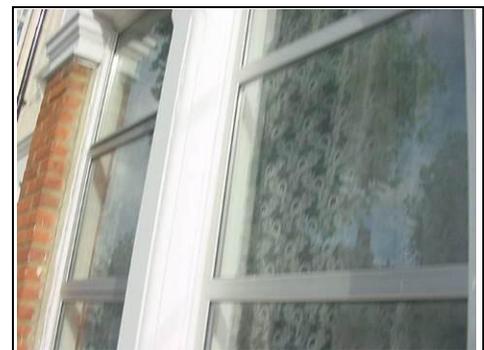
There is the odd pane of broken glass and also some misted windows. The main issue is the rotting timber which we recommend is replaced.

Aluminium window

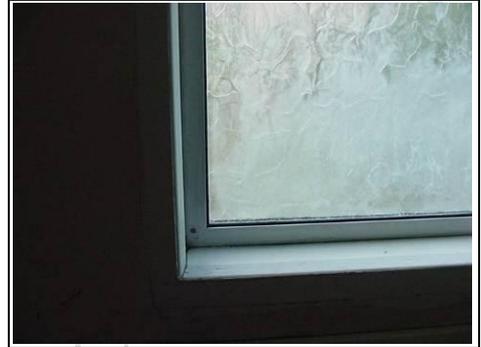
Misted up window to the rear bedroom window

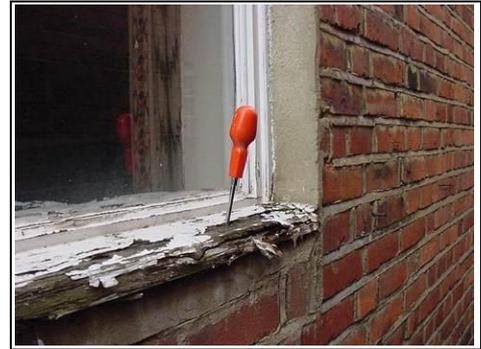
Plastic window in a timber frame with rotting sill

Rotting window sill right hand window

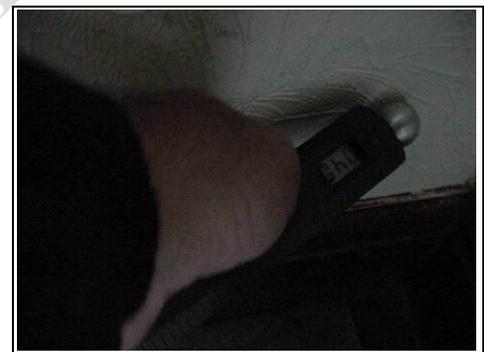
A random visual inspection and tests with a moisture meter have been taken to the perimeter walls. In this particular case we have found rising damp.

Testing for rising damp

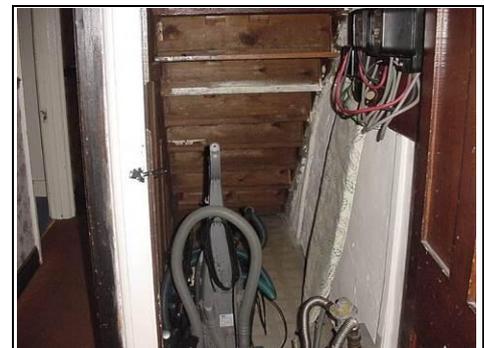
We noted that the underside of the staircase was exposed. It is more normal today to have a half hour fire barrier to stop fire spreading from the ground floor to the first floor in a worse case scenario. You may wish to take a view on whether you add this.

Under the stairs

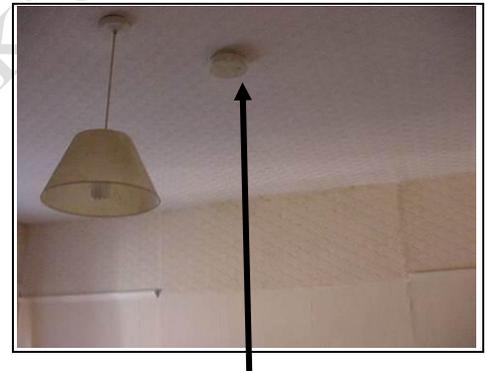
Some smoke detectors were noted. The current Building Regulations require that they be wired into the main power supply. Obviously in a property of this age this is difficult, as it would mean having surface mounted wires or cutting wiring into the plaster.

Smoke alarm

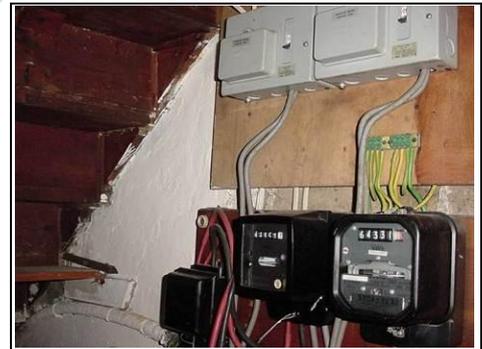
The electric fuses and consumer units were located in the cupboard under the stairs. The fuse board looked dated and better are now available. We would recommend it is replaced.

Fuse Board
