RESIDENTIAL BUILDING SURVEY

Croydon, Surrey CR0

Mr O

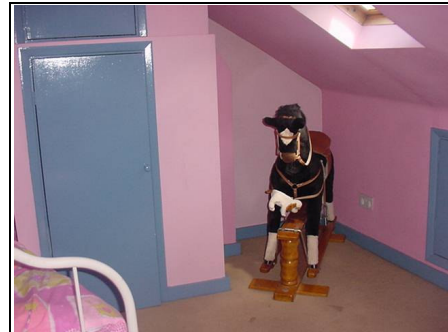
We think the loft conversion is unlikely to have met Building Regulation requirements therefore this is an unofficial loft conversion with original ceiling joists in the roof being utilised for the new floor and no improvements to the Fire requirements.

Loft room

We also found on the day of our survey there was a considerable amount of heat gain in the roof indicating that insulation has not been added, we would comment it was almost at an unbearable level and certainly would not be pleasant to sleep in the room. Modern day loft conversions, where approved by the Building Regulations, will have insulation in it.

ACTION REQUIRED: We would recommend you install a good fire alarm system and a fire door to the top bedroom area.

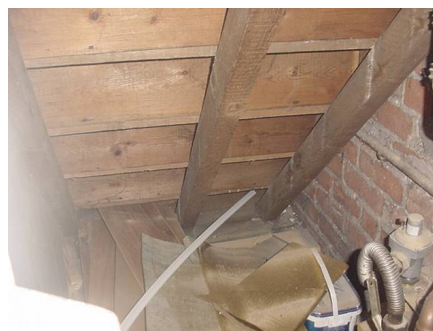
In addition to what we have mentioned already with regard to fire requirements we have noted that the staircase is not lined and given that you have a loft conversion we certainly would recommend that it is lined with two coats of plasterboard, this in a worst case scenario will help slow down the burning down of the staircase.

Staircase not lined

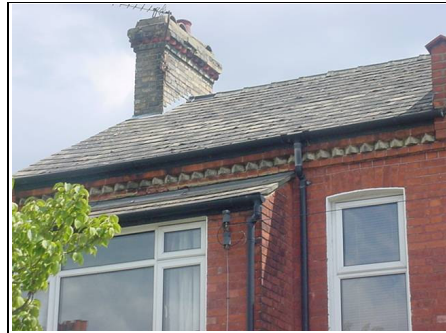
The roofs have been reroofed in asbestos slate. Asbestos was a commonly used material until recently it was banned when wide spread problems associated with were reported. However, we have recently (within the last two months) had this type of roof tile tested and it showed that the asbestos content was minimal and no work was required. However it is the perception people have where a property has asbestos a off and we this it would certainly limit the number of people interested in the property in the future

Roof tiles

ACTION REQUIRED: We would recommend an asbestos sample and check is carried out by a recommended reputable asbestos company and we would also recommend that you budget for replacing the roof due to people's perception of problems rather than actual problems.

ANTICIPATED COST: For the asbestos sample test we would expect costs to be in the region of £200 and this will advise if any further work is required no doubt you will then be able to get costs on this. We would recommend you re-read this section as it is a very important decision to make; quotations required.

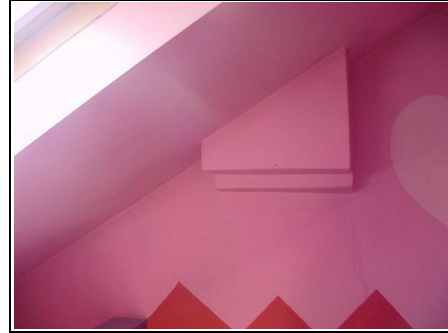
To gain access via the staircase we believe that part of the chimney was removed and it should have had Building Regulation Approval (your legal advisor to check and advise). The chimney has been racked back and we can see no signs of internal cracking etc however we appreciate that the area has been relatively recently decorated.

Missing chimney

ACTION REQUIRED: We would recommend that both chimneys are inspected within the next two years, this likely to need access scaffolding. You need to ensure that the chimneys are kept in very good condition. We would recommend you re-read this section as it is a very important decision to make.

ANTICIPATED COST: Set aside £1000-£2000 for the scaffolding and repairs to the chimneys; quotations required.

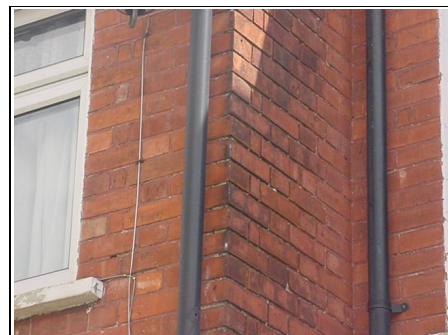
We believe that the brickwork to the front, particularly in the central area needs repointing. Gutters, downpipes, soil and vent pipes need replacing or repairing. The cause of this problem we suspect is from the leaking gutter, you need to check all your guttering, please see our comments below as once this is watertight you can repoint.

Area in the centre needs repointing

ACTION REQUIRED: Repoint brickwork once the area above is made watertight. Mortar mix should match the existing mortar and appropriate without too much cement as in this type of soft red brick property it would cause deterioration of the brickwork if the cement is too hard.

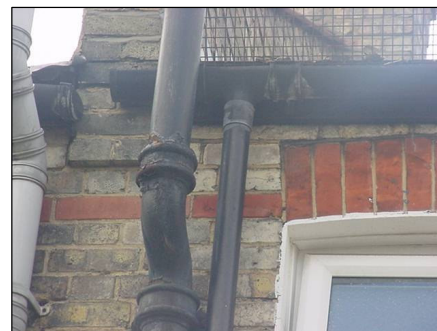
We believe that your gutters and downpipes require a general overhaul as you can see above where you need repointing there are certainly leaks occurring and the soil and vent pipe also has a lot of rust, it may be more economical to replace with although we don't normally recommend it as cast iron lasts far longer than plastic so if it is repairable we would recommend repairing it.

Leaking gutter and downpipe and rusting cast iron soil and vent pipe.

ACTION REQUIRED: A check and realignment of the gutters and general clean and carry out any repairs necessary when a close up inspection is seen. We would also look at repairing the cast iron soil and vent pipe and replace if it is not possible to repair.

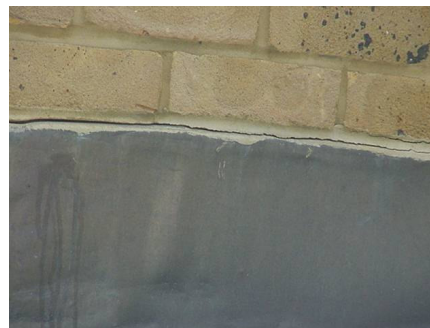
The lead flashing to the rear roof appears to have been installed poorly and we have noted hairline cracking to it and it is only a matter of time before dampness gets in.

Hairline cracking

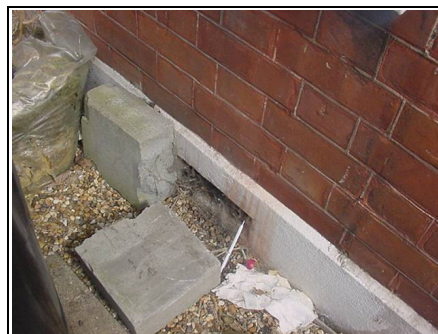
We noted that the airbricks to the front of the property have been blocked they have been partly built over to the rear of the property within the dining room area. This lack of ventilation together with the relatively high ground level in the area means that dampness is likely to be under the floor. We suspect that some of the timbers will have suffered from rot.

Airbricks to front being blocked

ACTION REQUIRED: We would recommend that you open up a section of the floor, ideally before you purchase the property, to check the condition of the timbers. We would be more than happy to comment on any photos that you may email to us. We would also be keen to see copies of any woodworm treatment and any wet rot/dry rot treatment.

ANTICIPATED COST: £500-£1000 maybe more dependent upon what you find when you open up the floor; quotations required.

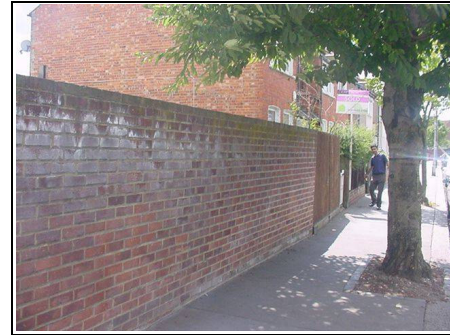
Although it is no direct responsibility to you it is close to your property, next doors boundary wall has moved over approximately 20-30mm out of plumb and looks to have been rebuilt in the past. We have commented on this as it is adjacent to the footpath that leads to your house and therefore maybe a problem.

Neighbours wall moving, LHS of your house

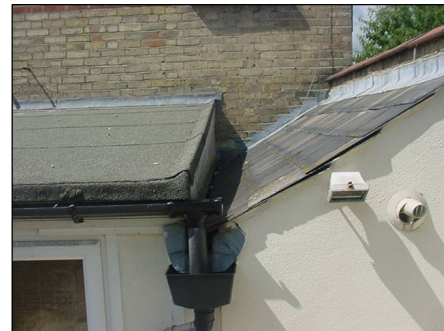
Valley Gutter

The valley gutter to the rear is an area we would expect dampness to get into as it is a weak area ideally sections should be removed altogether by redesigning the pitch. We feel that ultimately it will let water in and you will need to regularly clear this section as well as if it backs up it will cause dampness to come into the property.

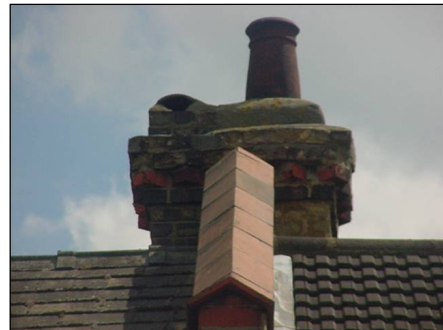
Right hand chimney

This chimney is brick finished and capped with a hog back tile and vented (to help prevent damp getting in), with a lead flashing, overall in average condition;

Our view of this one was limited however we are aware that it is the chimney that has had the chimney breast removed beneath it and therefore it is important to check the condition of this chimney closely.

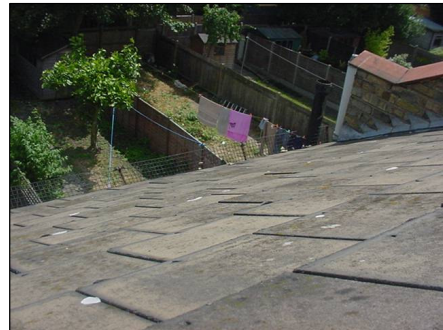
There is a very minor amount of moss growth present on the roof which can in extreme cases, impede the run-off of rainwater, lead to gutter blockages and cause water penetration, which, in turn, may lead to rot or other defects in nearby timbers.

Asbestos slates

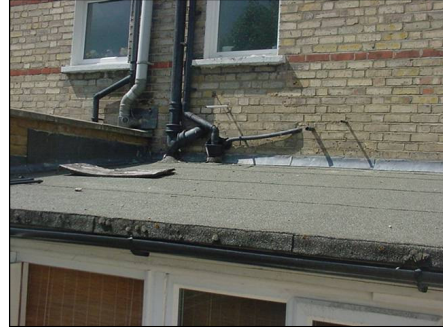
The flat roof is covered with mineral felt, with small chippings and generally looks in reasonable condition. This type of roof uses a modern torch on felt and tends to have a life of approximately 25-30 years. We believe this felt is approximately 10 years old. Where the flat roof meets the pitched there is an awkward valley gutter and also where the felt meets the main building and the parapet wall there is a poorly detailed lead flashing.

Flat roof to rear of property

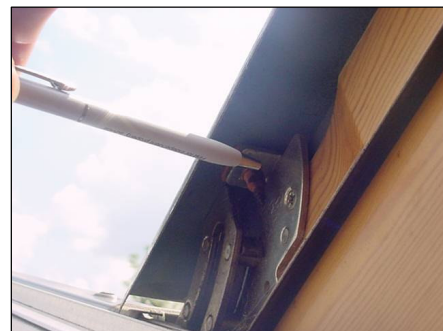
There are two roof lights to the rear of the property and were pleased to see they had blinds in them however we would comment that in our experience sooner or later all roof lights leak. They are purpose made ones with the metal outer casement and a timber inside.

Some rusting to the screws indicating that some minor dampness is getting into the roof light

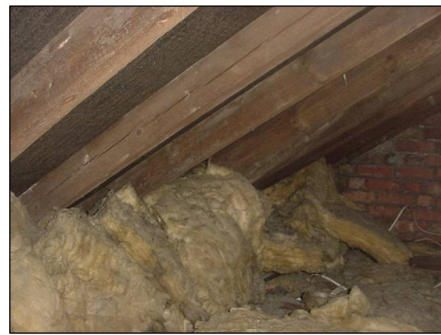
A split in the timber and also some dampness of the timber.

Whilst our examination is restricted by the room formed in the roof and insulation we would comment that we found splits in the timber which do indicate that there is condensation occurring in the roof.

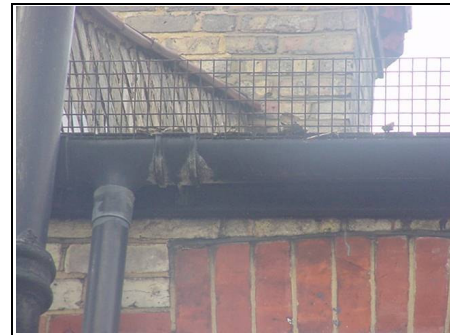
From ground level the gutters and downpipes looked to be plastic and appeared in average condition. There are a few repairs.

The plastic used is the older style with is effected by sun light and loses its colour slight and does become brittle over the years.

Minor leaks can be seen on the gutter

ACTION REQUIRED: We would always recommend that the gutters and downpipes are cleaned out, the joints are checked and the alignment checked to ensure that the gutters fall towards the downpipes. Please see our comments in the Executive Summary.

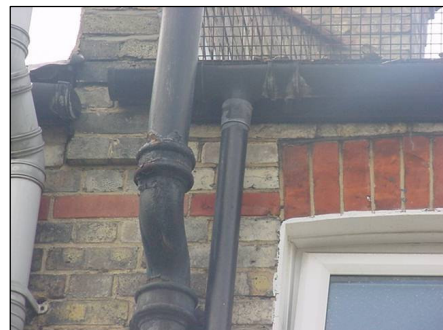
Soil and vent pipes

The soil and vent pipes are cast iron they are rusting quite badly and they are in need of repair.

ACTION REQUIRED: Repair cast iron pipes. We would always recommend keeping them as long as possible as they last far longer than plastic.

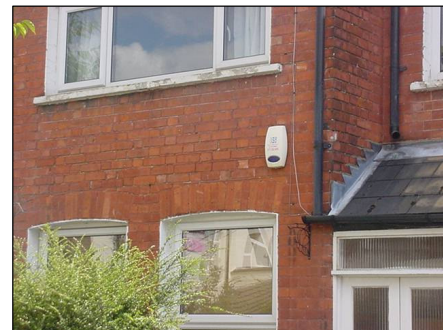
Brickwork needs repointing

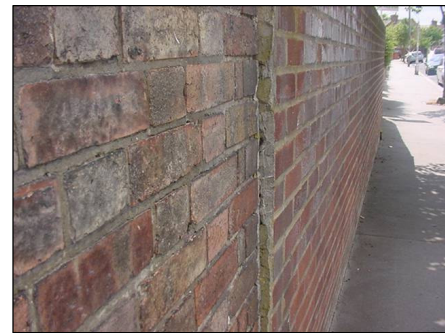
Note our comments with regard to your neighbours garden wall, garden walls are unlikely to have a foundation and there is movement in it which you do need to advise them of.

Movement in the neighbours' wall

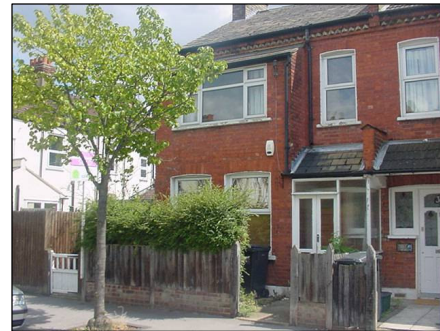
The house has trees nearby, we can see they have been cut back heavily in years gone by and some have been removed, there have been problems with trees in the area, which we believe are owned by the Local Authority. Most Local Authorities are aware of their responsibilities, but have many pressures on a limited budget.

Tree to front of the property

ACTION REQUIRED: Contact Local Authority if trees not regularly maintained.

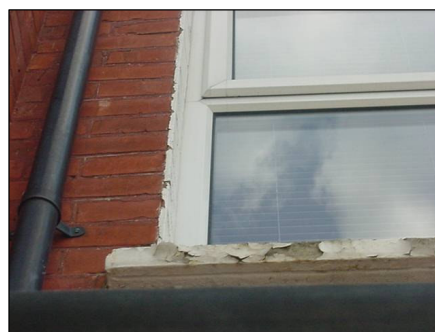
There is very little external decoration with the windows being plastic, however the surround around the window is in need of redecorating and where there are timber windows these also need decorating.

Windowsill in need of repainting

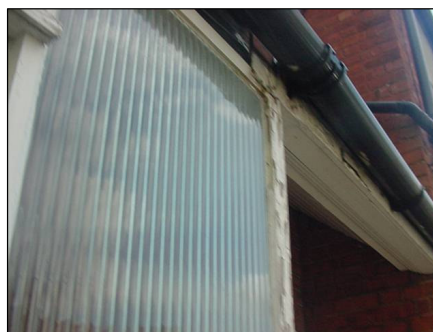
Timber surround in need of redecoration

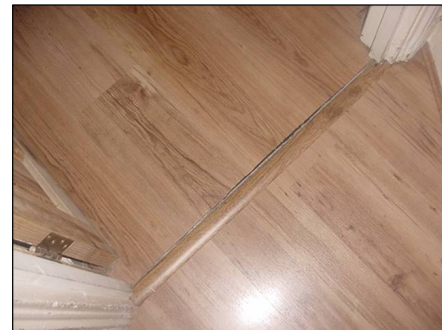
We had a limited view of the main floor and in fact the only area we could see is under the stairs. Based on our knowledge of this age of construction, we believe that the ground floor construction is predominantly a suspended timber floor. This type of floor needs air circulation under it to reduce deterioration from wet rot and dry rot; please see our comments in these sections.

Laminate flooring limiting our view of the main floor.

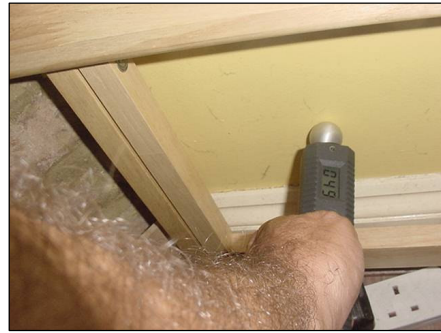
The readings we obtained indicated that there is no lateral dampness but as the property is poorly pointed this area may allow dampness in.

Dampness test

ACTION REQUIRED: Repoint
