RESIDENTIAL BUILDING SURVEY

Croydon, Surrey CR0

Mr Q

INDEPENDENT CHARTERED SURVEYORS

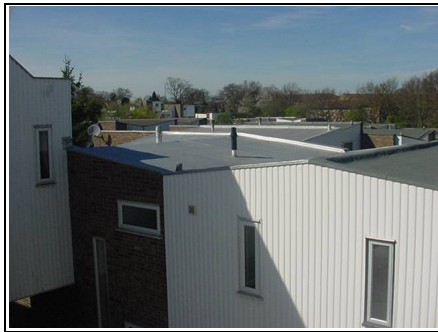
Overview of roof

The areas that we have been able to view, albeit from a distance, look to have some life left in them. We would however, if we had been able to get onto the roof, have been examining the valley gutters, as this is the weak area in this style of butterfly roof.

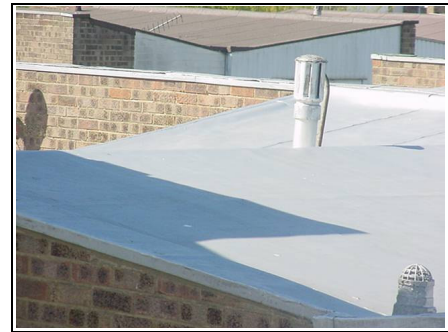
Close up view of roof

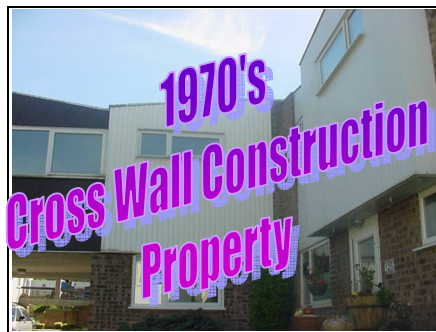
1.1 The property is a 1970's cross wall construction, which is a construction which is no longer commonly used. Cross wall construction means the weight of the roof is supported on the main brick walls and the in fill walls (the cladding panelled walls and the render walls) are a lightweight construction. Typically in a 1970's construction they were not insulated or not insulated very well at the time of construction (although they could have been insulated after by the Local Authority).

Cladding

ACTION REQUIRED: We suggest a section of the cladding is removed to check the insulation level before the winter of 2011, as this would then give the opportunity to increase the insulation if you so wish.

ANTICIPATED COST: In the region of £250 to £500 for investigation work, as it will need a tower scaffolding for all the cladding boards to be removed safely. Please note our comments later on about the damage and deterioration to some of the cladding boards.

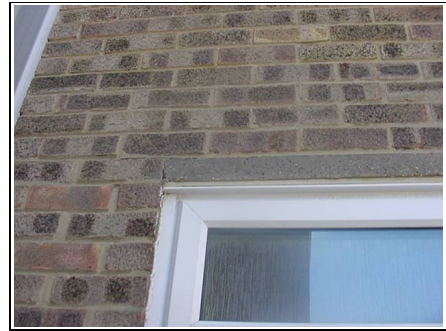
1.2 They are likely to have used concrete lintels which can cause condensation in this age, type and style of property.

Concrete lintel

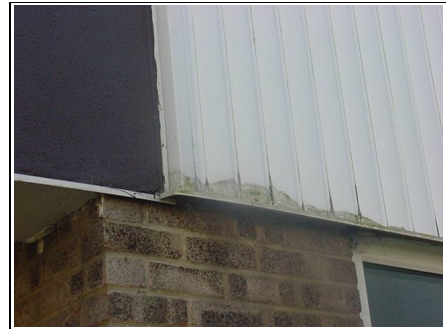
Deterioration to base of cladding board

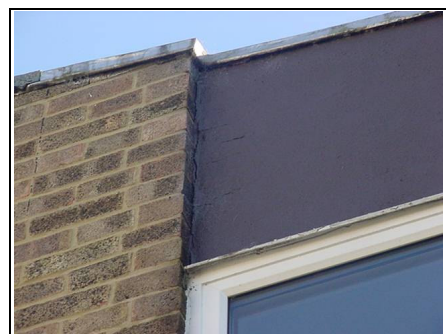
We noted that some of the mastic seals externally to the brickwork/cladding/render were starting to deteriorate and these should be replaced as they will allow damp in.

Mastic going between render and brickwork

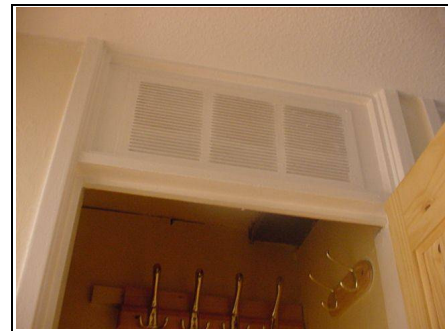
This property originally had a warm air system which has now been changed to a boiler and central heating system, but many of the radiators are internally positioned. Radiators are normally located under windows so that as the heat rises it circulates the cool air from the window.

Old air vent for old warm air system

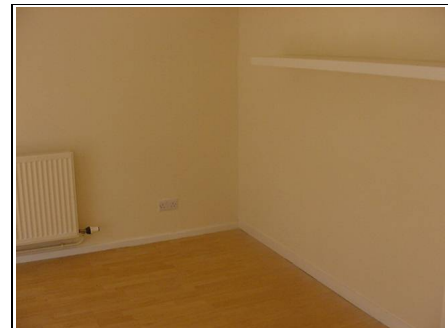
Internal radiator

Either way they do not work as well as radiators on external walls.

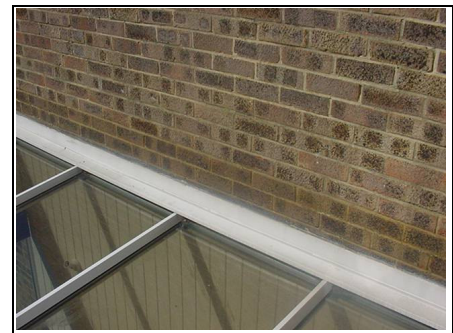
The conservatory has a single pitched roof. We are not certain whether it is plastic in the form of polycarbonate or glass; either way it needs a good clean. Our main concern is the amount of heat gain that the conservatory will give to the property and we would expect normally to have a window in the roof to allow the heat out and also to have blinds in this type of roof to reduce the sun.

Lack of flashing to conservatory roof

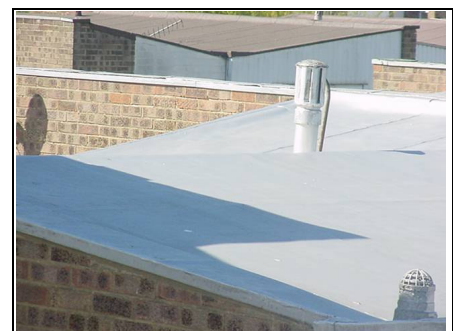
We were able to see the top of one flue. This looks to be the disused from the old air ventilation system and it looks to be asbestos, which was a common material used in this age of property.

Asbestos flue

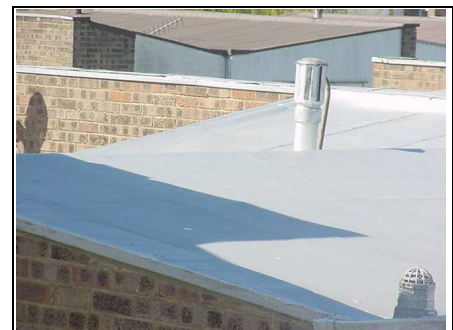
Soil and vent pipe in front right hand corner and asbestos flue pipe in rear

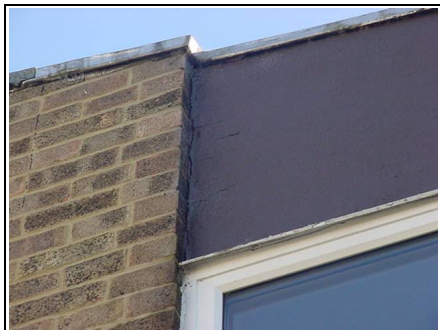
The mastic is starting to fail and this will lead to dampness. We think some dampness is already getting into the brickwork, as can be seen in the adjoining photo. It may also be due to the window detailing.

Mastic disintegrating

ACTION REQUIRED: Re-mastic. Please see our comments in the Executive Summary.

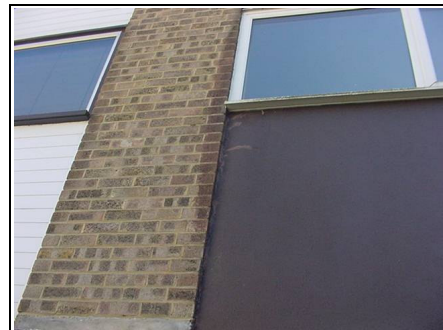
Dampness getting into brickwork

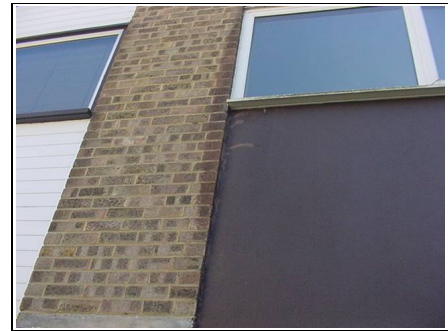
In this instance we can see some render cracks that have been repaired. We also noted on other buildings that the render has been completely clad over. Doing this gives the opportunity to add insulation as well as additional weather protection.

Render cracks that have been repaired

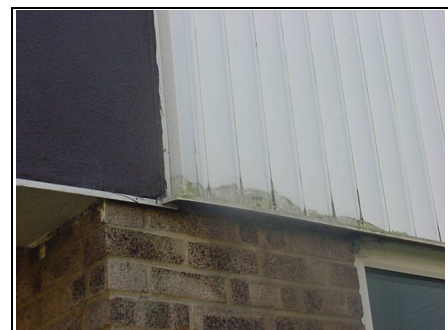
There certainly looks to be a problem with the cladding in some areas where it is deteriorating at the base. To us this indicates it is getting in at roof level, possibly via the parapet wall (if you recall we mentioned in the roof section that the parapet walls can be a problem), then transferring down behind the cladding and coming out at the base. We have come across this problem several times previously.

Some deterioration to base of cladding

ACTION REQUIRED: You need to check the parapet walls on the roof to ensure they are watertight and we recommend you strip back a section of the cladding to check the condition underneath. It could be that it sits on timber battens and these are rotting due to the water that is being transferred down from the roof.

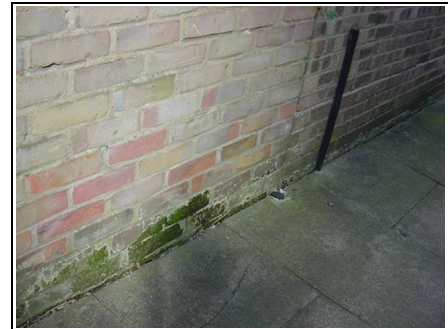
We can see a lot of moss to the base of the garden wall and we noted it was actually built in a different brick. It therefore leads us to the conclusion that may be a great deal of water running against this wall to cause the moss and it is certainly unusual to have a garden wall in a different brick to the main building.

Moss to garden wall

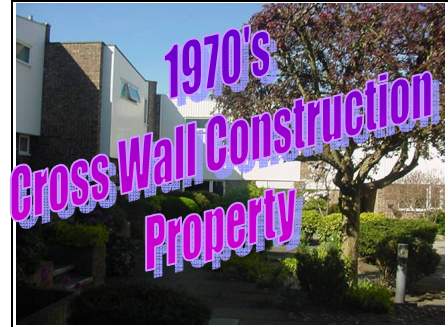
The property has a smallish tree nearby in the courtyard area which are probably maintained by the management company. We noticed there is a tree that looks to be dead within your garden, having said that many things come to life in spring! It should be remembered that trees need maintenance.

Nearby tree

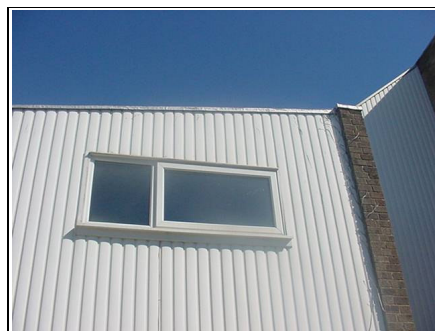
The property has plastic, double glazed windows, which generally look to be of average quality for the year made. We would term them as being from the poorer end of the market. We did not for example note any trickle vents, indicating the windows are pre 1990s and this is another reason why condensation could be occurring in the property.

Plastic windows without trickle vent

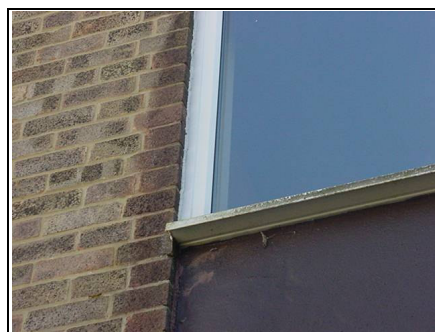
We would also add that some of the plastic has seen better days and needs a good clean, possibly replacement. We noticed for example to the window sill that can be seen in the photo that moss and mould were getting in to the sill.

Cleaning of plastic windows required

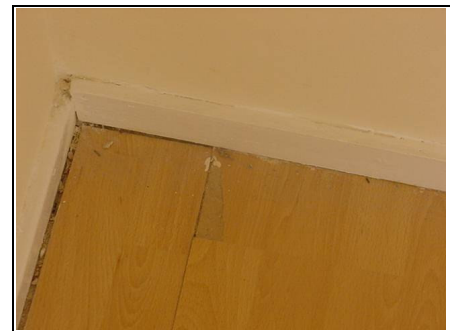
We do feel that it has an above average level of deflection; it is certainly more than we typically see. This can be for many reasons, from undersized timbers to lack of lateral restraint, to wet rot and woodworm. In this instance we feel it may be because there is proprietary style of construction that they were using to this type of property and it could well be a steel joist or what is known as an engineered timber joist. We simply do not know without opening up the structure.

Damage to timber floor

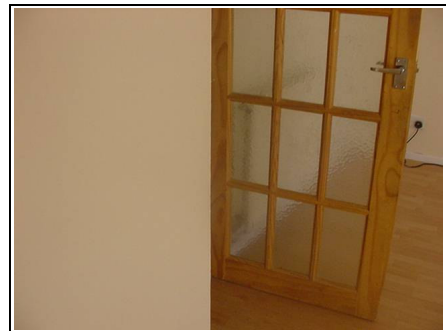
Glass door without any safety glass

ACTION REQUIRED: Replace with safety glass or replace doors.

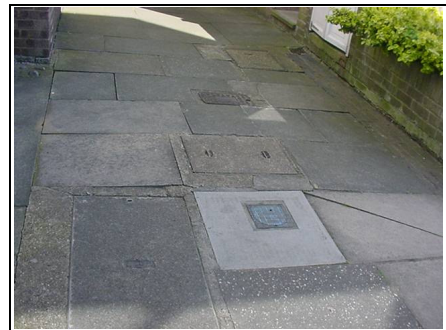
We have been unable to lift the manhole cover, which is often the case with this type of concrete manhole.

Manhole we were unable to lift

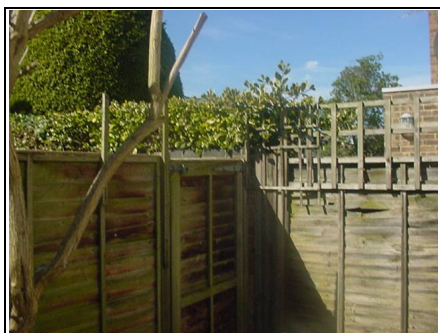
Fence requires re-staining

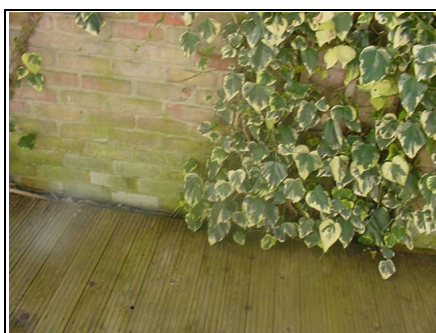
There is decking in this area. Please be aware that rodents living underneath decking is quite a common problem. The decking comes right up to the walls of the property and the garden which can cause dampness. We also do not think it is ideal to hide the drains.

The decking is become slippery

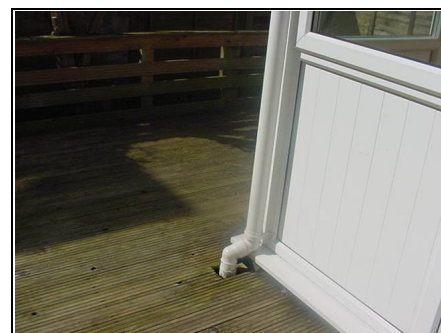
Discolouration of decking indicates it is getting slippery. It is also best not being brought right up to the building
