**RESIDENTIAL BUILDING SURVEY**  
**OF**  
**A Victorian End of Terrace Property**

This is an end of terrace property situated in Croydon.

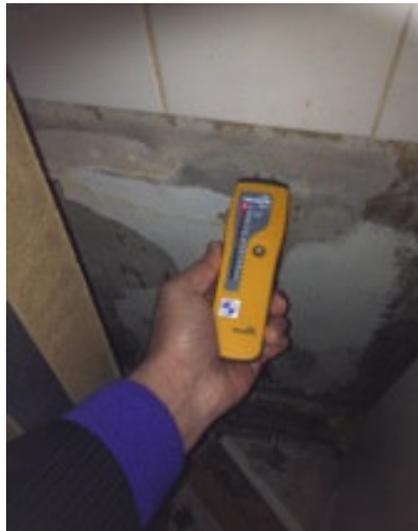
### **1.0)Dampness**

We have found high level of dampness below the window towards right hand side wall. We were advised that there it used to be a radiator which caused flooding. Rising damp could be in the result of flooding caused by the radiator.

We were advised by the owner that previously installed radiator in the kitchen caused flooding which has been removed few years ago. We have found high level of damp above this area.

**ACTION REQUIRED:** Damp Proofing Association Specialists to further investigate

**ANTICIPATED COST:** Please obtain quotations from Damp Specialists. Estimated cost is likely to be in the region of £80 to £250 depending which method is adopted. Damp proofing existing brick wall by aluminium sterate injection method (not including removal and making good plastered walls); would be in the region of £20 to £30m. Whereas cutting out one course of existing brickwork in alternate lengths not exceeding 1.00 m and insert damp proof course and replace with new brickwork: would be in the region of £130 to £150m.

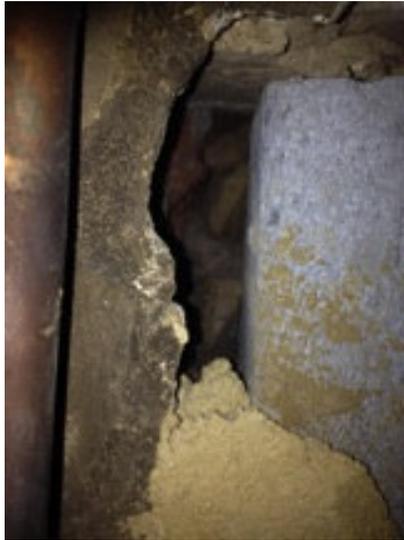
## **2.0)Hole in the Internal Wall**

Hole in the internal wall behind the boiler which was created when the boiler was changed. During our question answer session the owner advised this had been cause of rats in the property.

We were advised by the owner that hole in the wall behind the boiler was created when the boiler was changed. Please see executive summary for further actions.

**ACTION REQUIRED:** Filling the hole and repointing thereafter.

**ANTICIPATED COST:** Estimated cost is likely to be in the region of £50 to £150.

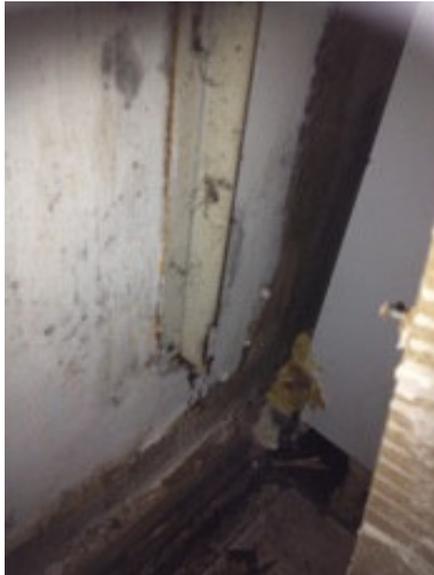
### **3.0)Paint and Decoration**

Paint throughout the wall is in poor condition due to the rising damp and change of boiler.

Internal decorations are in average condition. Walls and woodwork damaged areas and hole in the internal wall could potentially be caused by flooding and changing of boiler.

**ACTION REQUIRED:** Paint and redecorate following the damp treatment.

**ANTICIPATED COST:** Estimated cost is likely to be in the region of £40 to £100.

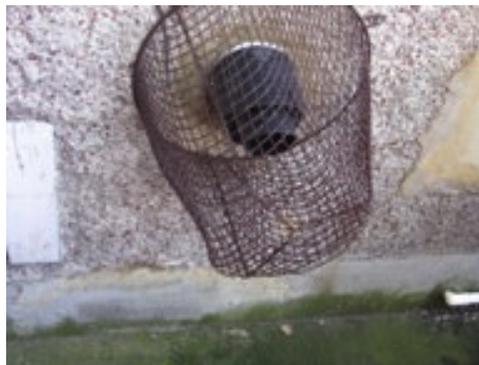
We have been advised by the owner that the flue is causing nuisance to her and the neighbours. We have taken advise from gas engineer. Please find report attached in appendices.

Flue to the external wall

**ACTION REQUIRED:** Flue management system to be fitted

**ANTICIPATED COST:** Please obtain quotations from boiler manufacturers. Estimated cost is likely to be in the region of £75 to £200

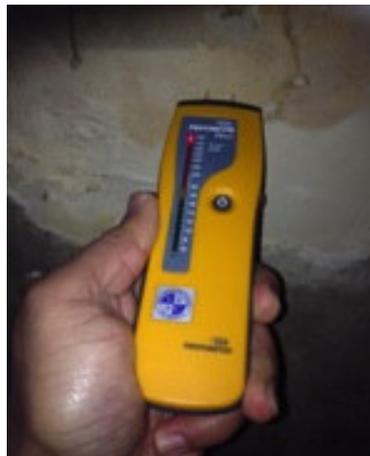
Damp reading in the kitchen internal walls

**ACTION REQUIRED:** Please see the Executive Summary
