# RESIDENTIAL BUILDING SURVEY

**Dagenham,  
Essex,  
RM10 xxx**

INDEPENDENT CHARTERED SURVEYORS

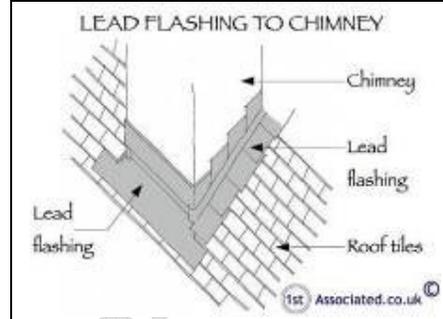
The chimneys are letting in damp. We recommend that the cement flashings are replaced with lead flashings. Cement flashings, in our experience, tend to let in dampness as often they can crack.

Lead flashing to replace cement flashing

**ACTION REQUIRED:** Remove cement flashings and add lead flashings. Also employ a roofer for half a day to reposition the displaced tiles. We would also recommend that you have a supply of tiles for when the roof next causes a problem. Ask the roofer to leave you some extra tiles.

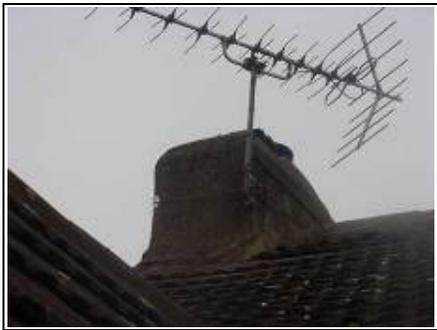
Chimney - left  
The cement flashing needs to be changed to lead flashing

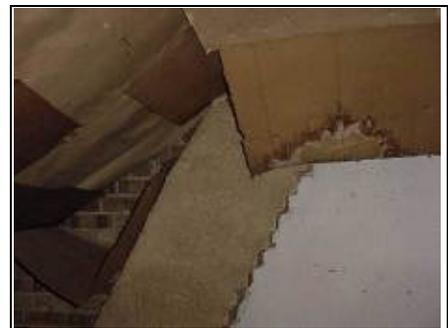
There are also some misplaced tiles that maybe causing dampness. The dampness can be seen coming in within the roof space.

Dampness visible in the roof space coming in from the chimney

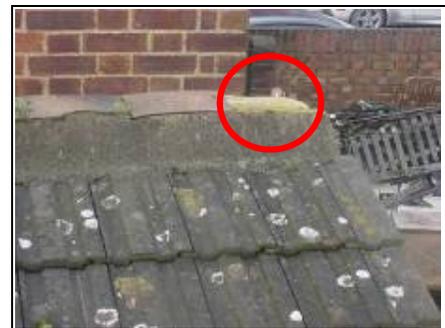
Missing tile on single pitch roof

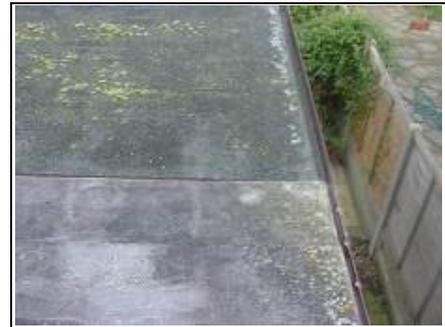
We feel that the felt on the flat roof to the rear of the property is coming to the end of its life. The felt roof over the kitchen area has become un-bonded and is blistering with cracks and crazing in it. The rear flat roof that has chippings in it also has moss on it indicating that it is a flat, flat roof (water sits on this and causes moss to grow).

Rear flat roofs

**ACTION REQUIRED:** We would recommend that a cut to fall insulation is added with high performance elastomeric felt or equivalent. These felts are more expensive than a traditional felt but, from our experience of carrying out surveys, they are lasting longer than traditional felt.

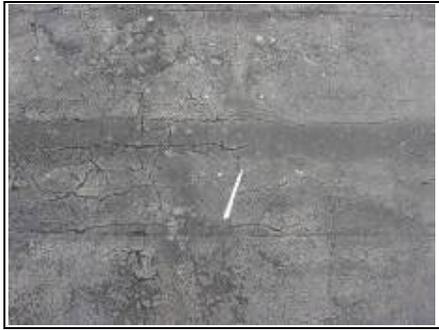
Cracking and crazing to the felt roof over the kitchen

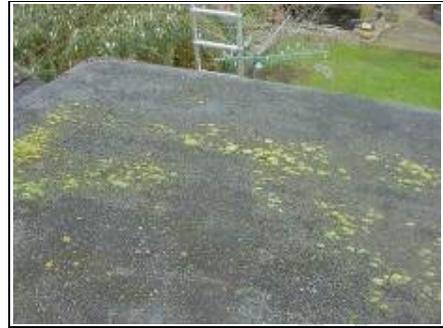
Flat, flat roof with moss growing on it

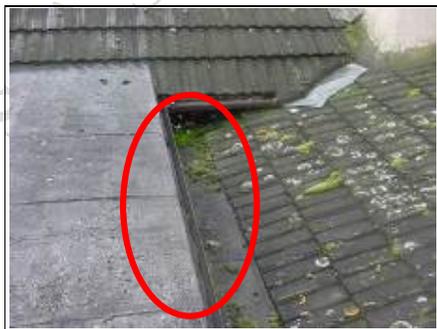
We suspect that the valley gutter to the rear of the property is leaking although this is hidden internally by the suspended ceiling tiles within the bathroom.

Hidden valley gutter where the flat roof meets the single pitch roof

**ACTION REQUIRED:** Ideally we would like all valley gutters to be carried out in lead. However we do appreciate that it is sometimes difficult to find a skilled tradesperson to carry out this work and in which case we would recommend a high performance mineral felt.

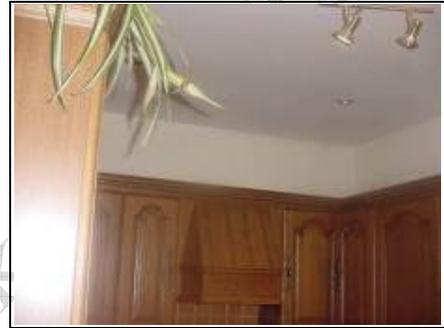
6.3 No extract fans to the bathroom and the kitchen. In these areas we would recommend large humidity controlled extract fans to external air.

Large extract fan needs to be added to external wall in

**ACTION REQUIRED:** Large humidity controlled extract fans to be added to the kitchen, bathroom and possibly the conservatory. If this is not carried out you may find black mould is occurring. We are still in the early days of discovering the health problems associated with this black mould.

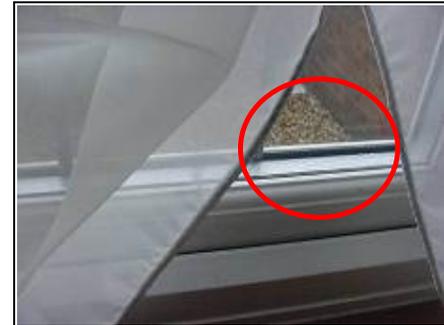
Also the single glazing to the rear of the property will tend to get condensation due to the humidity in the air.

Condensation on window  
Hard to see in the photo

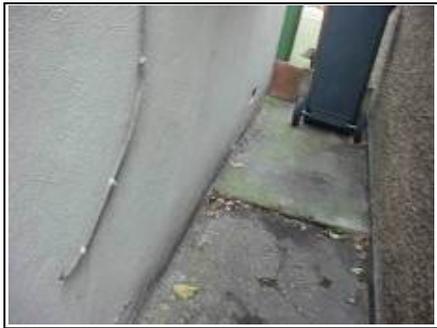
We would recommend the render to the sides of the property should have a bell mouth added.

No bell mouth detail

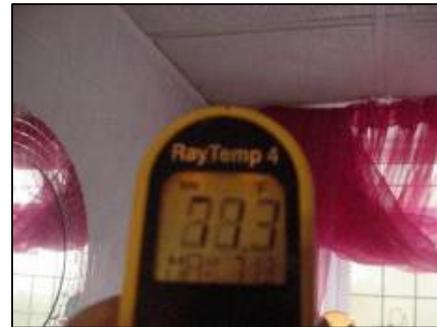
Surface temperature reading at the top of the wall is 77

**ACTION REQUIRED:** We recommend you start off with the other alterations that we have mentioned earlier such as adding large humidity controlled extract fans and trickle vents to windows. We would also recommend taking care over what is

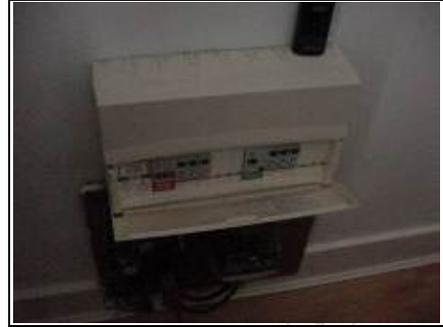
Dated electrics

**ACTION REQUIRED:** Replace the fuse board and you may wish to add additional socket points.

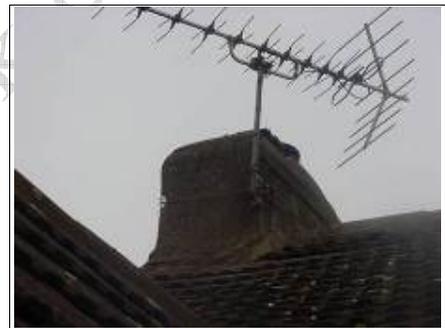
Chimney- front left

This chimney is rendered with a cement flashing and one chimney pot. From what we could see from ground level it looked in below average condition considering its age, type and style. The chimney is letting in dampness which may be via the cement render or via the flaunchings.

**ACTION REQUIRED:** Please see our comments in the Executive Summary regarding the chimney breast beneath it being removed.

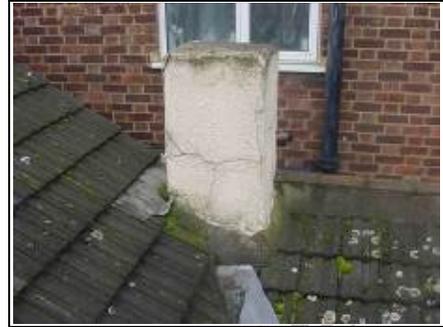
Chimney rear left

This chimney is finished in painted render and looks to have been sealed. There is a part lead and part cement flashing. We would comment that there is cracking visible to the render

**ACTION REQUIRED:** Add complete new flashings and redecorate. Please see our comments within the Executive Summary.

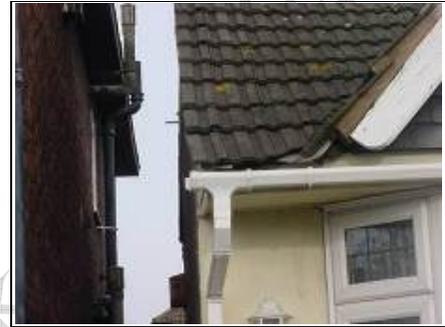
The main roof is pitched and clad with a concrete tile and, from ground level, this looks in average to slightly below average condition considering the roofs age type and style. We could see moss on the roof which indicates that the water is not running away properly and there is a lack of air circulation, ventilation and sunlight to the roof.

1970's concrete tile  
Not unusually for 1970's tiles they look to have been put on quickly

**ACTION REQUIRED:** Use a soft brush to remove the moss from the roof. We noticed that some tiles are out of place and recommend that you have a roofer for half a day to check them. Carry out periodic inspections and maintenance of the roof, as required

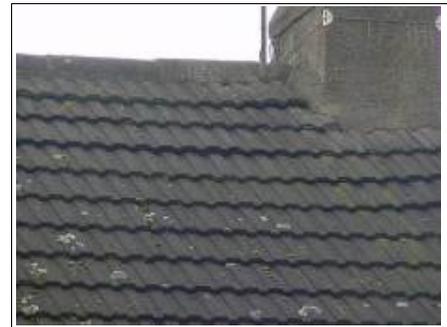
Moss on the roof.

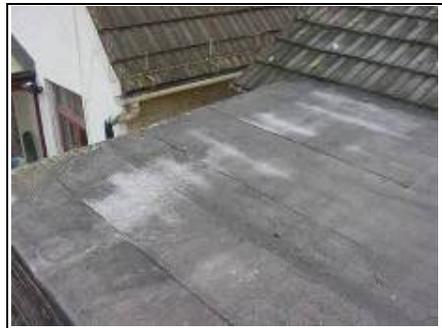
One has a bitumen finish which is crazing and cracking.

Rear flat roof with bitumen finish

**ACTION REQUIRED:** We would recommend this is replaced with an insulation cut to falls to take the water away.

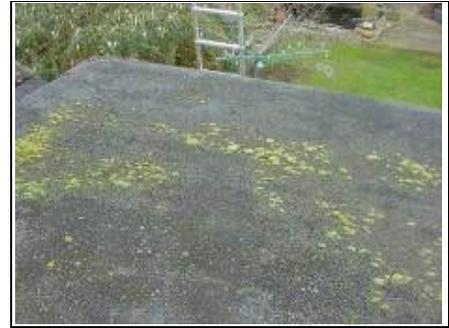
Rear flat, flat roof with a mineral finish

**ACTION REQUIRED:** We would ultimately recommend this is replaced with an insulation cut to falls to take the water away.

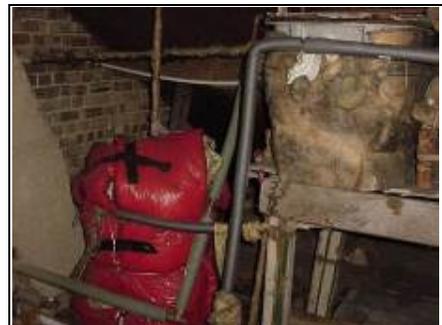
There is a water tank in the roof space. You advised that this will no longer be required as you intend to put a new boiler in place. If you do intend to use it for some time then we would recommend that the water tank be drained down and cleared of any debris etc.

Water tank and dated hot water cylinder

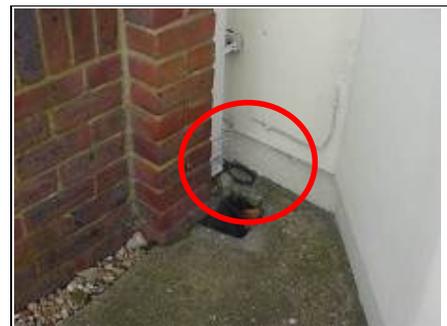
Downpipe needs a slate to prevent dampness getting into the property

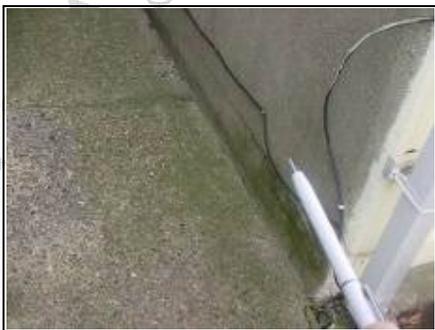
There is cracking to the render believed to be caused by the cement render being too hard in consistency.

Cracking on left hand side of render

**ACTION REQUIRED:** All hairline cracks need to be sealed.

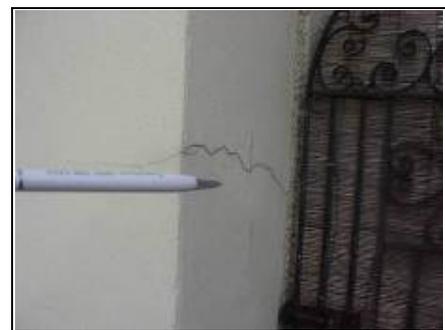
Cracking right hand side of render

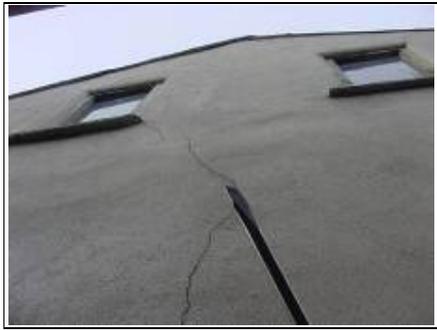
Crack in render

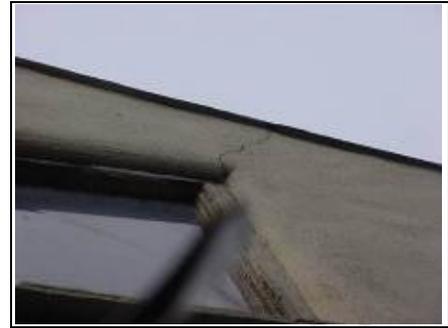
Crack in render on window

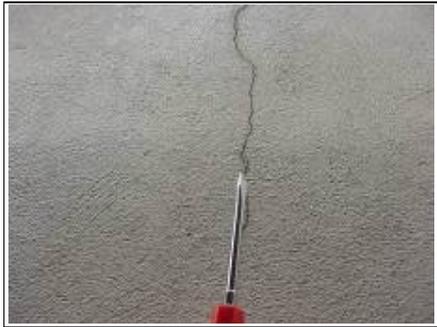
Cracks to the render

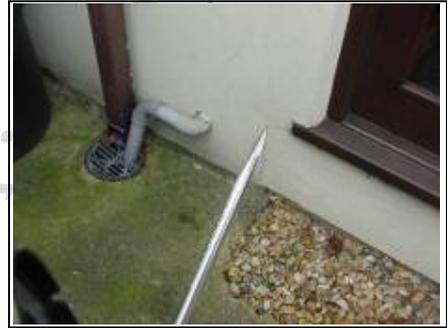
Cracking in render to the rear

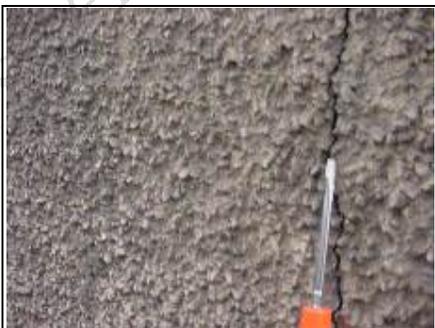
We noted cracking on the right hand neighbours building. This may indicate some leaks to the drainage. Older drains tend to be a push-fit type system that do leak.

Neighbours property also has cracking

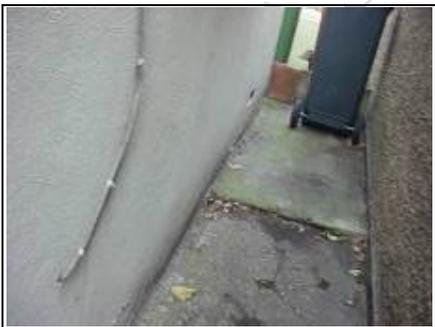
We could only see a bell mouth detail to the base of the property to the very rear of the extension. To both the left and right hand side of the original property there is no bell mouth with the render going all the way down to the ground. This will cause capillary action and allow some dampness in.

No bell mouth detail

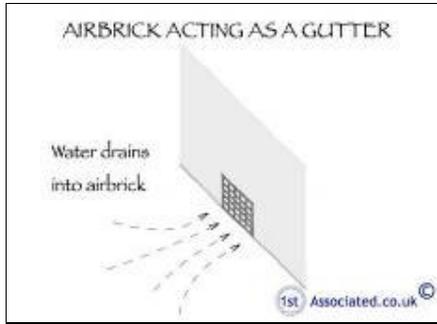
We are slightly concerned that the airbricks may be acting as gutters due to their position and so would recommend that you protect them.

Air brick unprotected allows water in

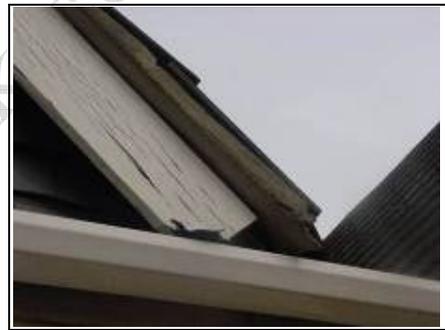
Fascias need painting

**ACTION REQUIRED:** Please see our comments within the Executive Summary.

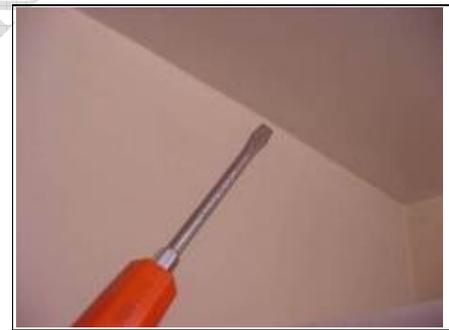
Cracking where the studwork wall in utility room meets the solid wall

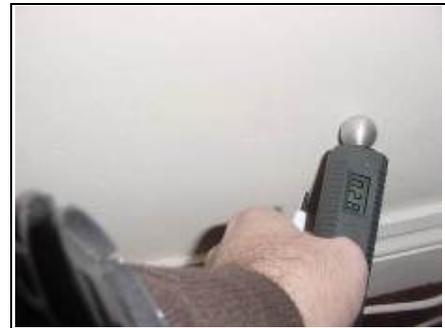
A visual inspection and tests with a moisture meter have been taken to the perimeter walls. In this case we have found rising damp particularly to the left hand side.

Testing for rising damp

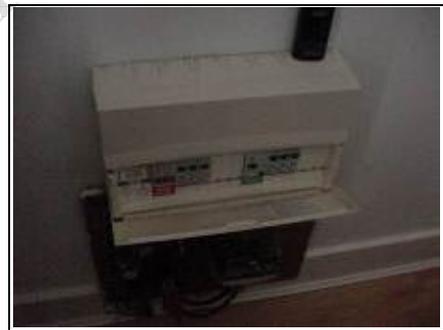
Fuse Board

The fuse board is dated and we would recommend replacement. The Institute of Electrical Engineers standards (IEE) recommend a test and report whenever a property changes occupancy. This should be carried out by an NICEIC registered and approved electrical contractor or equivalent.

The electric fuses and consumer units were located in the front right bedroom. The fuse board looked dated, circa 1970's/1980's, better are now available.

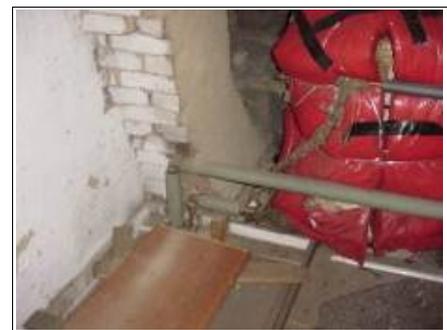
There is an older style hot water cylinder in the roof space which has an insulation jacket. This cylinder will therefore not have the same thermal properties as a modern factory insulated cylinder. The problem with these dated cylinders is they can just leak at any time.

Dated cylinder in roof space

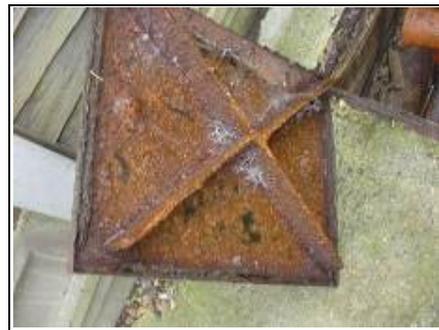
Whilst we have lifted the manhole cover to the rear right hand side of the property the only true way to find out the condition of the drains is to have a closed circuit TV camera report to establish the condition of the drains. In this age of property there have often been leaks over the years. We did note that the cover was rusting and could indicate previous blockages.

Rusting cover indicates it may have blocked up in the past

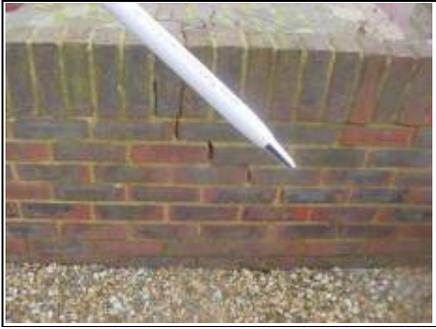
There is an alpine style garden to the front of the property. The brick wall has a stepped crack in it and will need repair.

Step cracking in wall will need repairs.
