# RESIDENTIAL BUILDING SURVEY

East Dulwich,  
London  
SE22

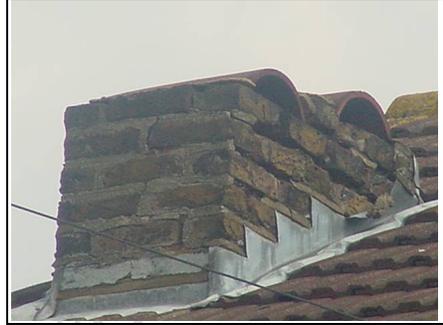
The chimney to the front left hand side (all directions given as you face the property) has been lowered and in need of repointing. The front chimney normally feeds the fireplace in the front room.

Chimney lowered with missing pointing on right hand side

**ACTION REQUIRED:** Repoint and check the condition of the chimney in the roof. Please note we viewed the chimney from the loft hatch.

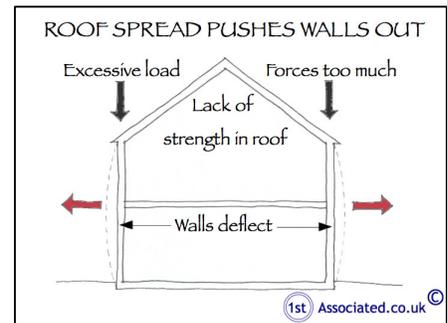
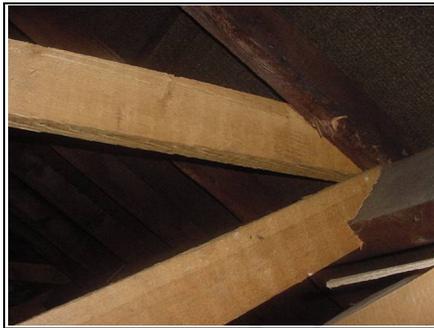
To the main roof a heavier concrete tile has been put on the roof, probably replacing the original lighter slates. We can see that extra supports have been put in the roof but we are not certain that these are sufficient and/or were added before the vertical crack occurred that we can see to the side of the property, which indicates the wall is being pushed outwards by the roof, known as roof spread. This would put many people off buying this building.

Extra timber supports in roof space

- 2.1 Check and confirm if Building Regulations Permission was obtained for the concrete tile roof.
- 2.2 Ask the owners have they had structural work carried out to pin together the vertical cracking on the left hand side (from the messy finish to it it does not look like this is the case).
- 2.3 If neither of these have taken place then this is a high risk purchase, but it could be purchased with the existing owner putting in an insurance claim which you then take over when you purchase the property. Your legal adviser needs to check this; the aim being to limit your liability to the premium and to reduce the purchase price by this amount plus an amount for inconvenience.

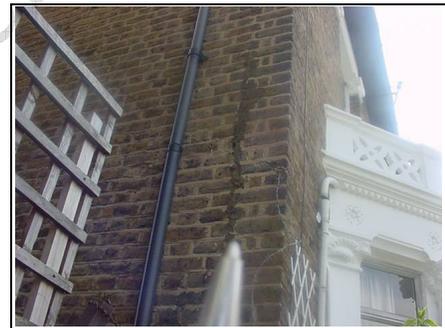
Pen indicates crack in left hand wall

Alternatively, there could be movement to the front bay window that has caused this problem.

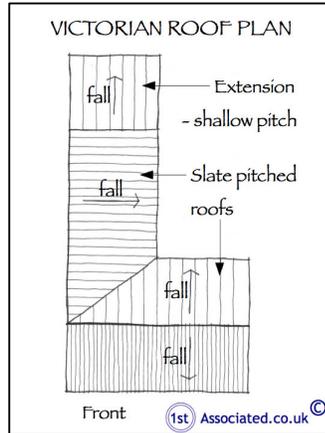
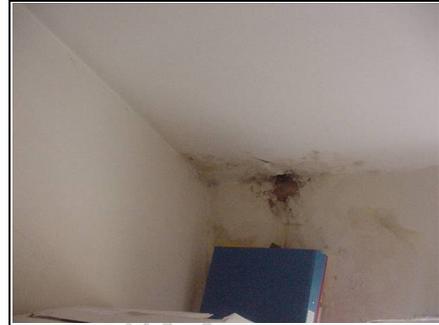
Where the roof meets the wall is a poor detail and dampness is coming in.

Dampness coming in to corner of top floor small room / store

**ACTION REQUIRED:** You need to first of all check that the gutters are not blocked and the valley gutter where the two roofs meet is clear and there are no broken or slipped tiles and is watertight. As this is high level work it is likely to need a tower scaffold to the rear.

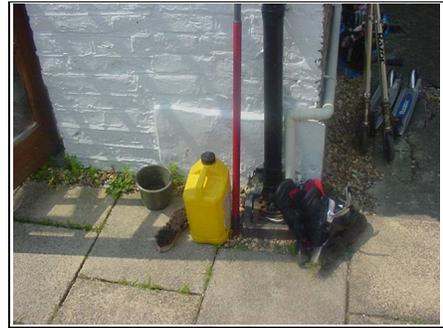
Minor damp was found to the kitchen / breakfast room. This we believe is due to high ground levels. It could be argued that the kitchen / breakfast room is not a habitable area and as such does not need to be as dry as the rest of the property.

**ACTION REQUIRED:** Lower the ground level, ideally adding a French drain. Please see Appendices.

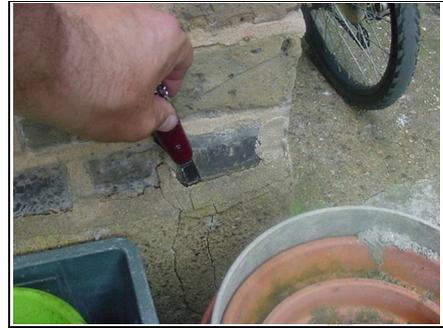
Cement mortar repointing

Close up of cement mortar

**ACTION REQUIRED:** We would recommend gradual repointing of the property, with a regular visit from an old bricklayer who knows how to work in lime mortar, who uses a stiff brush against the mortar to remove it.

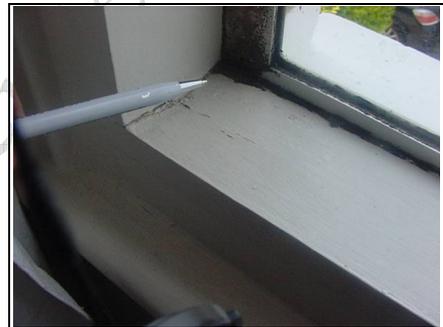
Aluminium windows are renowned for condensation. The darkening of the aluminium may be a sign that condensation is occurring in the property.

Pen indicates mould to window

**ACTION REQUIRED:** You may ultimately want to/have to replace the windows.

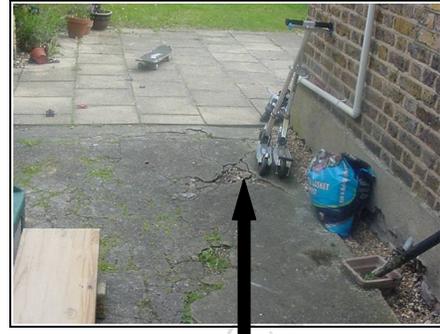
There were no manholes noted. We spoke to the owner and she advised they had had problems in the past with the drains and had to dig up the side of the rear left hand area of the property (all directions given as you face the property). There was cracking in this area which could be an indication there are further problems with the drains.

Cracking left hand side of property

**ACTION REQUIRED:** We recommend a closed circuit TV camera report of the drains.

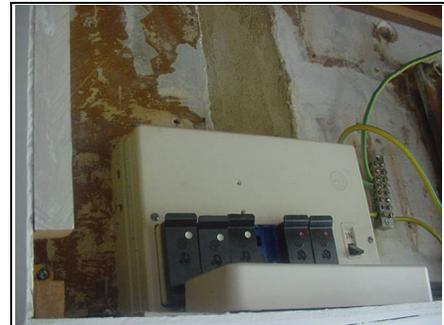
Dated fuseboard

**ACTION REQUIRED:** Replace the fuseboard and have an Institute of Electrical Engineers standards (IEE) test and report carried out by an NICEIC registered and approved electrical contractor or equivalent, which is recommended whenever a property changes occupancy.

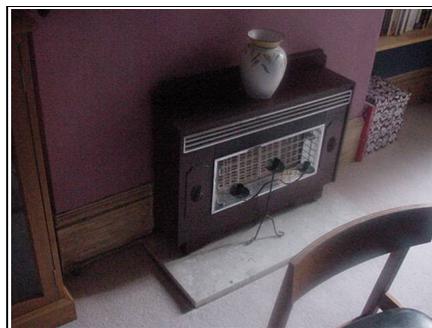
Gas fire

**ACTION REQUIRED:** You may wish to replace.

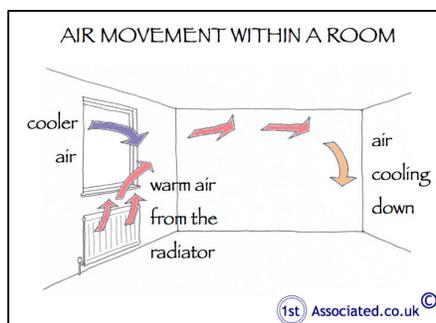
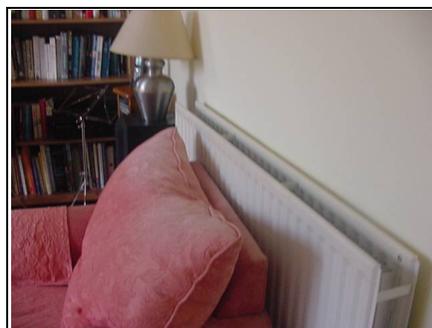
We noted the radiators are internal in some areas. This is often carried out on cheaper central heating systems to save the labour and piping costs of taking the radiators underneath the windows. However, it then reduces the air movement in the room.

Internal radiator

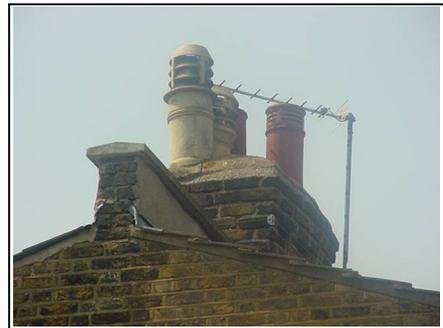
We had a limited view of this brick chimney. What we could see appeared in average condition. Interestingly one of the pots seems to have been removed; again we could not see the flaunching properly.

Rear right hand chimney

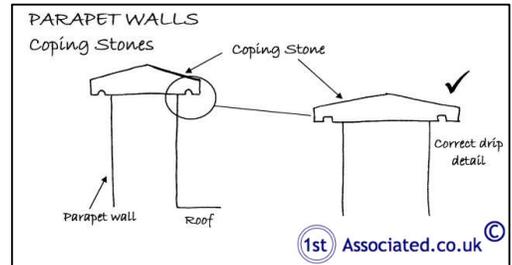
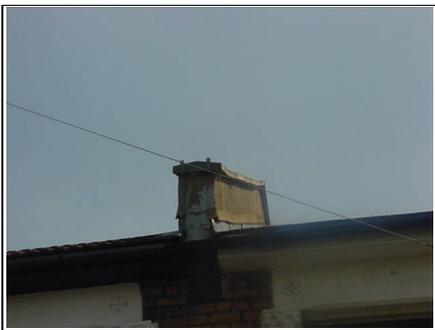
In this case there are brick parapet walls; one to the front right hand side and one to the rear right hand side (all directions given as you face the property). They look to be in reasonable condition, with a rendered finish and a coping stone. Often the drips are the problems with these parapet walls. Unfortunately we cannot get close enough to see them properly.

Front right hand side parapet wall

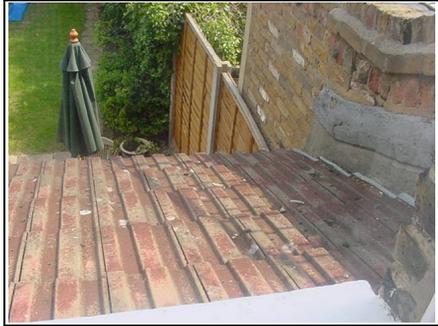
There is a low level pitched roof to the rear of the property which is clad with a concrete tile. There is some wear to the top of it, which is not ideal. We believe there is a problem with the right hand side flashing.

The protective coating on the tiles is wearing off

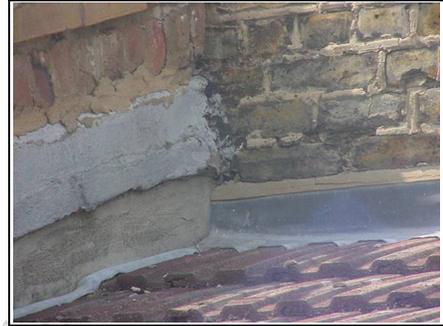
Poor detail where roof meets wall

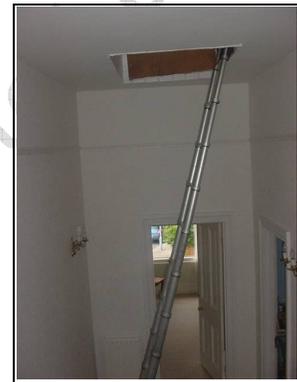
The main roof is accessed via the loft hatch located on the upper landing. It is fairly difficult to access due to the height. There is no loft ladder, electric light or secured floorboards. We recommend that these be added, as it will make the loft space safer and easier to use

Loft difficult to access

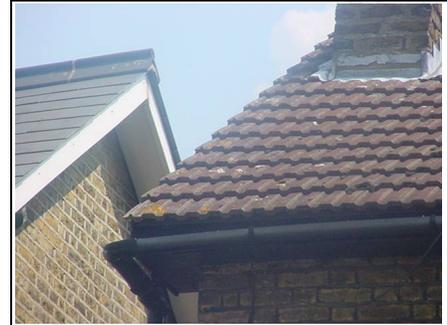
The gutters and downpipes are plastic, with some older piping visible, for example to the front bay window. Please see our comments on these. With high level guttering such as this it tends to be left and not cleared.

Gutters

**ACTION REQUIRED:** We would also recommend that the gutters and downpipes are cleaned out, the joints are checked and the alignment checked to ensure that the gutters fall towards the downpipes. This may be why there is a reason to the rear of the property.

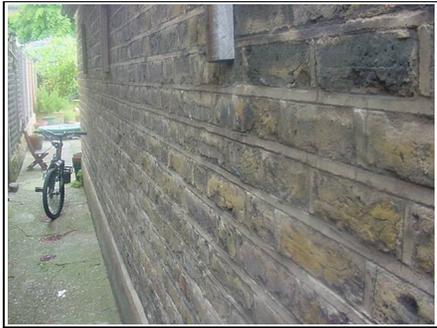
The walls have been repointed in a cement mortar, they would have originally been in lime. This does not allow the property to breathe properly.

Cement mortar repointing

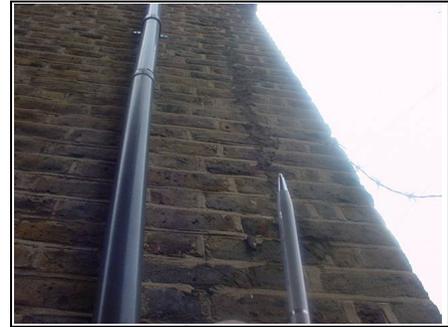
We would remind you of the vertical crack that is visible to the left hand side of the property.

Crack to left hand side

**ACTION REQUIRED:** Please see our comments in the Executive Summary.

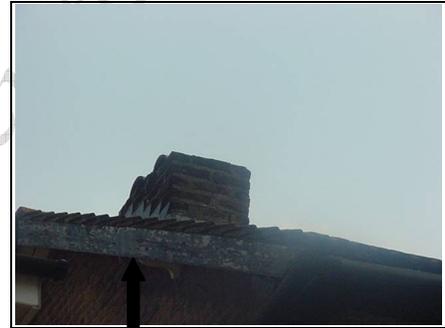
Fascias and soffits need redecoration

**ACTION REQUIRED:** Redecorate by the summer of 2013. You of course need to ensure the gutters and downpipes are watertight before you do this.

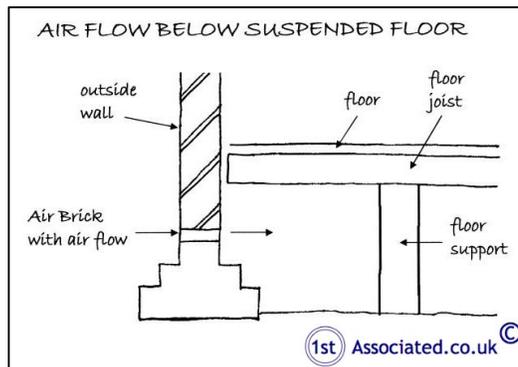
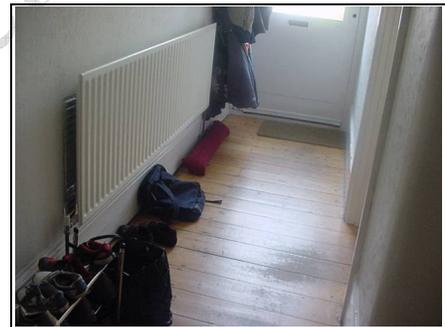
Wood floor – slightly worn

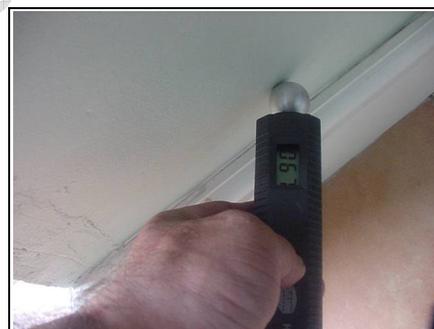
In this particular case we have found dampness to the rear of the property and believe this relates to the ground levels.

Finding high damp readings

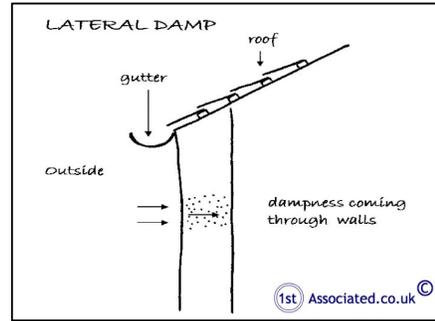
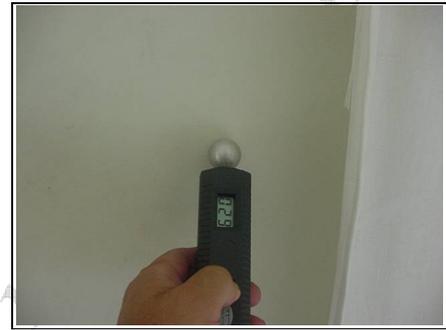
Testing for lateral dampness

**ACTION REQUIRED:** Please see our comments in the Executive Summary.

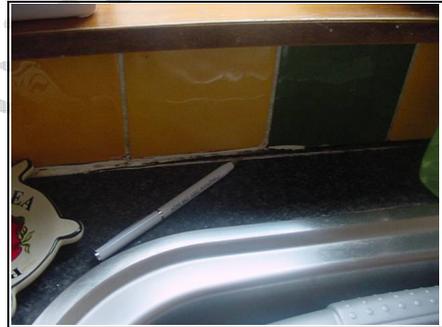
Seal around kitchen sink has gone

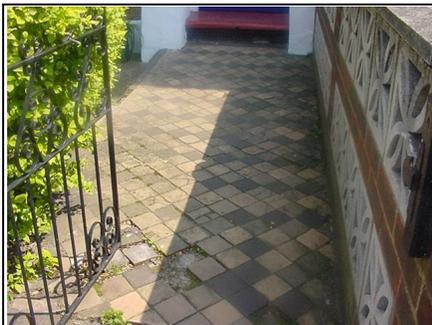
The property has a small front garden. The front path is deteriorating and needs putting back together again.

Tiled entrance path deteriorating
