RESIDENTIAL BUILDING SURVEY

Dulwich,
SE24 xxx

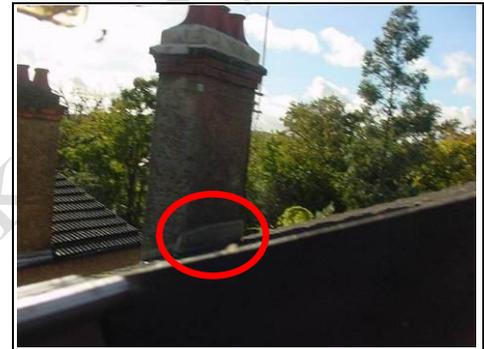
Some of the chimneys appear to be letting dampness in. To the rear of the rear chimney, where we could see the flashing properly, we noted a cement flashing rather than a lead flashing has been used. The cement flashings generally tend to become brittle and crack over time and allow water in.

Rear chimney with cement flashing

ACTION REQUIRED: We would recommend that all flashings are checked and replaced with lead flashings as shown in the adjoining sketch.

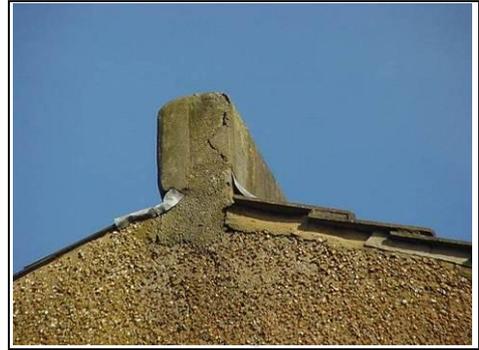
There are parapet walls to the right hand side of the property that are finished with cement render and were probably originally built in brick. We can see what looks to be a cover flashing. This is where a flashing has been put over the top of another flashing. In this case we believe the flashing was originally likely to be concrete and now has a lead cover flashing added.

Parapet wall

We can see also different cements indicating that repair work has been carried out. Internally we can see dampness is getting in.

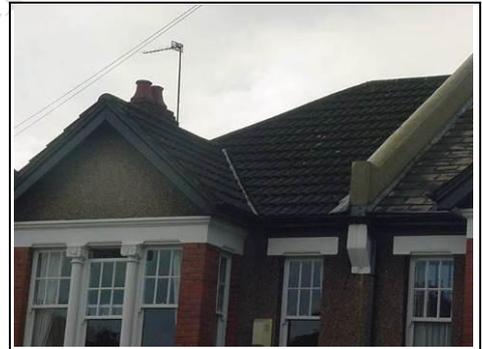
The property would originally have had a slate roof which has been replaced with a heavier concrete tile. We can see from within the roof space that original timbers have been added to help support the roof. We would comment that the original hipped cut timber roof has timbers smaller than we would normally expect.

Concrete tiled roof

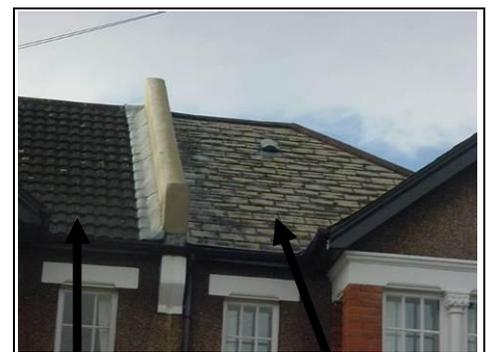
Slates replaced with heavier concrete tiles

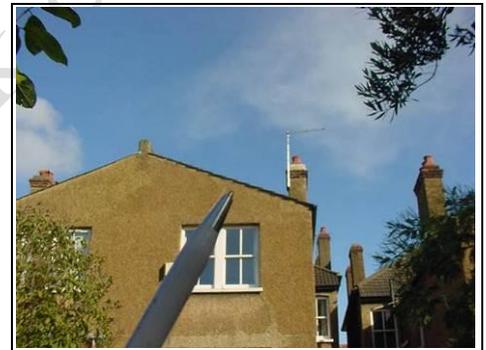
We noted cracking to the render in the rear wall. We could not see any cracks internally but we did, however, note cracks on next doors property. This leads us to believe that the cracks are possibly related to leaking drains.

Cracking on end gable

ACTION REQUIRED: Have a closed circuit TV camera report of the drains carried out to check if they are leaking and repair as necessary.

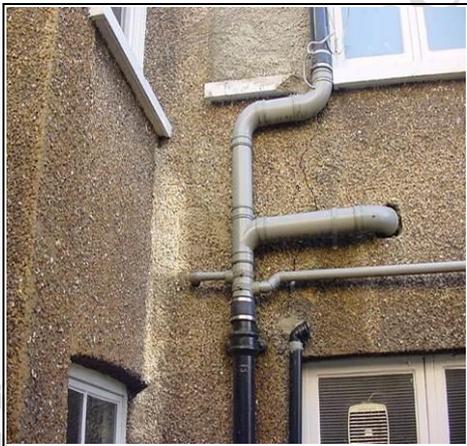
Crack on next door neighbour's property just to the right of the pen

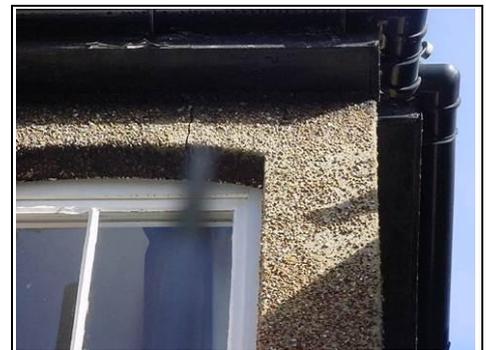
Cracking at the top of the window

The render has been carried out in a cement mortar which is slightly too hard and where there has been movement around the windows this has caused cracking in the render.

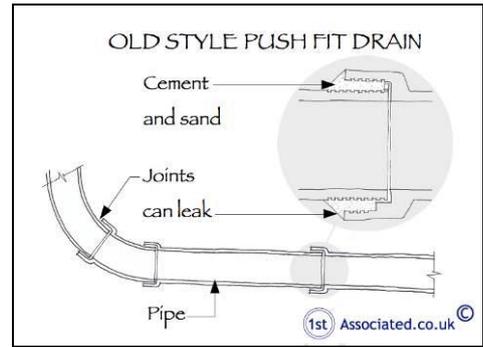
In this era of property the drains will have been a push-fit style and these are prone to leaks over time.

Push fit drain

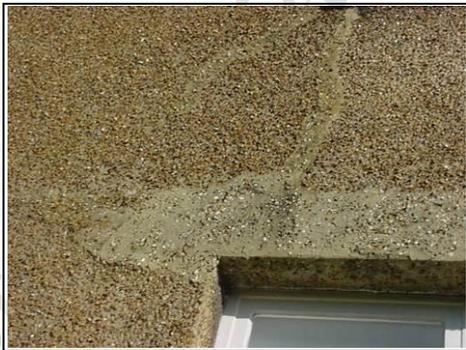
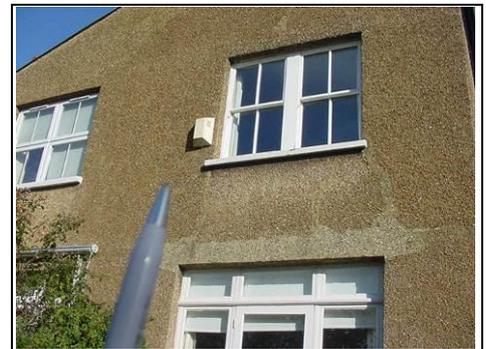
We would also comment that we can see render repairs to the rear of the property which looks very like a lintel has been replaced. When we spoke to the owner during our question and answer session she was not aware of this.

Repairs to render

ACTION REQUIRED: Your legal Advisor needs to specifically ask the present owner about any repairs that have been carried out to the rear of the property particularly in relation to windows and lintels.

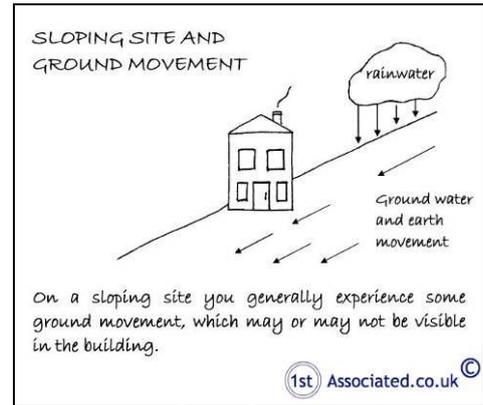
As a general comment we would say that the property sits on a sloping site and as such is more susceptible to movement due to the forces of gravity etc. This could be another reason why there is some cracking within the property particularly when combined with the hipped roof with the heavier concrete tile on it.

Sloping site

ACTION REQUIRED: Check with several insurance companies with regard to insurability of the property.

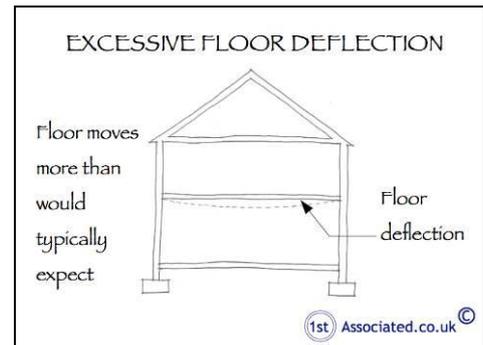
The first floor bedrooms deflected particularly the front and the middle bedroom. This could be a combination of the heavier roof that has been added to the property and the leaking drains and possibly wet rot to the joist ends which are likely to be embedded in the brick walls in this age of property.

First floor deflection

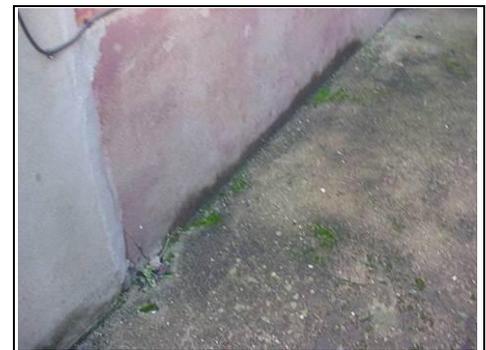
We found dampness to the rear of the property. We can see that damp proof courses have been inserted in the past which are generally considered not to work in this type of older style property.

Render to the rear of the property. A bell mouth needs to be added

ACTION REQUIRED: We would recommend that a bell mouth detail is added to the base of the render (see

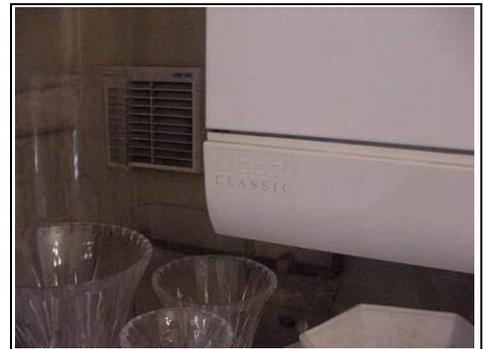
Ideal Classic Boiler

ACTION REQUIRED: Obtain any service records as it is an old boiler system. It's also worth having this boiler serviced as soon as possible to get a good indication from the heating engineer as to the life of the boiler. We would say it's coming to the end of its life

ANTICIPATED COST: If replacing this boiler then a new boiler seems to cost from about £2,500 to £3,500. Often the problem is that the new boilers are higher pressure than the old boilers and as such you will also have to replace radiators and associated pipes or at least power flush them; please obtain quotations.

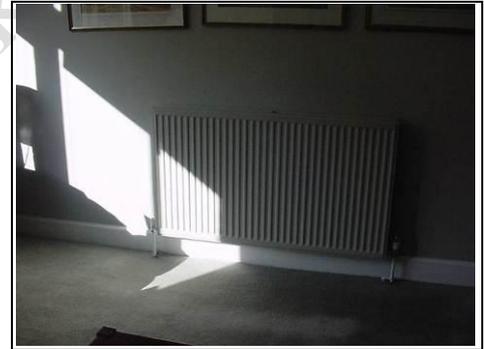
We also noted some internal radiators (on internal walls as opposed to external walls under windows). Internal radiators do not generate air movement in the way a radiator under a window does. Please see our sketch.

Internal radiator

ACTION REQUIRED: Replace the single panel radiators with double panel radiators. We would recommend the internal radiators are moved under windows where possible if you are upgrading.

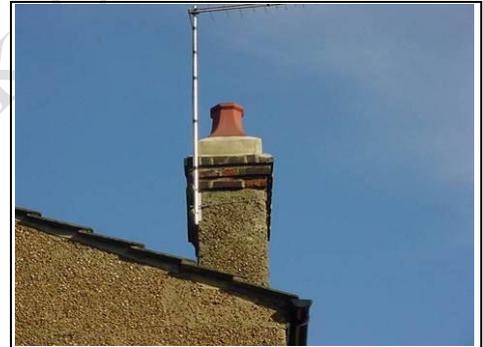
Chimney -rear

ACTION REQUIRED: Please see our comments within the Executive Summary. We see no reason why cement flashing would not have been used on the other chimneys as well so we recommend these are investigated and work carried out as necessary

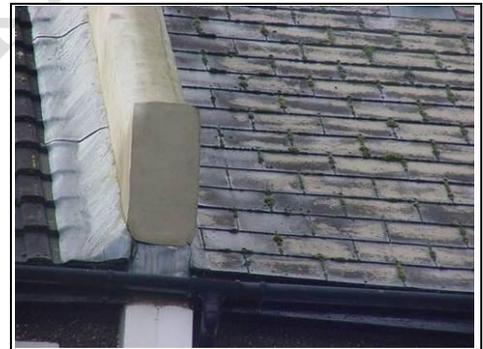
In this case there are rendered parapet walls to the right of the property. These look to have had repair work due to the different colour of cement mortar visible and we also noted what we would term as a lead cover flashing.

Front parapet wall

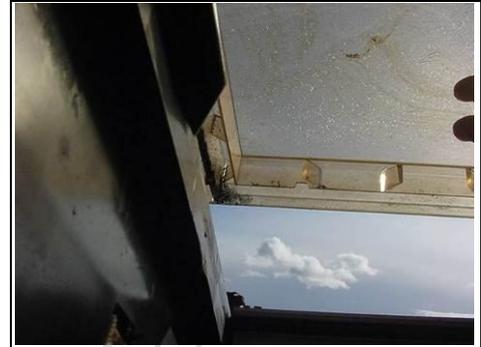
There is a rear roof window that we could not see from ground level but which we noted from within the roof space. This roof window is from the cheaper end of the market and is a plastic window and surround. From our experience these do leak and should be replaced. However no leaks were noted during the course of our survey.

Plastic roof window

ACTION REQUIRED: We would recommend replacing before the winter of 2013.

ANTICIPATED COST: In the region of £350 to £500; please obtain quotations.

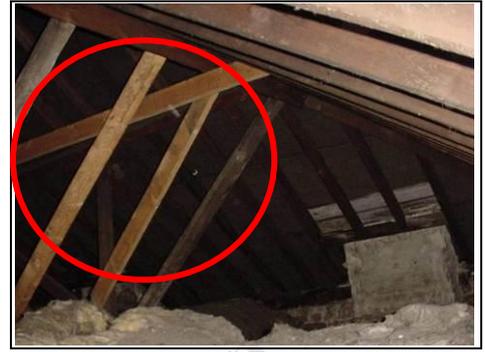
General view of inside of main roof. Red circle shows added timbers

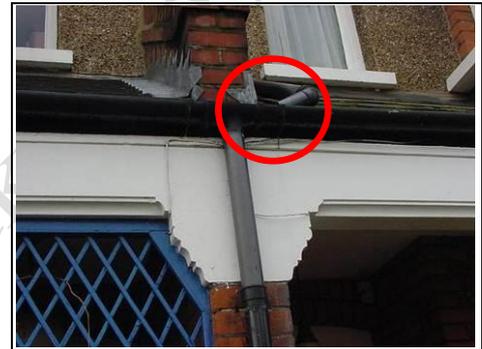
Possible overflowing gutter

We would also recommend that the gutters and downpipes are cleaned out, the joints are checked and the alignment checked to ensure that the gutters fall towards the downpipes.

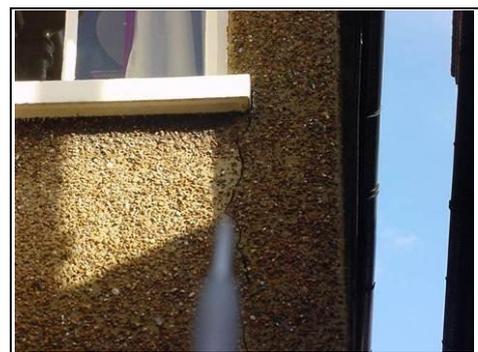
Crack in rear wall

ACTION REQUIRED: Please see our comments within the Executive Summary.

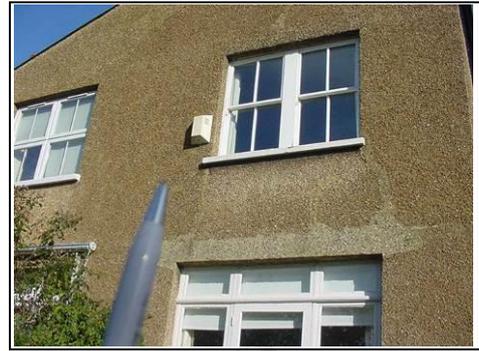
There have been repairs to the render particularly what looks to be the rear lintel and also to the vertical cracking of the windows. Please see our comments within the Executive Summary.

Render repairs

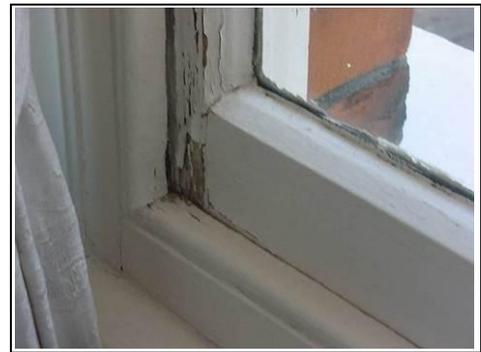
The knife test to the front windows showed them to be in average condition although we did note some rain was getting in and rot was visible in one of the bay windows.

Rot in bay window

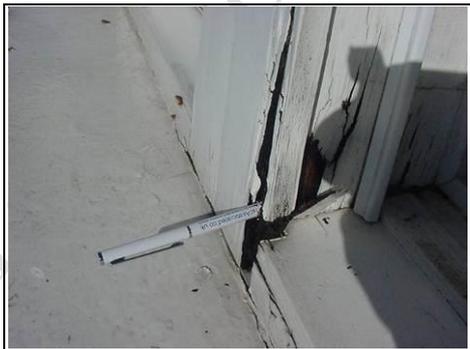
Rot in window frame to rear double glazing

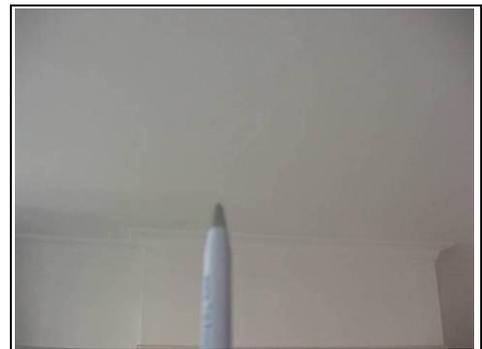
We did note some hairline cracking in the ceiling which is often the case with old lath and plaster where it is starting to lose its key, please see the above sketch.

Cracking in ceiling
in master bedroom(front left)

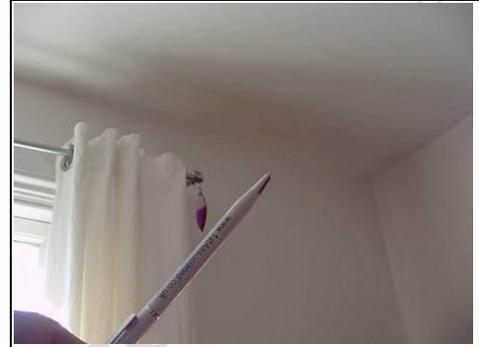
Hairline cracking to rear bedroom

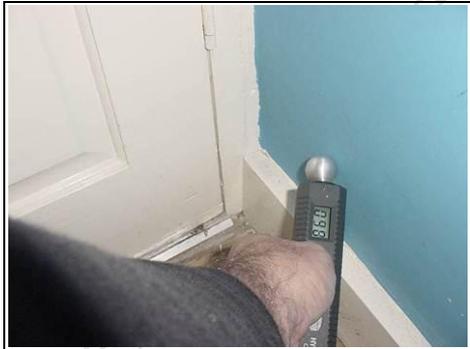
A random visual inspection and tests with a moisture meter have been taken to the perimeter walls. In this particular case we have found rising damp.

High damp readings in
cloakroom

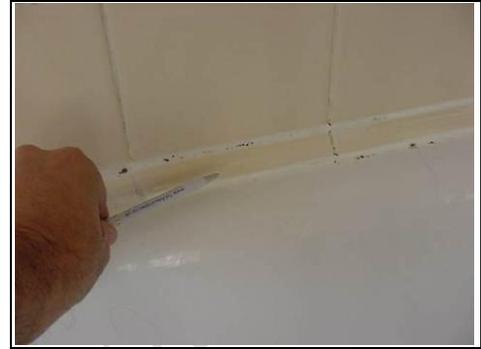
Mould in bathroom

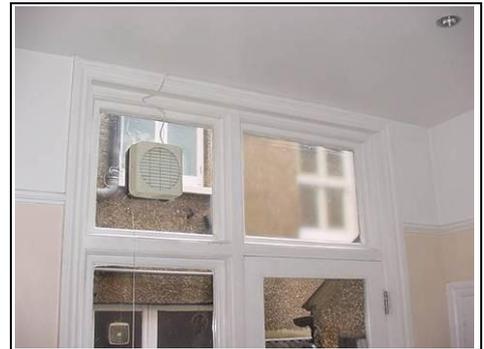
Extract fan in kitchen needs to be larger

ANTICIPATED COST: £500 to £750 depending upon the wiring needed.

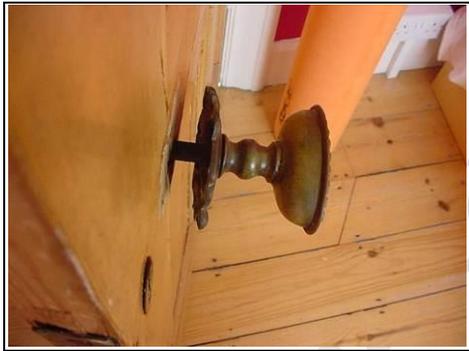
Door handles need repairs

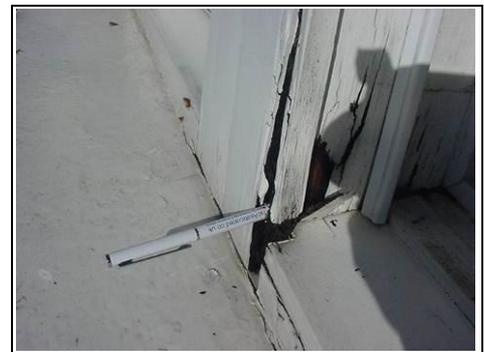
Rot in rear window

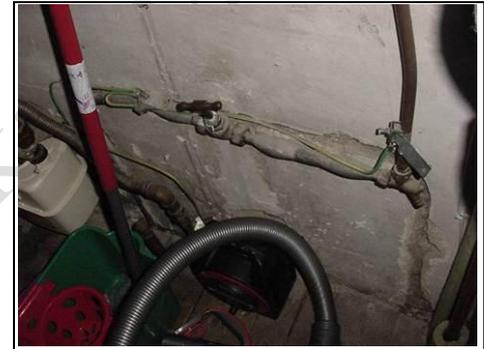
The plumbing, where visible, comprises copper piping and plastic pipes. We also noted some lead pipes that should be removed. No significant leakage was noted on the surface, although most of the pipework is concealed in floors, walls and ducts.

Lead piping

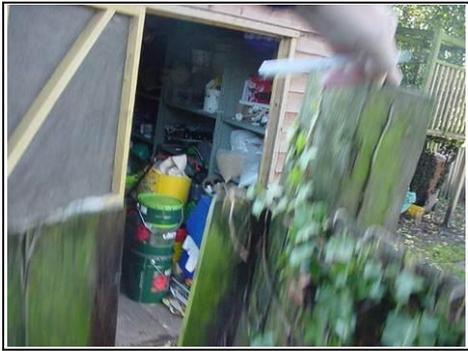
The rear of the fence is in need of work. We also noted that concrete posts had been added to secure the timber posts. This is often used when they have rotted away. We have recently been involved in a replacement of a fence of a similar size which to our surprise cost over £2,000! Fences are expensive particularly where the posts have deteriorated as it appears to be in this case.

The rear fence could literally be pushed and moved

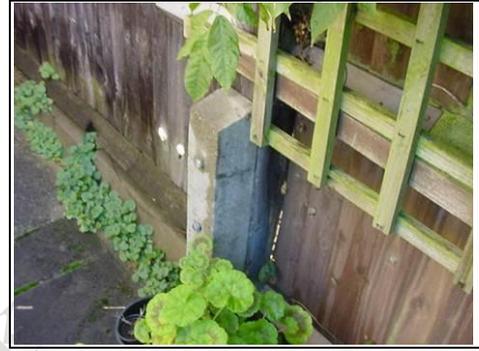
Fence secured with concrete posts
