# RESIDENTIAL BUILDING SURVEY

**XXXXXXXXXX,  
Dulwich,  
London,  
SE22 xxx.**

**INDEPENDENT CHARTERED SURVEYORS**

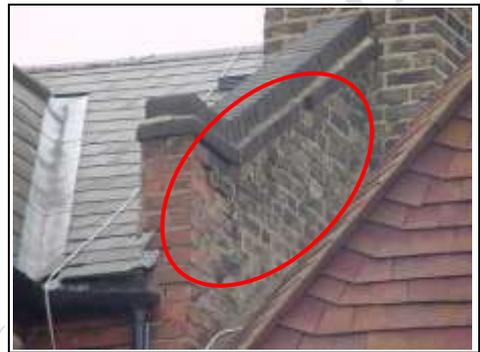
We could see that the left parapet wall needs re-pointing. Usually areas at high level weather more than those at low level. There may also be some re-pointing needed to the chimney areas. Unfortunately, we cannot see the chimney areas properly and in the case of the rear chimney, not at all.

**ACTION REQUIRED:** We recommend re-pointing the parapet wall within the two years and that you also check the flashings and the chimneys.

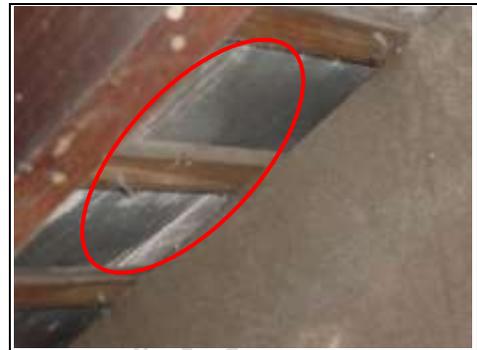
Rear roof

Slates are visible where the protective underlayer has deteriorated (see the next section)

There is a roof window to the roof but unfortunately we were unable to open this window to view the roof. The window has a metal mechanism that opens it but this has rusted. We can see some dampness coming in via the window and is probably the reason the mechanism has rusted over.

**ACTION REQUIRED:** We would recommend that the window mechanism is eased and adjusted to get this in working order. It would be a shame to have to replace it as it has an almost antique value! This would then allow a proper view of the rear roof, parapet walls and rear chimney.

**ANTICIPATED COST:** Likely to be in the region of a few hundred pounds but would save the cost of a tower scaffold to the rear as it will allow the roof to be viewed; please obtain quotations.

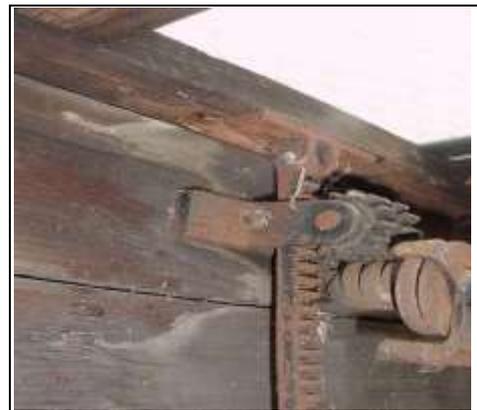
Mechanism for opening the window has rusted

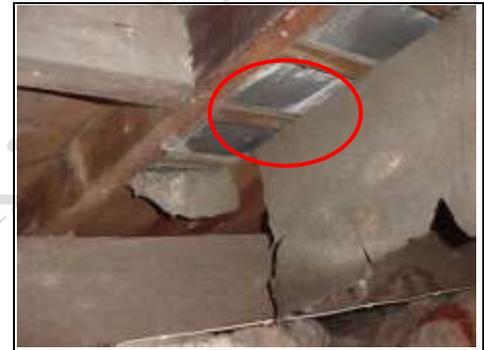
Protective underlayer

The roof has one of the earliest types of protective underlayers known as building paper. This is deteriorating more than we would usually expect to see. Without the secondary protective underlayer the roof is more prone to leaking.

Where the building paper is deteriorating we can see white on the tiles which is salt from the rain water getting through

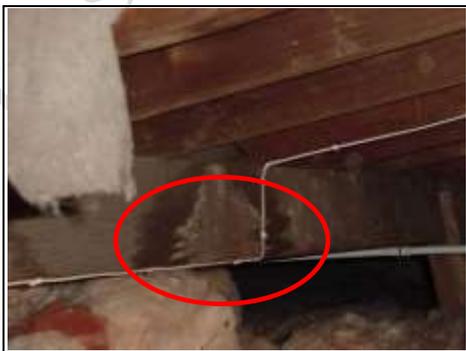
Where the protective underlayer has deteriorated we can see dampness is getting into the property.

Dampness coming in where the building paper has deteriorated

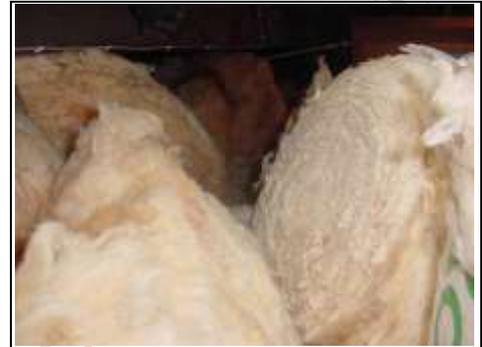
Mass of insulation

There is a mass of insulation within the roof and also bundles of excess insulation. This combined with the lack of ventilation in the roof may have caused condensation in the roof space which could explain why the building paper has deteriorated.

Bundles of excess insulation

**ACTION REQUIRED:** To replace all of the underlayer is almost as expensive as re-roofing the property as it would require scaffolding which is a major cost. It would also require removing all of the roof tiles and battens then adding the protective under layer and then re-battening and re-tiling. We would therefore recommend patch repairs are carried out. We would also recommend adding ventilation to the roof.

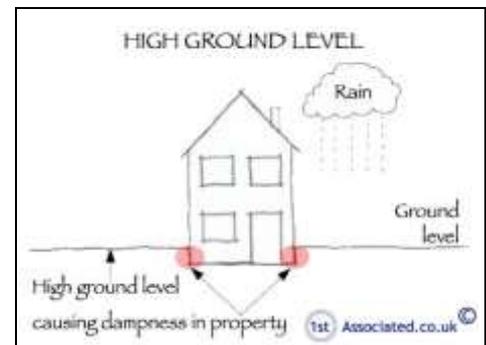
High ground level, the airbricks have been covered over

High ground level

This means that the floor may have problems with wet rot or in a worst case scenario dry rot and wood worm. We simply cannot see this to advise as the top of the floor has then been covered with a laminate flooring, this stops the floor from breathing and seals in any dampness problems.

**ACTION REQUIRED:** A worst case scenario will mean replacing floorboards due to wet rot, dry rot or woodworm. You need to open up all the airbricks and ensure they are protected from acting as gutters allowing water into the property. We would suggest lifting a section of floor beneath the staircase to check the condition.

Otherwise you should try to compensate for the risk by requesting a reduction in the price of the property. We would expect costs in a worst case scenario to be in the region of £5,000 or possibly more. However more typically the timber will have survived and costs will only be for the opening up of the floor, a few hundred pounds, to check the condition; please obtain quotations.

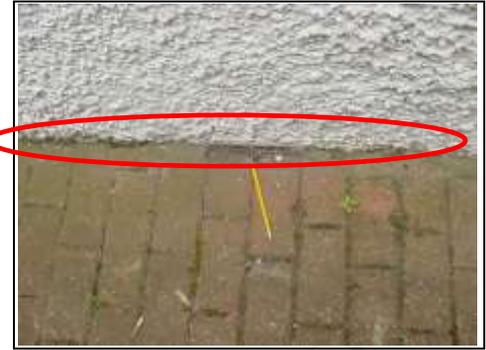
Bell mouth detail

No bell mouth to render

**ACTION REQUIRED:** We would recommend that a bell mouth is added to the base of the property to reduce dampness.

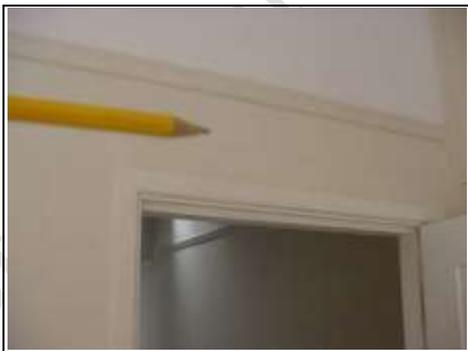
There is hairline cracking to the front bedroom around the door. We can also see some movement to the doors and door frames.

Hairline cracking above and to the side of the door to the master bedroom

This is not that unusual in this age of property and we suspect it may relate to the drains leaking as originally in this age of property they would have been push-fit drains.

When we opened the manhole to the rear of the property we found that it was concrete built indicating that it is newer than the building as a whole. This could also be due to the kitchen extension/alterations but in general we do find there is some leakage to the old push fit drains.

**ACTION REQUIRED:** Your Legal Advisor to specifically ask in writing if repair work has been carried out to the drainage system. We would also enquire with the insurers to see if there have been any problems in relation to the drains and associated insurance claims that may affect your premium or your ability to obtain insurance.

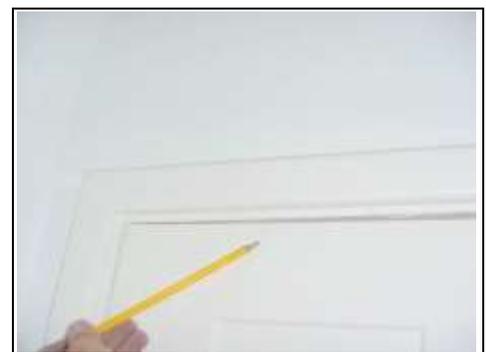
Doors can show signs of movement

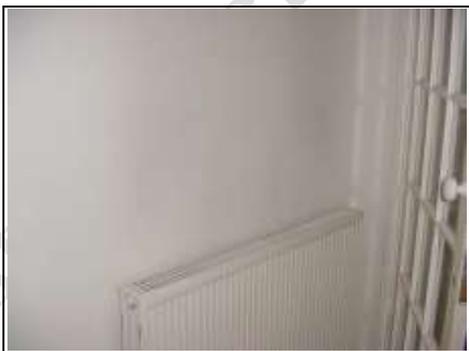
Internal radiator

We noted some internal radiators. These do not allow air flow as well as radiators placed under the windows.

**ACTION REQUIRED:** Ideally, where possible, move them under the window otherwise ensure there are large humidity controlled extract fans in the kitchen, bathroom, en suite and any room used for laundry/drying of clothes.

**ANTICIPATED COST:** A large humidity controlled extract fan is usually £200 - £300; please obtain quotations

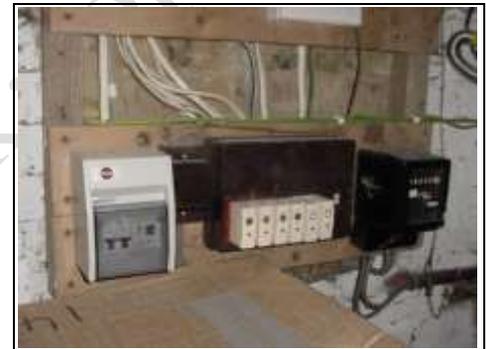
Fuse board

As previously mentioned the electric fuse board is dated and we would recommend it is replaced. The Institute of Electrical Engineers standards (IEE) recommend a test and report whenever a property changes occupancy. This should be carried out by an NICEIC registered and approved electrical contractor or equivalent.

**ACTION REQUIRED:** We would recommend that the fuse board is upgraded.

**ANTICIPATED COST:** £300 to £600 to replace the fuse board. At the same time we would allow for new socket points; please obtain quotations.

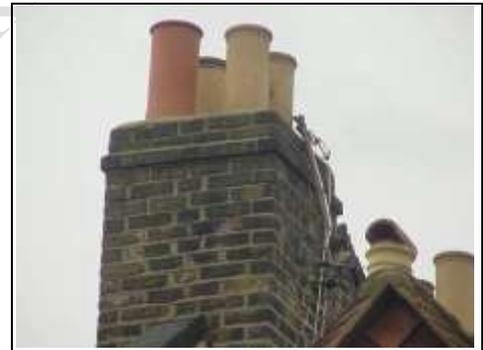
Chimney- front left

This chimney is brick built with four chimney pots (two of which we believe are yours). We could not see the flashing properly. From what we could see from ground level it looked in average condition considering its age, type and style but we would add that we could only see two sides of it.

**ACTION REQUIRED:** We noted that the parapet wall was weathered and needs re-pointing so we would check the chimney when the work to the parapet wall is being carried out.

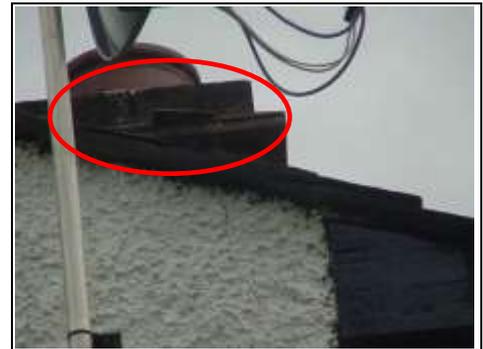
Rear chimney

Only the chimney pot is visible

**ACTION REQUIRED:** Once the roof window is opened we would recommend that the chimney is checked.

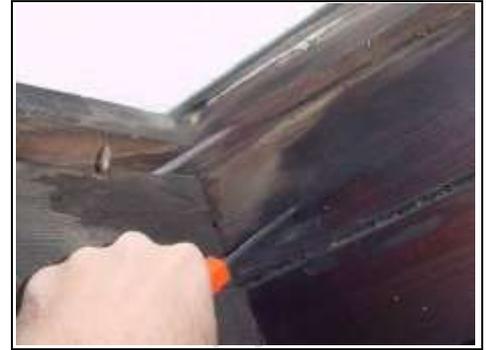
We could not open the purpose made roof window but we could see some dampness was getting in. Ideally we would have liked to open this window so that we could see the chimneys and parapet walls as well as the rear roof.

Roof window, dampness is coming in

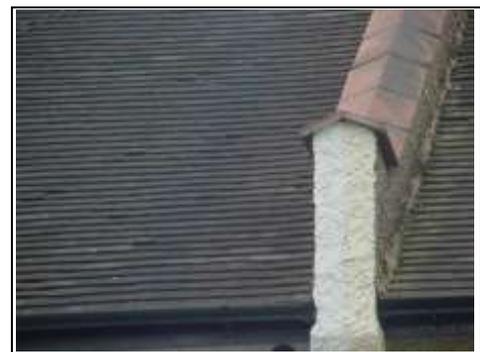
With this age of roof there will usually be a few missing or displaced tiles and which there is in this case, this is nothing unusual. Our concern with the missing tiles is that the secondary protective underlayer also known as sarking felt is deteriorating.

Slipped tiles

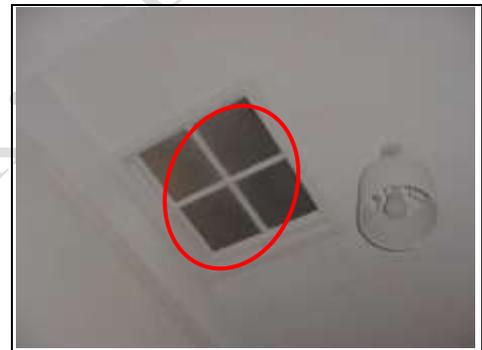
The main roof is accessed via a glass loft hatch located on the landing. There is no loft ladder, electric light or secured floorboards. We recommend that these be added, as it will make the loft space safer and easier to use.

Be careful when opening this glass hatch!

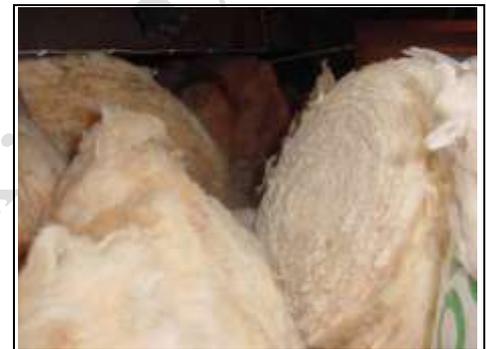
Our examination was limited by the general configuration of the roof, the mass of insulation and the bundles of insulation that have literally been left in the roof together with stored items. What we could see was generally found to be in slightly below average condition for its age, type and style particularly due to the condition of the underlayer. It is, however, feasible that there are problems in the roof that are hidden.

Bundles of insulation. This is the problem when you pay for amount of insulation rather than for it to be installed properly

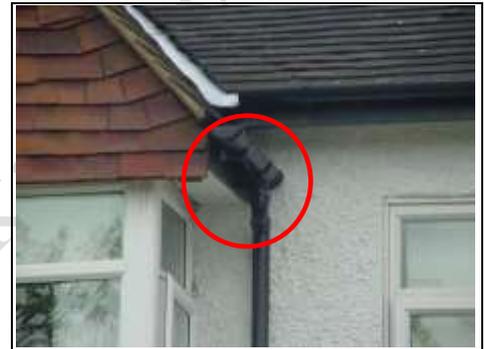
We also recommend that the gutters and downpipes are cleaned out as we can see what looks to be a piece of pipe in the gutter. The joints also need to be checked and the alignment checked to ensure that the gutters fall towards the downpipes.

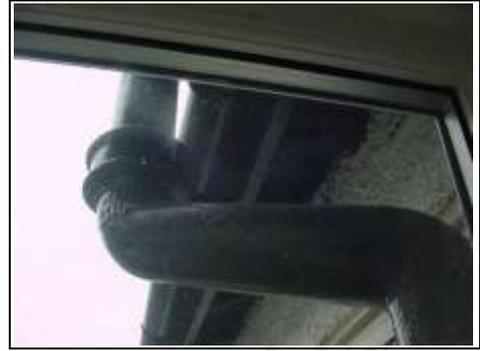
The property has a combination of cast iron and plastic soil and vent pipes. Cast iron of this age can crack and rust and needs regular maintenance particularly painting around the back of it.

Cast iron soil and vent pipe

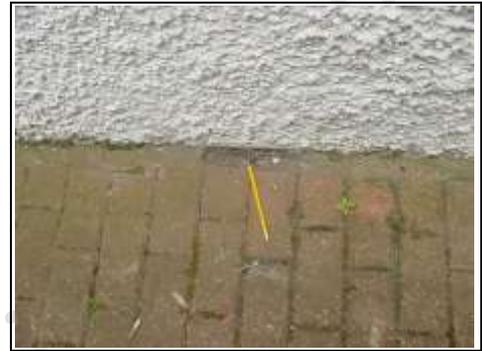
All modern properties should incorporate a damp proof course (DPC) and good building practice dictates that a differential of 150mm (6 inches) should be maintained between the damp proof course and ground levels. In this case the render will be hiding any DPC. With this era of property a damp proof course may have been added, however, although this was a regulation under the London Building Act many people resisted carrying this out. Our main concern is the high ground level that we believe will cause dampness in this property.

There may be a DPC hidden by the render but we cannot be sure of this

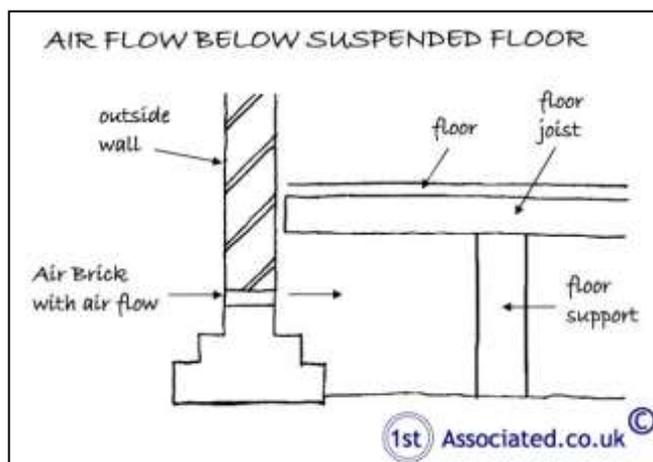
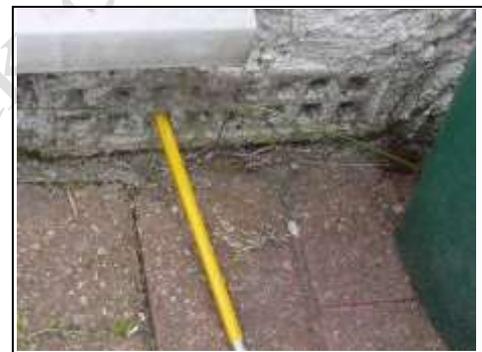
The property has a suspended timber floor and air bricks are essential to have a through flow of air as this helps to reduce the chances of wet rot, dry rot and woodworm. In this case the air bricks are too low or almost covered up (we suspect some are completely covered up).

Air brick to the rear is too low

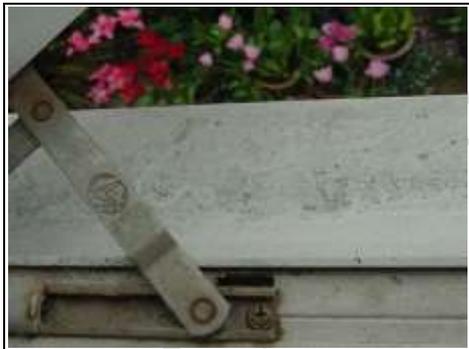
Ingrained dirt to plastic windows

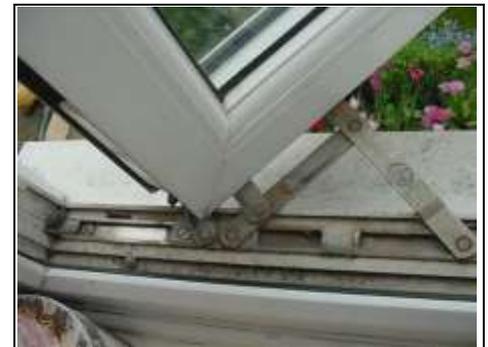
Rusting to the window hinges

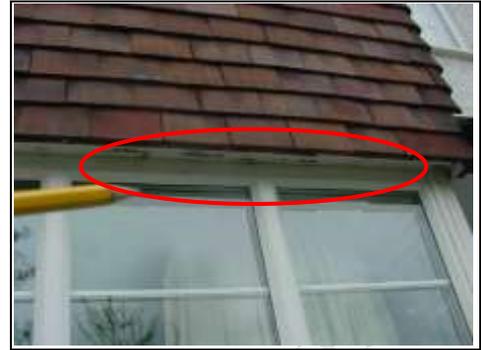
We would draw your attention to the fact that sealed double glazed units can fail, particularly as a result of poor workmanship during installation. Failure of the seal leads to condensation between the two panes of glass and simply replacing the affected units may not provide a satisfactory long-term solution.

Windows need sealant

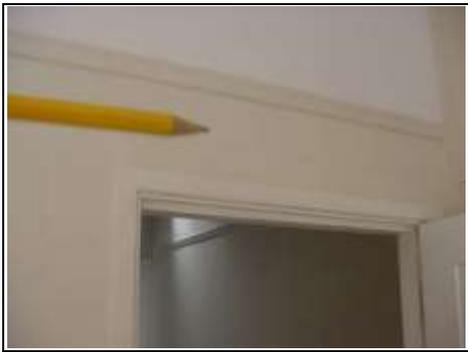
Hairline cracking above and to the side of the door in the master bedroom

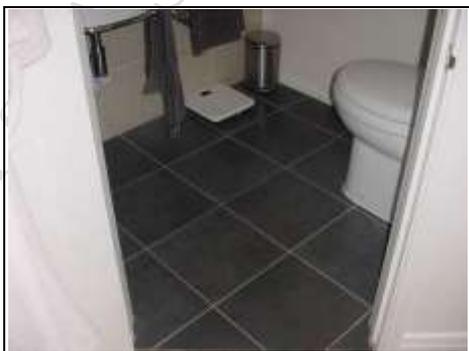
We noted that tiles have been laid in the en suite bathroom. We tend to find that over time, where tiles are put over a wooden floor, the grout becomes loose and comes out. Although in our opinion the tiled floors look good you will have to re-grout from time to time.

Tiles laid on a timber floor

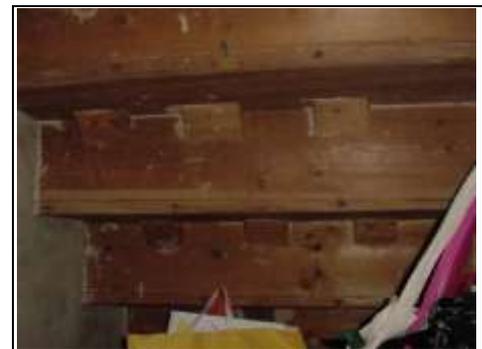
We noted that the underside of the staircase was exposed. It is more normal today to have a half hour fire barrier to stop fire spreading from the ground floor to the first floor in a worst case scenario. You may wish to take a view on whether you add this.

Stairs are not lined

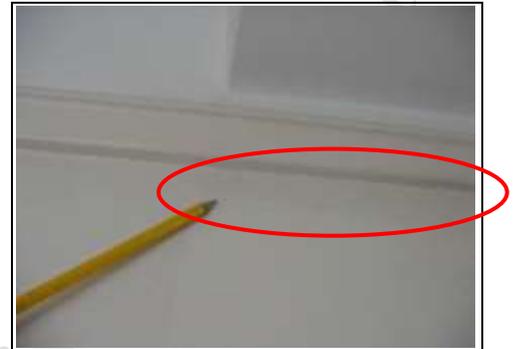
The new paint does not quite reach the picture rail in some places and a difference in colour is visible

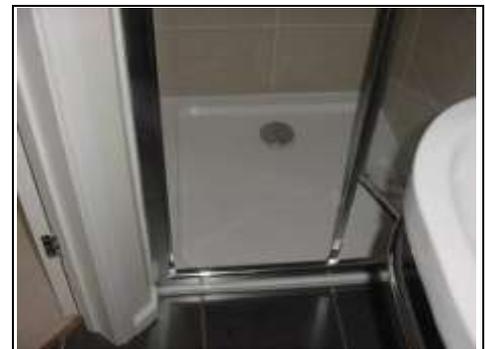
Shallow shower tray, there can be problems with these overflowing

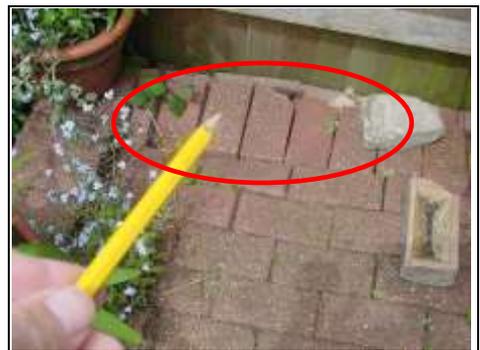
Loose brick paves
