RESIDENTIAL BUILDING SURVEY

London Borough of Enfield

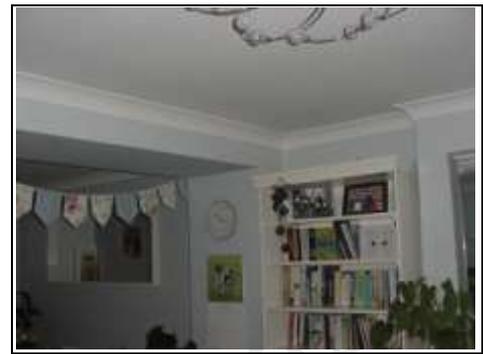
We noted walls have been removed at ground floor level to create the open plan layout. Your legal advisor needs to check and confirm that Local Authority approval has been obtained for removing these walls.

Wall removed

ACTION REQUIRED: Your legal advisor needs to check and confirm that Local Authority approval has been obtained.

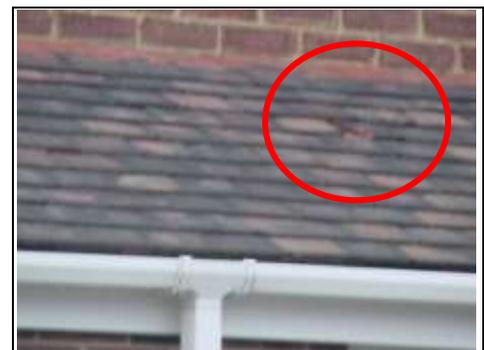
There is a tile broken on the front porch which needs fixing to stop dampness getting in.

Hole in roof

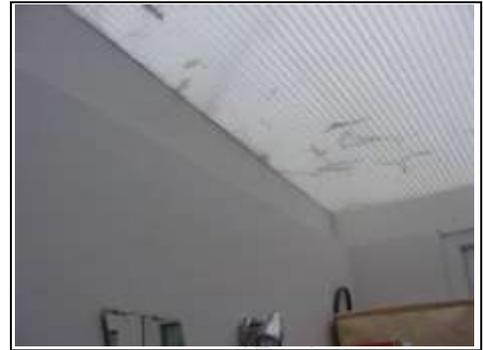
The rear conservatory roof is a polycarbonate roof which is a thin plastic roof and won't be very thermal efficient (if you recall, we showed you this). A ceiling has been added in the lounge area, however in the utility room area/corridor to the rear garden, there is just the polycarbonate plastic roof.

Branches and twigs on conservatory polycarbonate roof

We also noted that there was a flashband where the polycarbonate conservatory roof meets the main building and this was coming away and needs re-securing.

Flashband is a sticky backed felt which is best used for temporary repairs only.

ACTION REQUIRED: Repair and consider putting a ceiling underneath. Ultimately in the long term you should look to replace this.

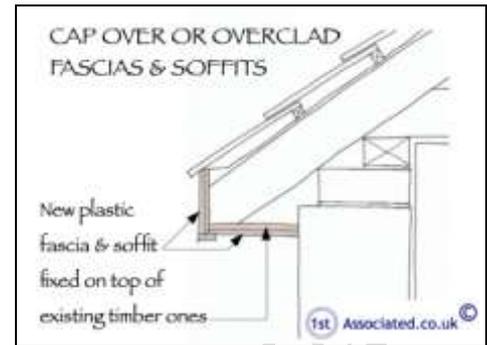
The timber fascias and soffits have plastic overcladding which we never recommend as this accelerates the deterioration of the timber fascia and soffits.

Usually the timber fascia and soffit is in a poor condition to start off with which is why it has been overclad and deterioration occurs further when hidden and encased by the plastic overcladding.

Overclad fascias and soffits

ACTION REQUIRED: Double check there is timber underneath the plastic cladding. Either way removing sections or drilling into it to see if there is wood and then replace. We would add that we often find that this comes unstuck and falls off on its own if you don't replace it.

ANTICIPATED COST: Unfortunately it is now more difficult to replace the fascias properly although it does give the opportunity to add a running vent to the soffit; we would expect costs in the region of £1,500 - £2,500. Note: this isn't an immediate requirement. Please obtain quotations.

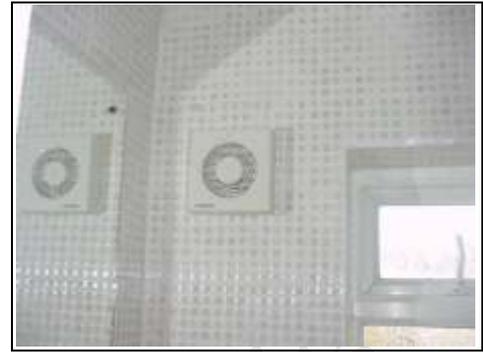
We noted in the bathroom that the extract fan didn't extract very well (we carried out a basic test by putting a piece of paper to the extract). In the kitchen we didn't note any extract to external air. The utility room in the rear extension didn't look to have an extract either.

Extract fan in bathroom

ACTION REQUIRED: Add large humidity controlled extract fans and check and open vents as necessary. Add trickle vents to windows if possible.

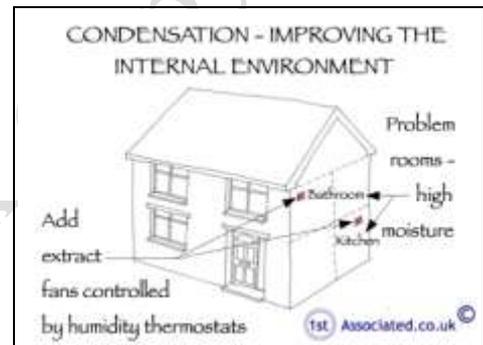
All of these areas create condensation which will then travel around the property possibly leading to black mould.

Condensation

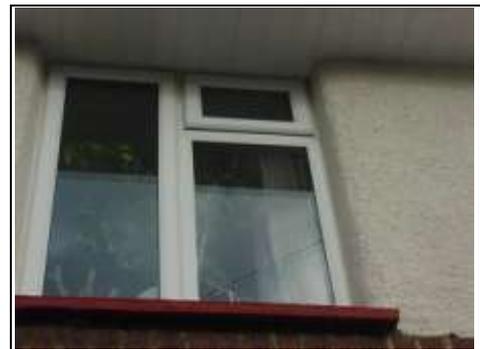
In addition we noted that the plastic double glazed windows with the older style/cheaper style didn't have trickle vents which means there is minimal airflow.

Window without visible trickle vent

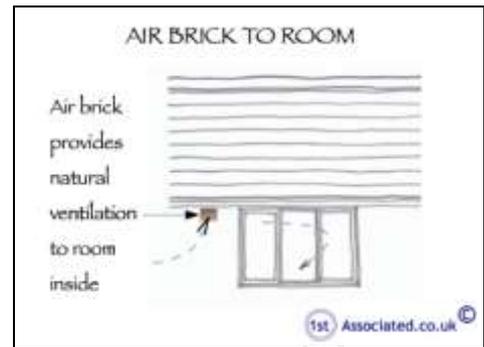
We did note high level vents but these look to have been blocked. You need to double check this and re-open them.

High level air vent

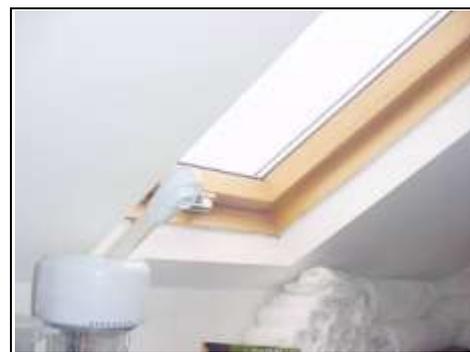
There were two roof windows to the rear of the property which were purpose made and looked in average condition. We couldn't see the flashings around the roof windows.

Unfortunately, we would comment that with the lack of extract fans from the bathroom, kitchen, etc any moist warm air could come up the stairs and condensate on them.

Roof window

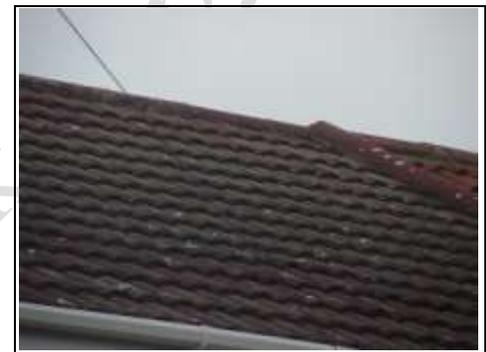
The main roof is shallow pitched and clad with concrete tiles and, from ground level, this looks in average condition considering the roofs age type and style. With this age of roof there will usually be a few missing or displaced tiles, this is nothing unusual.

Main roof

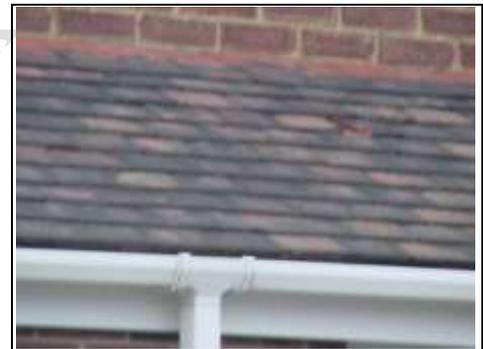
This porch roof is pitched and clad in a concrete tile. There is a broken tile which needs replacing to stop dampness getting in.

Porch roof

ACTION REQUIRED: Please see our comments in the Executive Summary.

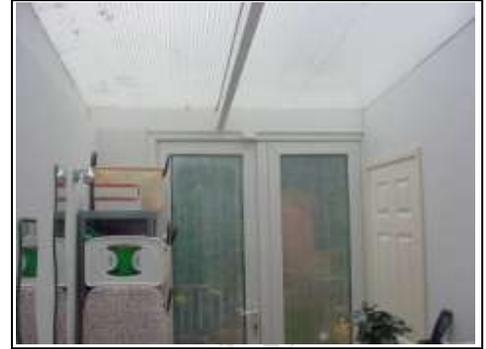
To the extension there is a single storey shallow pitched polycarbonate roof. The flashings are in need of repair/replacement. We would expect some dampness to get in, in their present condition. Due to the shallow pitch, it was starting to moss/green over and would benefit from a clean.

Polycarbonate roof

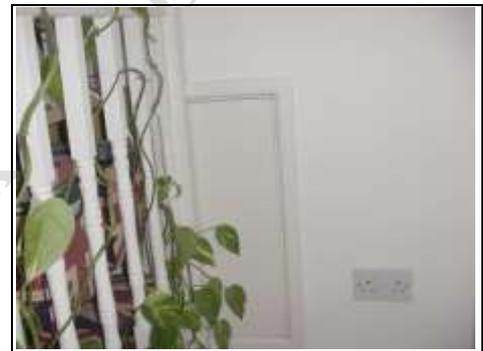
The roof has been converted into a room. There is an access into the rear of the roof via a panel. To the front of the roof there is a panel which has been blocked by the stairs. This leads us to believe that the stairs may have been added at a later date and are a DIY addition.

ACTION REQUIRED: Please see our comments in the Executive Summary with regards to checking this conversion has legally passed Building Regulations and has Local Authority approval.

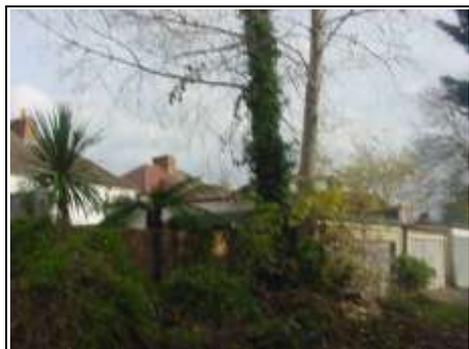
There are trees within what insurance companies would term as influencing distance of the property. We would always recommend that the trees are maintained on a regular basis.

Trees

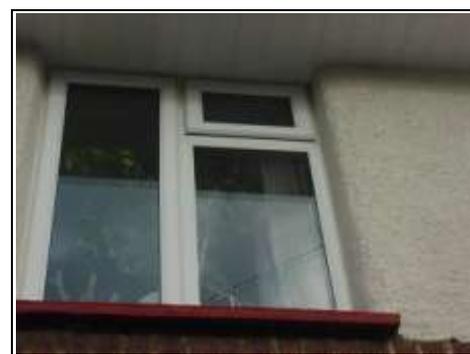
The property has plastic double glazed windows without trickle vents which generally look to be of an average to cheaper quality. We would draw your attention to the fact that sealed double glazed units can fail, particularly as a result of poor workmanship during installation. Failure of the seal leads to condensation between the two panes of glass and simply replacing the affected units may not provide a satisfactory long-term solution.

Plastic double glazed windows without visible trickle vents

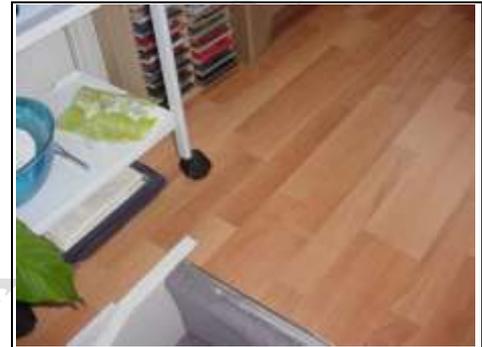
We couldn't access ceilings due to laminate flooring

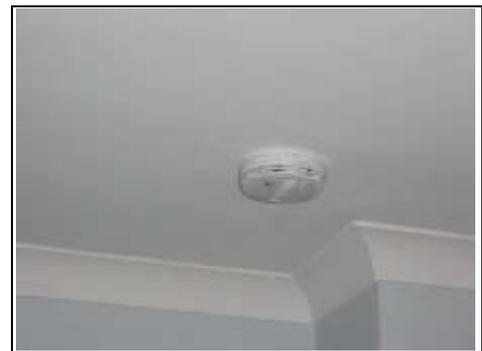
Some smoke detectors were noted. As this property has a room in the roof we would expect a hard wired system which should have been added as a Local Authority requirement. The current Building Regulations require that they be wired into the main power supply. Obviously in a property of this age this is difficult, as it would mean having surface mounted wires or cutting wiring into the plaster.

Smoke detector

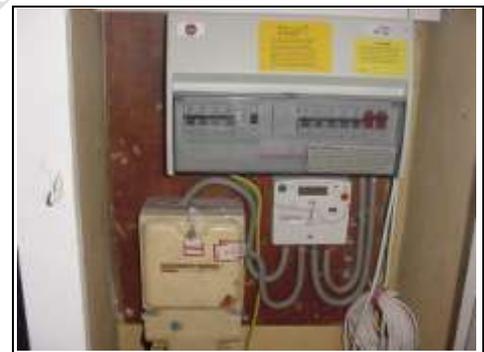
The electric fuses and consumer units were located in the hallway. The fuse board looked 1990's/2000's.

Fuse Board

We were shown documentation that the electrics were tested in 2007. Nevertheless the Institute of Electrical Engineers standards (IEE) recommend a test and report whenever a property changes occupancy. This should be carried out by an NICEIC registered and approved electrical contractor or equivalent.

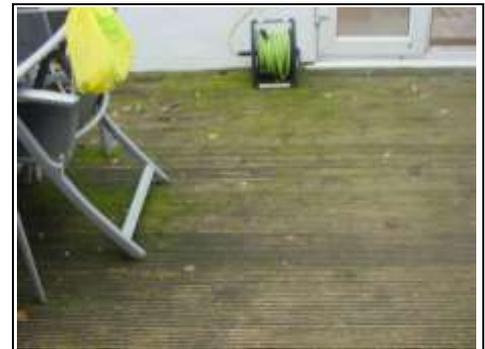
The rear garden is partly decked and partly grassed. There is a summer house to the rear as well as some trees. The decking was slightly slippery which is what we are finding more and more.

Decking goes right up to property with no gap, has moss on it and is slippy
