# RESIDENTIAL BUILDING SURVEY

**Esher,  
KT10**

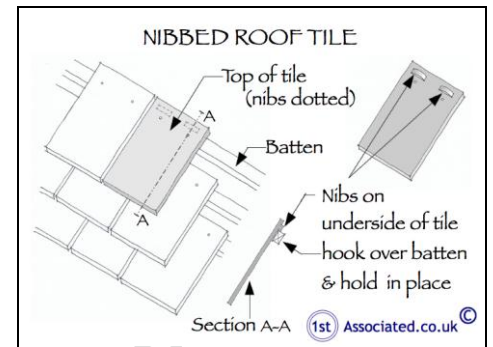
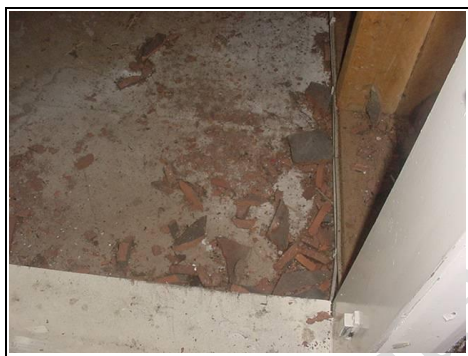
Broken tiles that have been replaced before

**ACTION REQUIRED:** It is a very close call on whether to replace the roof or not. If you were not carrying out extensive work such as extensions and other roof work then we would recommend that you keep the existing roof. However with the combination of extensions and alterations to the building we feel it will be worthwhile re-roofing and adding the benefit of a modern breathable protective underlayer.

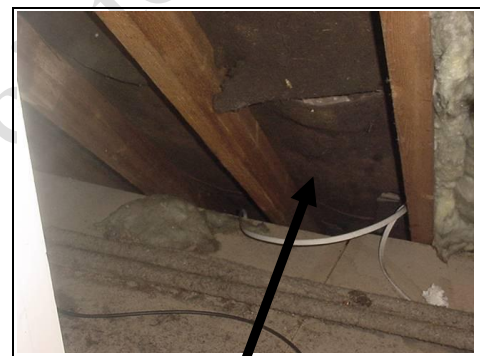
Builders felt

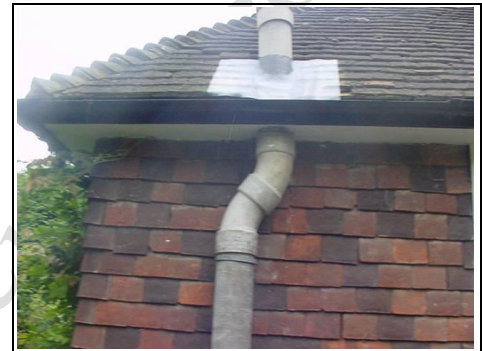
There is an asbestos flue to the left hand side of the property. This we believe was for the original boiler. We recommend that this is removed. We would also recommend an asbestos report is carried out particularly if you are carrying out major re-building work. Areas it is likely to be found in are areas of cladding of duct work and also soffit boards and possibly fascia boards.

Asbestos flue

**ANTICIPATED COST:** The cost of testing will be a few hundred pounds. This will then have recommendations that will have additional costs. Due to the specialist nature of asbestos removal our approximations of costs are just that. Approximately £500 - £1,000 (five hundred to one thousand pounds); please obtain quotations.

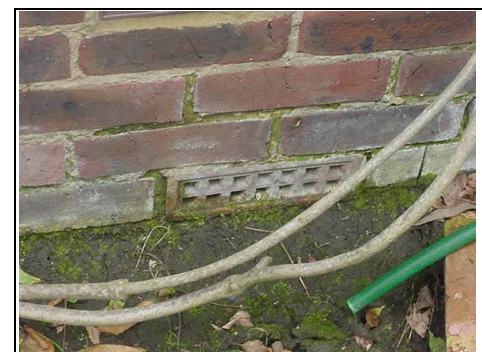
Air brick needs clearing

**ACTION REQUIRED:** We recommend that they are protected as shown in the sketch below and that sections of the floor, as mentioned earlier, are opened up to check the condition of the timbers beneath.

**ANTICIPATED COST:** In the region of £1,000 to £3,000 (one thousand to three thousand pounds). You need to ensure that the airbricks are clear and that the correct airflow is taking place under the building; please obtain quotations.

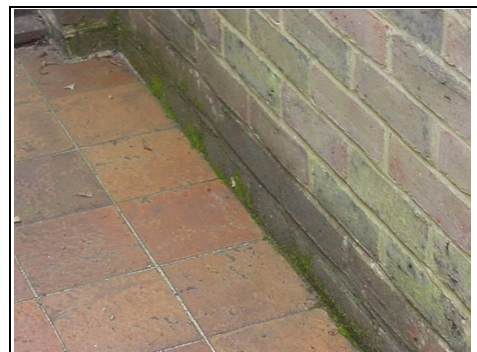
To the front of the property to the left hand door we can see moss on the brick work where rainwater has run against it over the years and sat against it. This in turn could have led to deterioration within the floor around this area. Whilst we believe the floor around this area is concrete there may be other similar problems elsewhere.

Moss on the brick wall

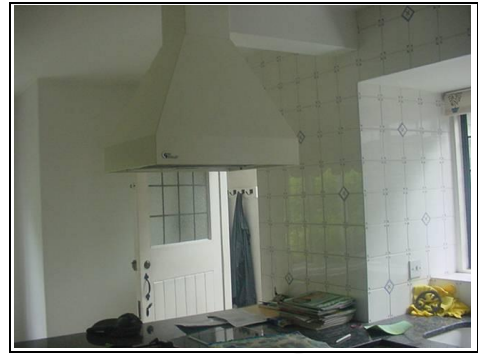
At first floor level we can see cracking to the left hand central wall. We can also see this to the stairway area. This is likely to relate to the alterations that have been carried out in the kitchen area where we believe the wall has been removed.

Where the wall has been removed in the kitchen

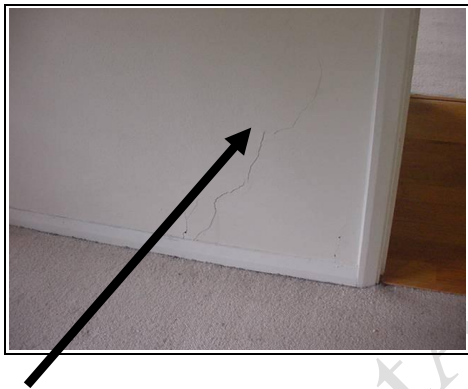
Cracking in first floor front left bedroom

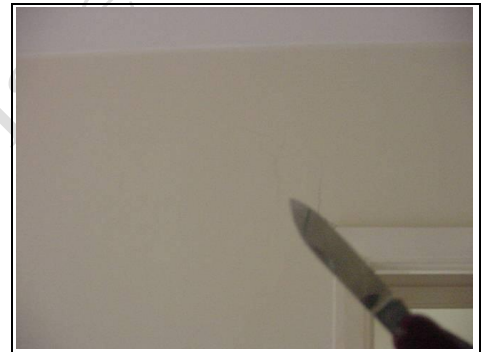
Cracking above the door

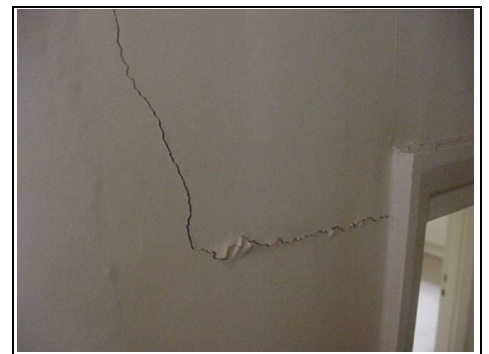
Cracking near the stairs to the top floor

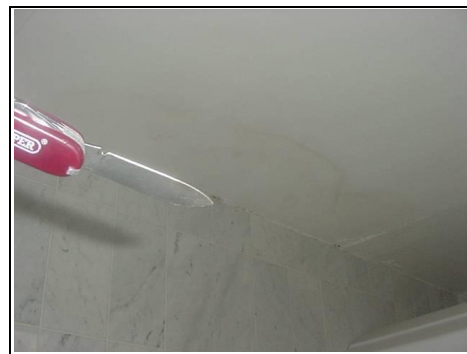
This is typical of the sort of leak you will get via wind driven rain. Please see our earlier comments about the roof and the ever increasing maintenance costs.

Leak in the top floor bathroom

**ACTION REQUIRED:** We would recommend that you have a roofing company spend two days plus on the roof replacing any damaged, broken or slipped tiles. Please watch the roofers carefully as they can often cause more damage than they solve. The term fiddler on the roof is very true.

**ANTICIPATED COST:** £1,000 - £2,000 (one thousand to two thousand pounds; please obtain quotations.

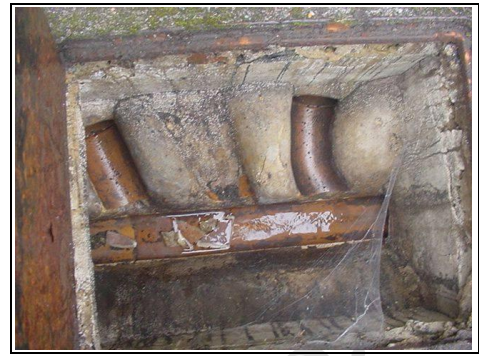
Manhole

We have lifted the drain covers and we noted that bits of the drainage pipe were in one of the manholes indicating to us that there may be problems with the drains.

In addition during our question and answer session with Xxxx (the handyman) he advised us that the rear left hand gully was not draining away particularly well.

**ACTION REQUIRED:** We recommend a closed circuit TV camera report is carried out. At the same time this can establish the exact route of the drains and will help you when you look at future developments of the property.

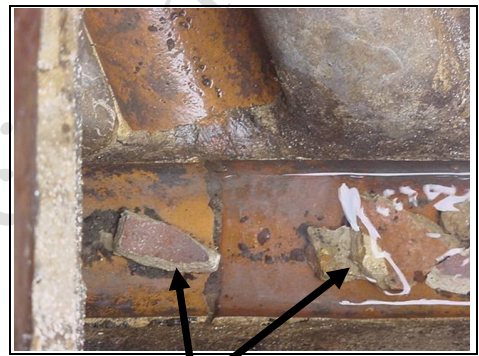
Pieces of pipe visible in the manhole

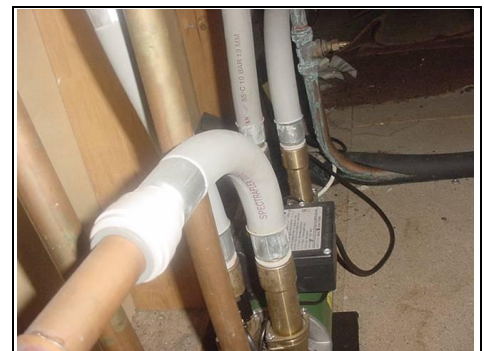
We are not keen on plastic pipework no matter how much we read the literature relating to it! We still seem to come across problems with it. For example, on a new build house just over a year old we found problems with the plastic connectors on warm water pipes.

Plastic and copper pipes

**ACTION REQUIRED:** When you are carrying out your refurbishments we would personally take the opportunity to remove all plastic piping and replace it with copper.

**ANTICIPATED COST:** This could cost hundreds of pounds. However if you are re-running the services then effectively there is no cost.

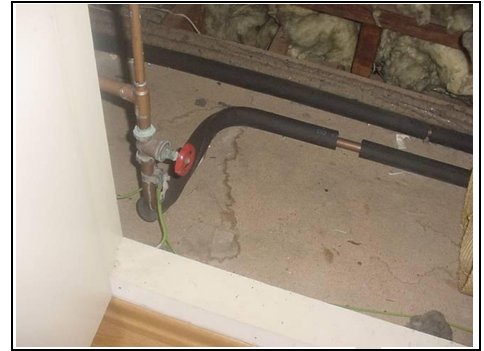
Leaks in the plumbing

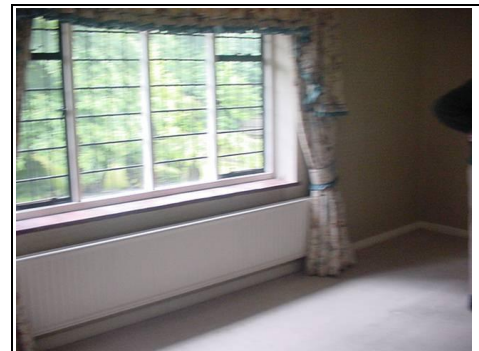
Single panel radiator

**ACTION REQUIRED:** You may wish to add double panel convection radiators. It is best to live in the property for a while and establish if it is warm enough for you before you carry out any work. We have replaced the odd radiator but generally find it is better to replace all of them.

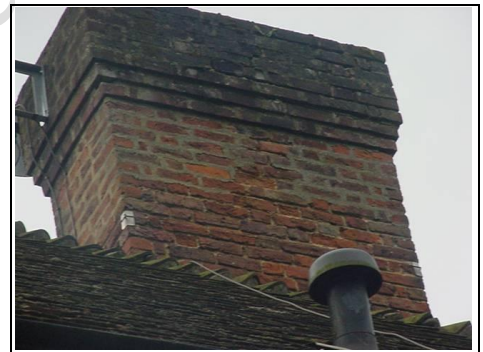
This is a substantial brick chimney with a tile on edge flashing and we could not see any chimney pots. The chimney needs re-pointing and there is some spalling as well. We would also check the flashings as tiles on edge can let water in quite easily. From what we could see from ground level it looked in below average condition considering its age, type and style.

Chimney – right hand side

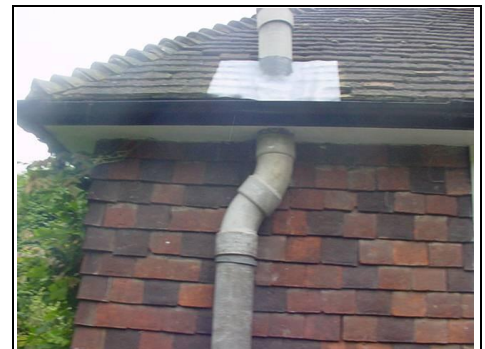
Asbestos Flue

**ACTION REQUIRED:** Please see our comments within the Executive Summary about removing the asbestos. You will also need to repair the roof.

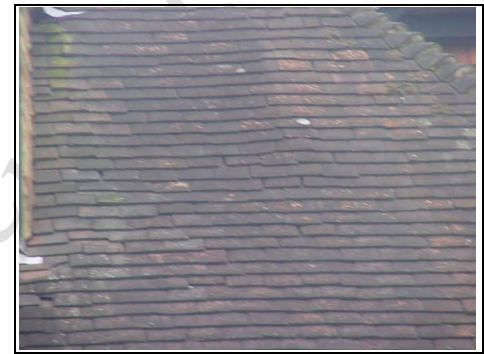
The main roof is pitched and clad with nibbed concrete tiles and, from ground level, this looks in slightly below average condition considering the roofs age type and style. With this age of roof there will usually be a few missing or displaced tiles, this is nothing unusual.

Main roof

**ACTION REQUIRED:** Please see our comments within the Executive Summary. Until such time as you replace the roof you will have to carry out good regular maintenance of the roof, as required.

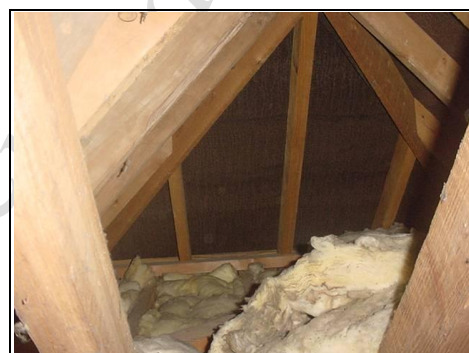
Mass of insulation may cause condensation

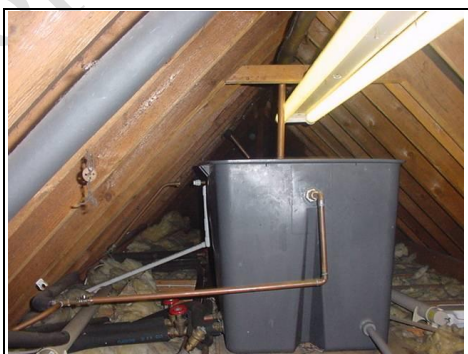
The water tank in the roof does not have lid. We would recommend that the water tank is cleaned out, lidded and refilled. As discussed a modern system would not normally have a water tank. Water tank installations are from the days when we had twenty four hours of reserve water within each property.

Water tank needs a lid

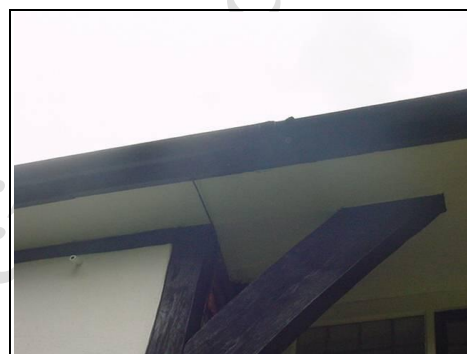
Leaking gutter (front)

We would also recommend that the gutters and downpipes are cleaned out, the joints are checked and the alignment checked to ensure that the gutters fall towards the downpipes.

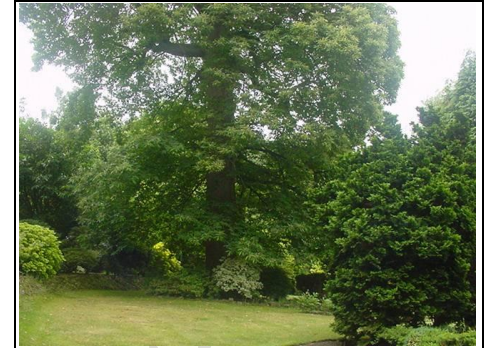
There is a very established mature tree to the rear garden. We would recommend you obtain advice from an Arboriculturalist (not a tree surgeon) before you remove the tree. We feel that the roots are likely to be under the house and could have an effect on the property.

Tree in the rear garden

Your Legal Advisor needs to check if it has a tree preservation order on it.

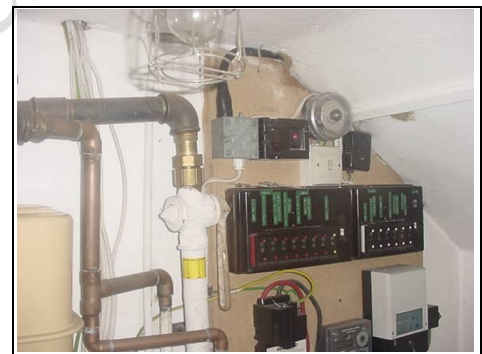
The electric fuses and consumer units were located in the cupboard in the walkway between the garage and the house. The fuse board looked dated, circa 1960's and better are now available.

Fuse Board

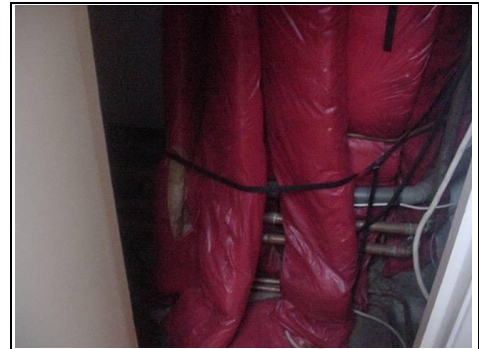
In this case there were some leaks visible to the floor of the cupboard.

Hot water cylinder

**ACTION REQUIRED:** Please see our comments within the Executive Summary.

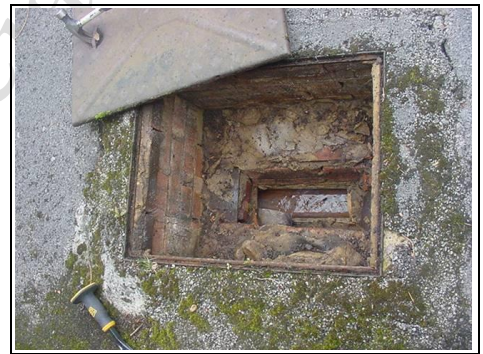
Manhole three

This manhole was in a terrible state and needs work carried out to it.

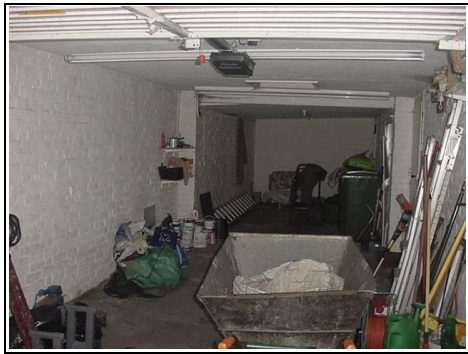
There is a garage to the left hand side of the property with a pitched roof in poor condition. On the sloping site is a running gully where the rainwater runs to from the driveway and as you can see in the photo it has affected the brickwork.

Dampness in the garage
