RESIDENTIAL BUILDING SURVEY

Flitwick, Bedfordshire. MK45

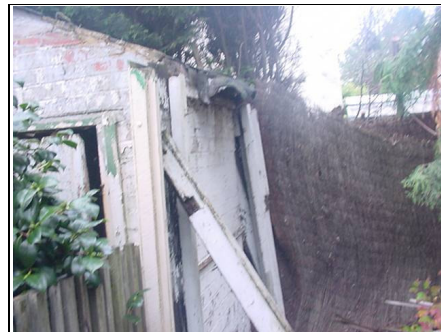
Dilapidated outbuilding at rear

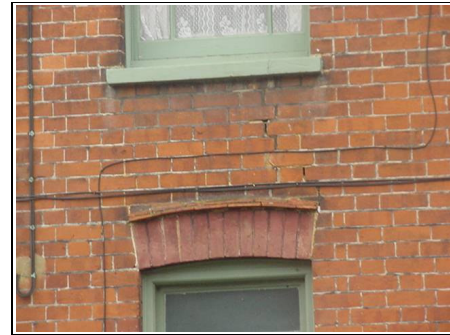
There are external cracks and internal cracks (a list of the cracks are included within this report) our concern in particular is due to the rebuilding of the gable end with a block work wall where it is visible within the roof. There are other factors that also may affect the stability of the property:-

Crack to front of the property

ACTION REQUIRED: We would recommend either you do not buy the property or the existing owners (and we have spoken to the existing owners about this) put in an insurance claim and that you then continue with the same insurers. The existing owners to put in an insurance claim that is agreed with the insurers that they will inspect and monitor the property then you continue with the same insurers as this would therefore limit your future liability (you need to check and confirm this of course with the insurance company) to the excess of the insurance. Additionally the insurers would have the benefit of monitoring the property for a year or so (the building research establishment

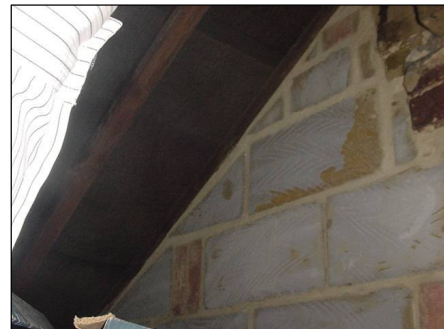
Gable end rebuilt in block work

All of the above could mean that there is progressive movement to the property. From a one off inspection it is not possible to confirm whether there is progressive movement in this property but there certainly has been major repair work.

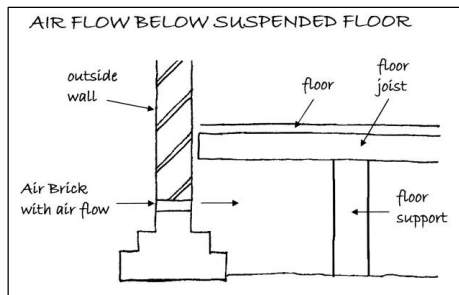
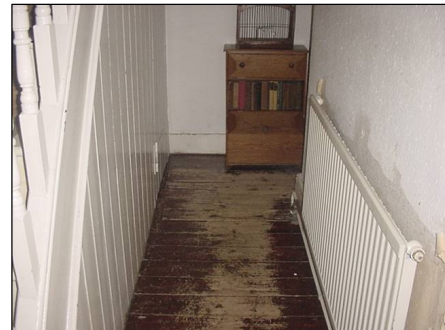
The front of the property has a suspended timber floor the rear has a solid floor and this means that there is not an air flow underneath the timbers which means they are susceptible to rot. In addition to this you have an airbrick acting as a gutter which will allow water into the property.

Suspended timber floor to front of property

ACTION REQUIRED: You need to amend the airbricks to the front and also we recommend a French drain is added. You also need to add a vent to the rear of the suspended timber floor. You also need to open up the floor to check the condition of the timbers beneath. Typically there is normally enough room to go underneath the floor and carry out repairs.

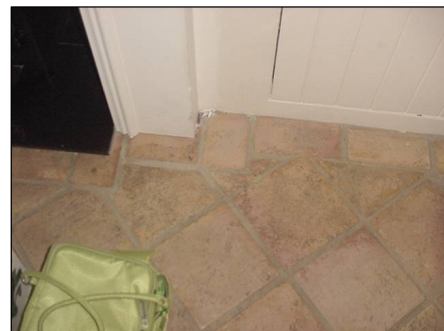
Quarry tile to rear of property

ANTICIPATED COST: £2000-£5000 assuming the floor is in average condition, the French drain you may partly be able to do as a DIY project but to carry out a proper French drain you do need to have a perforated pipe at the base; quotations required.

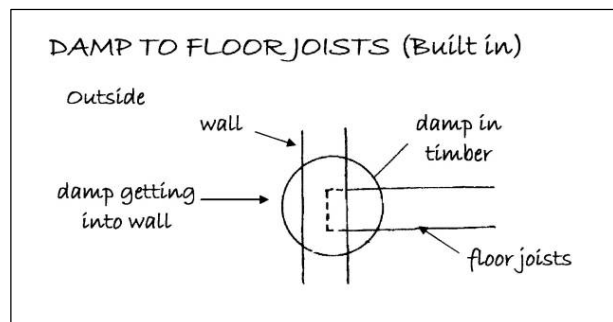
4) **A lean on the stairway**

There has been some movement to the stairway and this is likely to be due to embedded timbers being used for the staircase support. It is fairly normal for timbers to experience some rot however the movement has been exaggerated ~~w~~e feel by a general movement in the property as a whole.

ACTION REQUIRED: This should be included as part of the insurance claim.

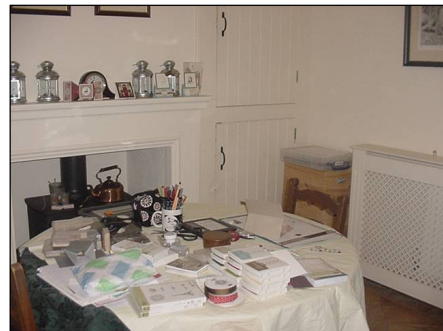
Internal radiators make condensation more likely as they do not assist in the circulation flow of airflow i.e. normally they are underneath the windows, the warm air rises and is affected by the cool air from the window and circulates around the room.

ACTION REQUIRED: We would recommend that radiators are located underneath the windows, we would first suggest that you live in the property to ascertain the extent of this issue as heat is a very subjective subject!

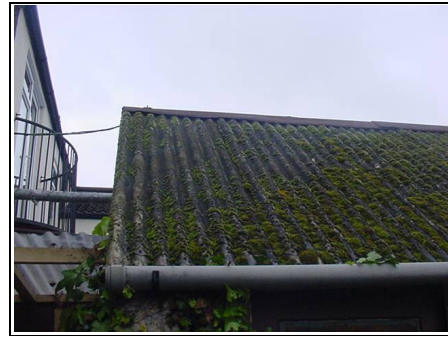
There is an Asbestos roof to the garden shed, we are recommending that all Asbestos is removed, this is more because of the way it affects value as perception when buying a property we know that some people would not entertain buying a property with any Asbestos whatsoever as the perception is that it can be a problem.

Asbestos roof to outbuilding

ACTION REQUIRED: Remove Asbestos roof and replace.

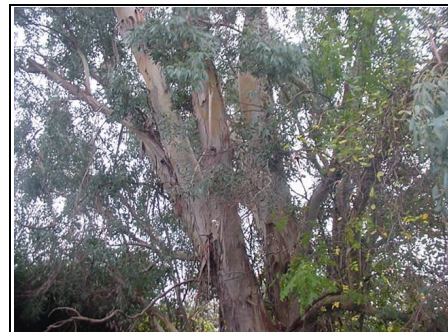
Large tree in the rear garden

We would recommend an Arboriculturist (not a tree surgeon) to inspect and carry out work.

ANTICIPATED COST: A few hundred pounds; quotations required.

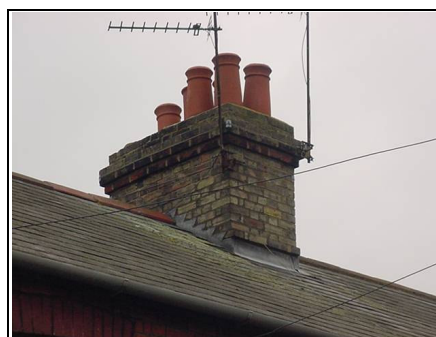
Chimney one

This chimney is brick finished with a lead flashing and numerous chimney pots. From what we could see the chimney looks to be in average condition for a chimney of this age although all chimneys are in exposed areas. Unfortunately we were unable to see the very top of the chimney known as the flaunching, we therefore cannot comment upon it. We did note some aerials on it sometimes the wire that is used to fix these can cut into the chimney.

ACTION REQUIRED: We would recommend close inspection and probably minor repointing to the chimney within the next two to three years, but this is nothing to be overly concerned about with the exception of we could see some dampness is getting in via the chimney.

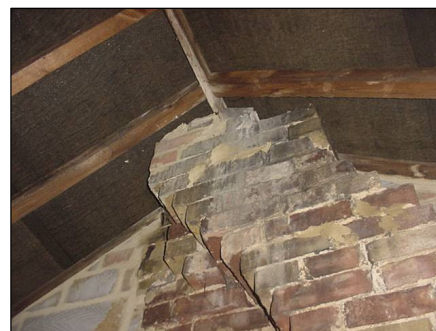
Chimney two

From within the roof space we can see that the left hand chimney has been removed at high level and the chimney breast being visible within the roof, unfortunately we were unable to locate them beneath this in the bathroom. We would need all the items removing in the roof to study the chimneys properly to see if they had been removed or supported.

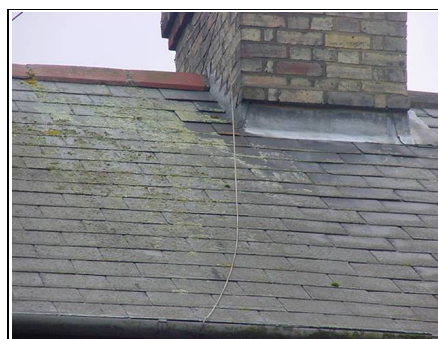
The roof is pitched and clad with quarried slate. The Slates sit fairly true and are generally in average condition considering the property's age, type and style. There is some very minor lifting of the slates near the chimney.

Slate roof showing minor lifting of slates

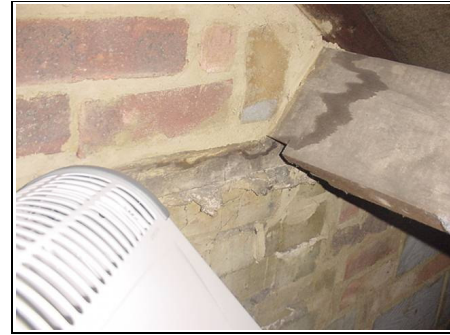
We found the roof timbers generally in average condition, with the exception of dampness which we found in it which we believe is a combination of condensation and minor probably wind driven rain getting into the roof structure . We have inspected the roof structure for:

Dampness to the purlin end

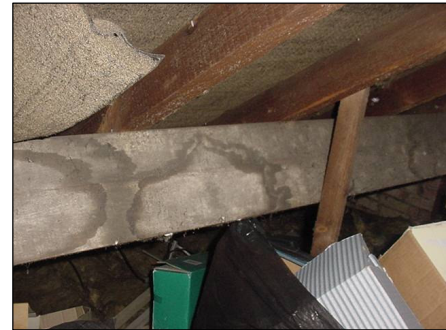
Our examination was limited by the general configuration of the roof, the insulation and stored items. As mentioned what we could see was generally found to be in average condition considering its age with some minor condensation and damp. It is feasible that there are problems in the roof that are hidden.

Roof timbers obscured by stored items

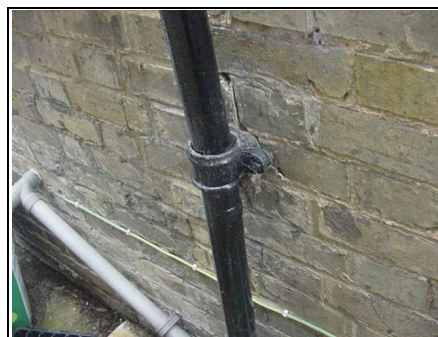
The property has a mixture of the original cast iron gutters and downpipes and the more modern replacement plastic gutters and downpipes. What we found were in typical condition for this mixture of materials but we have not seen the property when it is raining and suspect that there will be some leaks. However we feel that most people could live with this.

Cast iron downpipe

ACTION REQUIRED: We would always recommend that the gutters and downpipes are cleaned out, the joints are checked and the alignment checked to ensure that the gutters fall towards the downpipes.

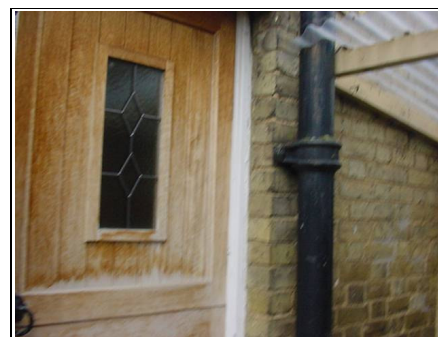
Cast iron – some rusting was noted.

Cast iron soil and vent pipe

ACTION REQUIRED: Use a rust stop agent and redecorate

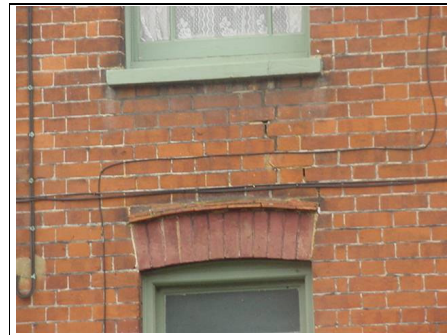
Close up of cracking to brickwork at front of the property

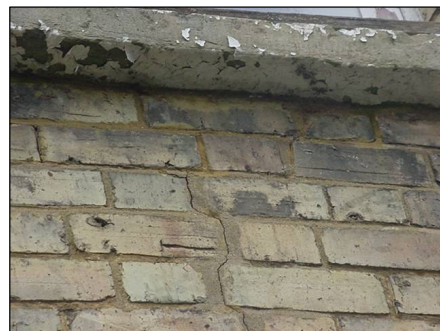
Close up of cracking to brickwork at back of the property

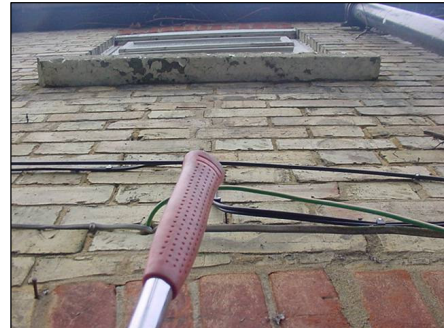
Vertical crack to rear

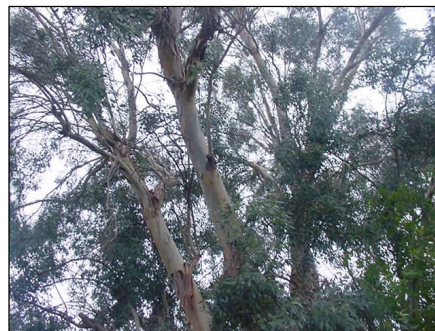
Damage to foundations and underground services can be caused by trees and shrubs. There are a number of these in the vicinity of the building, what we term within influencing distance, and we believe that these trees may be affecting the property.

Properties with trees nearby will always be susceptible to movement

ACTION REQUIRED: You need to obtain advice from an Arboriculturist (not a tree surgeon). Please see our comments within the Executive Summary.

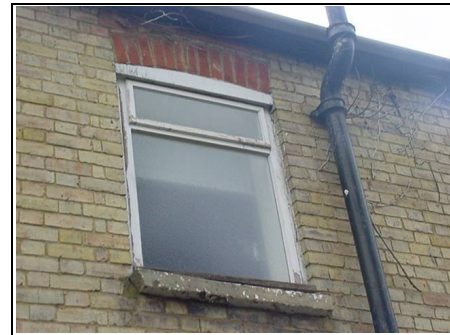
The fascia is hidden behind the guttering in this instance and so we cannot see it. However, it is common for this type of detail to have some deterioration to the timber.

Fascia hidden behind guttering

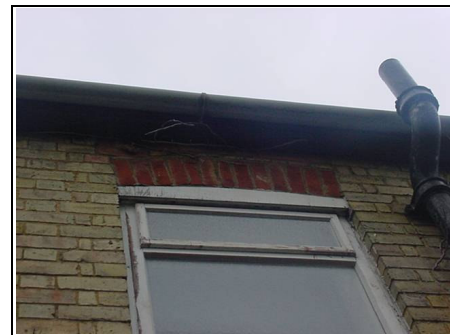
The property predominantly has painted timber sliding sash windows, which are single glazed and a nice feature of the property. There is however one ugly window to the rear, see photo . They are in average condition and need some repainting/repair.

Modern soft wood replacement window

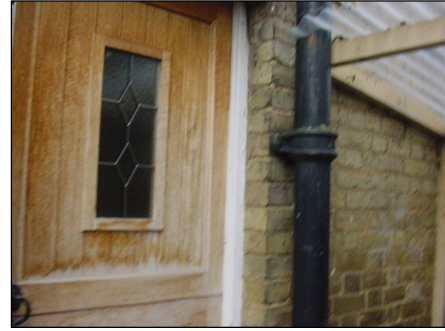
Door showing deterioration

The rear door would benefit from some varnish as soon as possible.

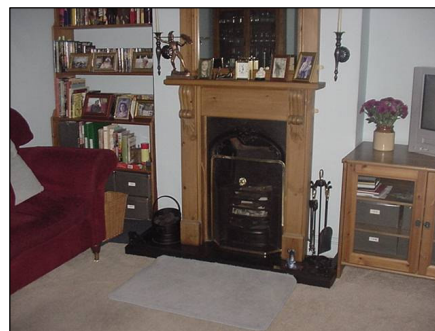
We are advised by the owners that the Chimneys on the right hand side of the property were not used very often and were more a feature for use at Christmas etc and have not been lined. In this age of property whilst you can get away with it we would recommend that a chimney sweep sweeps the property.

ACTION REQUIRED: We would Fire place
recommend the chimney is swept and if the lining of the chimney is loose (the chimney sweep will soon tell you) then we recommend you have repairs carried out. You may also wish to check the chimney pointing within the roof space as you do not want any sparks to get out within the roof space area.

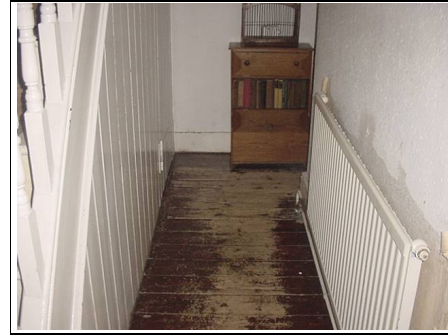
The front of the floor is a suspended timber floor with the joists running from the front to the rear, the rear dining and kitchen area is a solid floor which stops circulation occurring, please see our comments in the Executive Summary.

Suspended timber floor to front of property

ACTION REQUIRED: You need to ensure there is a through flow of air ventilation to the timber floor and check its condition by opening it up. In an ideal world the concrete floor to the rear should be removed, but this is expensive and disruptive work, we would only reckon it if a major refurbishment of the property was taking place

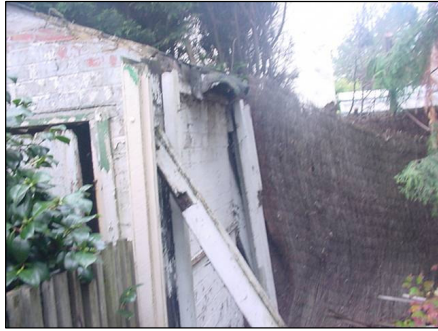
Dilapidated outbuilding

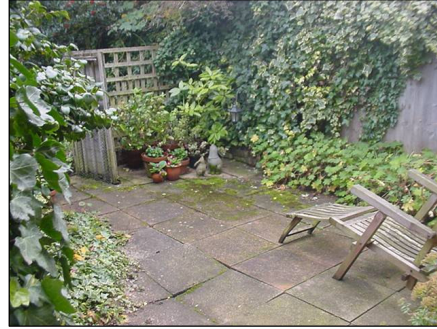
Rear garden patio area with uneven slabs
