RESIDENTIAL BUILDING SURVEY

Flitwick, Bedfordshire MK45

FOR
Mr T

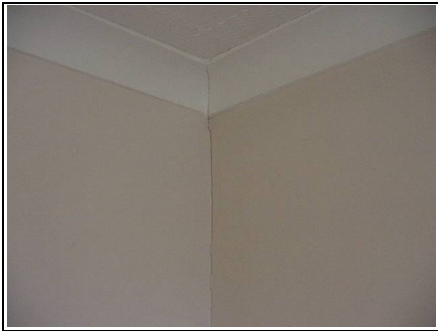
We can see within some of the bedrooms and the airing cupboard that there are an above average number of thermal cracks. This can mean one of several things:

Differential cracking

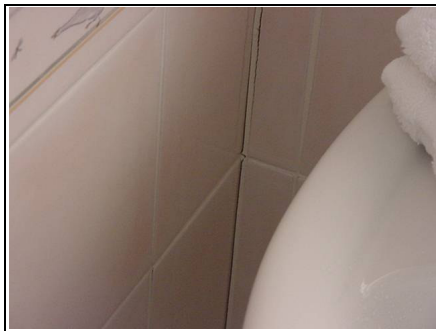
Cracking to en-suite bathroom

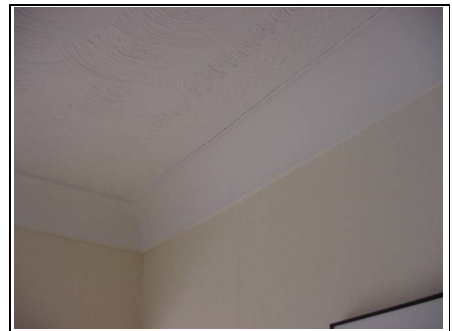
Thermal cracking

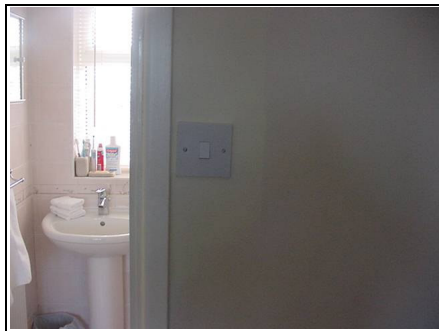
Whilst certainly not structural, this is what we would sometimes term as 'painted to sell', and the messy equivalent is 'painted fast'!

Two different colours to the walls adjacent to the entrance to the en-suite bathroom area

ACTION REQUIRED: Most people would wish to redecorate in their own style.

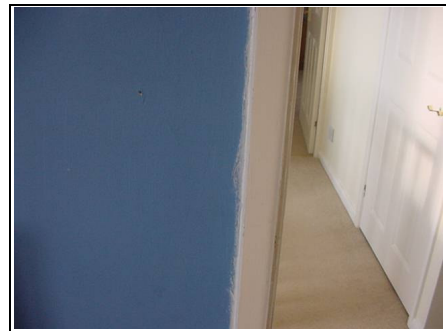
White from the skirting also on the blue wall

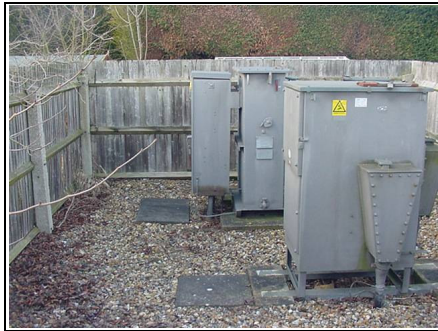
There is an electric sub-station to the rear of the garden. This may put people with young children off purchasing the property in the future. There have been various articles about electro-magnetic fields affecting younger children, equally we seem to have seen as many that say it is not a problem. It is probably fair to say that the jury is still out with regard to electric sub-stations, but it is often the perception than could put someone off buying a property rather than the facts.

Electricity sub-station
at end of garden

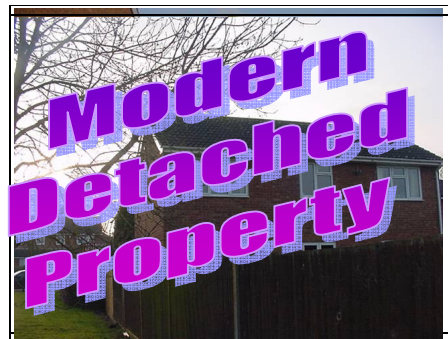
Fence

The fencing is a little bit out of alignment and will need some repair and possible replacement in some areas. Behind it you do have the electric sub-station and we would refer you our comments with regard to this.

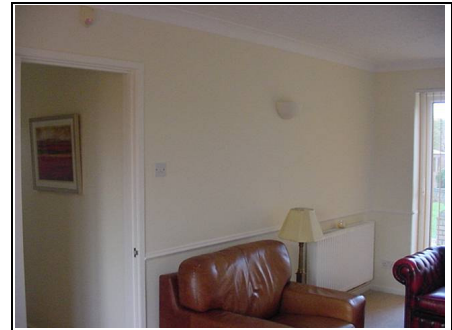
The wall can be removed. It will need structural support. You will also need to give consideration to where you move the radiator to.

Wall that can be removed

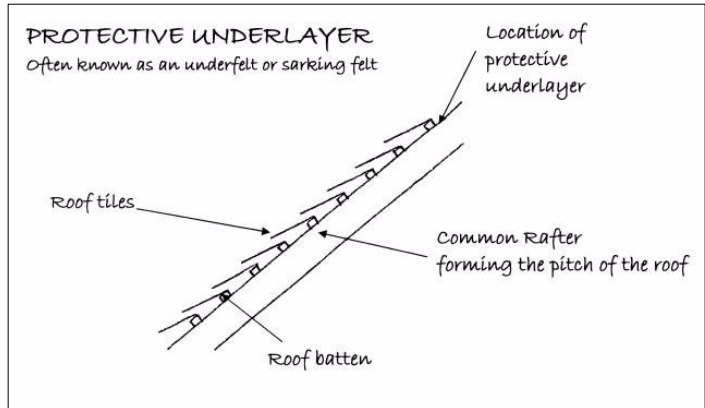
This is a Hessian base underlayer, which has typically been in use since the 1940's and looks in reasonable condition, although there were some tears.

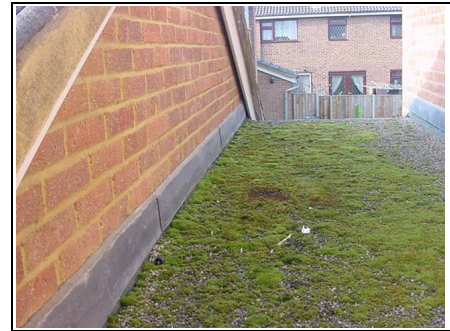
Flat roof

It could not be established if there is insulation within the roof or a vapour barrier, without the vapour barrier and combined with inadequate ventilation there will be an increase in the risk of wet or dry rot.

ACTION REQUIRED: We suggest that you clear the moss, as this will ultimately block gutters and cause drainage problems.

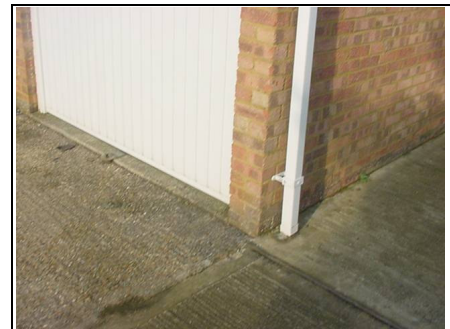
We noted that the downpipes discharge directly into the ground. We much prefer gutters, as this does allow any debris that gets past down a downpipe to be cleared.

Downpipe without a gully

ACTION REQUIRED: We would always recommend that the gutters and downpipes are cleaned out, the joints are checked and the alignment checked to ensure that the gutters fall towards the downpipes.

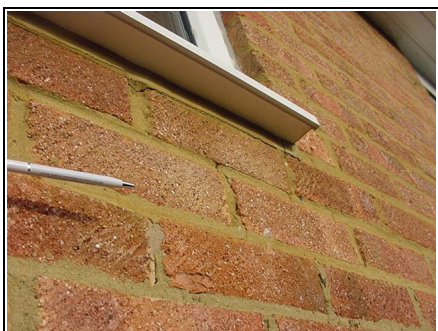
We generally found the brickwork and pointing in average condition, although we did note a colour change in the mortar mix indicating a change in the sand/cement ratio.

Change in the mortar mix
at halfway level

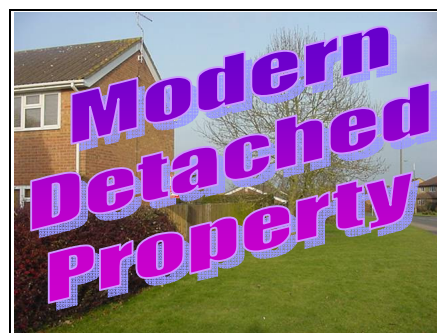
Tree nearby

As there is a tree on the adjacent land, which looks to be Local Authority land, you need to have a chat with them to ensure they do carry out the work. We find that Councils are often willing but unable to fulfil their commitments due to finances.

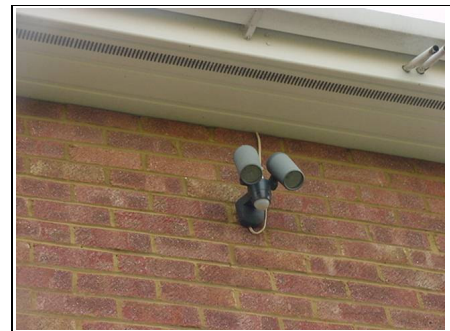
Plastic fascias and soffits

The property has plastic fascias and soffits and are in average condition. The vent allows a through put of air, but you do need to check whether it is blocked or not.

ACTION REQUIRED: Check if there is a through put of air.

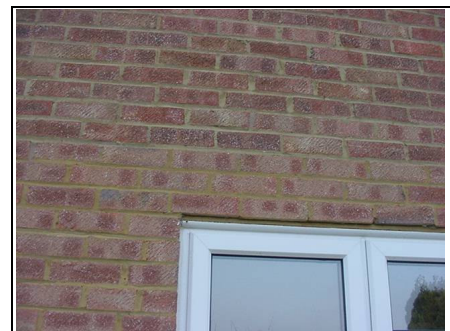
No trickle vent above window

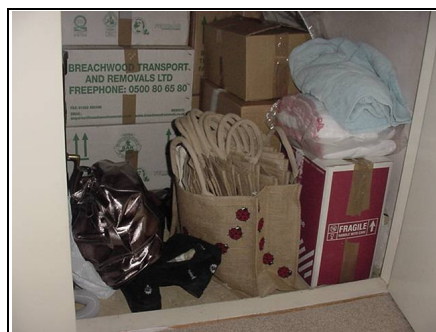
We have not been able to see the electric fuses and consumer units but there was a lot of stored items underneath the stairs, where they are commonly found.

Stored items under stairs

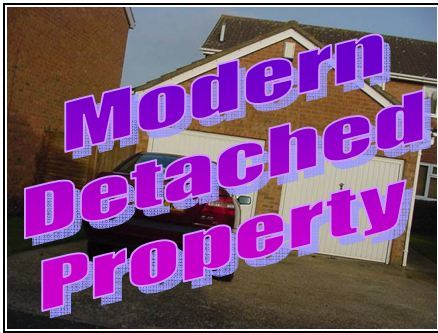
As the drive slopes towards the road we would advise in a worse case scenario you can flood the garage. Please see our comments in the Executive Summary.

As mentioned, there is a slight slope on the garage driveway. The garage itself is a good size, proper double garage. Please see our comments in Executive Summary.

Garage, on sloping drive
