RESIDENTIAL BUILDING SURVEY

London Borough of Lewisham

This is a two storey end terrace house with a basement to the front of the property and a two storey height bay window. Alterations and repairs have been carried out to the property over the years.

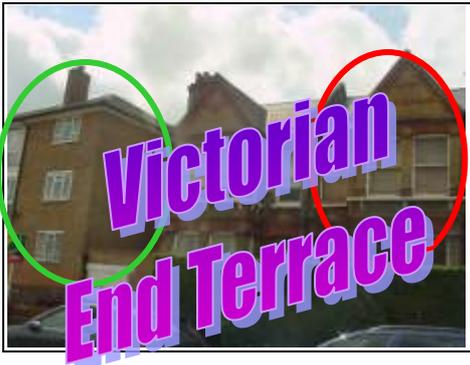
Cracking to flats to left hand side (post war development)

Green circle shows flats to left side and red circle shows period property on right hand side

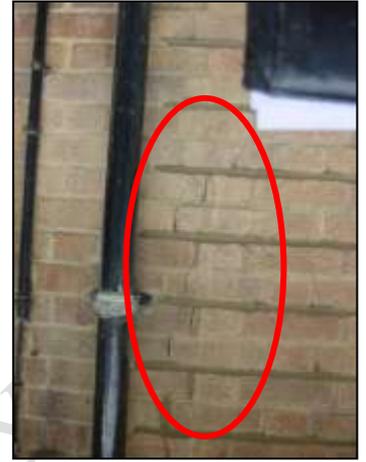
Flats to left side

Cracking to flats

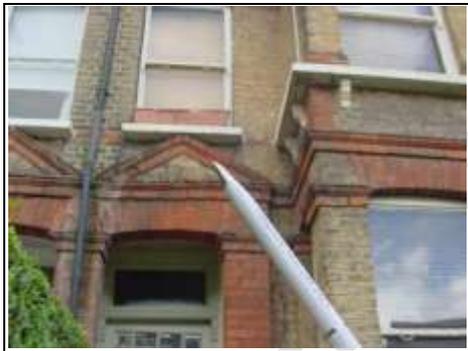
Cracking to period properties to right hand side

Cracking to right hand neighbours property

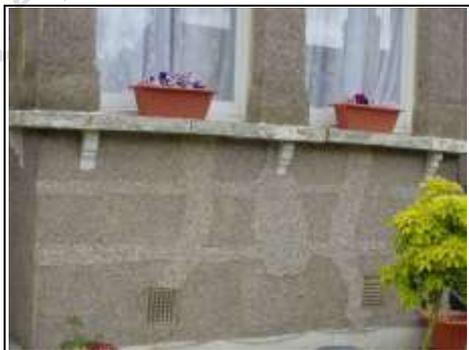
Cracks have been rendered over to base of bay window

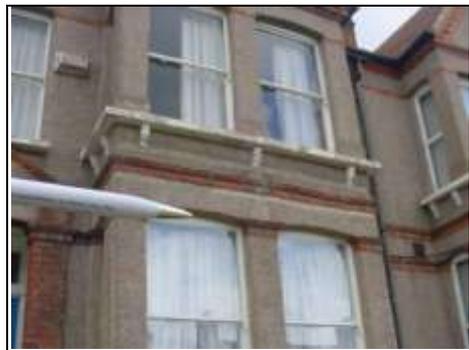
Cracks to first floor level of bay window

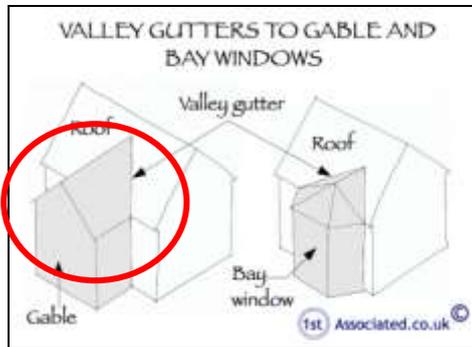
Valley gutter

Although the valley gutters appear to be in quite good condition externally we can see internally that they are allowing dampness into the property.

ACTION REQUIRED: We would recommend that the lead to the valley gutter is checked, made watertight and possibly the replacement of the boarding beneath and possibly the cement fillet.

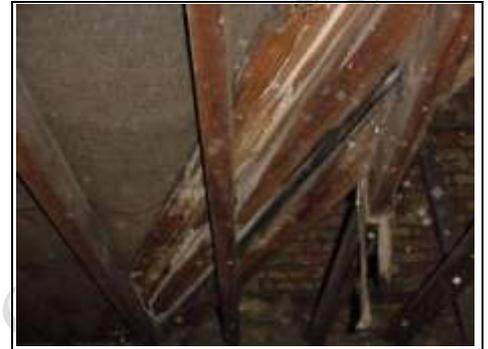
Valley gutter

Rainwater getting into timber roof structure

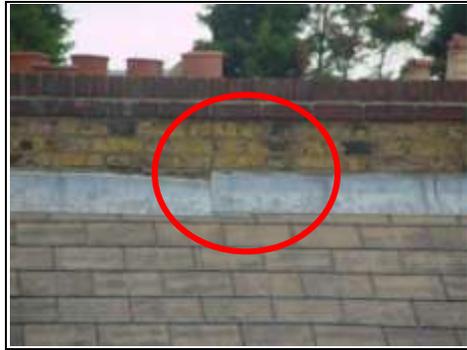
From our vantage point in the adjoining block of flats we were able to see that the lead flashing had slipped and we were also able to see the water damage beneath when we went into the rear part of the roof.

Lead flashing has slipped

ANTICIPATED COST: We would estimate the scaffolding would be more expensive than the actual work. In the region of £2,000 - £5,000 to repair the flashing; quotations required.

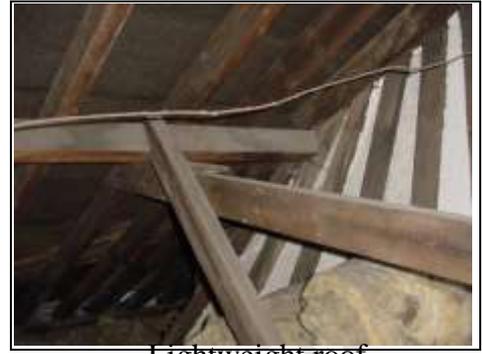
Our initial thoughts when we entered the roof space is that the timbers are smaller than we would typically expect to see on this age, type and style of property and as such are likely to be replacement timbers. They have obviously stood the test of time for however many years they have been in place but nevertheless this has not removed the factor that they are thinner than we would typically expect to see. This, when combined with the dampness getting into the roof structure is of concern.

Lightweight roof

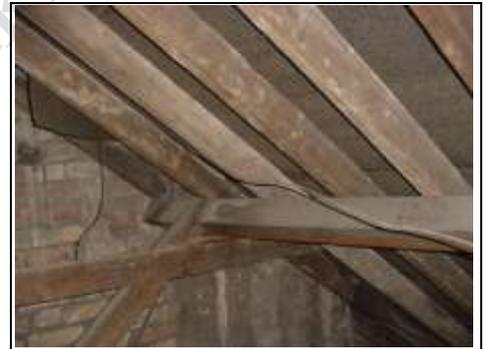
We also noted that the roof was not tied into the end gable via the purlins which can lead to problems of movement on the end gable.

Timbers thinner than we expected and timbers propped and not tied into walls

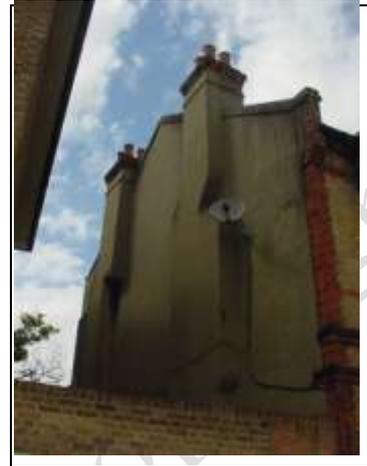
We are not sure whether this was originally an end terrace property. There may have been bomb damage or clearance in the area and this became an end terrace property as it would be more usual to have a brick gable rather than a rendered end gable.

Gable end to left side

ACTION REQUIRED: If you did buy the building, which we are not recommending, you would have to consider this to be a characteristic of the property or carry out major works to the gable end.

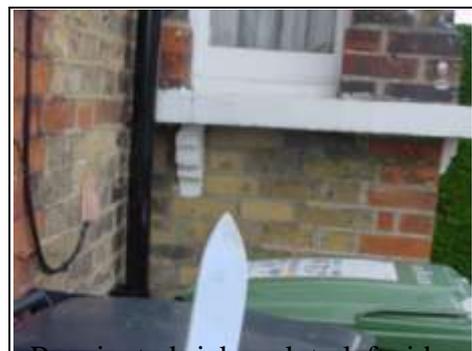
Movement over arch to front bay

Repairs to brickwork to left side of box bay window

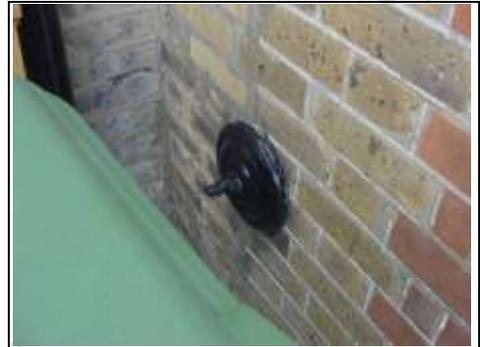
We noted a tie bar in the structure. These tended to be used post war when cracking was generally not considered as big a problem.

Tie bar

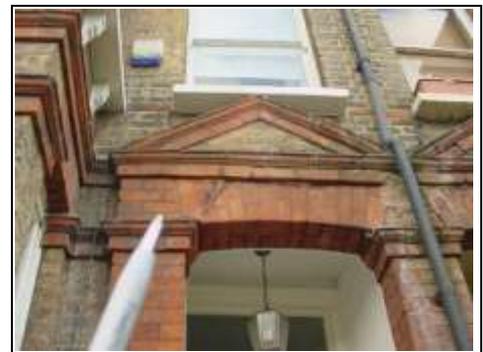
There are very visible cracks externally which will always put off purchasers in our experience or result in them negotiating and getting a discount. You are currently in the position of being the purchaser and as such you need to negotiate hard discount wise.

Crack in arch over door

ACTION REQUIRED: You need to accept that the movement and the repairs and peoples opinion of this type of property are part of the character of this property. There is little that you can do to change many of them. It may result in a lower than average price being obtained for this type of property and/or selling taking a long time.

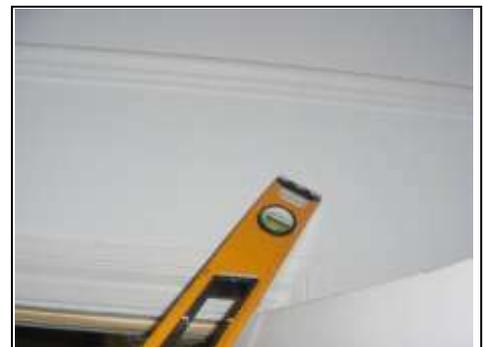
In our experience of living in older properties even if you do seal up the cracks many of them tend to reappear.

Crack in rear bedroom

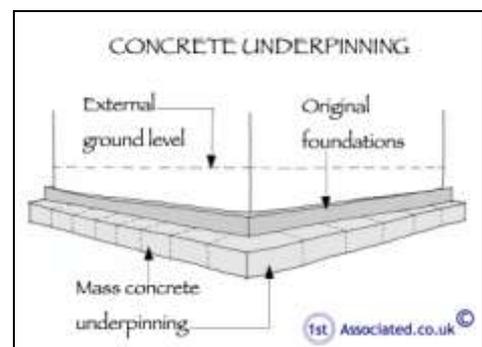
As mentioned we haven't seen specifications and details with regard to works carried out however typically insurance companies will carry out partial underpinning (as per sketch) and repairs to the brickwork which may include mechanical fixings but will depend upon the extent of the damage.

Underpinning

ACTION REQUIRED: Bearing in mind the problems the drains have caused in the past, we would recommend a close circuit TV camera report is carried out on the drains.

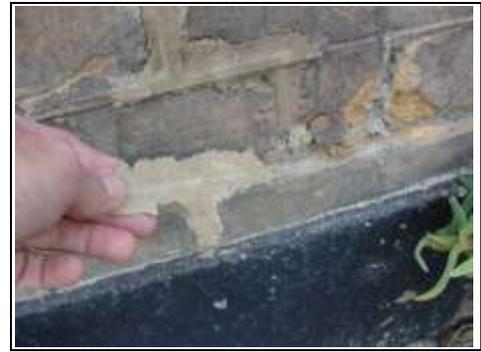
Cement pointing coming away

The use of cement mortar causes deterioration to brickwork and does lead to the face of the bricks deteriorating, which in turn leads to dampness. This is a very important point.

ACTION REQUIRED: Find an old bricklayer that is used to using lime mortar and for them to gradually remove the cement mortar over several years with a soft brush and repoint in lime mortar to allow the building to breathe.

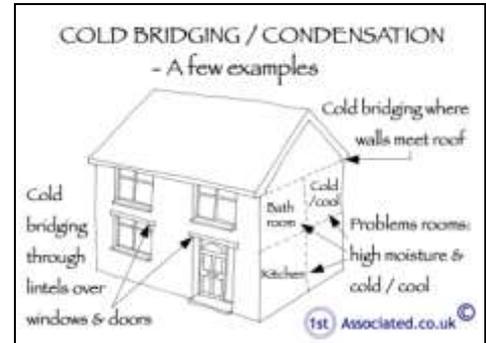
Cold bridging/condensation

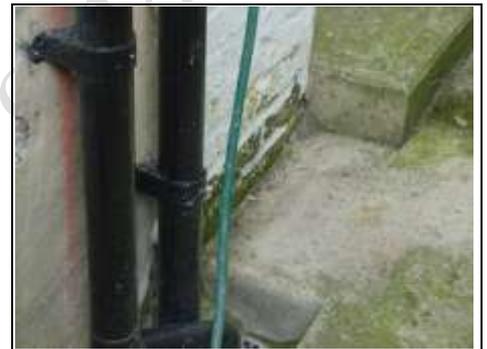
Dampness coming into utility room which looks to be from the leaking external tap

ACTION REQUIRED: We would recommend lowering the ground level and adding French drains to the rear of the property.

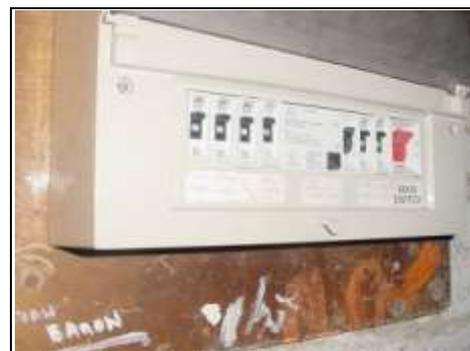
Fuse board

The fuse board looked 1970's/1980's and better are now available. We recommend that the fuse board is replaced.

ACTION REQUIRED: Replace fuse board. As the fuse board is dated there are likely to be electrics that are dated as well. As the property is changing occupancy an Institute of Electrical Engineers (IEE) test and report should be carried out by a NICEIC registered and approved electrical contractor or equivalent.

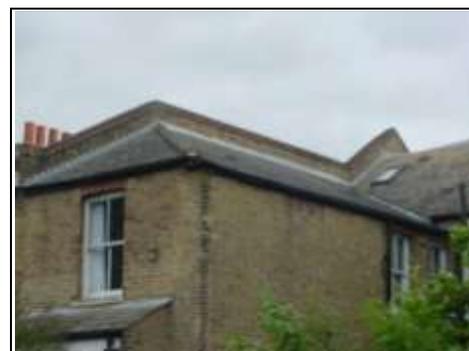
We have been unable to check and confirm whether this chimney has been removed and unfortunately we didn't gain access to next door (we knocked on the door but no one answered).

Missing chimney?

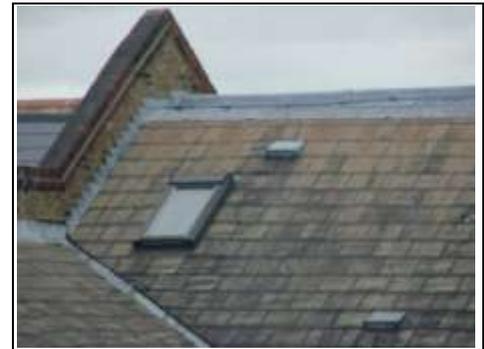
The property has a purpose made roof window, which looked in average condition. The important factor with roof windows is the flashing around them; in this instance we simply couldn't see it as we didn't have a vantage point where we could see the roof window properly.

Roof window

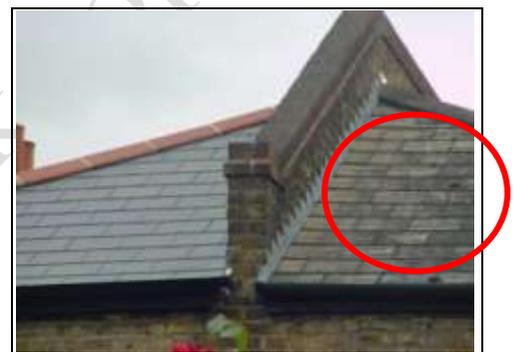
The problem with manmade slate is that it is relatively lightweight and can be lifted by wind. We would add that it is only in recent years, the past fifty or so years, (relatively speaking with regards to buildings) that we have used them so to some extent we are still learning about them, for example you can see the weathering and the discoloration in the slate compared compared to a new manmade slate as you can see in the first photo.

Your roof has weathered man made slates (circled)

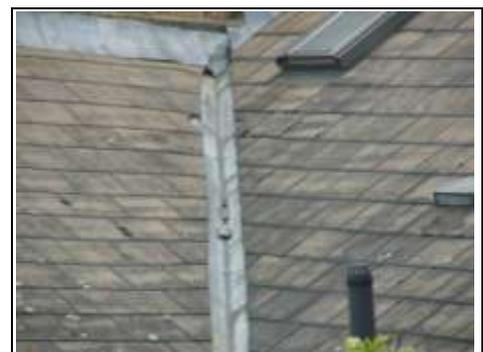
Damage to some slates

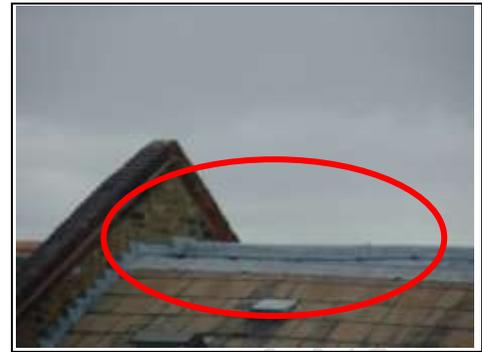
We would comment that there is an unusual lead upstand to the roof which is leaking and that the slates may have an asbestos content.

Unusual lead upstand

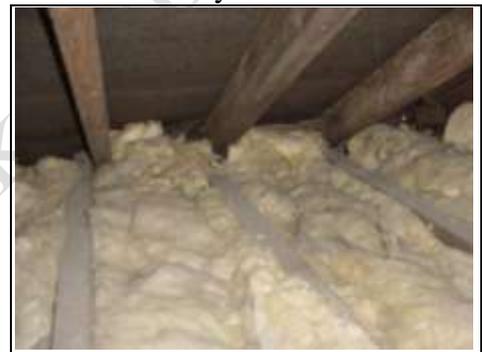
When we inspected the loft space we found a Hessian base Bitumen membrane. This type of membrane has been used since the 1960s. We generally found it to be in average condition, with damage in some areas which is what we typically find.

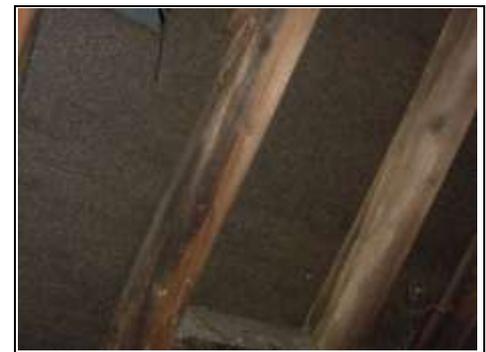
In addition there looks to have been a fire to the front right side of the property at some point in time (the present owners didn't know anything about this). The timber remaining from the fire looks to be of reasonable quality.

Fire damage

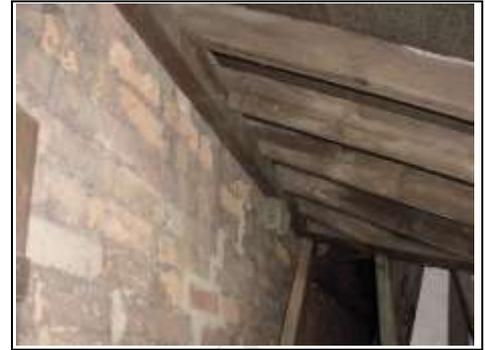
Dampness from parapet wall

Dampness in top of common rafters and crack in wall

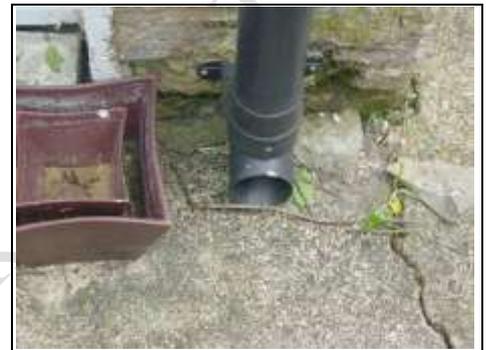
The property has plastic gutters and downpipes. There are a few problems to these with regard to support to the guttering and we also noted that in some areas the rainwater goods discharge directly into the ground which can cause dampness into the property and is a practice that we are not keen on as they are often prone to blockages. Ideally, they should be changed to a gully system but this would involve running in new drains as well. If the budget doesn't permit for this then we would recommend slates are added to protect the walls.

Downpipe discharging directly into ground

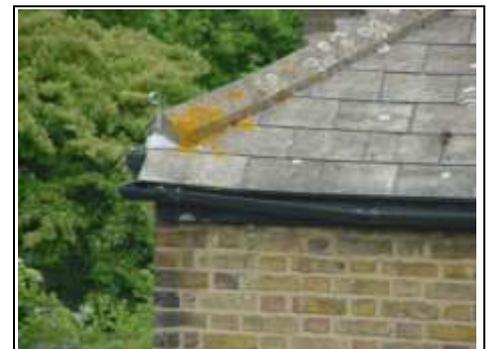
The support bracket to the gutters are spaced too wide (often the old cast iron gutter spacings). Plastic cannot support such weight and as such we can see a twist in the guttering which could in turn mean the water discharges down the wall.

Unsupported guttering and missing downpipe on left side

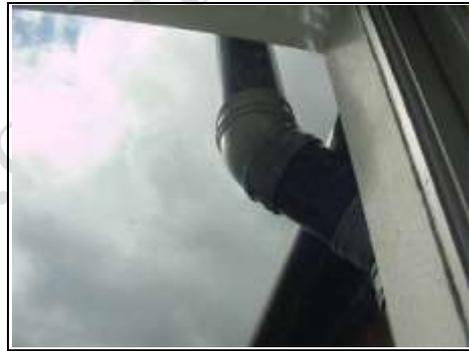
Repairs needed to soil and vent pipe

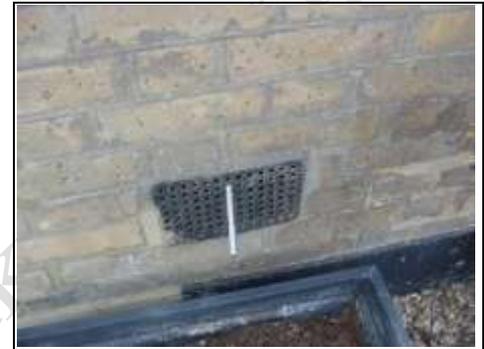
The property has a suspended timber floor which needs air bricks to vent it. There are airbricks to the front of the property. Air bricks are essential to have a through flow of air as this helps to reduce the chances of wet rot, dry rot and woodworm. Some of the airbricks are low and are acting as gutters.

Air brick into basement/cellar

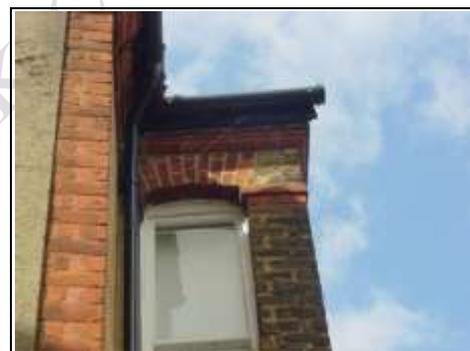
Fascias

The fascias and soffits are timber. Where we can see this detailing it is predominantly a fascia only. As mentioned the guttering is not supported and as such has twisted therefore may be discharging rainwater onto the timber fascia boards which of course will cause them to deteriorate.

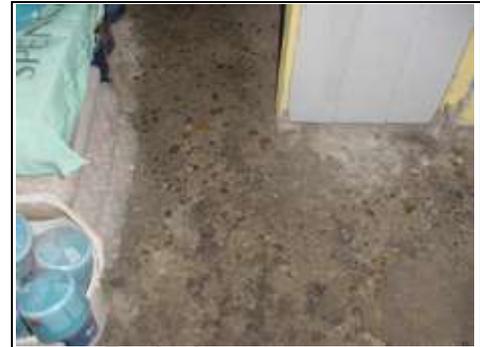
There is a worn concrete floor within the cellar. Please note our earlier comments with regards to not being able to find a sump pump to remove water should the cellar get flooded.

Concrete floor in cellar

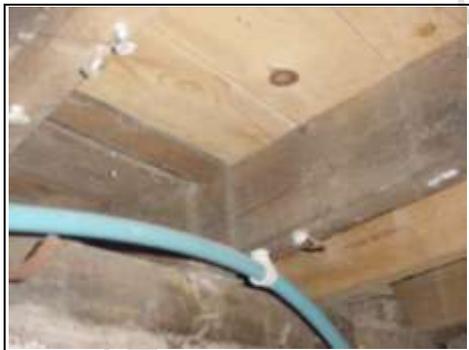
There is a suspended timber floor to the property, which require air movement underneath to minimise wet rot, dry rot and woodworm. The timber floor is a modern, thinner board than we would have expected to originally find.

New and old timber in ground floor viewed from within cellar

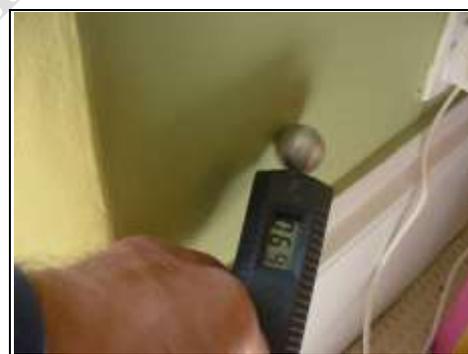
High damp readings

ACTION REQUIRED: Please see the Executive Summary.

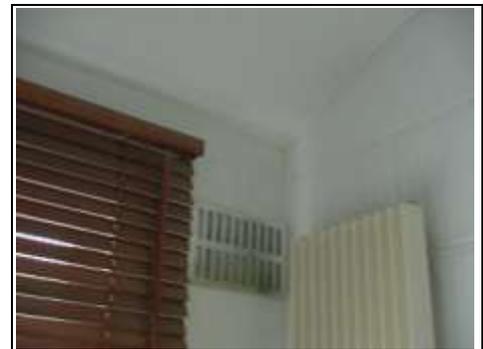
Vent rather than extract fan in bathroom

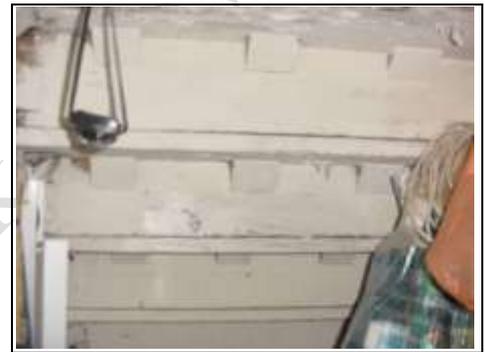
Cellar stairs not lined

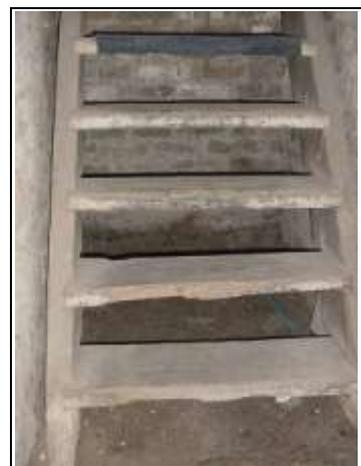
Stairs to cellar

The stairs to the basement are worn and would benefit from repair or you need to take care.

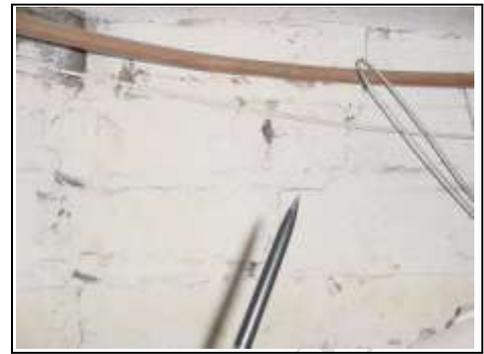
Crack in cellar

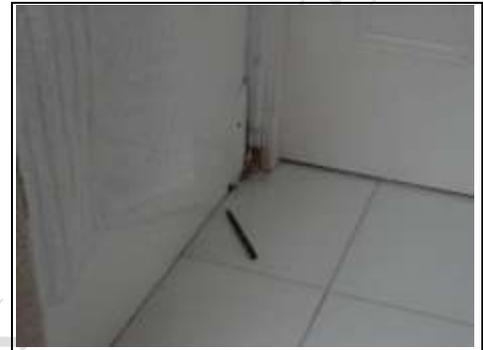
Dampness from shower has caused problems in utility room

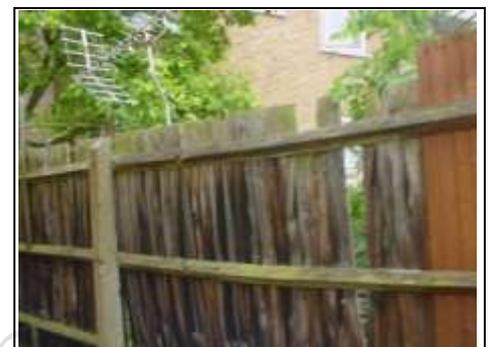
Fence needs repairing to left hand side
