JOB REFERENCE: RBS/RM

RESIDENTIAL BUILDING SURVEY

**A Converted Victorian Chapel, Hammersmith and Fulham,
London, W14**

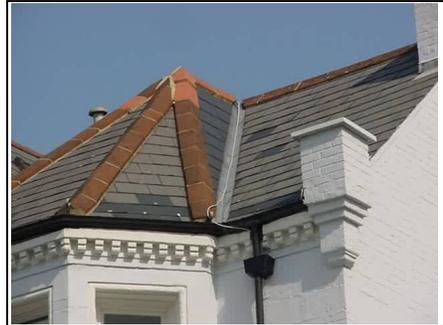
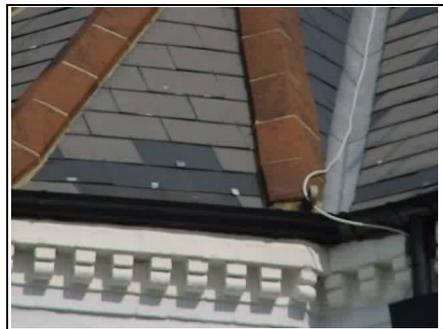
At high level there are problems with dampness getting into the property at various points. For example it is visible at ceiling level within the stairs area. These stains appear to coincide with the valley gutters and the parapet walls on the roof.

Note the poor valley gutter and also the repairs to the slates on the left hand side.

ANTICIPATED COST: Repairs to the roof will be expensive as high level work needs scaffolding and this alone could run into many thousands of pounds.

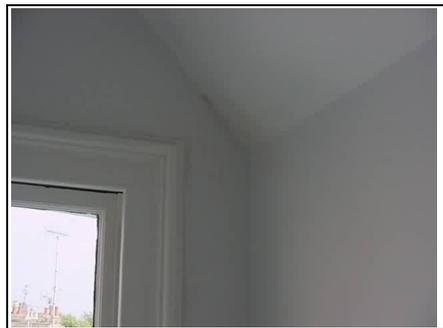
Water getting into shared stairway.

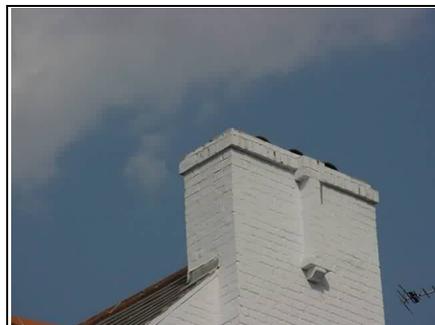
We noted flaking paint at high level near the boiler. This could be due to heat given off by the boiler, but we also noted that there is a hopper head outside and these are renowned for leaking. There is also a chimney on one of the walls that we feel will draw damp in this area too. We noted at high level that the chimney is closed and we did not see any venting.

ACTION REQUIRED: Again this should be mentioned in a 'planned maintenance schedule' for the property.

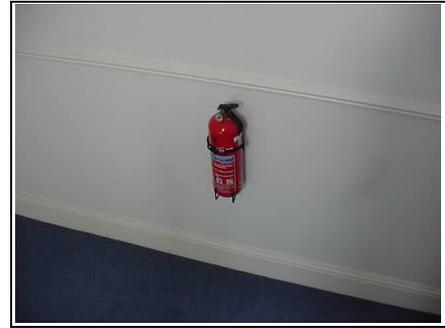
We also noted within your proposed purchase that the entrance door was not a fire door (by this we mean that it does not have a door closer, which a fire door should). We are also concerned that the doors inside the apartment do not have door closers on.

Fire Extinguishers are not signed and therefore not to standard.

We recommend that door closers are added in the apartment, as in the event of a fire these do limit how quickly the fire will spread.

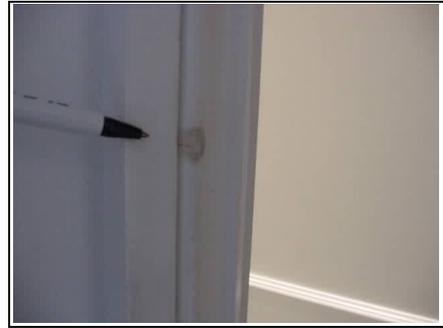
We noted that knots in the timber are visible (known as ‘grinning’ through). Unfortunately this is difficult to paint over as the knots have not been treated originally, which means that they continuously weep.

ACTION REQUIRED: Redecorate.

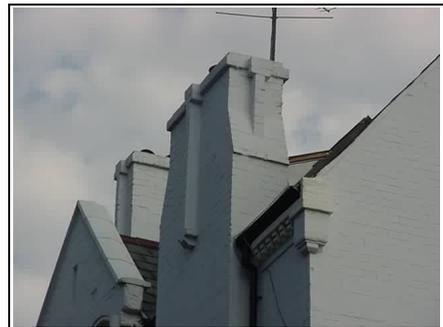
Chimney Three – Rear Left Hand Side

This chimney has a painted brick finish. From our close up photo it does look to be starting to weather on the joints and would benefit from repointing. Again, we were unable to see the flashings or flaunchings properly and therefore cannot comment upon them.

When the high level work is carried out next the chimneys need to be inspected closely and repairs carried out as necessary. We are concerned that the paintwork may be hiding defects.

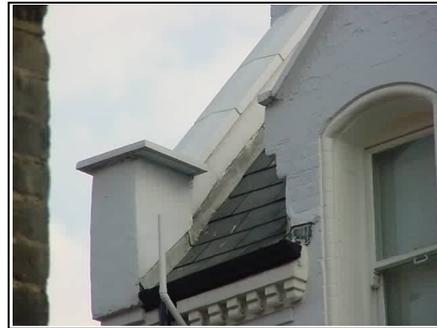
Rear Left Hand Side Parapet Wall. This flashing does not look to be cut in and bedded under the slate as it should be, although we would reiterate it was very difficult to be certain from ground level.

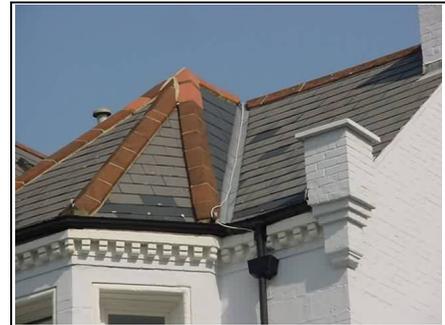
The roof is pitched and clad with manmade slates which should sit very flat and true, as they do in the areas we can see. However, as the manmade slates are thin and light the wind can catch them, so it is important that the slates are fixed at the perimeter. This is what we think may have happened where the roof repairs have been carried out. If you look at the photos the darker areas are where replacement slates have been added. This may well have been where the wind has caught underneath them. You can also see some of the ridge tiles (the red tiles) are a different colour.

From all of this we think that the wind is catching the slates on the roof, which may not have been fixed down properly and this type of work will be on-going maintenance, which no doubt you will have to pay for through your service charge. Where the slates have been repaired we could see lead tingles.

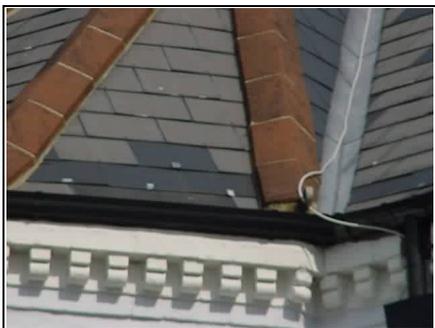
Showing tingle repairs.

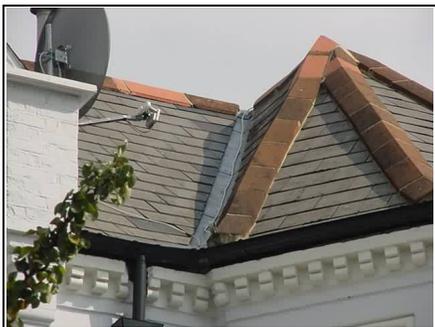
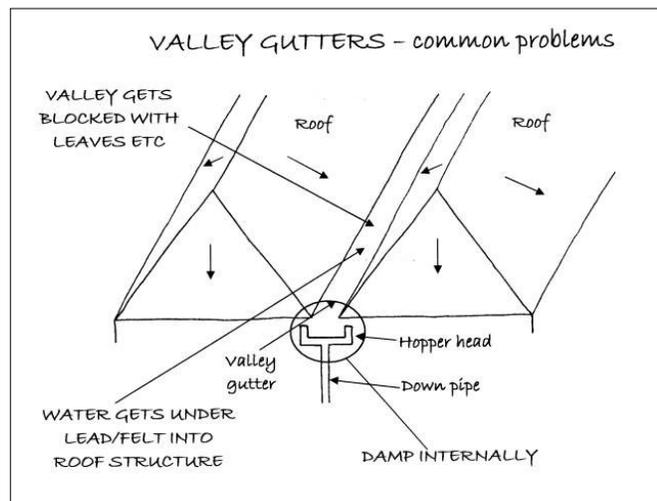
We think that the water is likely to run directly off the valley gutter and over the guttering causing dampness into the property

ACTION REQUIRED: We would always recommend that the gutters and downpipes are cleaned out, the joints are checked and the alignment checked to ensure that the gutters fall towards the downpipes.

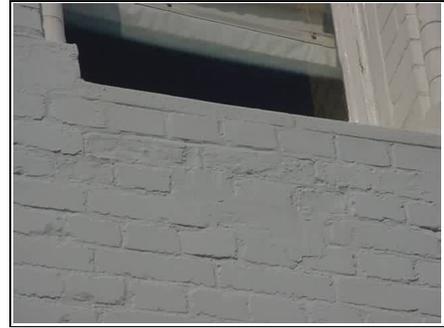
A close up inspection of the brickwork does tend to suggest that concrete repairs have taken place to deteriorating brickwork if you look at the centre of the adjoining photo.

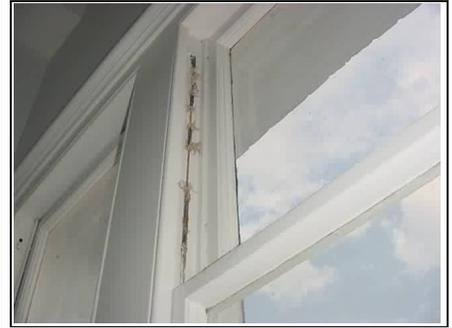
Sash cord deteriorating.

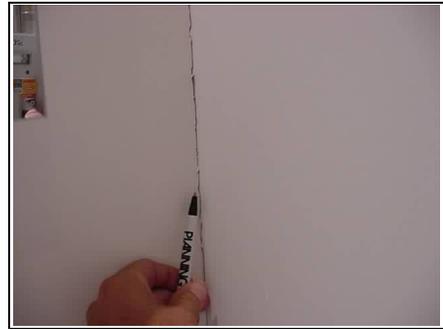
Differential movement between the main solid walls and the studwork partitioning.

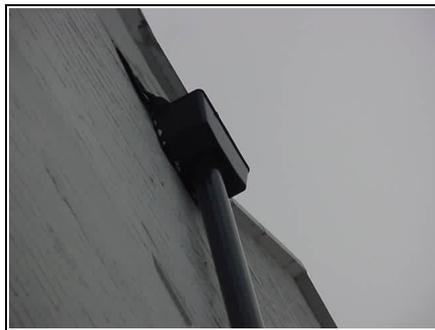
This photo shows a hopper head with a lead guard added behind it.

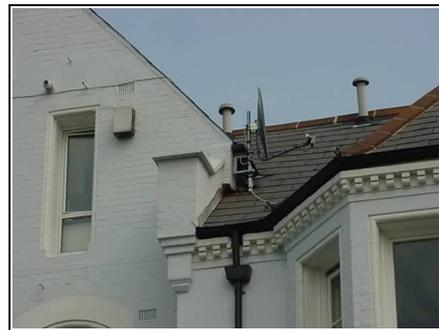
Hopper head in centre of photo with no lead guard behind it.
