RESIDENTIAL BUILDING SURVEY

Shooters Hill, London,
SE18 xxxx

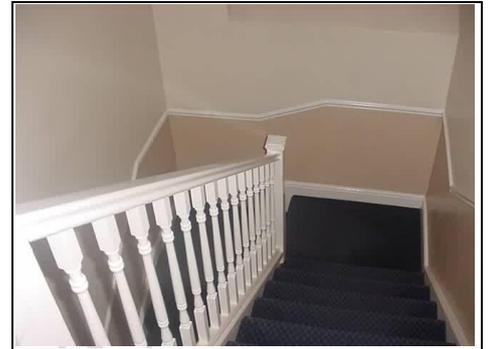
Communal stairwell
These would benefit from re-decoration

We noted that the communal areas would benefit from a re-decoration. Whilst this does not affect you much, as you do not have to walk up the stairs etc., it does give an indication of the quality of the management company.

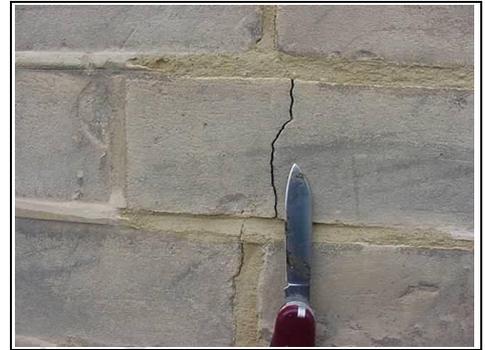
We can see vertical cracking in the bricks particularly to the right hand side wall. Internally there is also cracking particularly to the rear right hand bedroom.

Vertical crack in the brickwork

ANTICIPATED COST: Usually, if there are any problems, as stated above it will be limited to the excess of the policy. You do need to speak to the freeholder about this and inform them that your survey has identified that there has been/is movement in the property albeit minor at present; please obtain quotations.

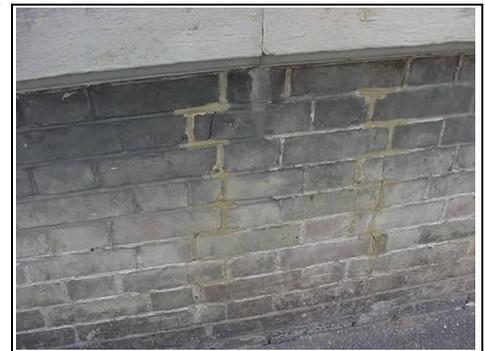
Repairs to cracking

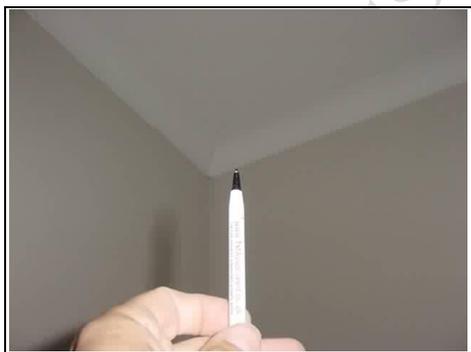
Internal cracking

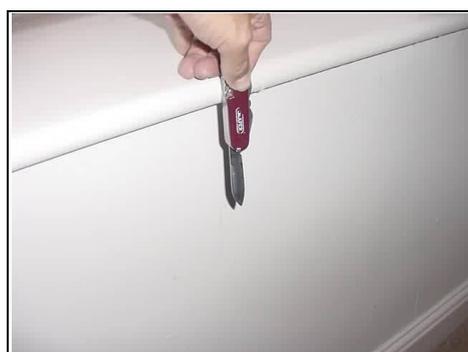
Cracking- lounge - front right

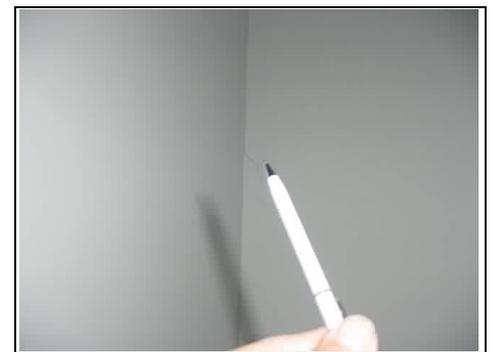
Cracking – rear right bedroom

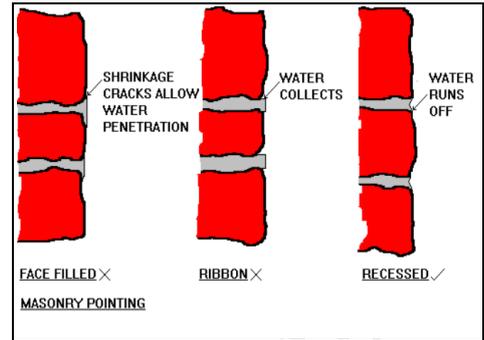
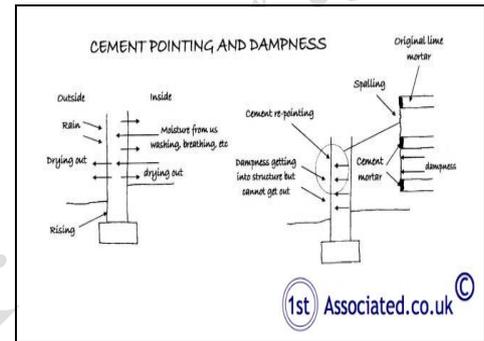
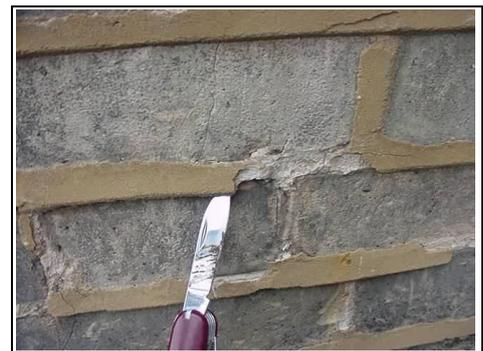
Unfortunately the cement re-pointing, whilst well meaning, is not appropriate for this type of construction. A cement mortar has been used rather than a lime based mortar. We recommend you use lime mortar in any future repairs regardless of what the builders say! Using lime mortar will limit further damage to the brickwork, which is almost impossible to repair successfully. However, we would add that many, if not most, of the properties that are re-pointed are re-pointed wrongly; it is only in recent years that we have discovered the problems that can occur from it.

Poor re-pointing. Just a skim coat. we are amazed it has stayed on.

ACTION REQUIRED: The using of cement mortar would seem to be due to a lack of knowledge and next time the building is re-pointed it should be carried out in a lime mortar. This will not be that long as this is a very thin/poor re-pointing and is starting to come away.

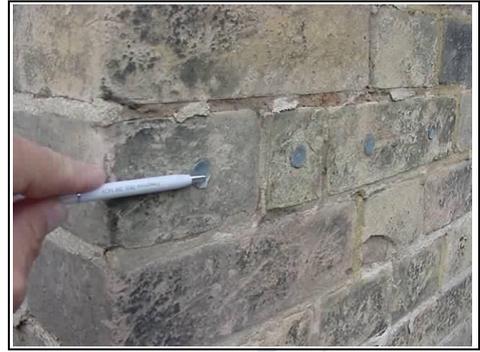
Damp proof course – right hand side of property

ACTION REQUIRED: We would recommend that you meet your downstairs neighbour for a cup of tea before you purchase the property to ask if they still suffer from any damp problems.

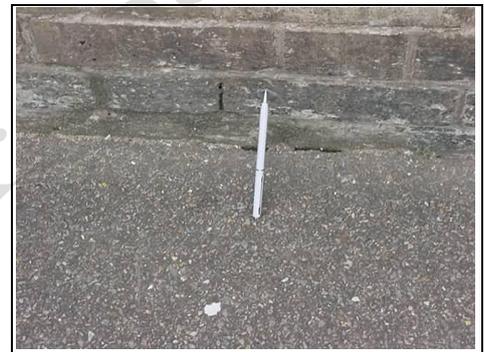
Damp proof course is too low for the ground level

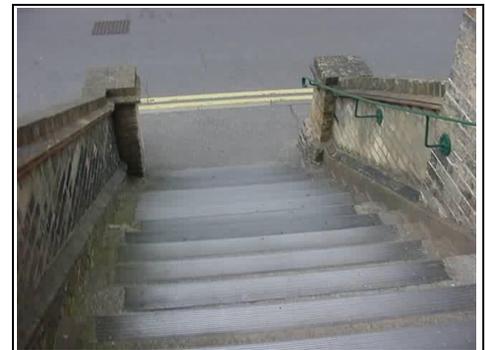
Dampness may be coming in via the stairs

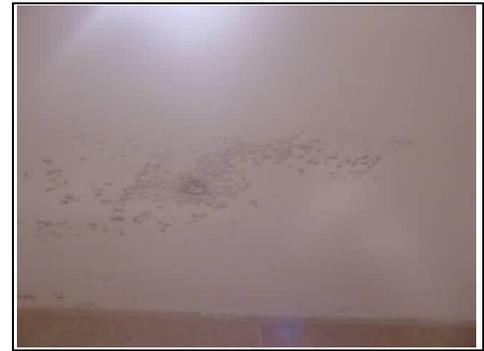
We noted mould in the internal bathroom. Whilst the mould and condensation may be partly due to the lifestyle of the previous occupant we would recommend that you install large humidity controlled extract fans. We would add that it will be a struggle to stop the problem of condensation altogether due to the design of the bathroom being internal and also the low ceiling height.

Mould in the bathroom

ACTION REQUIRED: Add large humidity controlled extract fans to the bathroom and ideally the kitchen. The beauty of humidity controlled extract fans is they switch on and off by themselves.

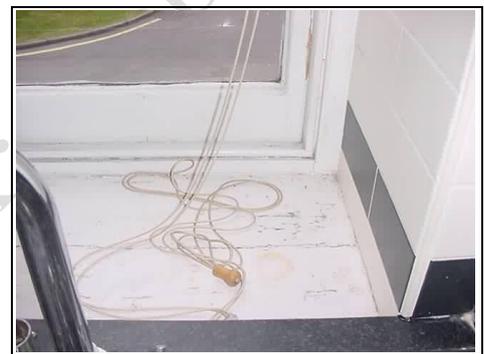
We can also see what looks like condensation to the sliding sash windows. This may be water ingress via wind driven rain. You may wish to think about a secondary glazing system assuming that the landlords and the local authority/ listed buildings planners give approval.

Kitchen window sill.
Signs of condensation.

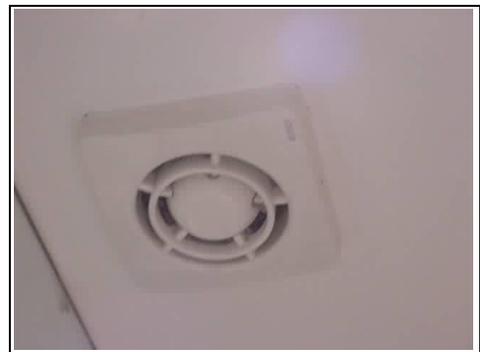
We recommend replacing this extract fan with a humidity controlled extract fan

ANTICIPATED COST: A few hundred pounds; please obtain quotations.

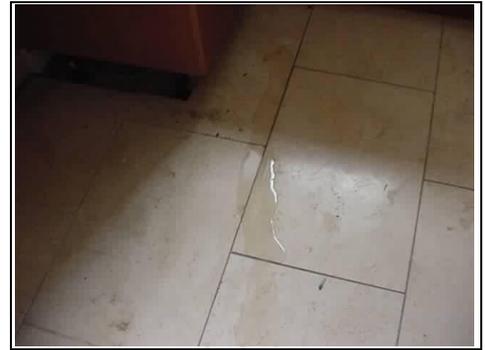
When we ran the tap water leaked onto the floor

ACTION REQUIRED: Check the plumbing under the sink. Ideally you should tile under the kitchen units so that there is not a drop in that area where water can get in. As previously mentioned you need to have a cup of tea meeting with your downstairs neighbours.

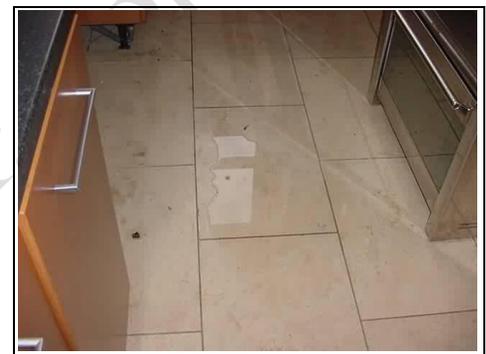
Leak in the kitchen

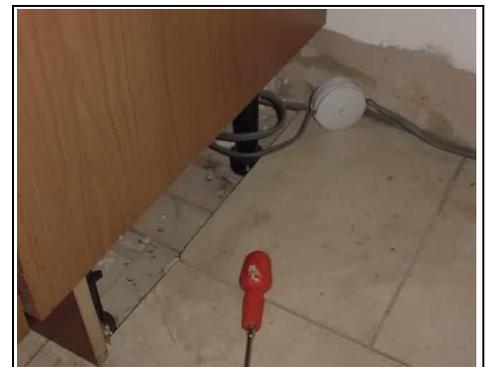
The kitchen floor has been laid on top of the old kitchen floor and has been cut around the units. In our experience this means that if there is any water that leaks (there was a leak at the time of our inspection) the water can get behind the units and under the floor causing the floor to blister (lose its grip) and also dampness can enter the apartment below.

Tiled floor has been laid on the old floor and cut around the units

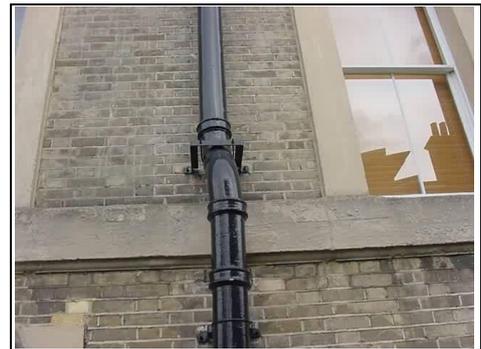
What we have noticed is that it looks like you have asbestos downpipes (we cannot be certain as they have been painted over many times. A good management

Possible asbestos downpipes

Our insurance company require us to advise we are not asbestos specialists. We recommend you have an asbestos survey carried out by a specialist asbestos company.

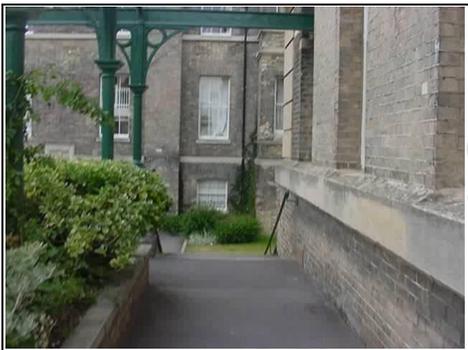
It was noted when we carried out the survey that other occupiers literally walk right past your window to the side of the property and to the rear. The entrance to the block of properties is at the rear. You need to revisit the property and make sure you are happy with this.

Passage way to the side of the property passes your windows

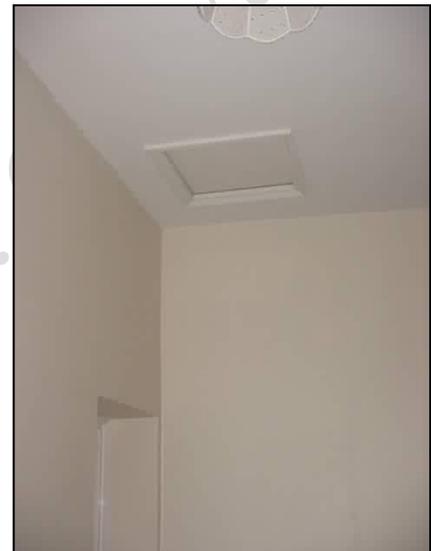
We did not feel we could safely access the roof space with the ladders that we had and more importantly be able to get out of the roof space!

Very high Roof access
Our ladder was not long enough

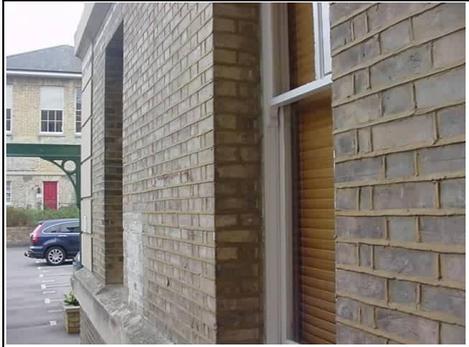
From what we can see, whoever carried out the re-pointing does not understand the usual process of working on a Listed building.

Re-pointing carried out in cement and not lime

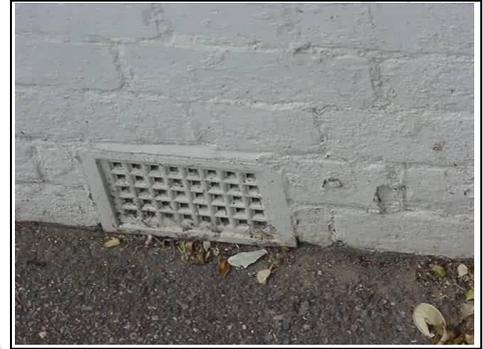
We smelled gas here. Is this the gas vent for the boiler in the property below.

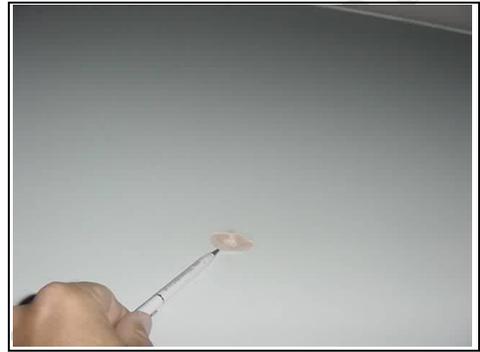
In some areas we can see popping which is where the plasterboard does not cover the nails sufficiently and has popped off.

Skim coat of plaster coming away

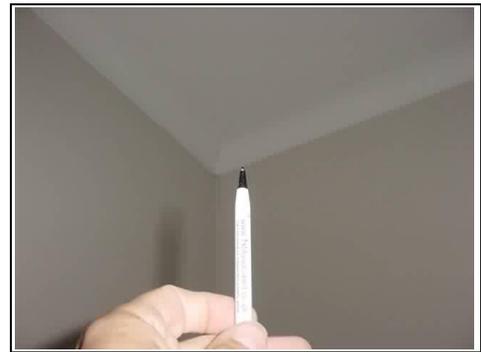
We noticed some cracking internally although it is quite difficult to see on the photos. The cracking internally and externally is a concern.

Cracking

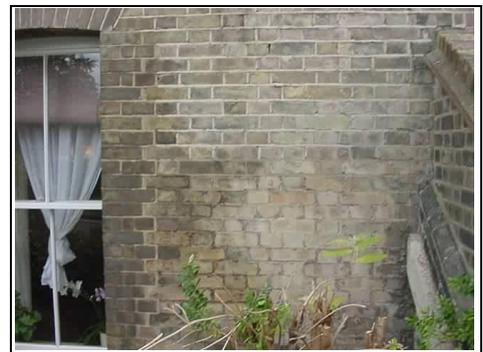
We noted that the downstairs neighbours flat, which is where the damp proof course was inserted, had what looked to be a wet area to the front of the property which may be from a leaking rainwater gutter at high level (check next time it rains heavily). Remember that this flat is partly underground and that it is directly under your property. We knocked on the door to ask about this but did not get an answer. Our concern is that this dampness may affect your property.

Wet area to flat below – right hand side of property

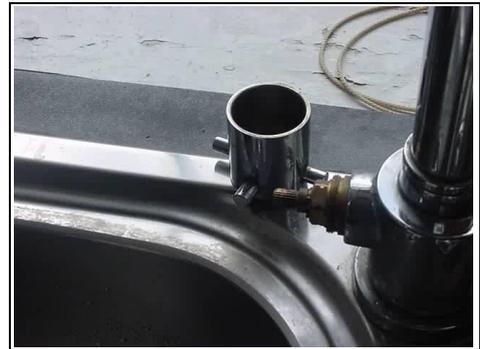
We found the kitchen in average condition, subject of course to some wear and tear as one would expect. Please note our comments with regard to the floor in the Executive Summary and the tap did come off in our hand.

Tap fell off in the kitchen

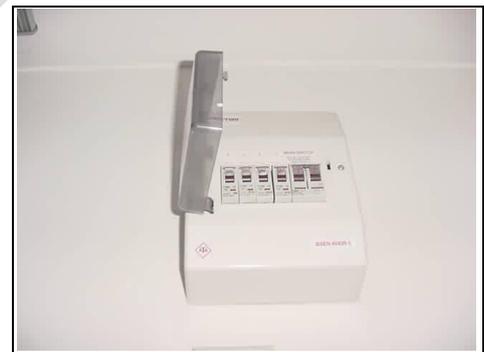
The electric fuses and consumer units were located in the hallway to the right hand side. The fuse board looked to be dated, circa 1990's, which was when the property was refurbished, better are now available. In multi occupied properties a defective fuse board can be particularly dangerous.

Fuse Board

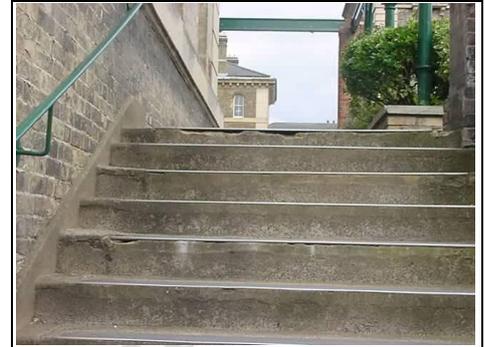
Stairs need repairing
