RESIDENTIAL BUILDING SURVEY
OF
Greetham, Nr Horncastle, Lincolnshire, LN9

FOR
Mr F

INDEPENDENT CHARTERED SURVEYORS

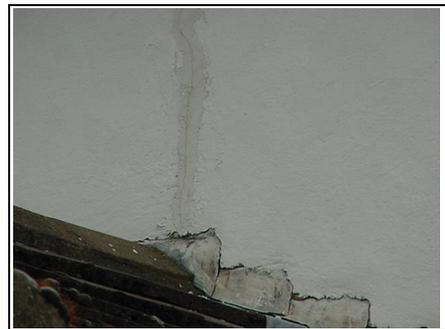
Vertical Crack to Render

We could see a vertical crack in the render to the driveway side of the property. There was no obvious apparent reason for this vertical crack.

Vertical crack to the centre of the photo

coming to the property. The crack may be caused by the openings to the study and the guest bedroom beneath, meaning that this is a weak point in the wall structure. Equally it may be caused by minor settlement to the front or the rear of the property.

ACTION REQUIRED: Ensure that all cracks to the render are sealed and made watertight to stop rainwater getting behind the render.

ANTICIPATED COST: To seal the cracking: £500 - £1,000. To do this properly you need to get a tradesman to cut out the render on either side and then re-render and redecorate. Alternatively you can continue using mastic which is currently being used.

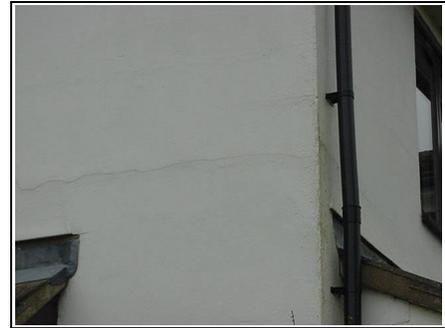
Horizontal Crack on Right Hand Side

Again, this cracking may be caused by the openings and minor settlement in the structure.

Horizontal cracking to centre of photo.

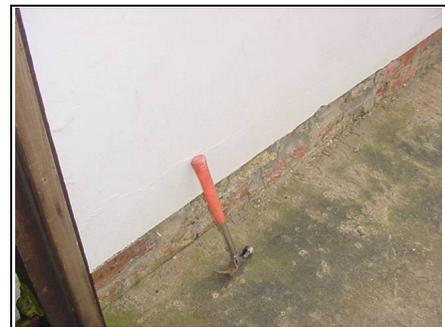
We noted that there were no drip details over the windows and no bell-mouths at low level. This does tend to be a sign of a poorer quality rendering.

No bell-mouth

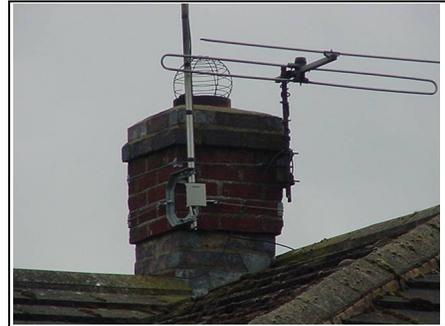
This property has one chimney, which is located centrally. This chimney is brick finished with a chimney flue. From what we could see the chimney looks in slightly below average condition. It is quite unusual to have a step in it, it is almost as if it used to be rendered to the base; a close look at the chimney would certainly be beneficial. Unfortunately we were unable to see the top of the chimney known as the flaunchings and we could not see the flashings properly, we therefore cannot comment upon these.

ACTION REQUIRED: Inspect the chimney closely within the next year.

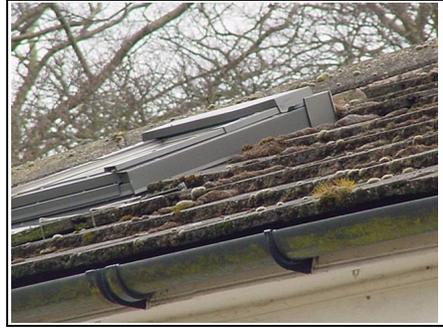
These are often known as Velux windows or roof lights. You have one roof window in the en suite walk-in cupboard area; this is a purpose made metal roof window and there was no obvious signs of water coming in internally. Unfortunately the area where these type of windows often leak is around the flashings, but we simply could not see this area.

It seems inevitable with roof windows that they will sooner or later leak. If this doesn't occur then they seem prone to condensation; this may be slightly more of a problem where it is presently situated close to the bathroom (keep a cloth handy!).

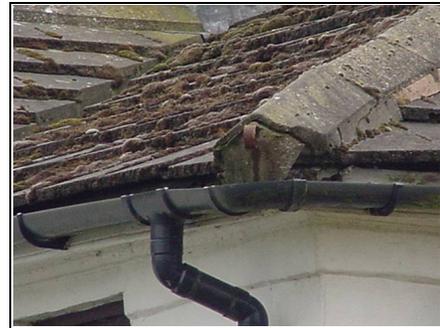
Moss can build up on the concrete tiles and needs clearing from time to time.

From what we could see of the concrete tiles (and this was a fairly small area) they are lying level and true and look in reasonable condition considering their age. Sometimes we find that deterioration occurs to the ridges and the perimeter, so you should periodically check these areas.

ACTION REQUIRED: We would recommend a close inspection within the year. We have also recommended that an access hatch is opened into the roof to check the condition and add vents to reduce any chances of condensation / wet rot.

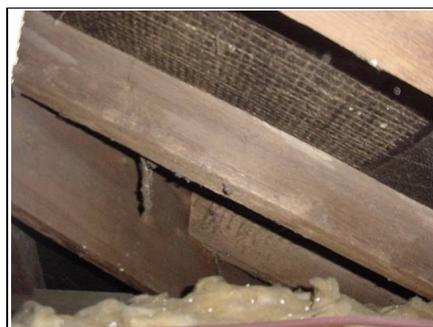
From our very restricted inspection of the loft space we found a Hessian based Bitumen membrane. This type of membrane has been used since the 1960s. We generally found it to be in average condition, although it is damaged in a few places but this is not unusual considering its age.

We would add that there looked to be a newer felt in some areas, which may have been added because of problems with the ridges or valley gutters, but the area of roof we could see really was very small, so it is difficult to make specific comment.

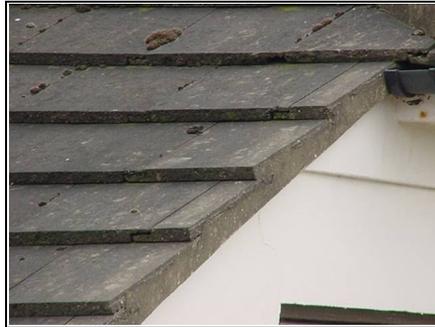
The low level roofs are pitched and clad with interlocking concrete tiles. Where they meet the main building there are metal flashings believed to be lead. Generally we would comment that they look in average condition.

Interlocking concrete tiles

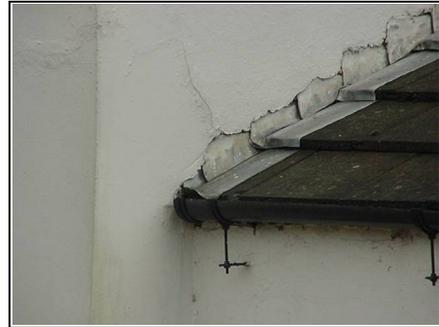
Metal flashing where roof meets the main building.

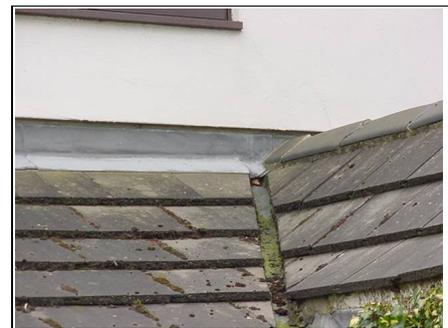
Low Level Valley Gutter

The only adverse comment we would make, and this often occurs where a property has had lots of extensions, is that you have an awkward roof layout which means you have some awkward narrow valley gutters.

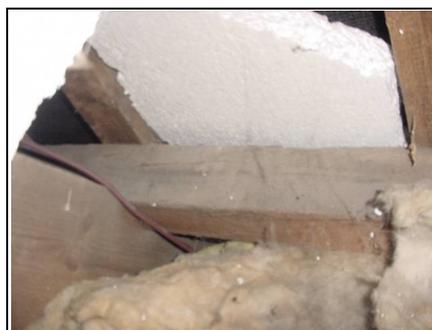
We had a limited view of the roof timbers, partly due to the limited access space of 5-10 percent of the whole roof, and partly due to the polystyrene insulation that had been put in place. We spent some time removing one section of polystyrene insulation only to discover another section behind it!

As we have explained, our examination was limited by the general configuration of the roof and the access, together with the insulation. The little we could see was in average condition. It is, however, feasible that there are problems in the remainder of the roof.

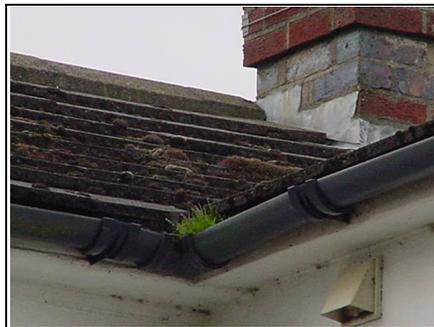
Grass growing in the gutter (centre of photo); this is the base of the valley gutter.

ACTION REQUIRED: We would always recommend that the gutters and downpipes are cleaned out, the joints are checked and the alignment checked to ensure that the gutters fall towards the downpipes.

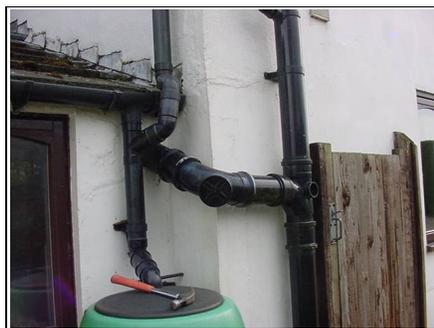
In this photo you can see how the soil and vent pipe has been added to over the years.

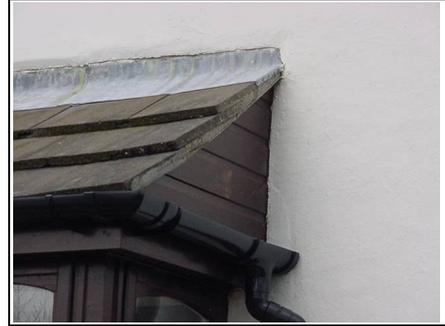
Render meeting the box bay window which appeared to be in good order.

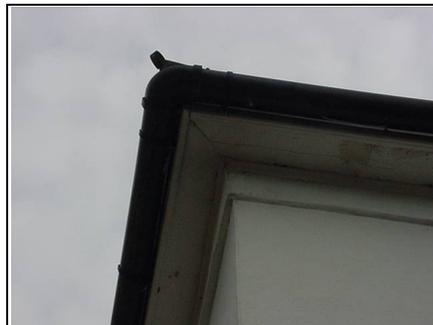
The property has painted timber fascias and soffits and these are in average condition, (which means there is likely to be some minor rot) although much of the fascia is hidden by the guttering.

You may wish to take the opportunity to replace the gutters and fascias and add a ventilation to the soffit to vent the roof.

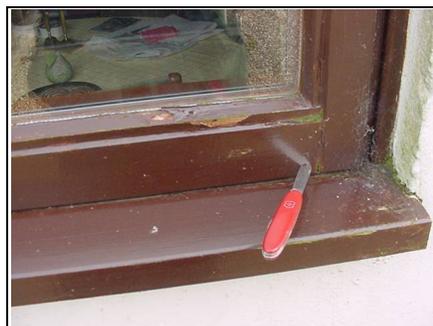
The property predominantly has stained timber double glazed casement windows. They are generally well decorated with Sadolin or an equivalent.

Generally we consider the windows in average to above average condition.

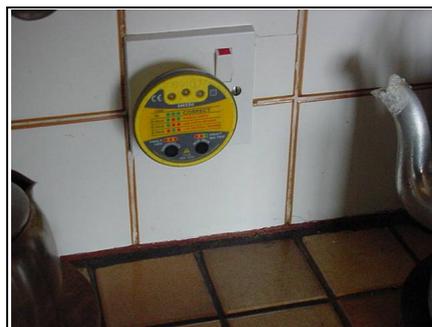
Neither of these indicators can give certainty as to the condition of the rest of the wiring

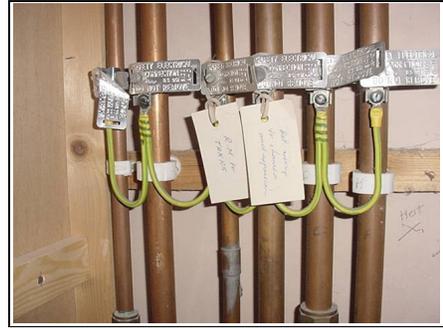
We were pleased to see earth bonding to the pipes.

ACTION REQUIRED: As the property is changing occupancy an IEE report should be carried out by a NICEIC registered and approved electrical contractor.

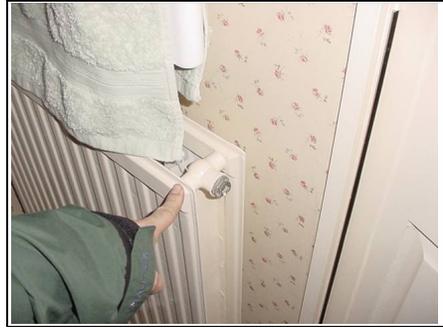
In the photo the towel rail above the radiator is not plumbed in, but is getting heat off the radiator below.

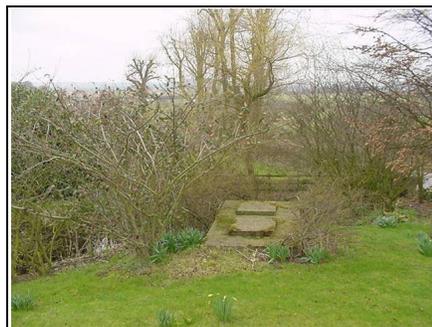
It appears that the property's foul drains discharge to a cess pit, traditionally an underground chamber designed for the storage of foul water. Once the chamber has filled it will require pumping out by the Local Authority or a private contractor.

We have been unable to determine the size, construction or condition of the chamber: obviously the size of the chamber will determine the frequency of the required pumping out, which is, nowadays, a relatively costly operation. In some cases, cesspools have been provided with overflows, or some similar arrangement, designed to reduce the frequency of emptying. This course of action should not be adopted and will result in pollution taking place and the building owner could be liable for prosecution. With regard to the subject property, we have been unable to confirm whether an overflow has been provided or not.

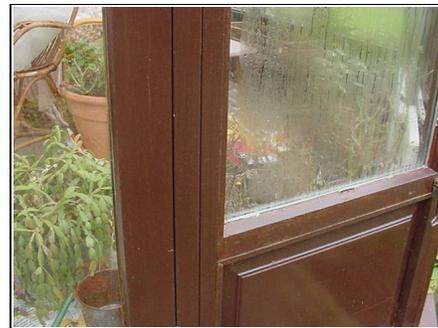
One of the double glazing panels has condensation within it.
