# RESIDENTIAL BUILDING SURVEY

**Guiltsborough, Northamptonshire NN6**

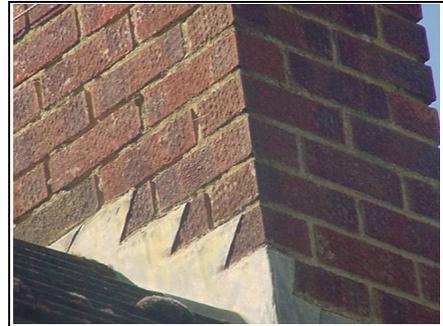
We noted that the chimneys would benefit from being re-pointed. The middle chimney, in particular, would benefit from being re-pointed in the next few years, otherwise we suspect it will get damp within it and this then in turn will get into the property.

Chimney in need of repointing

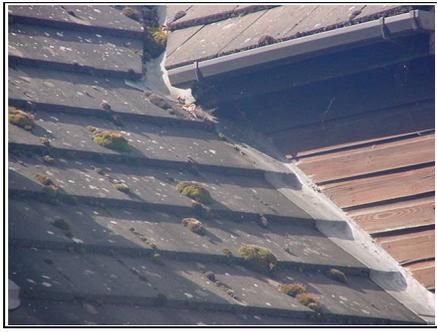
We noted that there was moss accumulating to parts of the roof. This is relatively common on concrete roofs but is probably accelerated by the surrounding trees limiting sunlight.

Moss on roof tiles

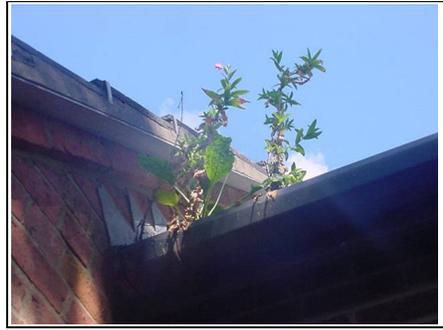
We also noticed that gutters were blocked with moss and other vegetation, for example to the front near the steps and to the rear at the corner junction of the property between the old and the new.

Vegetation in gutters

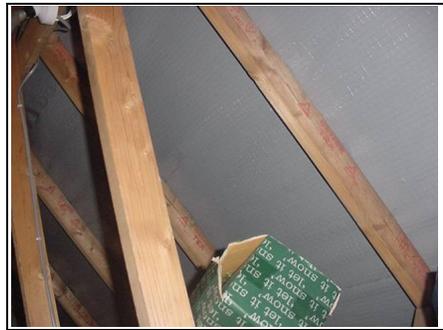
The underlayer in the roof space is plastic. These can cause condensation.

Plastic underlayer

**ANTICIPATED COST:** A few hundred pounds. Please obtain quotes.

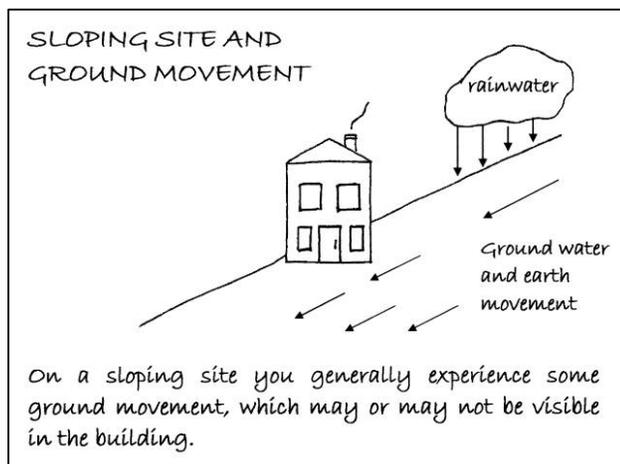
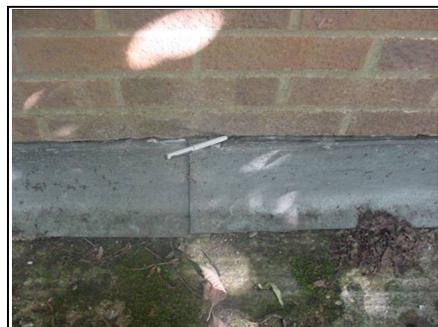
The property sits on a sloping site. If you recall we showed you the rear of the property where the flashing is loose and needs securing/re-bedding. We also commented on how damp earth was sitting against the wall of the rear of the property with little more than a bitumen paint to separate it from the surrounding damp earth.

Lead flashing to rear where we believe dampness is getting in

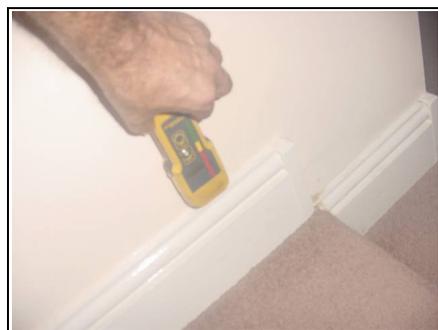
Internally we were able to show you damp meter readings, particularly to the corridor area. These areas may prove problematic with returning dampness that you simply cannot get rid of.

Taking readings using a damp meter

**ACTION REQUIRED:** To resolve this problem 100% would be very expensive, involving the addition of tanking and deep French gully on the outside of the property. It will also be difficult due the ownership of the boundary to the rear. An acceptable alternative is the addition of a shallow French gully (pea shingle gutter). Please see our further information in the Appendices. Alternatively, redecorate when signs of dampness are noted internally, possibly adding a false wall and a drainage channel.

We suggest you live in the property for a while and see how it develops. If you do wish to have a 100% answer before you purchase the property then trial holes around the property will need to be dug to establish the condition of the damp proof membrane to the rear of the property.

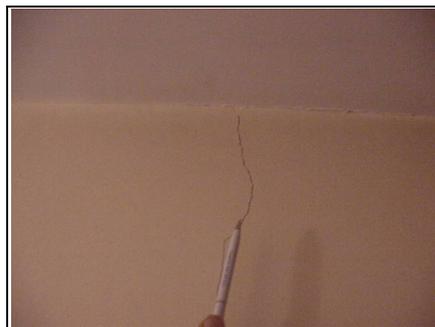
We believe this to be differential movement between the old and the new property, possibly combined with the leaking gutters, which has a mass of vegetation in it.

Cracking caused by differential movement

**ACTION REQUIRED:** Monitor and if you wish to be 100% certain we would recommend the existing owner puts in an insurance claim with regard to the matter and you use the same insurance company when you take on the property and have the liability transferred yourselves.

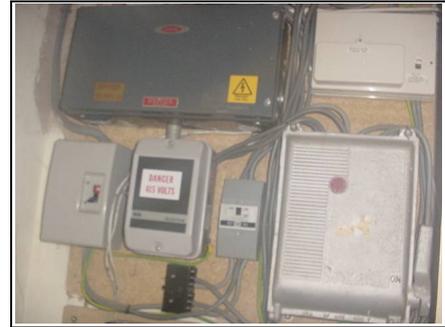
There are two separate fuseboards. We are not 100% certain what they do. The owner thought that the right hand board looks after the right hand side of the house and the left hand board looks after the left hand side of the house. When we carried out an electrical test it tripped the circuit.

**ACTION REQUIRED:** Have an NICEIC approved electrician carry out an IEE (Institute of Electrical Engineers) test and report. We would be happy to comment upon this if you e-mail it on to us.

**ANTICIPATED COST:** In the region of £350 plus any recommendations. Obtain quotations.

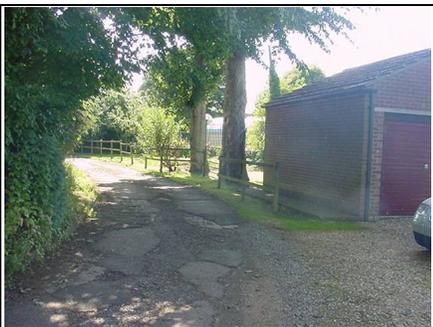
Access road – who maintains it and who pays for it?

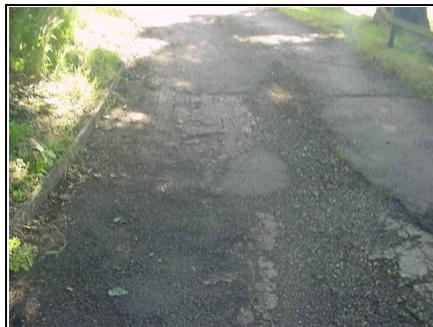
Access road needs maintenance, who is responsible?

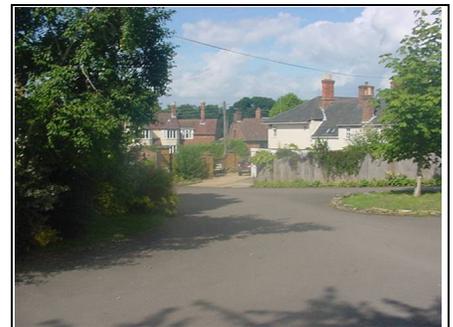
Roadway leading to property - another area may have to pay for

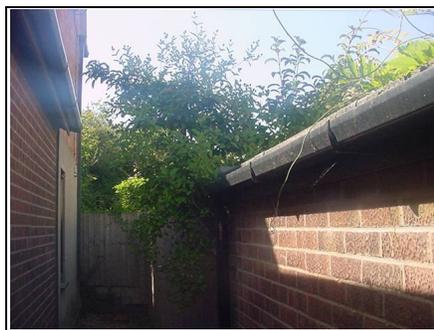
The gutter from next door. This needs to be checked as to where the boundary ends, or is this guttering trespassing?

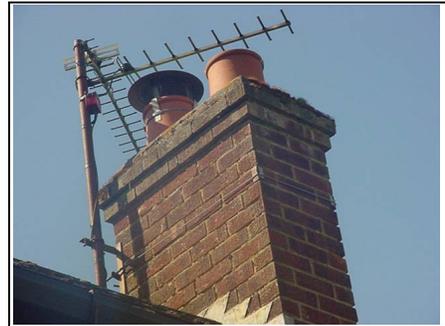
Middle chimney

This chimney is built in brick with a lead flashing and two chimney pots. From what we could see the chimney needs repointing and the flashing needs checking/repairing. We were unable to see the very top of the chimney know as the flaunching, we therefore cannot comment upon it.

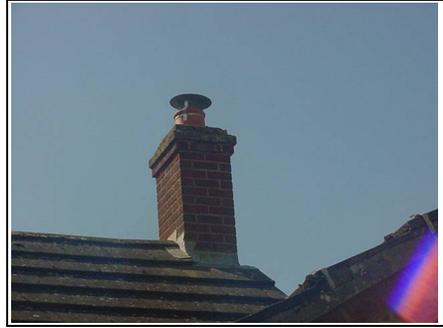
Right hand chimney

This chimney is brick finished with a lead flashing and one chimney pot. It looks to have been re-built, which is understandable as this chimney is to the older part of the structure. Unfortunately, again we were unable to see the flashing, we therefore cannot comment upon it.

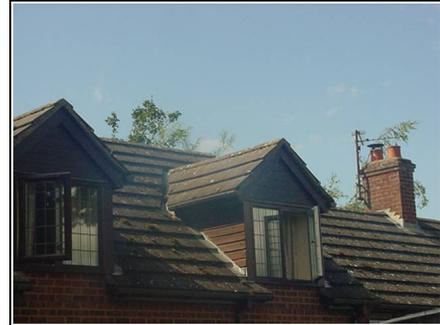
Dormer windows

There are two dormer windows to this property. They have been inspected from ground level. It has a large plain concrete tiled roof with shiplap boarding to the sides, which is in need of redecoration, and some lead flashings.

**ACTION REQUIRED:** Paint/stain fascias and soffits in the next three years. At the same time we suggest you re-do the dormer window shiplap boarding.

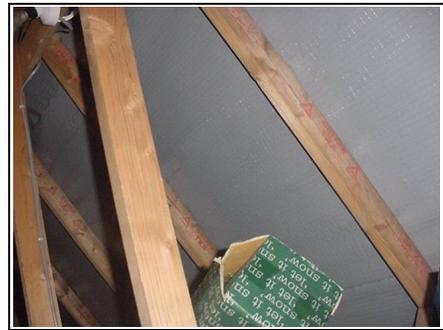
When we inspected the loft space we found a reinforced plastic protective underlayer. This type of underlayer was used in the 1970s/1980s and its use was generally stopped because it was susceptible to causing condensation unless the roofs are adequately vented, which they are usually not.

**ACTION REQUIRED:** We would recommend vents are added.

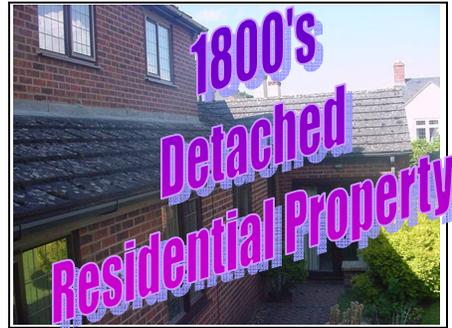
This roof is also pitched and clad in a large plain concrete tile. Again it suffers from moss.

There is moss growth present on all the roof slopes. This can, in extreme cases, impede the run-off of rainwater, lead to gutter blockages and cause water penetration, which, in turn, may lead to rot or other defects in nearby timbers. In this case the moss does seem to be causing a problem with the blockage of gutters.

**ACTION REQUIRED:** Clear all moss from the roofs, and remember this will be a yearly job, and then clear it from the gutters. We recommend that the moss is cleared with a soft brush rather than pressure hose, as this can take the surface of the concrete tiles off in some cases.

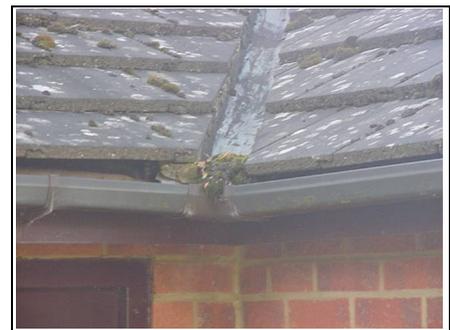
The valley gutter looks to have been tarred in the past (the black marks on it). This normally indicates that there have been leaks. Again, we also noted a built up of moss. This is a weak area.

blocked valley gutter,  
which has been tarred in the past

**ACTION REQUIRED:** We suggest you clear the valley gutter and check the condition of the lead and re-tar as necessary.

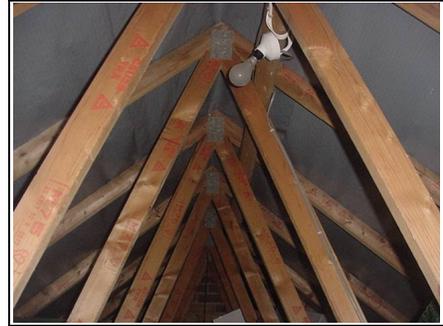
We have inspected the roof structure for serious active woodworm and for structurally significant defects to the timber together with dry rot and wet rot. Whilst our examination is restricted by the general configuration of the roof and the insulation and stored items, what we could see we found in generally average condition, with some minor condensation and staining.

**ACTION REQUIRED:** The only way to be 100 per cent certain is to have the roof cleared and checked. Add ventilation.

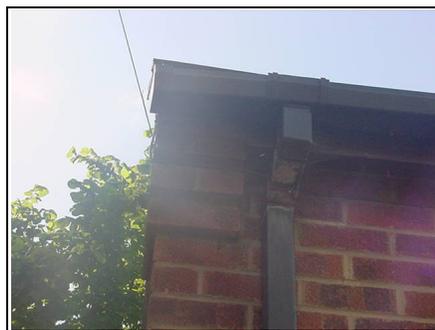
From ground level the gutters and downpipes looked to be what is known as profile plastic, which means the gutters and downpipes are shaped. There also look to have been minor leaks on the guttering, some of which have been sealed with a mastic. We think that most people could live with these minor leaks, however we think the main problem is with the gutters being blocked with the moss and various debris building up.

Leaking downpipe

**ACTION REQUIRED:** It is essential that you regularly clean the gutters and downpipes and also collect leaf debris and branches from the nearby trees. We would always recommend that the joints are checked and the alignment checked to ensure that the gutters fall towards the downpipes.

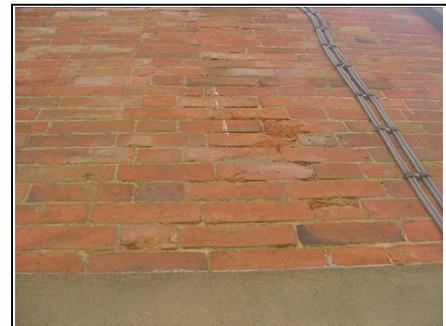
Older brickwork spalling

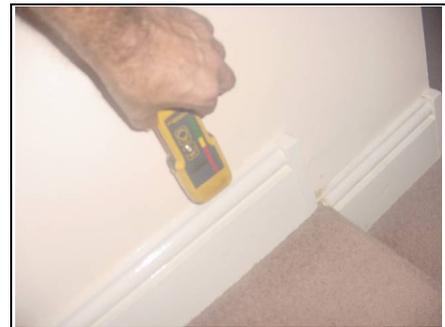
We have carried out tests with an electronic damp meter to a random selection of areas and we found rising damp.

Testing for rising damp

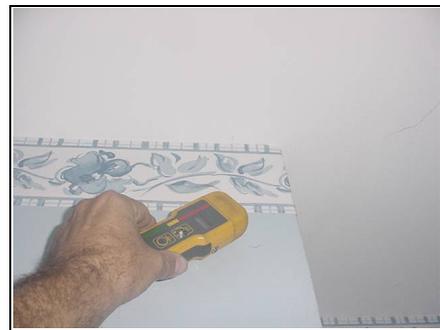
Tests were taken with a moisture meter at random points to internal walls, floors and other surfaces. We get high readings, in some areas due to walls on the ground floor being below ground level. Please see our comments in the Executive Summary.

Testing for lateral dampness

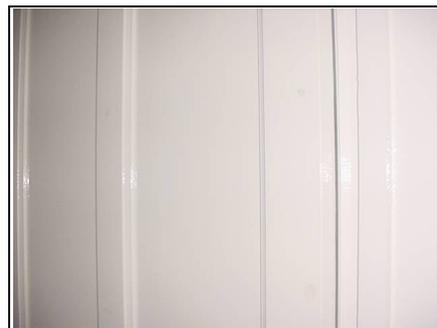
The property has traditional painted panel doors and, all things considered, they are in good condition and fit acceptably. We noted a glazed door in the middle reception room area. This should be safety glass and should be changed. We did not see any kite marks on the glass.

**ACTION REQUIRED:** Change glass in glazed door for safety glass.

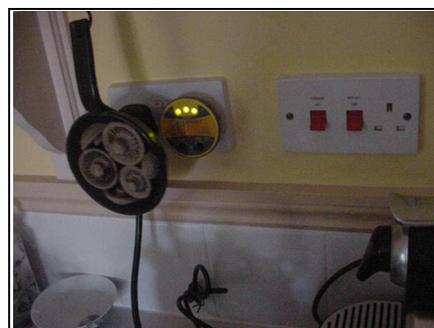
Earth test

We carried out an earth test in the kitchen area to the socket point that is normally used for the kettle and this caused the electrics to trip when we tested them for the second time, as you are aware because we were trying to put the electrics on when you arrived.

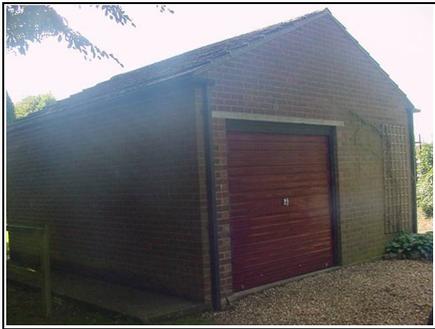
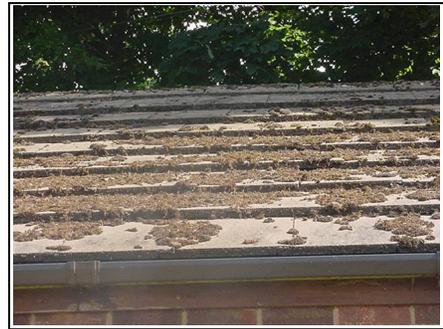
Garage roof

The property has a detached garage that we have not inspected internally. We noted externally that there is moss to the roof, as we would expect on a shallow pitched roof, that needs removing. We also noted the windows are not in the best condition and there was cracking around the lintel.

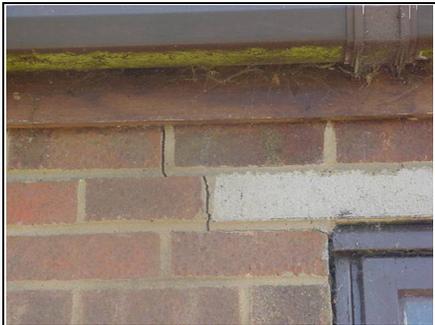
Cracking to garage wall

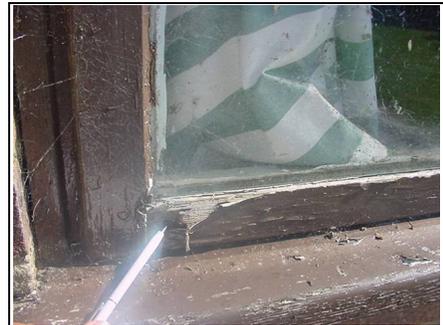
Rotten timber to garage window

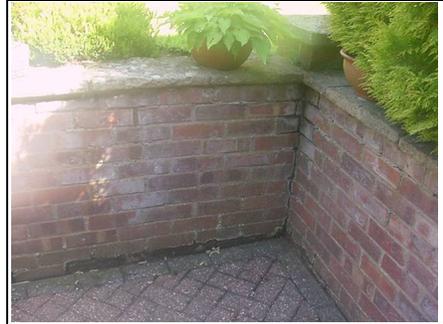
There was a small walled front garden. We noted the boundary wall did not have any weep holes. We would suggest these are added.

weep holes should be added  
to the garden wall
