# RESIDENTIAL BUILDING SURVEY

Hackney,  
London E5

Mr M and Ms H

INDEPENDENT CHARTERED SURVEYORS

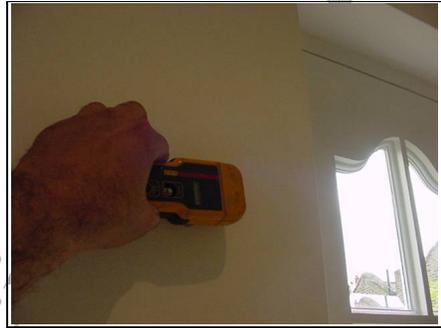
As the property is newly painted (painted to sell), from a visual inspection we were unable to confirm whether or not dampness was coming in however, using conductivity meters (damp meters) we established that there were higher readings than we would normally expect to the rear wall of the property. Unfortunately we were unable to gain access to the garden to view the property properly.

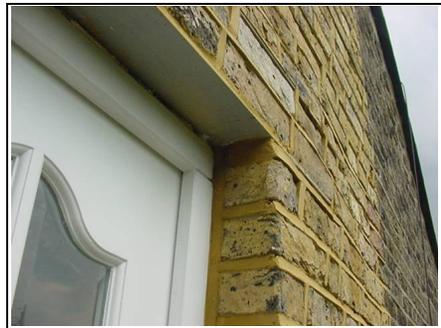
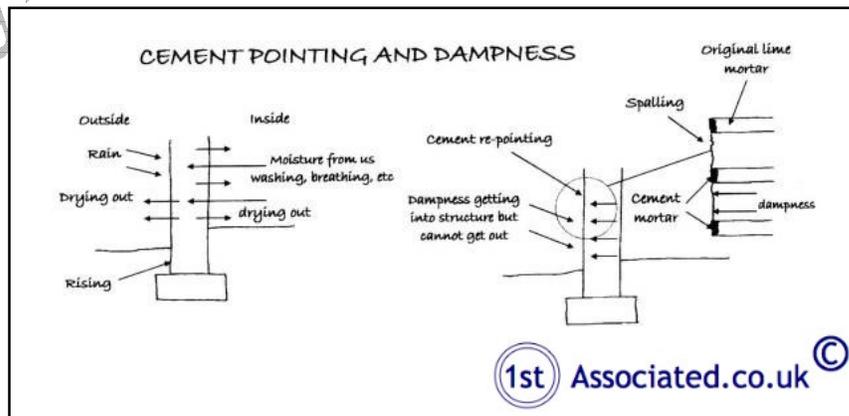
We have only been able to view this area out of the rear French doors and the Juliette balcony area. We can see that the area has been repointed in a cement mortar and proud pointed. This is not ideal. We would much prefer to see a lime based mortar on this age of property and flash pointing, although we do not see the lime mortar pointing on many buildings but do see the flash pointing on most buildings.

**ACTION REQUIRED:** We have already mentioned that the roof needs to be opened up. We believe that this would also help us to identify the problems in this area. We are aware that the owner / builder has already said that they have carried out some repointing however, we could not see any areas of repointing that were missing. It was the type of pointing that is the problem. Please see the sketch above.

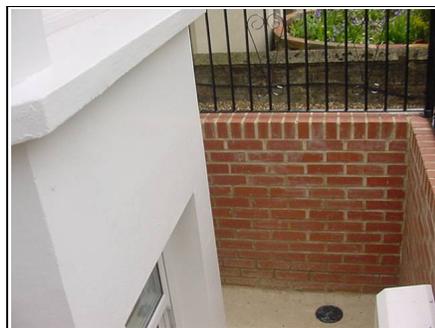
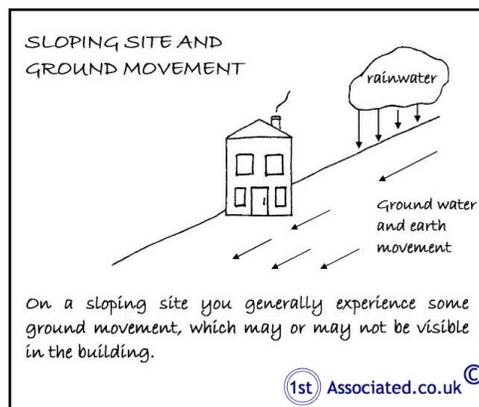
There is a Basement to the front of the property. We typically find that there are problems with dampness in these areas. Again as this is a leasehold / shared freehold property you would also have associated costs in relation to these. We would identify possible dampness as being something that may crop up in years to come. We also noted that the basement wall didn't have any weep holes in. These are to reduce pressure against the wall.

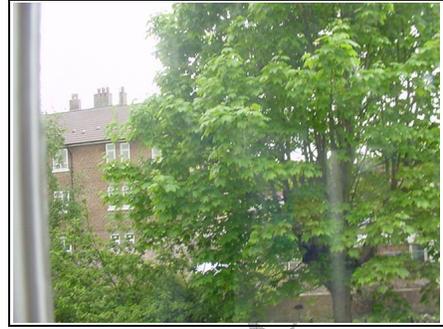
There is a large tree in the rear garden. This is the garden which the ground floor apartment has the use of. Whilst it is not in your garden, any damage it causes to the property will be a shared cost as we are advised that the property is a shared freehold / leasehold.

**ACTION REQUIRED:** You should speak to the owners of the ground floor apartment and advise them that the tree requires maintenance.

**ANTICIPATED COST:** In theory this should cost you a “share” of work carried out. We would expect therefore costs to be in the region of a few hundred pounds. Quotations are required.

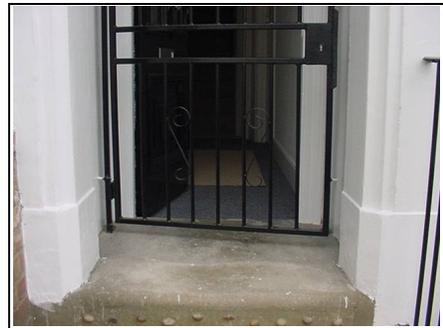
We would comment that while there is a metal door to the front of the property, you could nevertheless improve the locking system to your entrance door within the property and use a three lock system. We would also recommend putting a “London Bar” on the door.

**ACTION REQUIRED:** Purchase a better door and also use a “London Bar”.

**ANTICIPATED COST:** This would be in the region of £500 - £750 dependant upon the type of door used.

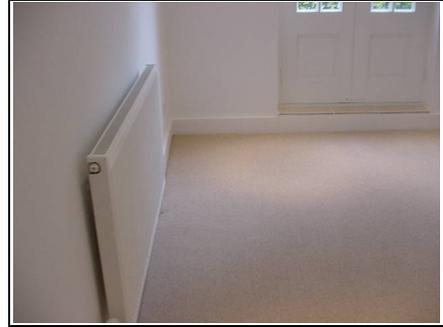
We have termed this property as being “painted to sell” and as such latent defects may be hidden that we were unable to see at the time of our inspection, for example we have identified some dampness to the rear of the property.

Property is “Painted to Sell”

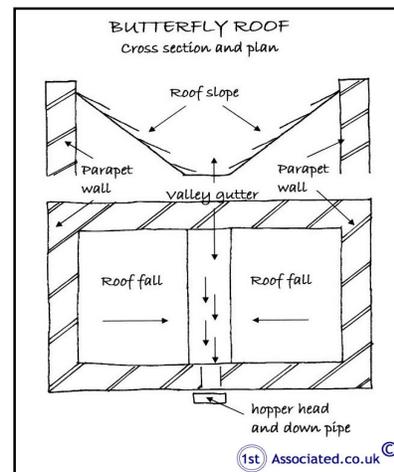
Unfortunately, we were unable to see the butterfly roof however, we can see that nearby roofs show the typical signs of roofs which have not been well maintained. Unfortunately in this instance there has been no opening up of the roof space so we are unable to confirm its condition.

**ACTION REQUIRED:** Ideally the ceilings need to be opened up checking the condition of the roof timbers and the roof above, unless the present owners can provide photographic evidence as to the roof condition. Alternatively you could access the roof using a Cherry Picker or some similar lifting device.

Either way we do recommend that the roof structure is opened up in order to view the timbers within it.

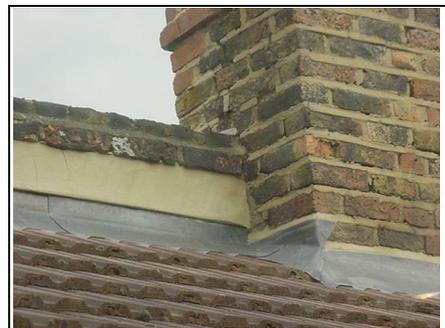
### Chimney Two

This chimney is built in brick with one chimney pot and one vented chimney on your side. From what we could see the chimney needs repointing and the flashing needs checking/ replacing. We were unable to see the very top of the chimney know as the flaunching, we therefore cannot comment upon it.

**ANTICIPATED COSTS:** Again this is likely to be costly due to scaffolding. The sum of £2,000 to £3,000 is inclusive of both chimneys, but you will of course need quotations, as scaffolding can vary in price. We would also add as mentioned, that we need to get into the roof space to see the condition of the chimney beneath.

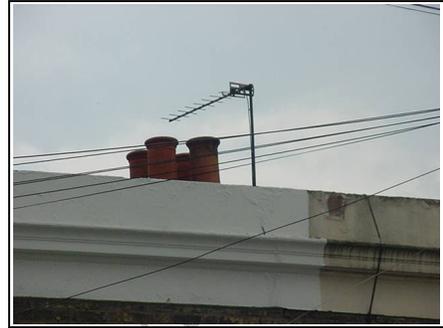
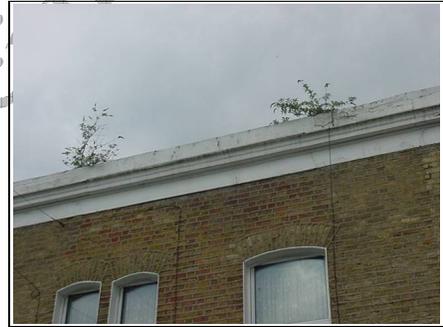
It was fashionable in Georgian properties of this period to not wish to show the roofs or the gutters and downpipes. We cannot see any repairs which have been carried out. Therefore this parapet may deteriorate quite quickly. If you look to adjoining properties you can see the sort of thing which happens to them.

Adjoining properties with plants literally growing out of the roof!

**ACTION REQUIRED:** A close up inspection of the parapet wall needs to be carried out on both sides; therefore we do need to gain access to the roof.

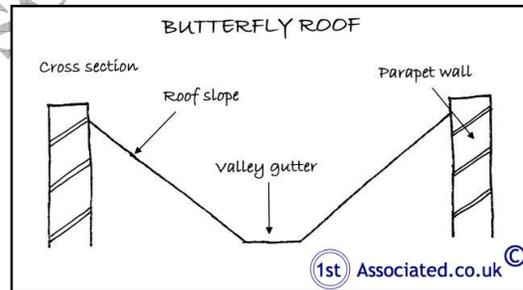
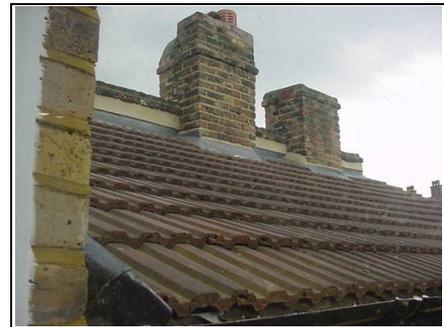
As previously mentioned, this is a butterfly roof, also sometimes known as a London Roof. Unfortunately we could not see the main roof properly. We have made an educated guess based upon our general knowledge of this type of construction. We would comment that, typically, this type of roof would have originally had a slate covering; these can be replaced over the years with a heavy concrete tile or they can be repaired. We simply do not know without accessing the roof, equally it is very common for the valley gutter which is central, to leak and rot the spine beam which is beneath it. It would be a fair comment to term these roofs generally as problematic.

**ACTION REQUIRED:** As mentioned several times, we need to be able to access the roof void and the roof itself.

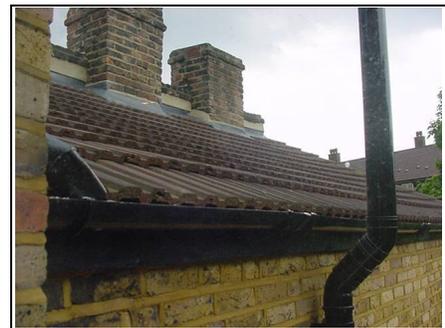
The rear roof is a pitched roof and clad in a concrete tile. We would have liked to have seen this roof when it was raining as we think the concrete tiles are very close into the gutter and may cause the rainwater to miss the gutter.

**ACTION REQUIRED:** You will need to inspect this when it is next raining, to establish whether the gutters are catching the rain and add a wide flow gutter if they are indeed missing.

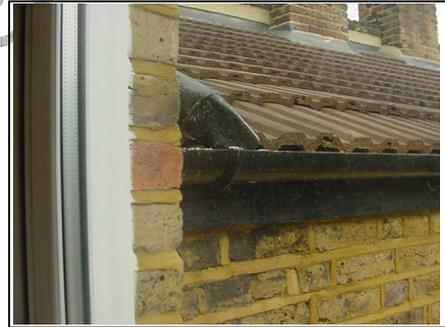
Gutters

Typically with a Butterfly roof you will have a hopper head and downpipes located to be rear. We often find problems with hopper heads overflowing and some leaks on down pipes particularly at high level, whilst in an ideal world these should be fixed, we find most people can live with them

**ACTION REQUIRED:** If this is indeed the way the water discharges, it looks likely that you will require larger guttering. We would always recommend that the gutters and downpipes are cleaned out, the joints are checked and the alignment checked to ensure that the gutters fall towards the downpipes.

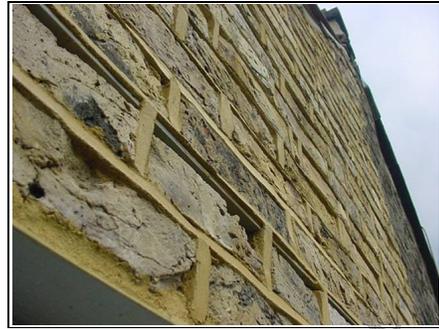
Pointing to the front brickwork

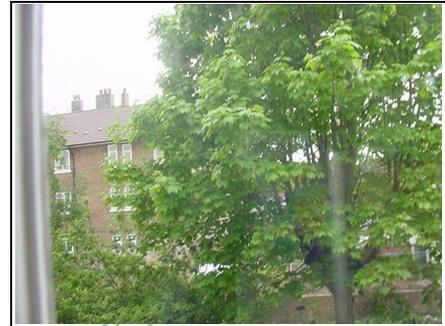
Damage to foundations and underground services can be caused by trees and shrubs. There is a tree to the rear of the garden. This is within what is known as influencing distance and we believe that this tree may ultimately affect the property if not properly maintained. Properties with trees nearby will always be susceptible to movement

Tree to the rear of the Property

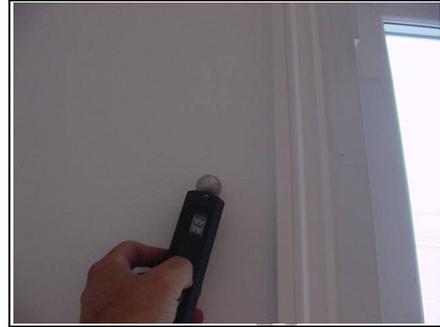
Tests were taken with a moisture meter at random points to external walls. We were getting high readings to the rear of the property. We believe that this may be a problem with either the pointing of the roof itself but as we have been unable to see the rear of the property it is difficult to comment further.

**ACTION REQUIRED:** Please see our comments in the executive summary

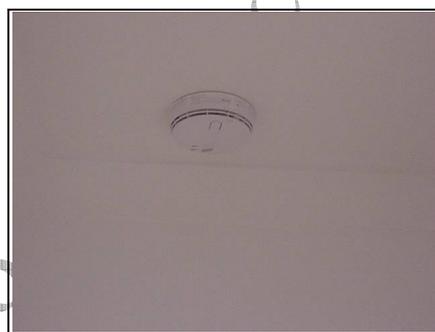
Some battery operated smoke detectors were noted. The current Building Regulations require that they be wired into the main power supply. (this means you no longer have to remember to change the batteries). We like to see systems which identify where the first is, as this gives you the best chance of escaping the property.

**ACTION REQUIRED:** You need to check and confirm that the system which you have is “hard wired” in or if it is batteries you should ensure that you test and change them if necessary.

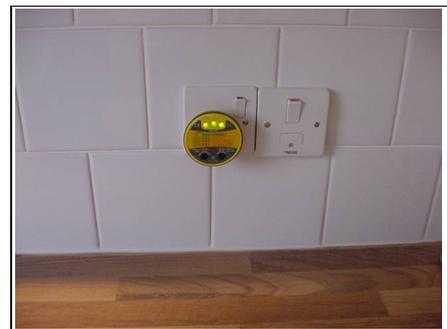
Earth Test

We carried out an earth test in the kitchen area to the socket point that is normally used for the kettle and this proved satisfactory.

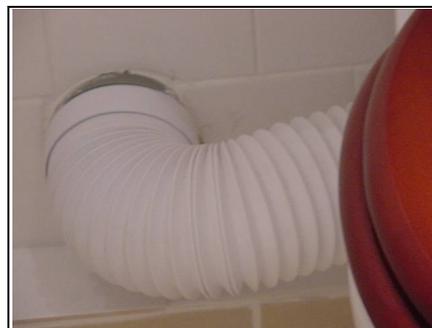
The property has a three piece bathroom suite, which looks in an “as new” condition. There is an unusual concertinaed waste pipe that we have not come across before. We would like the builder to confirm that all work has been carried out to building regulations. As mentioned, the bathroom is internal and therefore may suffer from condensation, even with an extract fan.
