# RESIDENTIAL BUILDING SURVEY

Harrow, Middlesex HA1

FOR  
**Mrs H**

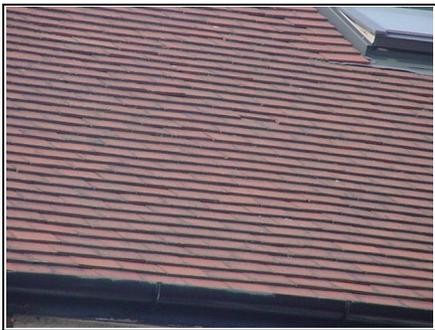
The main roof has the original clay tiles. There is no protective underlayer (often known as a sarking felt). This means that wind driven rain may well get into the roof.

We would make a more general comment that we can see that there has been damage to the roof tiles on the front right hand side of the property and also to the verge.

Clay tiles to main roof

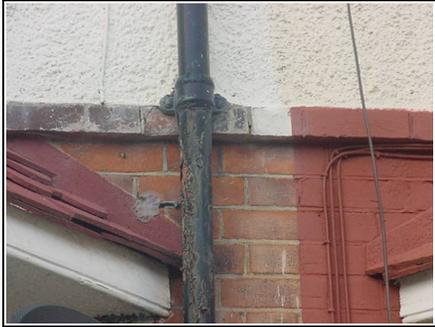
You have some cast iron that is in poor condition and in need of repair and redecoration or replacement. Equally, the plastic can be seen to be leaking and again will need repairing or replacing. Once these are repaired you can repair the fascias and soffits.

Cast iron rusting to the front of the property

**ACTION REQUIRED:** Repair and/or replace cast iron and plastic as necessary.

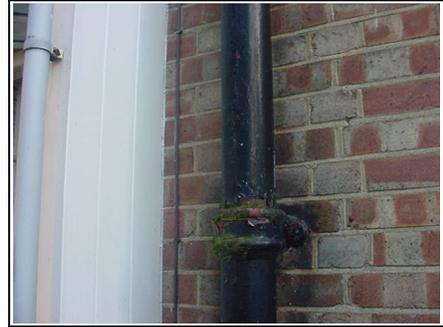
Rusting soil and vent pipe

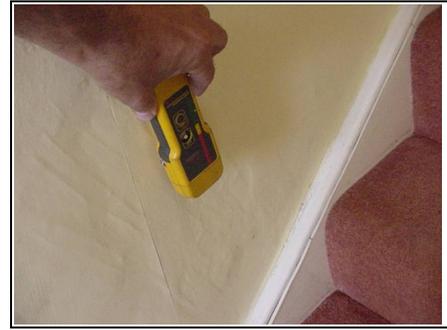
Blown plaster

**ACTION REQUIRED:** This is very difficult to resolve. You need to check periodically that the pointing is in good condition. You may need to carry out some re-plastering when carrying out redecoration work.

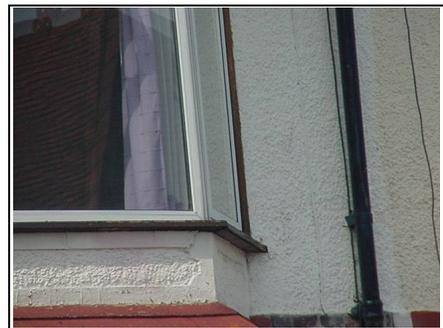
Double glazed metal windows were very popular in the 1960's/1970's and to some extent the 1980's. However, we would say they have been superseded by timber or plastic double glazed windows. The main problem with metal windows that we have come across is that they can cause condensation.

Aluminium windows

**ACTION REQUIRED:** You need to consider replacing these.

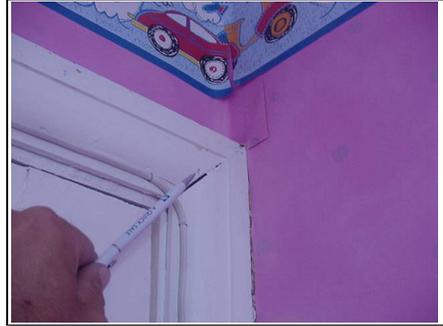
There has been some movement in the property, although we believe it to be historic. We can see there is a twist to the stairs and there are also some areas that do not fit properly in the way the doors close. We believe this properly occurred when the roof work was carried out, with the change of the distribution of loading with the metal “I” beams being added to give support to the top floor and this weight being transferred down through the structure.

Movement visible

Although we would equally add that in this age of property it could also be leaking drainage, which we have not been able to identify any manholes for, which sometimes occurs in this age of property, as does minor settlement taking place from leaking drains over many years.

**ACTION REQUIRED:** Ideally we would recommend a closed circuit TV camera report of the drains to check and establish their condition. Also there should be a manhole. Please ask the existing owners, although they are not aware of any to the rear of the property from our discussions during our question and answer session.

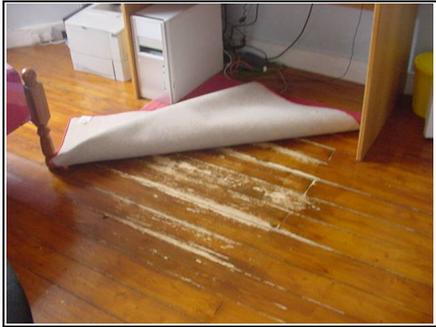
We noticed it has been cross-floor boarded to the front and rear first floor bedrooms. We find this will mean that floorboards have been put on top of the original boards, which we rarely come across, as normally the original boards are either sanded and made good or they are replaced completely, but not floorboards placed on top of floorboards.

Cross floorboarding

**ACTION REQUIRED:** You really need to consider this as a characteristic of the property and ensure that it is acceptable for you to live with this. Deflection may also relate to a removal of a wall, which in turn goes further to explain the movement that we could see within the structure noted earlier.

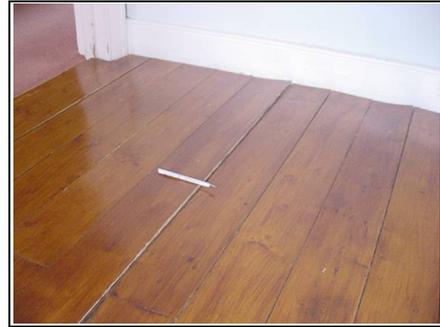
Cross boarding and the timbers cupping

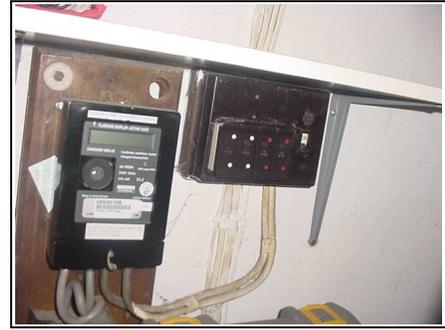
Fuseboard

**ACTION REQUIRED:** Replace the fuseboard and have an Institute of Electrical Engineers test and report carried out by an NICEIC registered and approved electrical contractor.

**ANTICIPATED COST:** In the region of £300 to £400; please obtain quotes. We would also expect the electrician to require replacement of some wiring and for your benefit we would also recommend adding additional electric points.

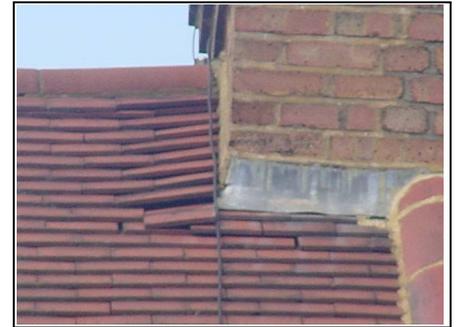
Close up showing the cement flashing to left hand side and lead underneath and displaced tile

**ACTION REQUIRED:** We would like to view the chimney close up from the flat roof when the opening has been added, as we have recommended. Cement flashings are notorious for leaking as they are brittle and crack. There are also some tiles displaced around the chimney which is another reason we would like to inspect it close up.

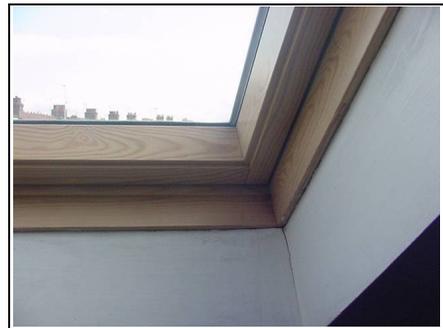
The property has one roof window to the front of the property. It is purpose made with metal externally and timber internally. There are no visual signs of major staining to the timber. We would add that it seems inevitable with roof windows that they will sooner or later leak. If this doesn't occur then they seem prone to condensation. Keep a cloth handy!

Roof light showing no signs of leaking internally

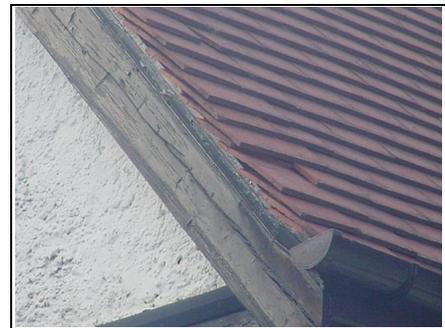
There are tiles missing to the gable end. The tiles to the front look like they have been caught by the wind. You may be able to mend the bargeboard detail to protect the tiles or add a cement fillet.

Tiles missing to gable end

**ACTION REQUIRED:** We recommend that general work to the roof and specifically to the valley gutters at the gable end is carried out by the summer of 2012.

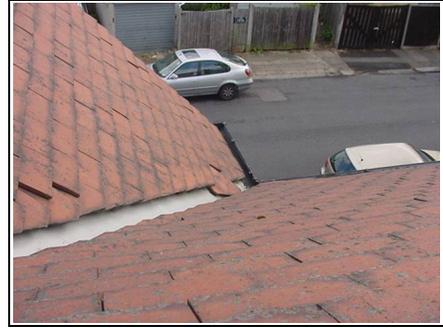
There are valley gutters to the front of the property. The valley gutters are formed in lead, we can see that some of the cement is coming away and some tiles are loose in the area.

This photo shows a tile missing to the edge and shows that the edge needs finishing in cement and in lead valley gutter cement is coming out of it.

**ACTION REQUIRED:** Ideally repairs are required.

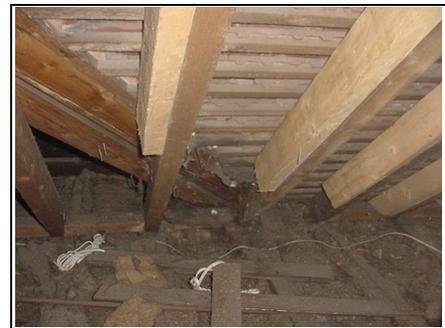
When we inspected the loft space we found there was no underfelt and it is therefore possible that during periods of heavy and prolonged driving rain some water penetration could take place through the roof coverings.

Lack of sarking felt

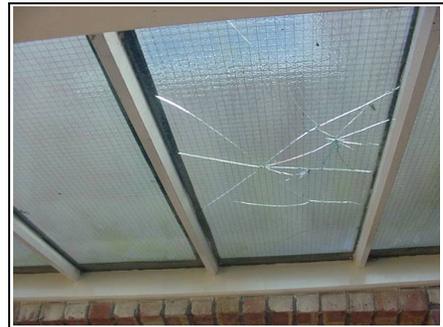
There is a low level glazed area which has Georgian wired polished plate glass. We note that one of these is broken and needs replacing. This gives a good covered sitting out area to the rear which is protected from the rain.

Broken pane

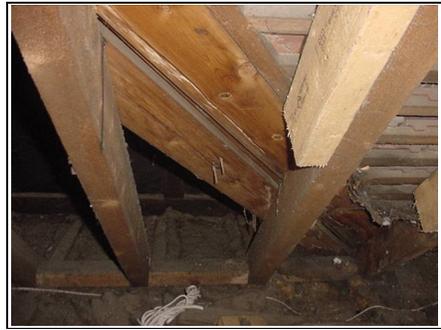
We were also able to see the base of the valley gutter. Here there is some staining, which leads us to believe dampness is getting in.

Base of valley gutter

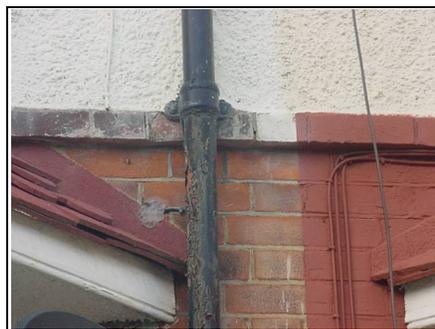
The property has a mixture of the original cast iron gutters and down pipes and the more modern replacement plastic gutters and downpipes. What we saw of the gutters and downpipes were mainly in below average to poor condition and therefore they are causing deterioration to the property.

Old cast iron downpipe

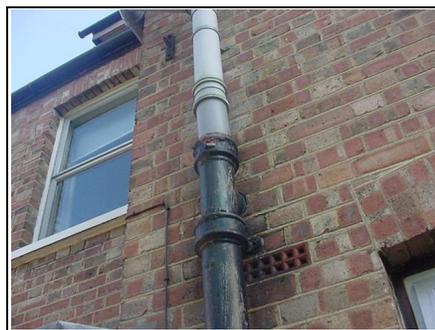
The soil and vent pipes are a mix of cast iron and plastic, they appear to be leaking from our visual inspection.

Soil and vent pipe

**ACTION REQUIRED:** You need to decide whether to maintain the existing system or replace with it with plastic.

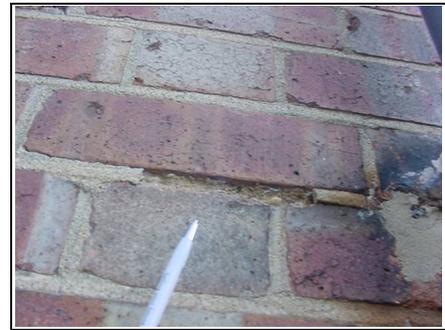
Original lime mortar repointed in cement mortar which needs

**ACTION REQUIRED:** Careful repointing is need, removing the cement mortar with a soft brush where it is loose and repointing in a lime mortar. This can be carried out over a number of years, gradually returning the brickwork back to its original characteristics, where although it gets damp it does then dissipate the dampness through the brickwork.

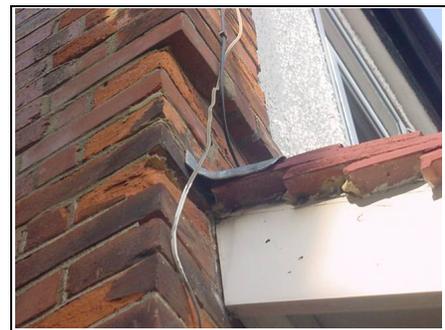
Soft red brick deteriorating due to cement mortar and also lack of sunlight in the area

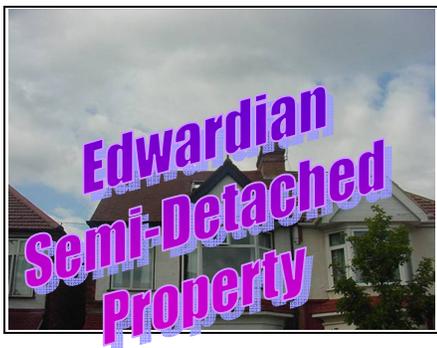
The top of the walls to this property are finished in a pebbledash painted render. The walls are in average to slightly below condition. We suspect this is due to the leaking of the gutters and downpipes.

Pebbledash render to first floor

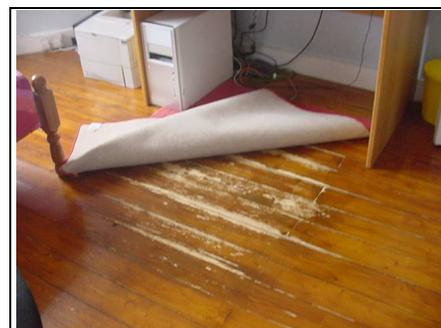
Wear to floor in front bed

We have comment about the deflection within the front first floor room. This is above what we would expect and may be due to some dampness getting into the embedded timbers.

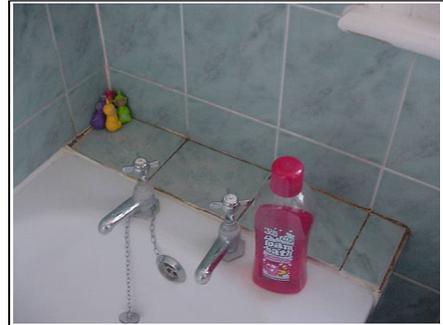
Mould in bathroom

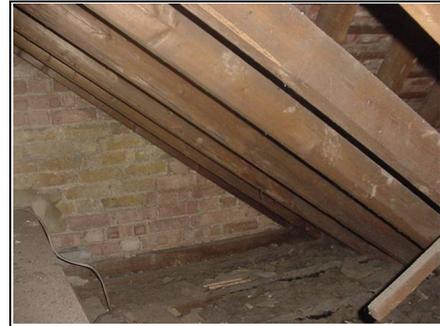
Possible woodworm?

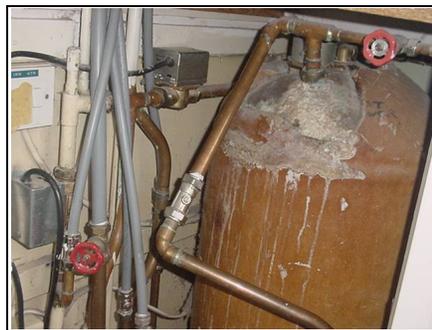
Hot water cylinder has seen better days

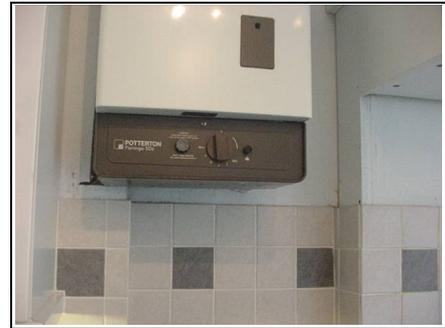
Old Potterton boiler

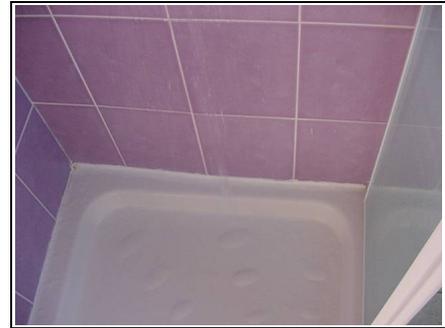
Shower looks to have previously leaked and has been re-masticed
