# RESIDENTIAL BUILDING SURVEY

**Heath and Reach,  
Nr Leighton Buzzard,  
Bedfordshire,  
LU7**

**Mrs A**

**INDEPENDENT CHARTERED SURVEYORS**

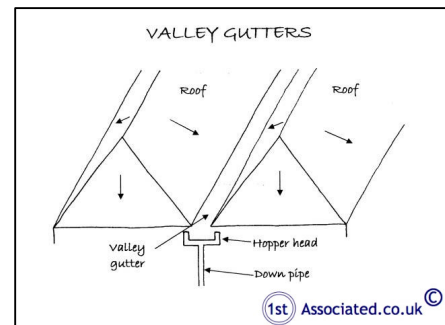
Valley gutters

The property has hidden valley gutters which can cause problems. We have not been able to view or access them but from our general knowledge of this type of construction they do tend to block.

**ACTION REQUIRED:** We recommend a roof window is added to the main roof to allow viewing and access to the valley gutters for maintenance.

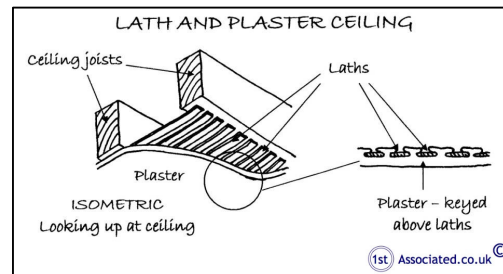
We could see within the roof and also from the undulations within the ceilings that the lath and plaster may have lost its key in some areas.

**ACTION REQUIRED:** It is very difficult to comment upon what to do with the ceiling as it has lost its key, which means you are likely to have to replace the ceiling almost any time these ceilings give way without warning, particularly given the high moisture levels that we found in the property (often the case where a young child, as in this case, lives in the house).

**ANTICIPATED COST:** In the region of £5,000 top £10,000 to replace the ceiling and approximately a few hundred pounds to add caps to the electric lights. Please obtain quotations.

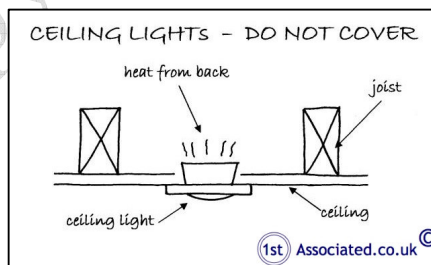
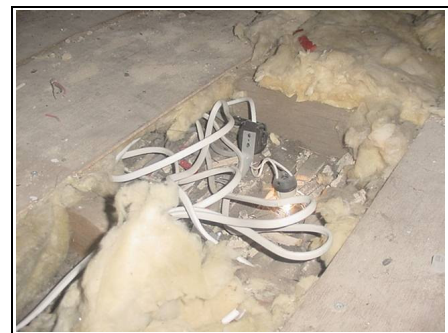
In addition to this, we noticed that there are no caps on the lights which is a fire hazard.

Exposed electric wires  
– no caps on lights

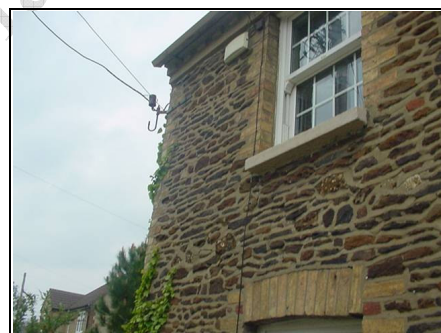
The walls are constructed of a sandstone, which is reasonably common in the area with older properties. The sandstone to the front of the property where it is exposed has been wrongly repointed in cement mortar and therefore is deteriorating and ideally needs to be repointed in a lime mortar.

Sandstone to the front of the property

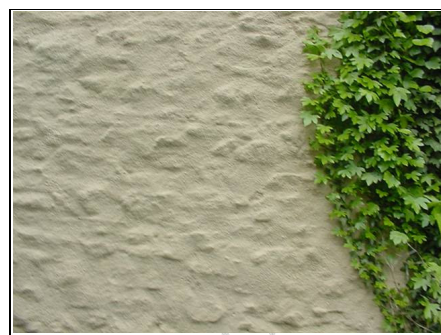
The property has had a plastic type paint sprayed on to it over some of the sandstone. This type of wall needs to breathe and without this deterioration can be caused and dampness.

Painted sandstone

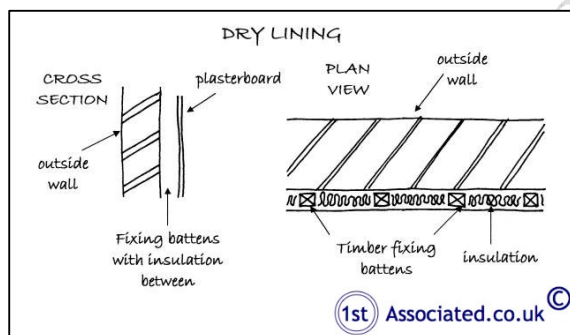
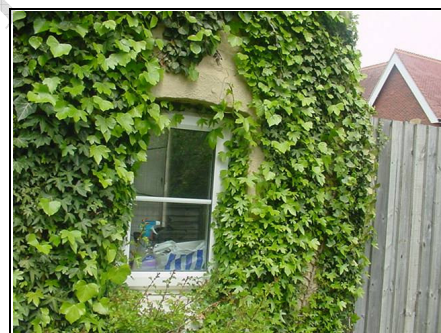
In addition to this you have plants growing on the property which can add further to the dampness. The only reason we are not getting a lot of dampness readings inside is due to the dry lining.

Ivy on left hand side of property

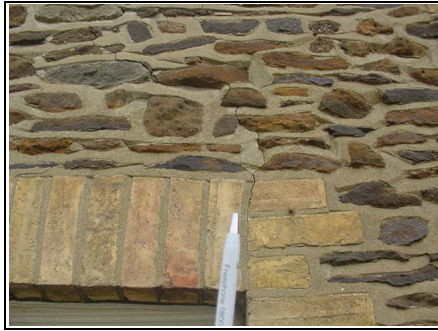
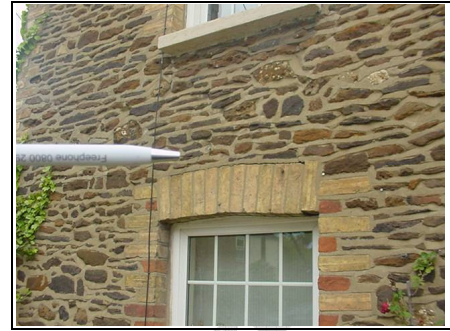
We can see cracks throughout the property indicating that there is movement. We think this relates to the defects in the roof we have mentioned and is not helped by the poor condition of the outer walls, as mentioned previously.

Crack to front of property

**ACTION REQUIRED:** Existing owners to put in an insurance claim with regard to the movement and this to be obtained in writing and taken on by yourselves if you purchase the property, which we recommend against.

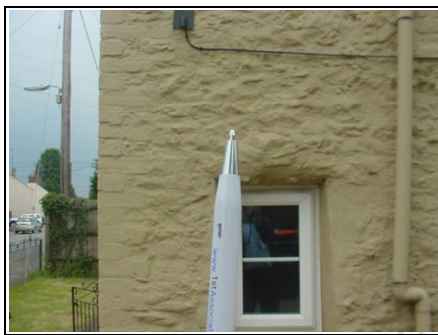
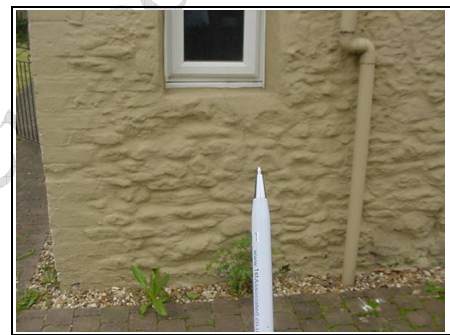
Crack on right hand gable

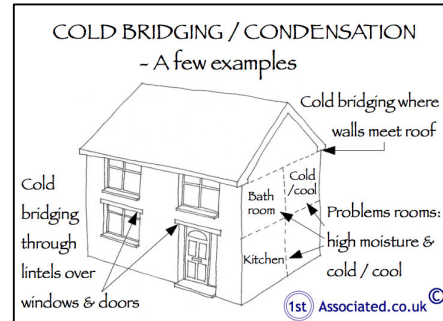
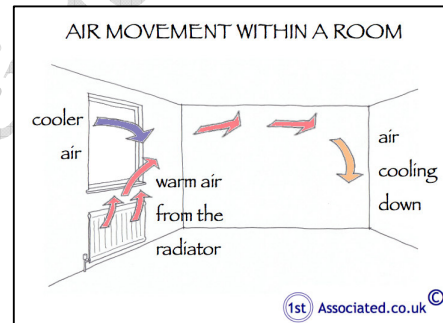
4. ineffective extract fans to the bathroom and shower room.

**ACTION REQUIRED:** We recommend adding extract fans that are humidity controlled to the bathroom, shower room and kitchen and we would recommend changing all the radiators so they are underneath the windows, however you do have to realise that condensation and cold bridging are a characteristic of this era of property. Please see our Cold Bridging article in the Appendices

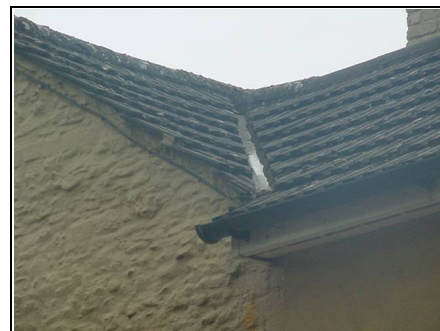
Other valley gutter to rear

**ACTION REQUIRED:** Please see our comments in the Executive Summary where we recommend roof windows are added to allow the viewing of the condition of the valley gutters.

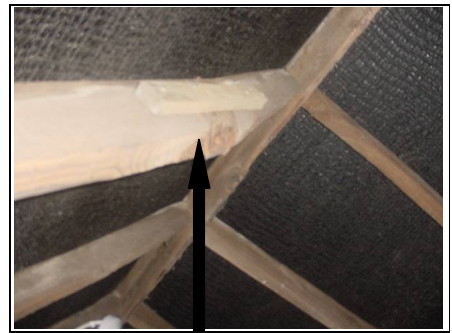
Common rafter broken and has been patch repaired

**ACTION REQUIRED:** We would refer you to our comments in the Executive Summary – these roofs are in poor condition. Ideally we would recommend the entirety of the concrete roof is removed, the timbers are checked and replaced and repaired as necessary and a new lightweight roof is put on, such as a slate roof or manmade slate roof.

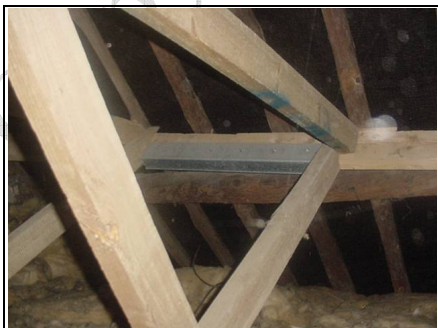
There have been replacement cut timbers added over the years, together with structural supports added to the right hand roof.

Right hand side roof  
– structural supports

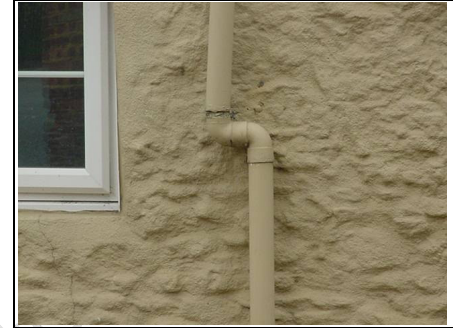
This property has been amended and extended over the years and little thought has been given to the gutters and downpipes. We mentioned in the Executive Summary about the metal gutter to the front with the small downpipe, there are also awkward 90° joints to the downpipes and there are also the awkward valley gutters to the roofs.

90° awkward joint on downpipe

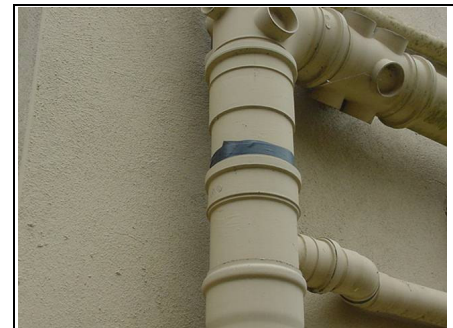
The soil and vent pipes are plastic and have been amended and altered over the years. To the rear of the property we can see what looks like repairs with black tape (see photo), although nothing leaked out of them when we flushed the WC, etc.

Plastic soil and vent pipe

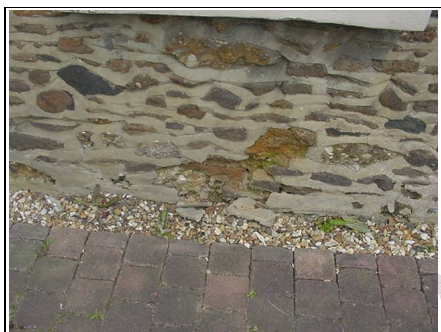
The sandstone has been wrongly repointed in a cement mortar and needs to be repointed in a lime based mortar. This is causing dampness and deterioration to the stonework.

Sandstone wrongly repointed in cement mortar

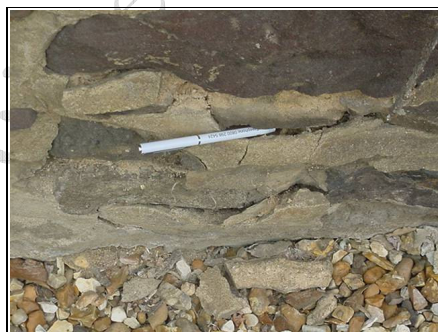
Pen indicates where cement mortar is breaking away

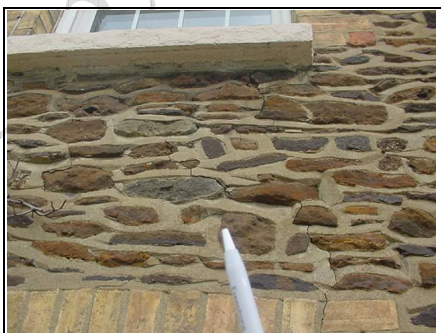
Cracks to front of property

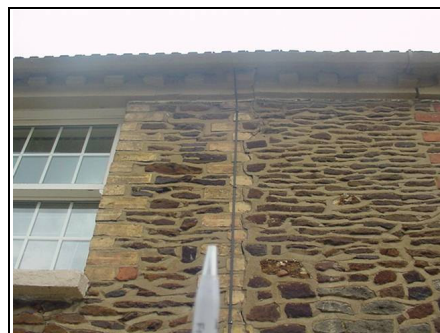
Splitting of the two cottages

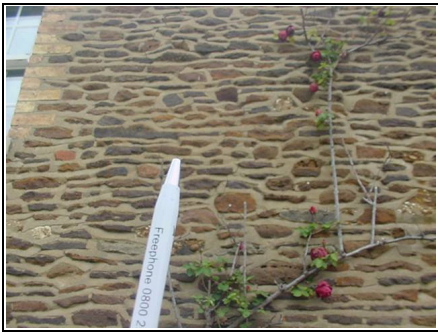
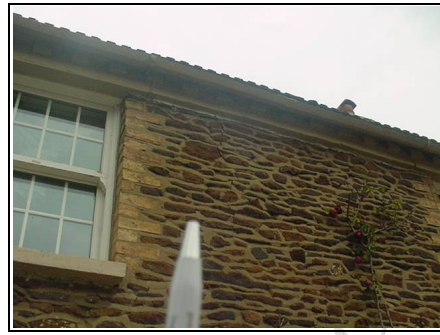
Cracks to front of property

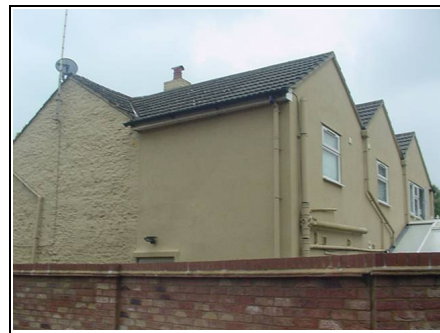
There is render to the right hand side and rear of the property. This is a modern cement render which is not ideal for an older property and will tend to crack and you need to ensure that these cracks are sealed.

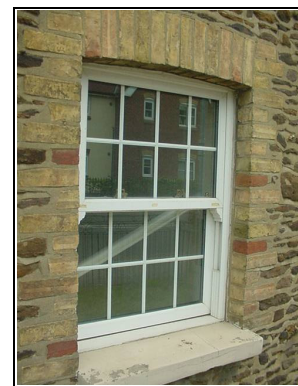
The property has plastic double glazed windows with some trickle vents, which generally look to be of a average quality for their age, type and style, however many surveyors will argue that as they have not got trickle vents they are in below average condition, and they are certainly causing argument with regard to ventilation of the property and condensation..

Window without trickle vent

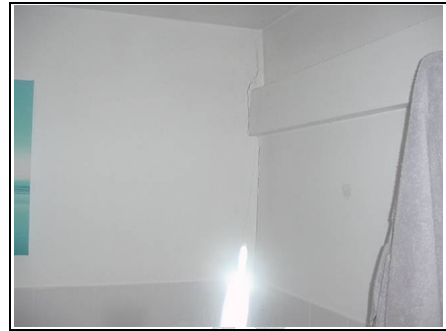
Crack in bathroom wall

**ACTION REQUIRED:** Please see our comments in the Executive Summary.

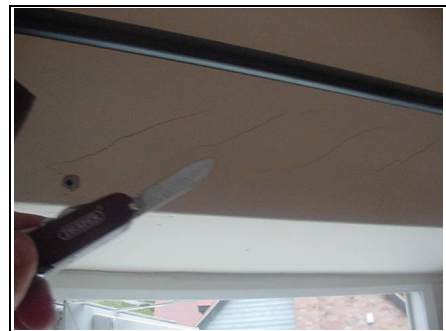
Crack over window in master bedroom

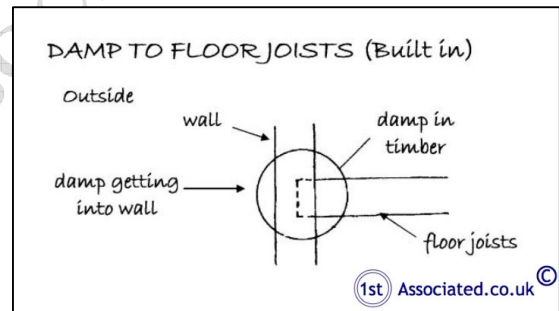
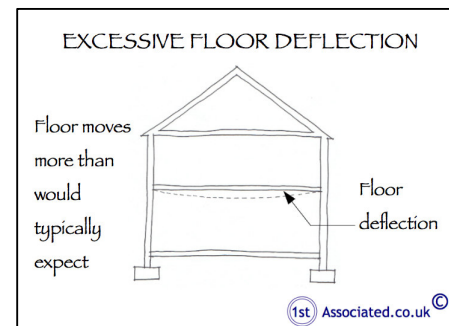
The first floor deflected much more than we are happy with. We believe this is due to embedded timbers and, given the deflection in the floor we feel, the smaller timbers used than we normally come across and / or the embedded timbers are getting damp and deteriorating.

In addition to this, it should be appreciated that the floor timbers help give lateral restraint to the property and as these have deteriorated this can contribute towards bellying in a property, together with the cracking on the front of the property with the heavier roof and the lack of lateral resistance from the floor is part of the reason why the property is moving.

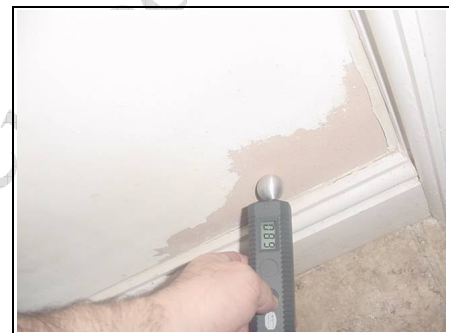
A random visual inspection and tests with a moisture meter have been taken to the perimeter walls. In this particular case we have found rising damp.

Checking for rising damp  
in the kitchen

**ACTION REQUIRED:** Please see the Executive Summary.

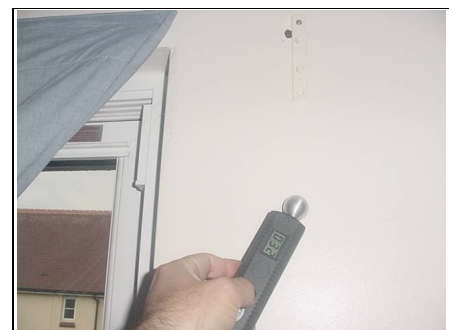
We would have found dampness but the property is dry lined so we were unable to test for lateral dampness in most areas.

Trying to test for lateral dampness

**ACTION REQUIRED:** Please see our comments in the Executive Summary.

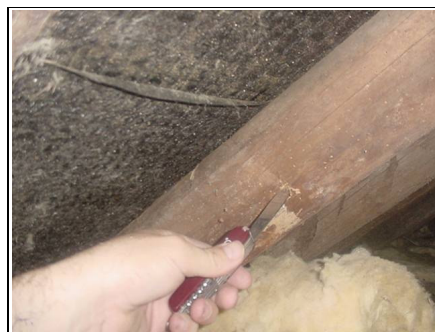
The roof is the main area that we look for woodworm. Within the roof we found visual signs of woodworm activity or indeed signs of past woodworm activity that has caused what we would term 'structurally significant' damage. In many properties there is an element of woodworm that is not active. Our inspection is usually restricted by insulation covering some of the timbers and general

Woodworm in timber 57
