RESIDENTIAL BUILDING SURVEY
OF
A 1960's Detached Property, Hemel Hempstead,
Hertfordshire

FOR
Mr M

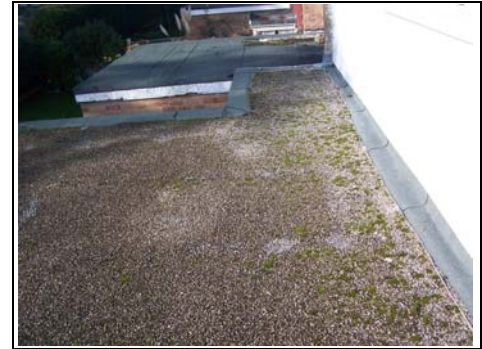
To the front of the property is a very large flat roof. We could see moss on it, which does indicate that water sits on it when it rains. We could not see any real fall on the roof, which does tend to cause problems with water sitting, which eventually gets in.

General view across the front of the roof

ACTION REQUIRED: Ideally the roof should be re-laid to a fall; the best way we have found to do this is to use a product, which is an insulation cut to a fall and then a high performance felt over the top of it.

ANTICIPATED COSTS: For this sized roof we would expect costs to be in the region of £5,000 - £7,500 (estimates required), depending upon how much work is required to the decking. However, we would stress that this roof has a fair amount of life left in it providing you keep it regularly maintained.

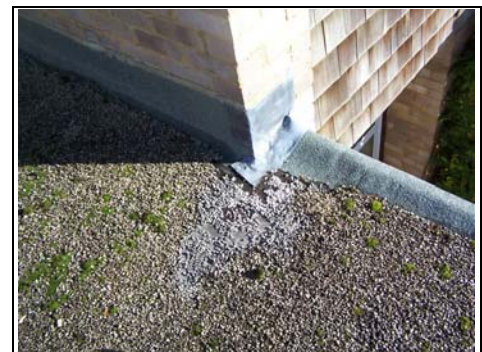
Looking at the felt flashings, we would prefer these to be replaced with lead flashings. These are likely to need some work in the near future.

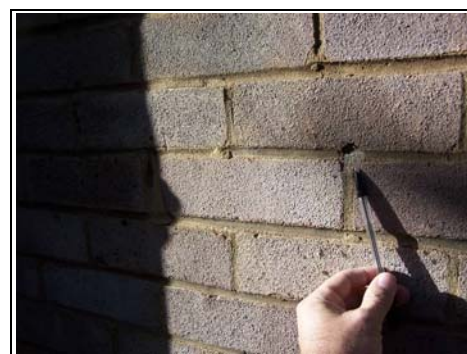
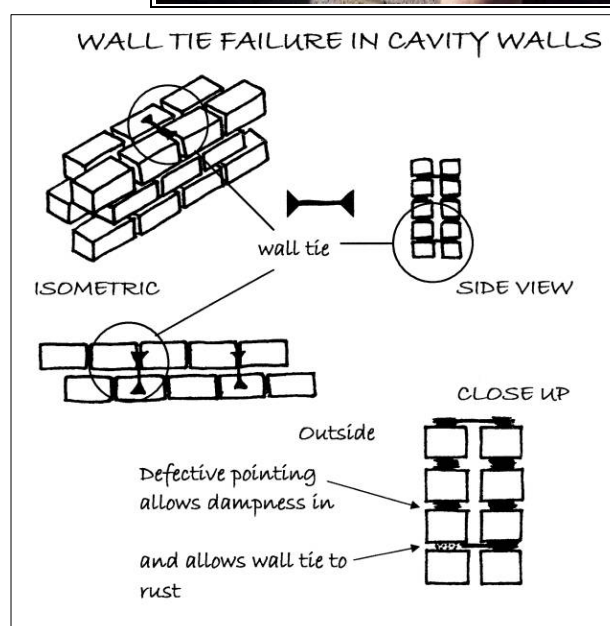
To the brickwork we could see circular marks where cement has been filled in mainly on the mortar joints. This usually indicates that either an insulation has been added or wall ties have been replaced.

In either case we need to know more information from your Legal Advisor. The problem with insulation being added after is that it is often added and voids are present and / or it settles. Both ways you have what is known as ‘cold bridging’ which can lead to dampness getting in the property. Generally we would not recommend this type of treatment to a property.

ACTION REQUIRED: Your Legal Advisor to make further enquiries and to advise us with regard to this matter so we can comment further. We would add that there were no obvious visual signs of wall tie failure; these typically are horizontal cracking to the brickwork.

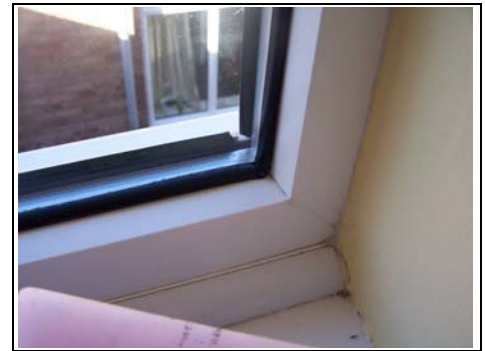
We noted that the seals around the windows to the double glazing has been cut short in many instances; this in turn leads to the double glazing failing earlier than would normally be expected.

The trim has been cut too short.

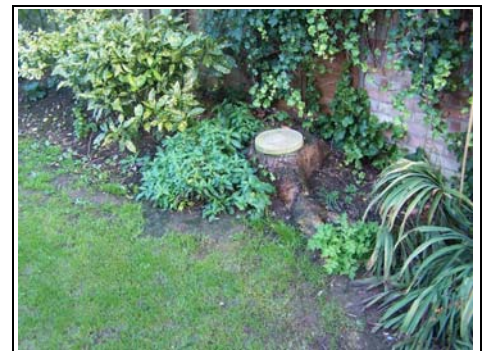
Cut down Tree.

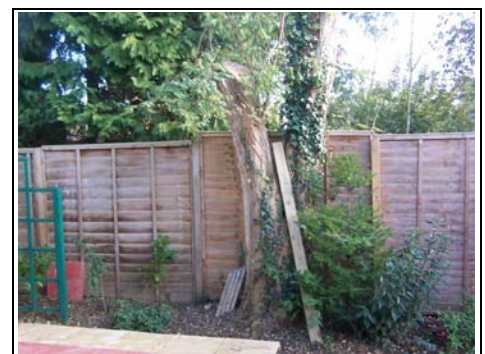
Halved Tree.

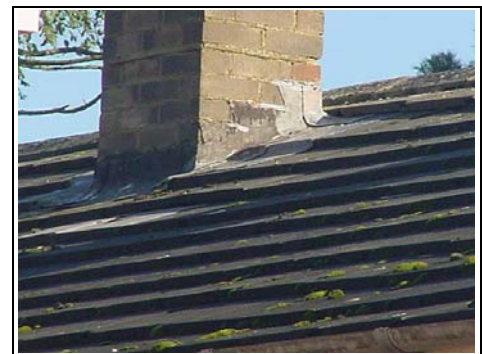
The flashing looks to need repair / replacement.

ACTION REQUIRED: Carry out repointing, as soon as possible, Check flashing immediately. And replace with lead in the long term.

ANTICIPATED COSTS: £500 - £1,000, depending upon whether access can be gained with or without scaffolding.

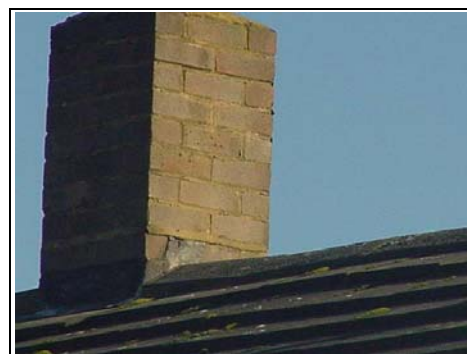
Close up view

We could see that repairs have been carried to the inside of the roof, but it does look like from this chimney and the previous chimney that your flashings are from the weakness in the construction.

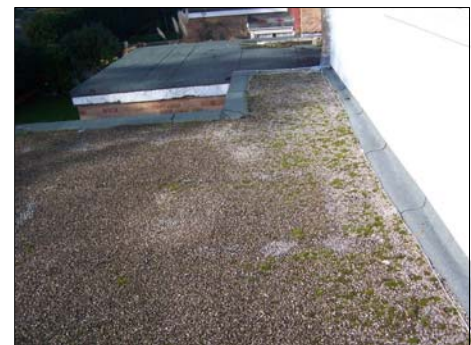
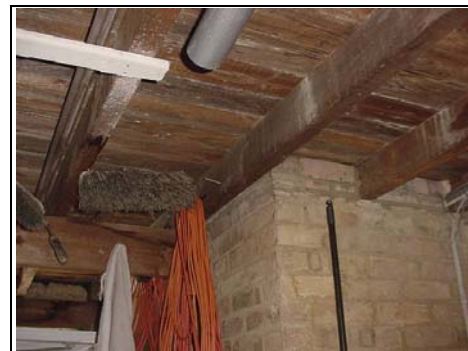
We noted on the underside of the flat roof some water staining indicating that dampness is getting through. This is okay to some extent in the garage area but not if / when it gets into the kitchen area.

The underside of the flat roof.

ACTION REQUIRED: Budget for a new roof.

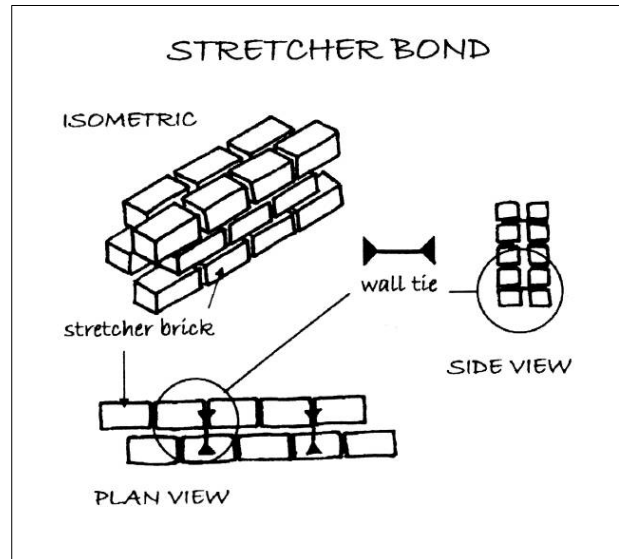
Circular Holes

Circular holes / mortar indicate that either insulation has been added, which is what the owner advised, or wall tie repairs have taken place.

ACTION REQUIRED: In both cases your Legal Advisor needs to investigate further and advise us of any findings as soon as possible (before you legally commit to purchasing the property).

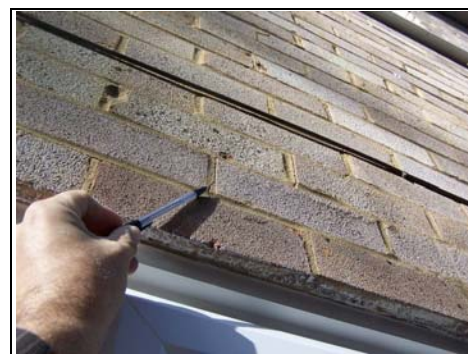
There is hairline cracking above the window from the lounge. This may be due to the size of the window and the window directly above it.

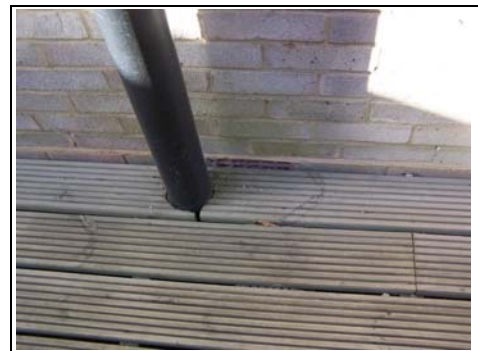
Airbrick, hidden behind the pipe.

ACTION REQUIRED: The airbricks need opening up. Please see our comments in the Executive Summary.

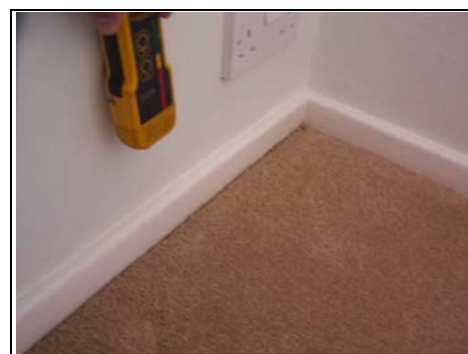
No evidence of any significant rising dampness was detected in the random areas checked. It is not unusual in this type of property for some minor dampness caused by the fall towards the house at the front and often also caused by raised levels of earth around the property. In this instance we think also that the decking may cause future issues.

ACTION REQUIRED: We would therefore recommend that the earth level is reduced around the building and that the decking is cut a fraction further away from the property.
