RESIDENTIAL BUILDING SURVEY

**Hemel Hempstead,
Hertfordshire
HP2**

INDEPENDENT CHARTERED SURVEYORS

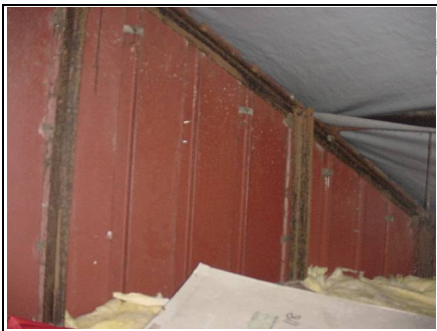
Wall cladding as viewed from the roof, and vertical metal – part of the metal frame we believe the whole building is built from

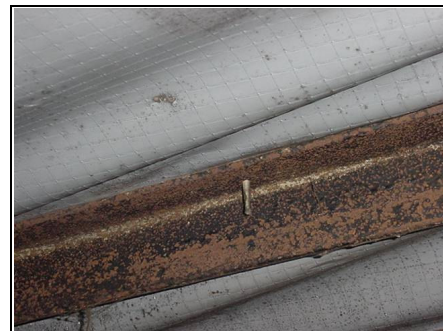
There was considerable rusting visible within the roof (the only area where we could truly see the structure of the building) which we believe relates to the condensation in the property.

Close up of rusting to rolled steel angle

ACTION REQUIRED: The most efficient method we believe of reducing condensation is to remove the condensation at source, which is normally the humidity creating areas such as the kitchen and the shower room, where we would recommend large humidity controlled extract fans are added as soon as possible.

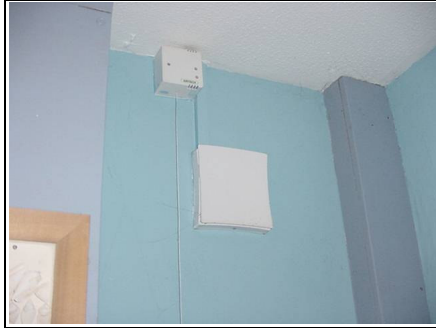
Extract vent in shower room
which we would enlarge and have
a humidity control

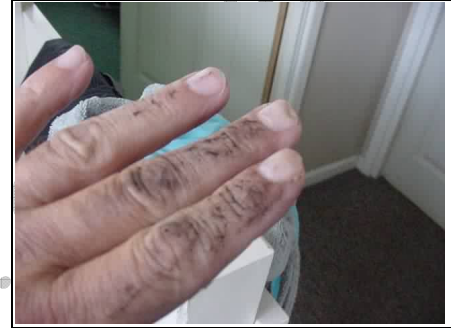
Black mould visible

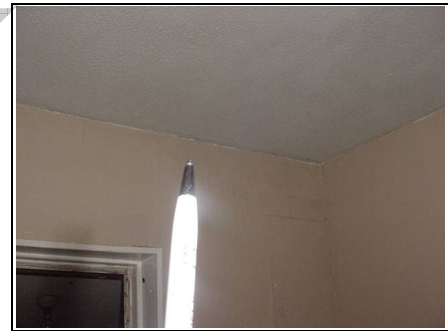
We fear that the property has suffered/will be suffering from interstitial condensation. This is condensation within the structure which is why you are getting the rusting stains visible in the bathroom, in the kitchen and in the hallway, which are all in humidity creating areas or close to these areas.

Our concern is that in turn will be affecting the structural frame.

Rusting stains in kitchen
from the metal structure

ACTION REQUIRED: The only way to be certain of how this is affecting the structure of the building and the construction is to open up walls to check the structural frame.

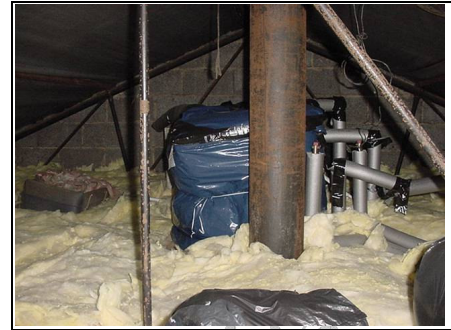
Within the roof space we can see a metal flue. You advised us that you had rusting/flooding from the chimney and the cap has recently been replaced, however if dampness does get in again you will get the rust staining back.

Rusting chimney flue in roof space

ACTION REQUIRED: We believe that the mock/pre-fabricated chimney is coming to the end of its life and needs to be replaced.

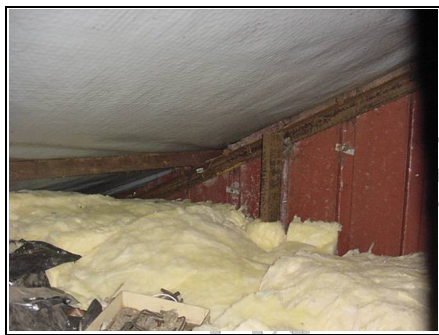
Plastic underlayer
(and masses of insulation)

Ideally this plastic underlayer needs to be removed and replaced with a breathable protective underlayer but this would mean removing all of the roof and would be an expensive job; likely to be in the tens of thousands due to the scaffolding needed around the property.

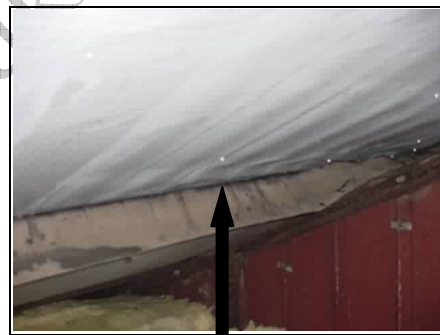
When we inspected the loft space we found a plastic underlayer which unfortunately is the worst type of underlayer in our opinion, as it causes / contains condensation which is the last thing that you want in this type of construction. The condensation then causes rust to the structural frame.

Globules of water running down
the plastic underlayer

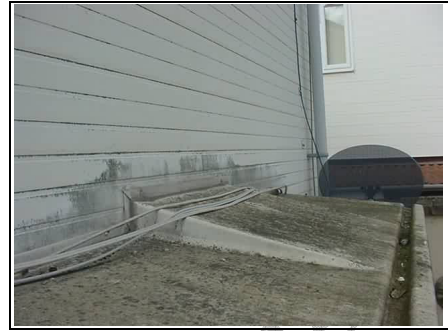
The porch roof to the property is a small canterlevered plastic roof, which is a slightly unusual design, and it was weathered.

Porch roof to front

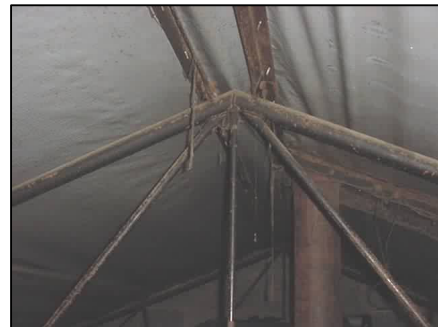
Ridge of metal tubular truss
with signs of rusting on it

Our examination was limited by the general configuration of the roof and the mass of insulation. We generally found the roof truss to be in average to below average condition; it is suffering from rust, which in turn puts in question its long term life particularly considering the condensation that was within the roof.

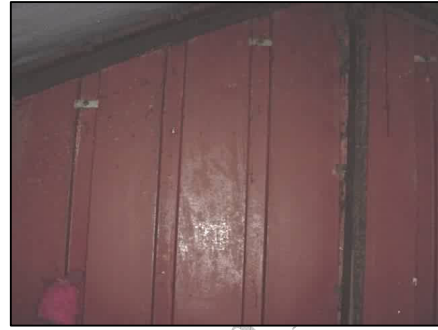
Condensation occurring
on metal wall face

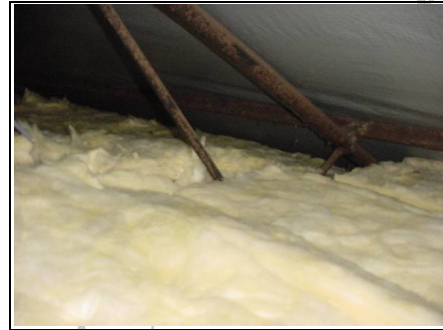
Mass of insulation

ACTION REQUIRED: We would recommend vents at high level/the ridge. Please see our comments in the Executive.

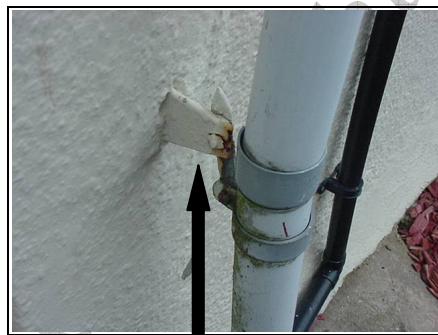
The gutters and downpipes are plastic; originally they may have been metal (as these were built in the era before plastic). We can see that the metal fixings to the plastic downpipes are starting to rust.

Rusting occurring on fixings to downpipes

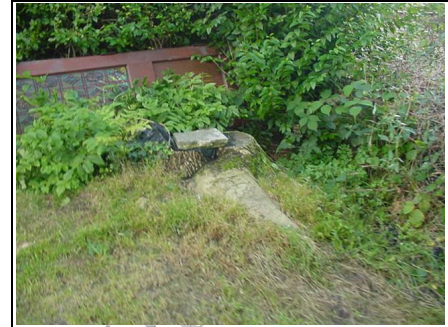
A tree has been cut down in the rear garden, as you are probably aware. This can have long term effects on the structural integrity of a building but we could see no obvious signs of any impact at the time of our survey.

Rear tree that's been cut down

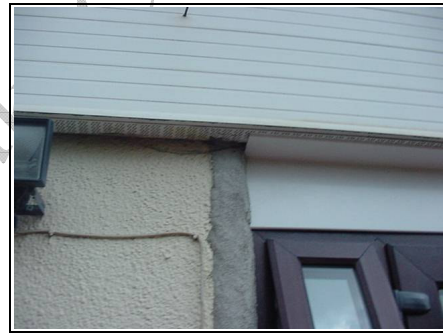
Rear patio door perimeter
unfinished

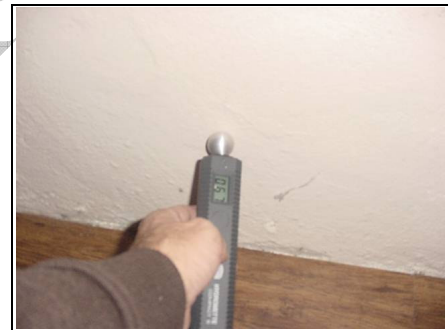
A visual inspection and tests with a moisture meter have been taken to the perimeter walls. In this particular case we have found rising damp.

High damp meter readings in toilet of over 60

ACTION REQUIRED: Please see the Executive Summary

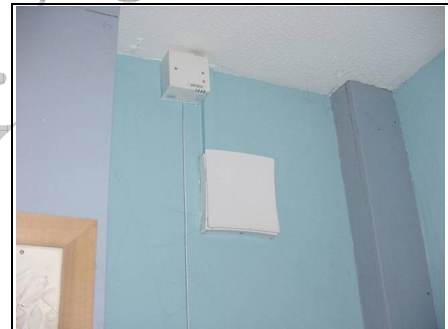
Small extract fan in shower room

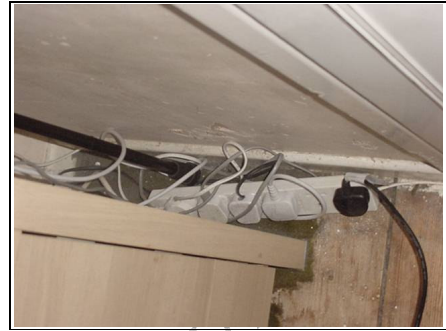
We can see also that you are short of socket points from the additional sockets around the property and generally our usage of electricity has increased considerably since the time these houses were built. We believe the house is in need of re-wiring.

Multi socket extension lead

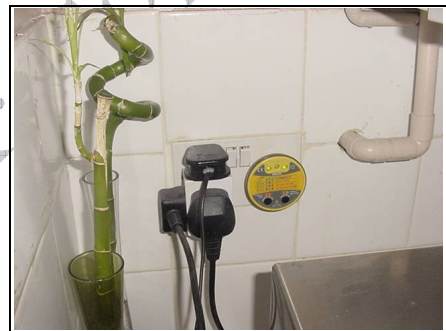
We carried out an earth test in the kitchen area to the socket point that is normally used for the kettle, this proved satisfactory.

Earth Test
