# RESIDENTIAL BUILDING SURVEY

Henlow, Beds

**INDEPENDENT CHARTERED SURVEYORS**

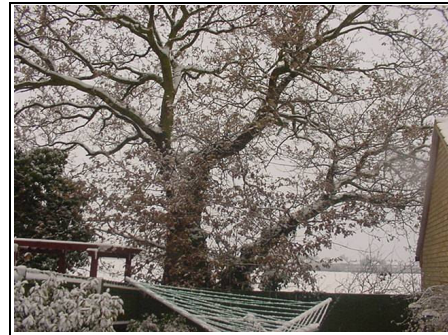
The tree is in what we would term influencing distance meaning that it can affect the property however in modern properties such as this it should have been allowed for with the foundation design. It is essential you establish who owns the tree and therefore who is responsible for maintenance of it. We noted there is a locked gate to the right hand side of the garage, we spoke to the owner during the question and answer session and they were unsure as to who owned it, you do need to establish this before you purchase the property.

Large oak tree

**ACTION REQUIRED:** Your solicitor to specifically request details from seller's solicitor/Building Control Department as to the depth of the foundation and then we will advise as to whether we feel this is sufficient. We are slightly concerned with this property having a suspended floor as this does indicate to us that it may well be a clay soil area and the suspended floor has been put in to allow for any movement in the ground level. If this is the case it would mean that we would have to insist on more information regarding the foundations before you purchase the property.

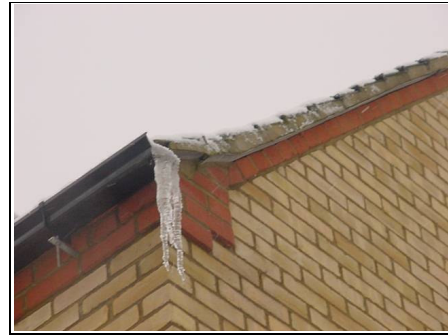
2) **End cap of the gutter had come away, we could see stalactites had been formed there**

Unfortunately as there is snow on the rest of the gutter it is difficult to comment on their condition.

End cap of guttering missing

**ACTION REQUIRED:** Replace end cap

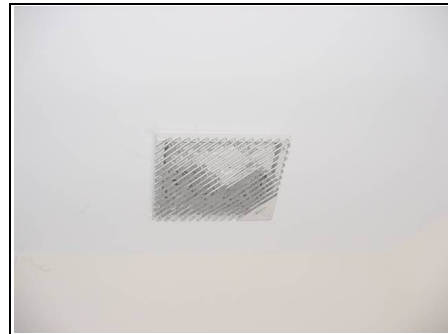
Most modern properties have high humidity generating areas such as the shower rooms, bathrooms and kitchen therefore it is important to ensure that the extraction systems are working properly. We noted that the fans would benefit from being cleaned.

Dirty extract fan

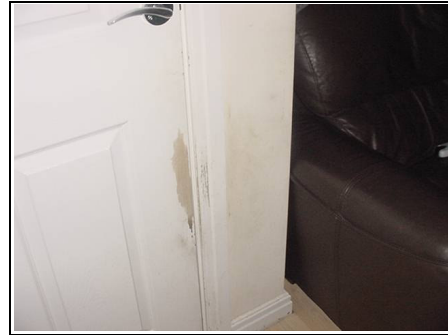
The property has had over and above average fair wear and tear in some areas particularly due to having a dog.

Door in need of redecoration

**ACTION REQUIRED:** Decoration of some of the doors, as these are modern hollow core doors it maybe more economical to replace them than to paint and repair them.

**ANTICIPATED COST:** This type of door is relatively cheap, the main cost is in the hanging of the door which can cost more than the price of the door; quotations required.

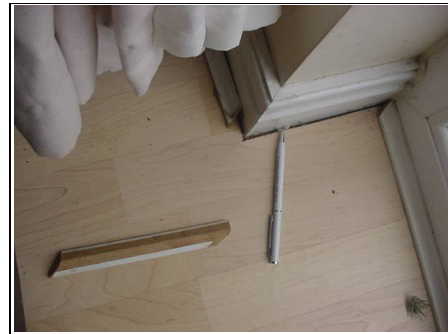
As you often find with laminate flooring it has been put down and not finished properly for example in the photograph you can see where the quadrant bead has not been fitted and also we noted areas where movement was occurring.

Laminate flooring in need of repair

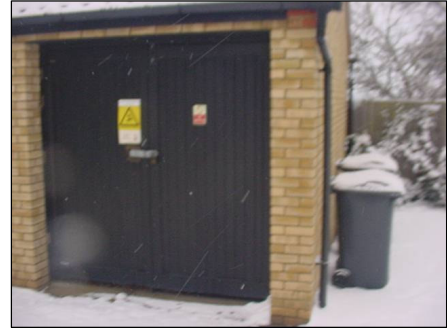
We noted that you are close to an electric sub station there is conflicting evidence as to whether these are detrimental to health particularly relating to the young and the old we feel it is fair to say the jury is still out on this, you need to take this into consideration.

Sub station close to property

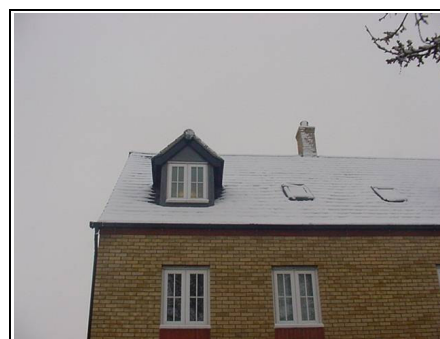
Whilst the vast majority of the roof was covered in snow we believe the pitched roof is clad in a concrete tile. From what we could see the concrete tiles are lying true and flat by this we mean that the snow is lying true and flat! Sometimes when it is not snowing we see deterioration occurs to the ridge and exposed areas such as the perimeter so you should periodically check these areas.

Roof with limited view due to snow

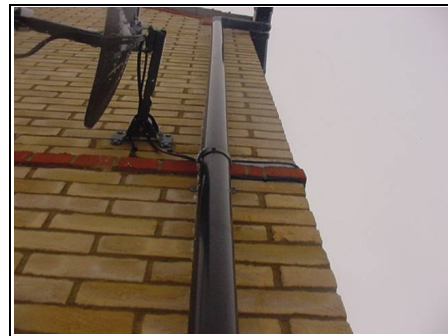
From ground level the gutters and downpipes looked to be plastic and appeared in reasonable condition. What was very obvious was the stalactites hanging from the front right hand corner of the gutter telling that the end cap was missing. There may also be a few other repairs, but we feel that most people would be happy with getting these carried, please see our comments in the Executive Summary.

Downpipe

**ACTION REQUIRED:** We would always recommend that the gutters and downpipes are cleaned out, the joints are checked and the alignment checked to ensure that the gutters fall towards the downpipes. Please see our comments in the Executive Summary.

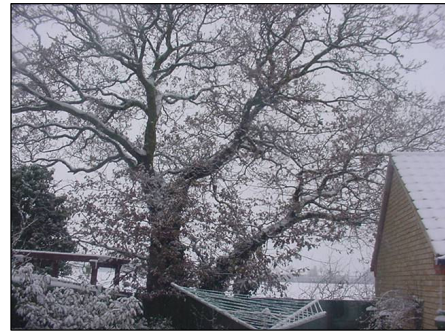
There is a tree to the rear garden but not within it, as we are sure you are aware it is an oak tree and we are advised it has a tree preservation order on it. Damage to foundations and underground services can be caused by trees and shrubs. This is what we term within influencing distance, meaning that its roots could affect the property. With this age of property i.e. relatively new, the foundations should have been designed to allow for the tree.

Oak tree to rear of property

**ACTION REQUIRED:** Please see our comments within the Executive Summary. You may need to obtain advice from an arboriculturist (not a tree surgeon) who specialises in this type of work.

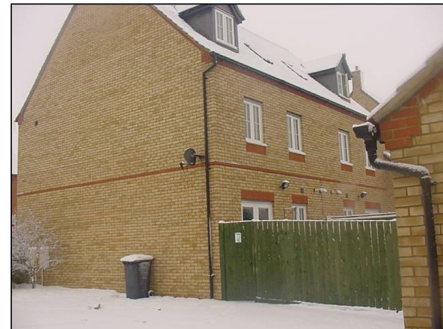
The external decoration required is minimal; the fascias and soffits will need painting in years to come and the fence.

Fence that will need to be maintained regularly

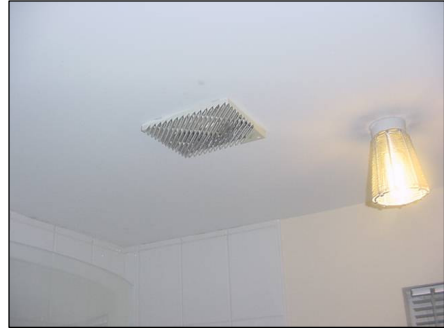
Extract fan in need of a clean

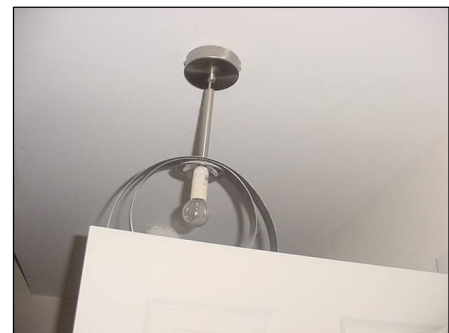
Door hitting ceiling light on first floor

**ACTION REQUIRED:** As the property is changing occupancy an IEE report should be carried out by a NICEIC registered and approved electrical contractor.
