RESIDENTIAL BUILDING SURVEY

A Converted Terraced Property, Hitchin, Hertfordshire SG4

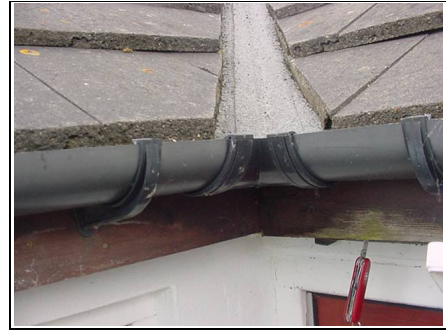
1) Valley Gutter Overflowing

Although it was not raining at the time of the survey, from our experience we believe the valley gutter adjacent to your entrance door is overflowing. From what we could see this has caused wet rot to next door's fascias and soffit. Due to its location the overflowing of this gutter will be a nuisance as it overflows directly above your main entrance door.

The valley gutter overflowing, causing damage to the fascia and soffit. Note our knife to the right hand side.

ACTION REQUIRED: Amend the gutters using what is known as a 'deep flow' gutter, which is a larger gutter.

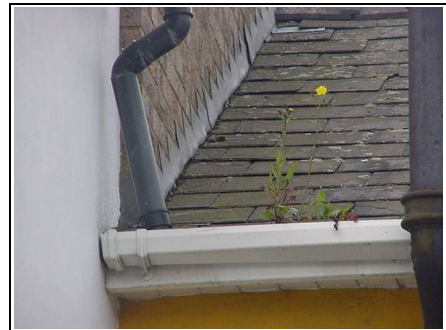
2) Possible Damp from Adjoining Gutter

The adjoining gutter to the neighbouring property looks like it is blocked (in this photo you can see a plant growing from the gutter) and will be overflowing against the side of your flat, which could cause dampness.

ACTION REQUIRED: Speak to your neighbour about clearing their gutter.

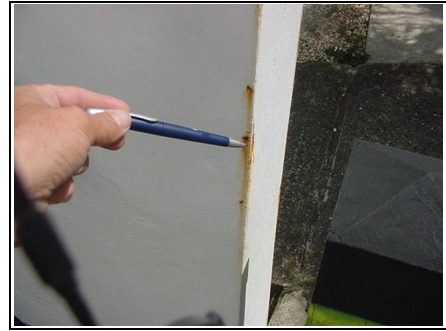
3) **Render**

The render is newly painted and may be hiding defects. We noted that the corner beads are rusting where the stairs are located; this is because an internal angle bead has been used (i.e. one suitable for use inside only).

Corner bead rusting to the render to the external staircase area.

ACTION REQUIRED: We personally would paint over these for the time being. Unfortunately it does lead us to think that the render as a whole may have similar problems.

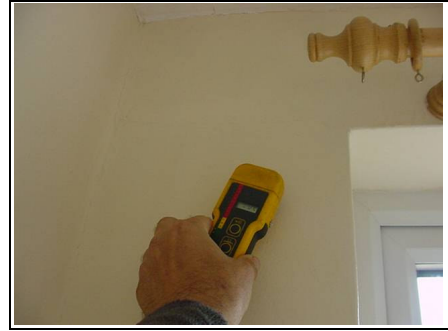
5) Smells Damp

Upon entering the property it smelt damp - more than we would expect to find in an empty property. We have checked the walls for lateral dampness and not found any significant readings; however we are aware that the property has been newly decorated, which normally hides such smells of dampness. Unfortunately we really cannot be certain in this instance.

Checking for lateral dampness.

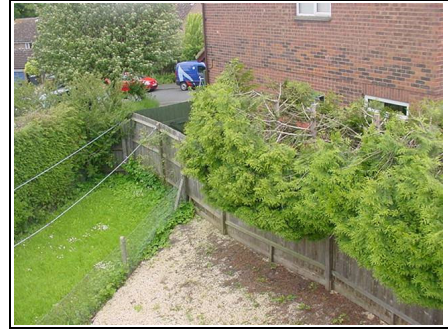
8) **Boundary**

Unfortunately we were unable to identify exactly where the boundary runs from and to; we would be happy to comment on any Deeds that you have. We did note that conifers run along the rear boundary and part of the road boundary, albeit that this is within your neighbour's garden it is fairly overgrown.

ACTION REQUIRED: Ask neighbour to cut the conifers back and regularly maintain.

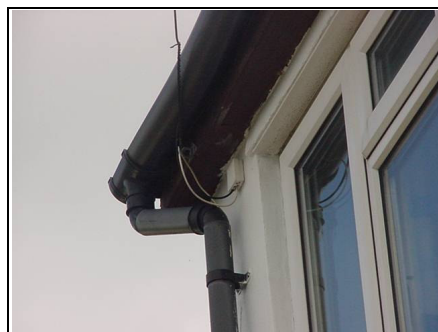
From ground level the gutters and downpipes looked to be plastic and appeared in reasonable condition. There may be some minor leaks, but we feel that most people could live with these.

ACTION REQUIRED: We would always recommend that the gutters and downpipes are cleaned out, the joints are checked and the alignment checked to ensure that the gutters fall towards the downpipes.

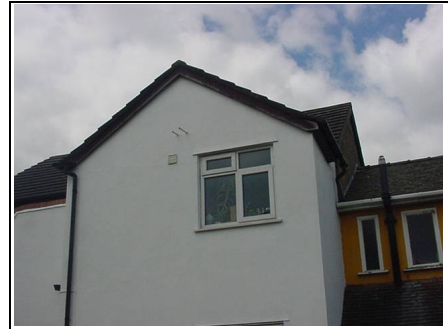
The walls to this property are finished in a smooth faced painted render. We have carried out a tap test to the render at low level (literally hitting the render with the back of a hammer to try to establish if there are any hollow areas). We have found some areas but this is typical for this age of property.

We believe the render has recently been painted and may be hiding defects.

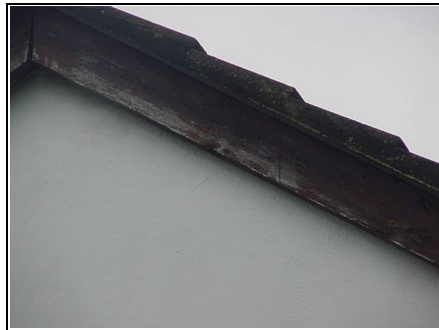
The property has painted/stained timber fascias and soffits; these are in need of repair and redecoration.

In need of redecoration.

ACTION REQUIRED: Once the valley gutter problem is sorted out the fascias and soffits should be repaired and redecorated.

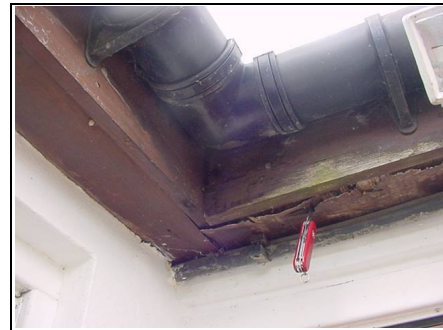
Note the deterioration to your neighbour's fascias and soffits. You will have a share of the costs.

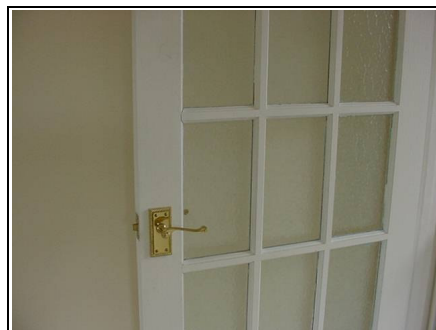
The property has a glazed panel door internally. From a safety point of view current Building Regulations (who monitor minimum standards) require that a toughened glass be used to prevent any problems. In this instance we did not note a British Standards Kite mark.

ACTION REQUIRED: Replace door.
