**RESIDENTIAL BUILDING SURVEY
OF
Horbling, Lincolnshire NG34**

FOR

Mr F

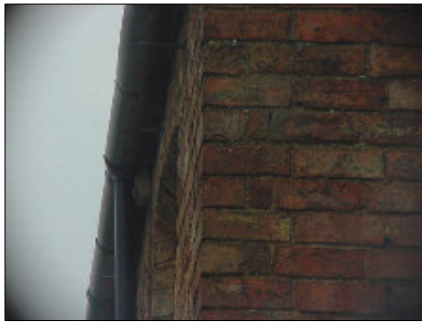
Some re-pointing is required to the older part of the property, particularly on the gable end. We do not consider this emergency work, but we do consider it necessary, as without it the property is susceptible to dampness. This photo has not turned out particularly well, but the pointing is weathered. Please see our further comments in the next section of this Executive Summary on dry lining.

This photo has not turned out particularly well, but the pointing is weathered.

ACTION REQUIRED: Ad hoc re-pointing. We recommend that a skilled bricklayer is used who is able to match the existing pointing in both colour and mix.

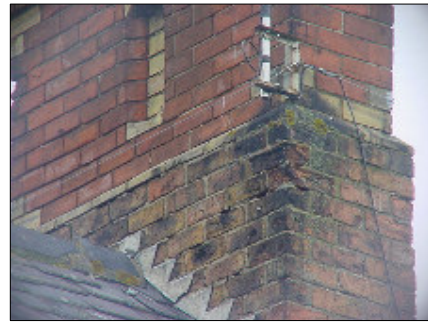
This is a close up of the rear of the chimney, you can see some weathering has occurred to the pointing and also to the brickwork. Chimneys are usually the most exposed items and therefore suffer.

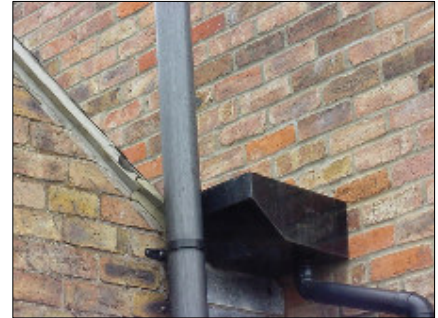
To the rear of the property, where the single storey extension changes direction, there is an awkward box valley gutter. We believe this has been formed in lead, which, we believe, is the best material. There are no obvious signs of disrepair. We have checked internally with a damp meter to see if damp is coming through; it is not. The photo shows the rear of the box gutter, some of the mortar has fallen out to the perimeter of the roof, ideally this should be re-pointed.

This photo is taken looking down the valley gutter, you can see that there is some slight ponding on it, but nothing excessive. The bit we could not see is where it sits against the new building. We suggest you get a long ladder and get onto this bit of the box guttering as soon as possible to check out the other side of the flashing.

ACTION REQUIRED: Nothing at present.

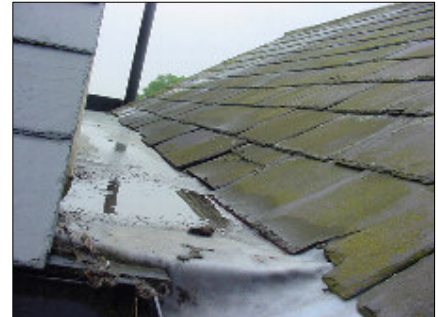
Having said all that, this sort of detail leads to problems and you will need to regularly maintain it, keeping it clear of leaves, etc. We noted some of the slates around it are slightly displaced. These need to be watched as well.

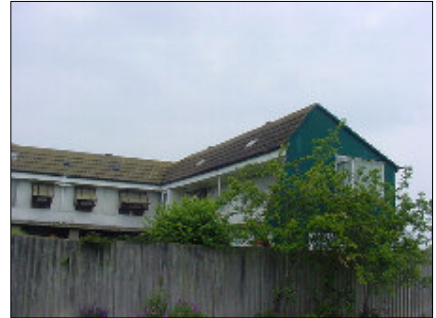
Just in case you have not noticed, next door there is a two-storey birdhouse, for want of a better description, which is literally Travel Inn size. We have never seen anything quite like it before. We went round to talk to the neighbours, but unfortunately there was no one in at the time. You need to ensure that you are happy to live with this and we assume that it could also have a change of use into residential housing fairly easily.

This is the largest bird house we have ever seen in someone's garden.

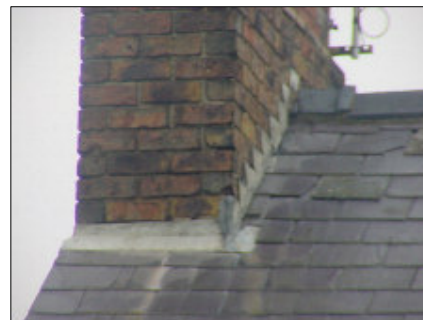
There is one chimney to this property. This chimney is brick built with a lead flashing and two chimney pots, it looks to have had more at one time, possibly four. The photo shows a close up of the base of the chimney showing the lead flashing, which on reflection may not be lead at the very bottom as it does not look to be tucked into the brickwork. We suggest a closer look at this chimney is carried out when it is re-pointed.

From ground level the pointing looks to have weathered and some re-pointing is necessary. This is fairly typical for a chimney of this age as it is in an exposed position. We were unable to see the flaunchings and therefore cannot comment upon these.

ACTION REQUIRED: Re-pointing.

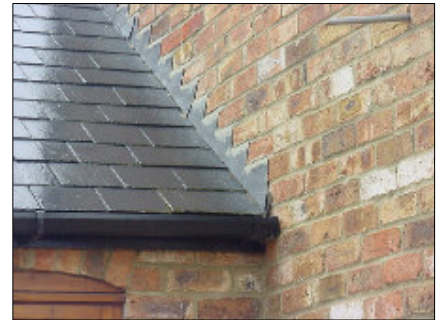
Here, we are pleased to say, we found a lead flashing detail and, although rather messily pointed in, it looks to serve its function. We could not actually see the far side of it even when we went next door to view the roofs.

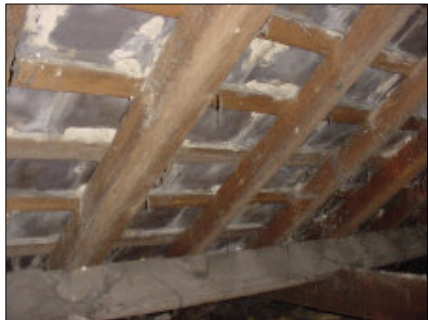
General view of the inside of the roof. You can see there is no felt. What is known as blinding has taken place where lime cement mortar has been filleted on the back of the battens.

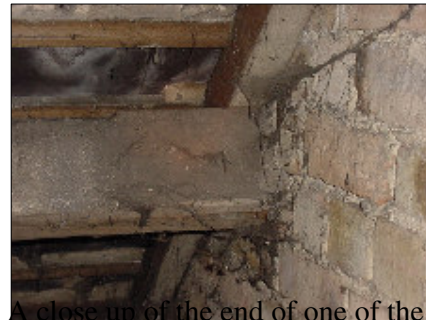
A close-up of the end of one of the purlins. These areas can rot, but not in this instance.

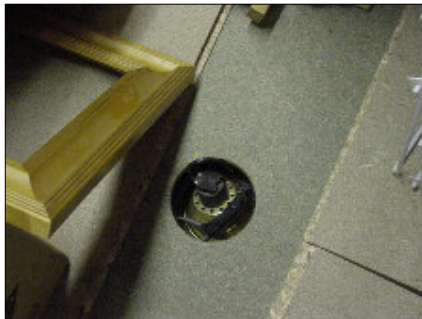
An area that did concern us was the ceiling lights that have been used as the heat from these can cause fires. We noted that some of the ceiling lights have been cut around and in some areas the insulation had started to cover them.

Ceiling light cut around.

ACTION REQUIRED: When the loft space has been emptied we suggest that you check that none of the backs of the lights are covered.

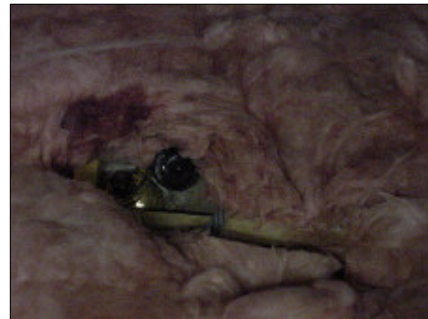
The insulation starting to cover the ceiling lights.

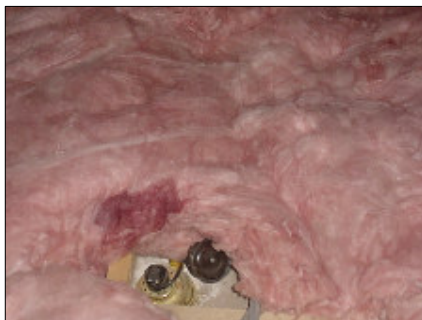
Insulation covering the back of ceiling light.

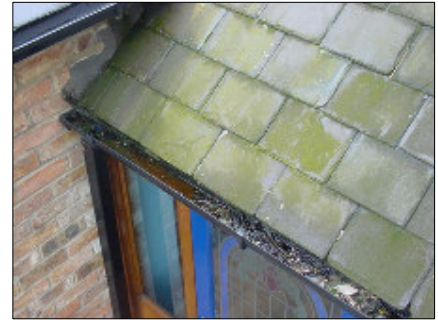
The original property would have had cast iron rainwater goods and some of these may still remain, although most have been replaced with plastic. The new section of the property has plastic rainwater goods. We could see that some of the low-level gutters required clearing, as shown in this photo.

We would generally comment overall that from ground level the condition and alignment of the rainwater goods appeared to be satisfactory.

ACTION REQUIRED - We would always recommend that the rainwater goods are cleaned out, the joints are checked and the alignment checked to ensure that the gutters fall towards the downpipes.

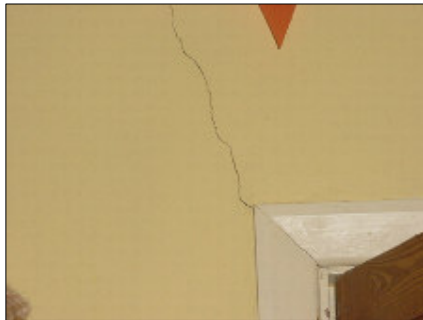
There is a hairline crack to the wall in the front right hand small bedroom.
