**RESIDENTIAL BUILDING SURVEY  
OF  
Horbling, Lincolnshire NG34**

**Mr F**

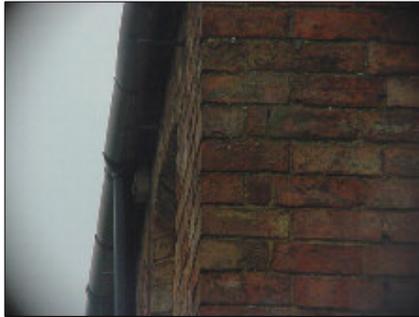
Some re-pointing is required to the older part of the property, particularly on the gable end. We do not consider this emergency work, but we do consider it necessary, as without it the property is susceptible to dampness. This photo has not turned out particularly well, but the pointing is weathered. Please see our further comments in the next section of this Executive Summary on dry lining.

This photo has not turned out particularly well, but the pointing is weathered.

**ACTION REQUIRED:** Ad hoc re-pointing. We recommend that a skilled bricklayer is used who is able to match the existing pointing in both colour and mix.

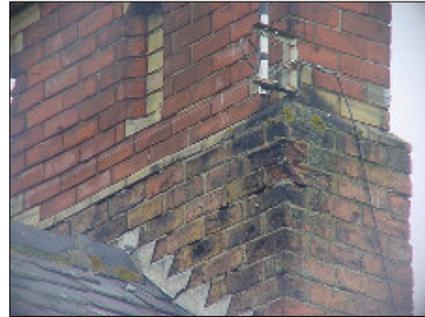
This is a close up of the rear of the chimney, you can see some weathering has occurred to the pointing and also to the brickwork. Chimneys are usually the most exposed items and therefore suffer.

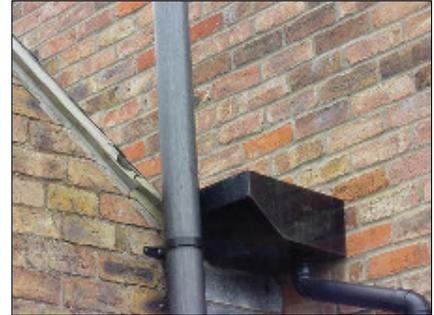
To the rear of the property, where the single storey extension changes direction, there is an awkward box valley gutter. We believe this has been formed in lead, which, we believe, is the best material. There are no obvious signs of disrepair. We have checked internally with a damp meter to see if damp is coming through; it is not. The photo shows the rear of the box gutter, some of the mortar has fallen out to the perimeter of the roof, ideally this should be re-pointed.

This photo is taken looking down the valley gutter, you can see that there is some slight ponding on it, but nothing excessive. The bit we could not see is where it sits against the new building. We suggest you get a long ladder and get onto this bit of the box guttering as soon as possible to check out the other side of the flashing.

**ACTION REQUIRED:** Nothing at present.

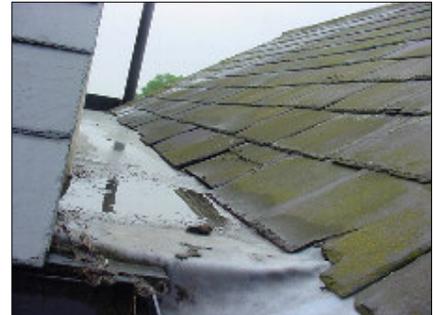
Having said all that, this sort of detail leads to problems and you will need to regularly maintain it, keeping it clear of leaves, etc. We noted some of the slates around it are slightly displaced. These need to be watched as well.

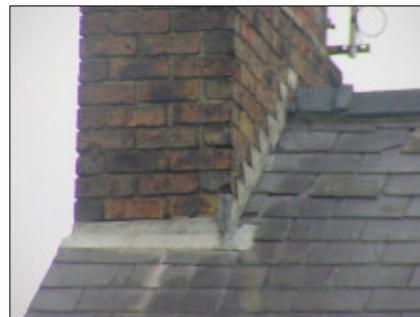
From ground level the pointing looks to have weathered and some re-pointing is necessary. This is fairly typical for a chimney of this age as it is in an exposed position. We were unable to see the flaunchings and therefore cannot comment upon these.

#### **ACTION REQUIRED:** Re-pointing.

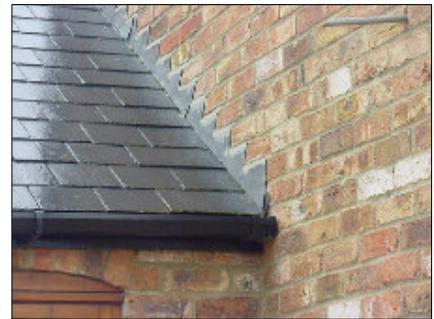
Here, we are pleased to say, we found a lead flashing detail and, although rather messily pointed in, it looks to serve its function. We could not actually see the far side of it even when we went next door to view the roofs.

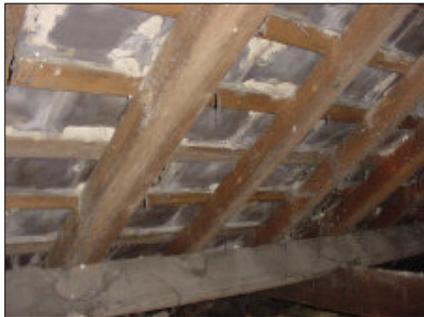
General view of the inside of the roof. You can see there is no felt. What is known as blinding has taken place where lime cement mortar has been filleted on the back of the battens.

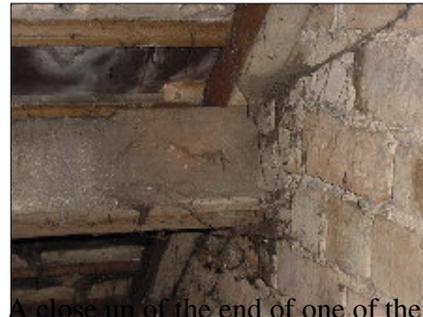
A close-up of the end of one of the purlins. These areas can rot, but not in this instance.

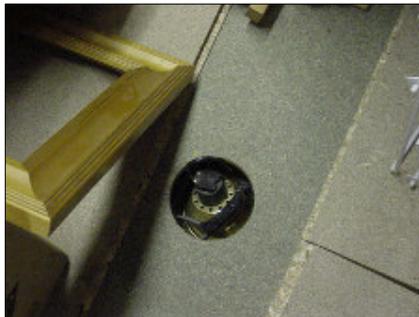
An area that did concern us was the ceiling lights that have been used as the heat from these can cause fires. We noted that some of the ceiling lights have been cut around and in some areas the insulation had started to cover them.

Ceiling light cut around.

**ACTION REQUIRED:** When the loft space has been emptied we suggest that you check that none of the backs of the lights are covered.

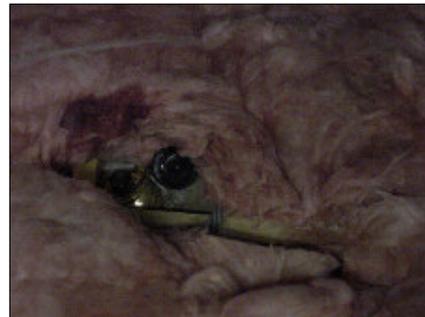
The insulation starting to cover the ceiling lights.

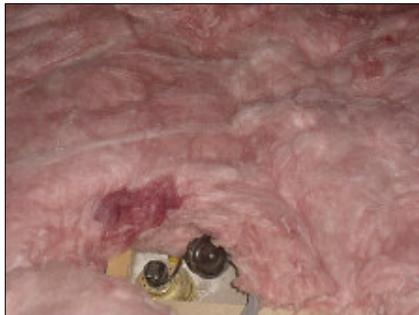
Insulation covering the back of ceiling light.

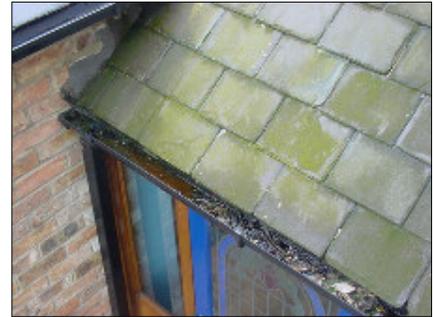
The original property would have had cast iron rainwater goods and some of these may still remain, although most have been replaced with plastic. The new section of the property has plastic rainwater goods. We could see that some of the low-level gutters required clearing, as shown in this photo.

**ACTION REQUIRED** - We would always recommend that the rainwater goods are cleaned out, the joints are checked and the alignment checked to ensure that the gutters fall towards the downpipes.

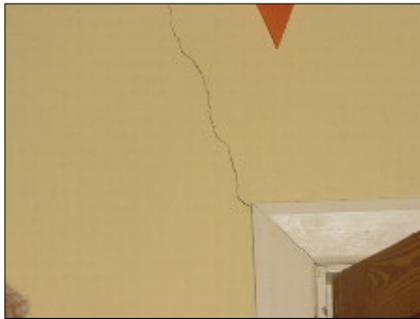
There is a hairline crack to the wall in the front right hand small bedroom.

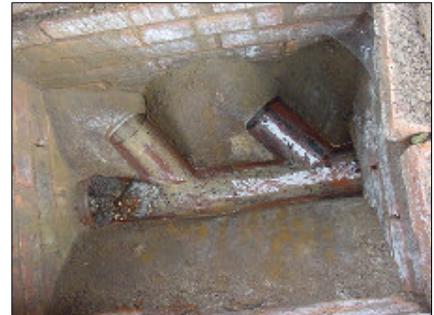
This manhole is brick built and a reasonably neat and tidy job has been made of the benching. We duly lifted the cover and found it to be free flowing at the time of our inspection.
