# RESIDENTIAL BUILDING SURVEY

Houghton Regis, LU5

**GEM Associates Limited**

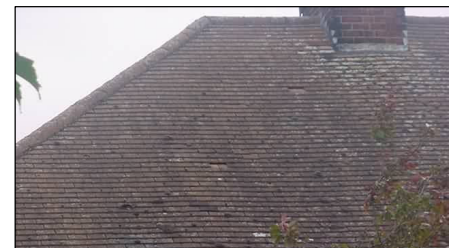
Roof looks to have been cleared of moss

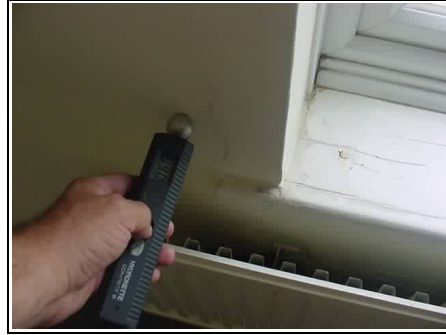
We were very surprised that we found a lot of damp coming in from the back wall in the rear bedroom and readings were over double what we normally expect, which considering the dry weather we have had lately was very surprising.

We noted that this dampness is long term as some areas have blown plaster (hollow or blistered plaster it is also known as) indicating that over the years this area has had a considerable amount of water/dampness.

Damp to rear of the property

**ACTION REQUIRED:** Next time it rains we suggest that you stand and look at the property, it may be that the gutters are not catching the rainwater properly and discharges down the render into the property. It may be simply that paintwork is relatively new and prior to this was in a poor condition allowing dampness in.

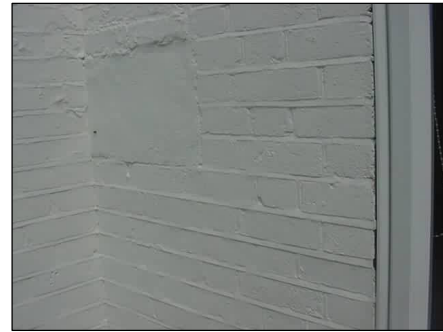
Cement repair to the lower portion at the rear is one of the reasons dampness is getting into the rear lower level.

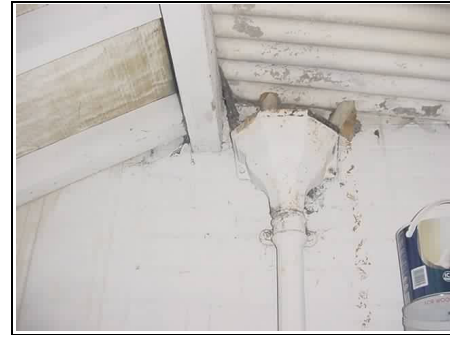
As we come across quite commonly with this age of property it has an asbestos roof to the garage and often there is also one to the outbuilding. Whilst there has been a lot of publicity in relation to asbestos we feel the main problem is a perceived problem to any future potential purchaser and as such we would recommend that it is removed as soon as possible and replaced with a profile metal roof particularly as regulations relating to asbestos dangerous materials are likely to get more strict.

Asbestos roof to garage

**ACTION REQUIRED:** Remove asbestos roof and replaced

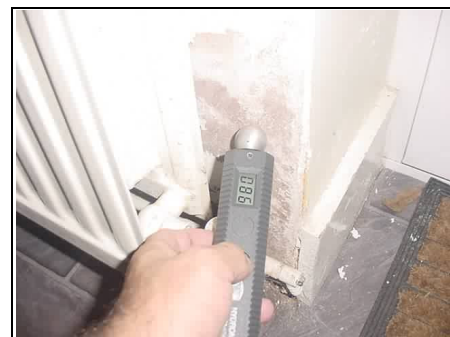
We would also bring your attention to the rear the patio that is high, particularly on the right hand side and we can see dampness getting in here within kitchen by the door, we physically could not get to the rest of the room due to the kitchen units.

Dampness around rear door

**ACTION REQUIRED:** You may wish to ultimately put a running gulley to the front driveway to keep the water away from the property and to the rear put a French gulley to move the patio water away.

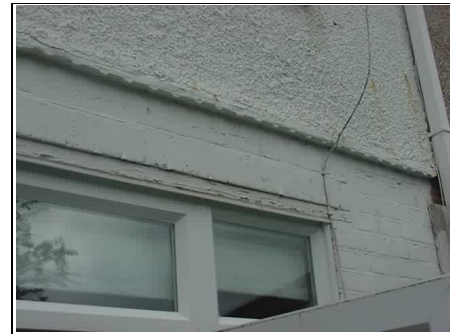
We noted timber lintels to the rear French doors and also to the outbuilding and maybe other timber lintels, bearing in mind the dampness that is getting into the rear of the property we would suggest that these are checked once you have stopped the dampness to this area.

Timber lintels

**ACTION REQUIRED:** Bearing in mind that the dampness is getting into the rear of the property we suggest that you check once you have stopped the dampness in this area.

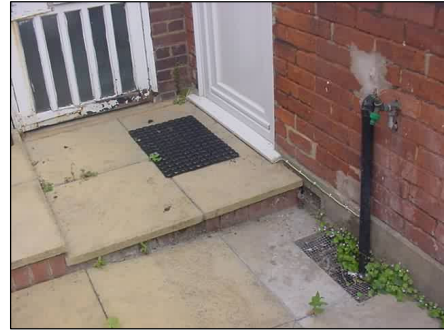
The airflow under the property is essential to stop wet rot and general damage.

You can just see the airbrick in this photo

**ACTION REQUIRED:** We would recommend that airbricks are added.

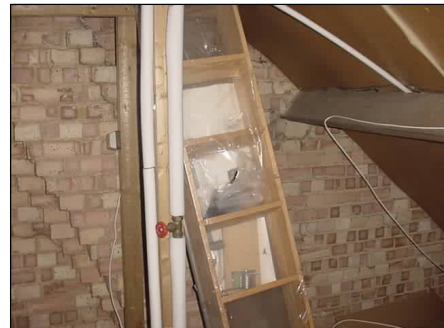
Safe access to get to boiler required

**ACTION REQUIRED:** We noted there is a ladder in the roof space although it is obviously not fixed it should be fixed next to the water tank!

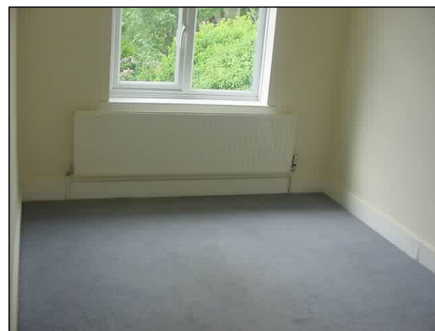
We noted that you have a number of single panelled radiators, these may not warm the building as much as you would like or as quickly as you would like. You may wish to replace these with double panelled radiators.

Single panel radiator

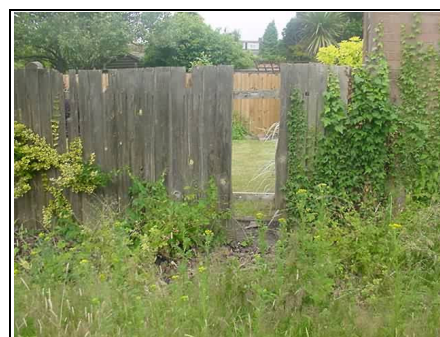
Garden fence in need of repair

**ACTION REQUIRED:** Repair and re-stain if it is your fence.

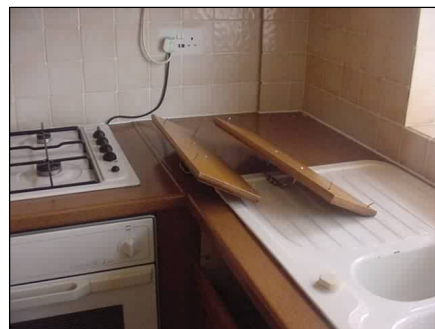
The kitchen unit needs some DIY as the cupboards fell off in my hand.

DIY kitchen unit needing attention

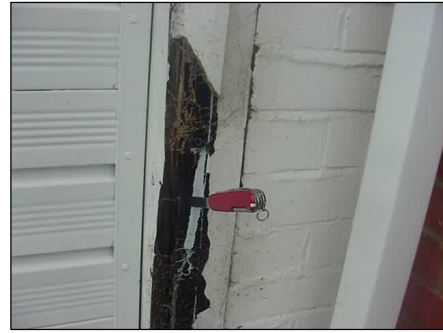
Garage door frame

### **Wet rot to garage frame**

**ACTION REQUIRED:** Repair timber.

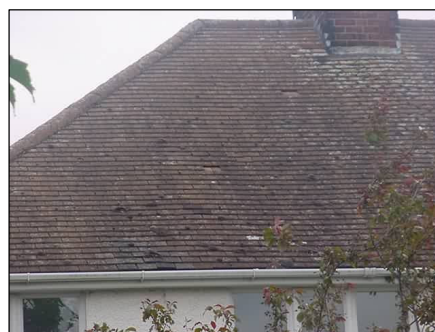
Roof tiles – some missing

We noted to the rear of the property that there are a few missing tiles which we suggest should be replaced before the winter.

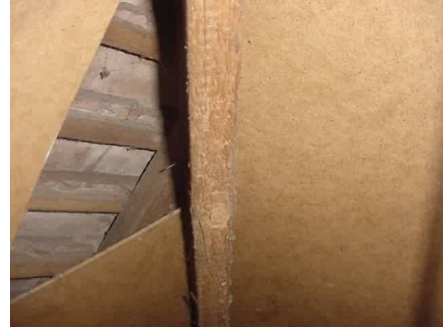
When we inspected the loft space we found there was no underfelt (also known as sarking felt) and it is therefore possible that during periods of heavy and prolonged driving rain some water penetration could take place through the roof coverings.

Underside of nibbed concrete tile

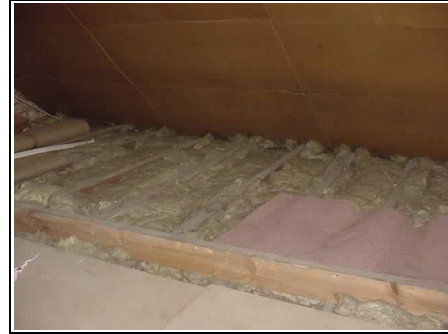
We found the timbers in average condition, although we had a very limited examination as our examinations were restricted by the general configuration of the roof, the insulation and the boarding out of the roof to most of the ceiling joists the pitch of the roof was also hard boarded. What we could see we found in generally average condition, the pitch is shallow which tend to get condensation.

General view of the roof – the hardboard is covering our view of most of the timbers

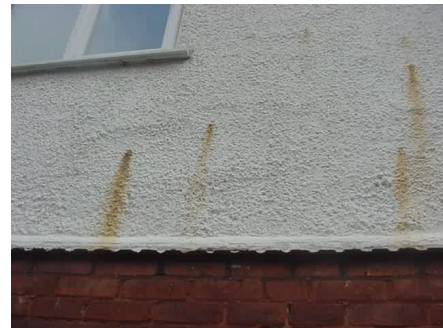
We were surprised the amount of dampness coming through the rear section render and we therefore suspect hairline cracking. This could be a problem throughout the render given its age, you could do temporary repairs with materials such as mastic but ultimately you will need to re-render. The difficulty will be getting your render to match.

Pebbledash

**ACTION REQUIRED:** Before the winter of 2010 we would suggest that you carry out a render check to the rear of the property and in particular all over ideally looking at hairline cracks and loose render.

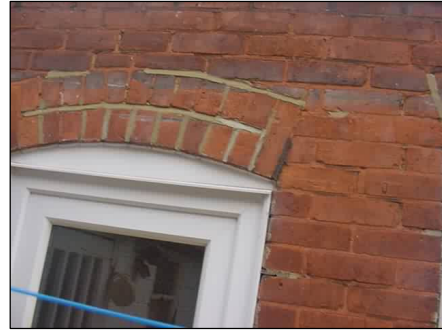
We noted that it suffered from water damage over the years and has been partly repointed. You can see from the colour of the cement mortar that has been used to repoint there should have ideally been more of a lime mix in it.

Brickwork repointed

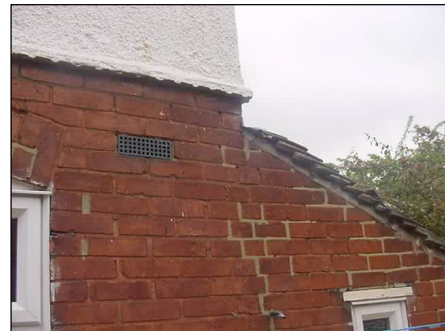
Further minor movement to the rear outbuilding against the main building.

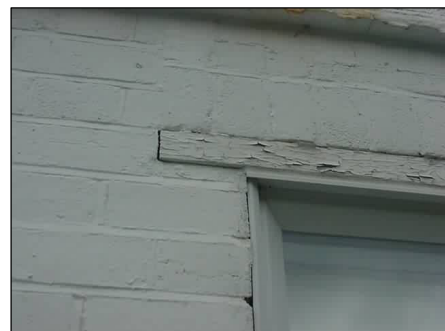
Please see our comments in the Executive Summary regarding timber lintels, which given the dampness in the property may have some rot in them.

Timber lintels

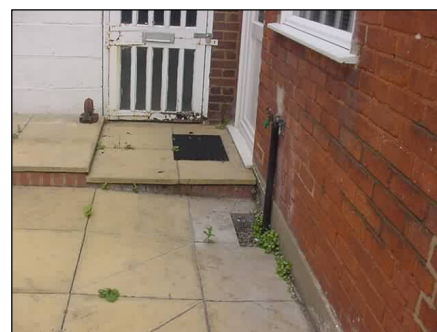
Render plinth forms effectively a damp proof course, there may well be slate behind this. Ironically the newly added paving slabs etc undermined the original DPC by allowing dampness to bypass it

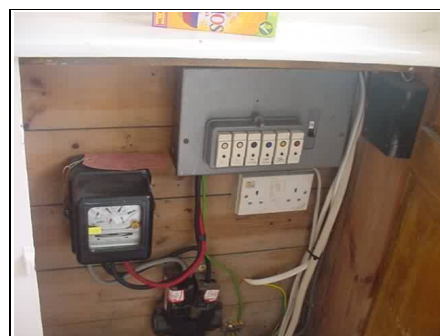
Fuse board

**ACTION REQUIRED:** NICEIC approved contractor to carry out an IEE (Institute of Electrical engineers) inspection test and all recommendations to be actioned. A new fuse board is recommended.
