# RESIDENTIAL BUILDING SURVEY

Hounslow, London TW4

## **INTRODUCTION**

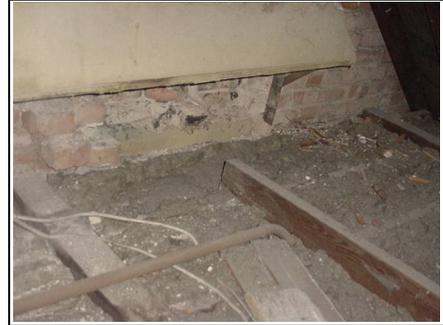
The Chimney Breasts have been removed in an unconventional manner.

Chimney Breast has been removed

**ACTION REQUIRED:** Ask your legal advisor to check to see if the existing owners or previous owners have obtained building regulation approval for this amendment. If not then this would need to be applied for.

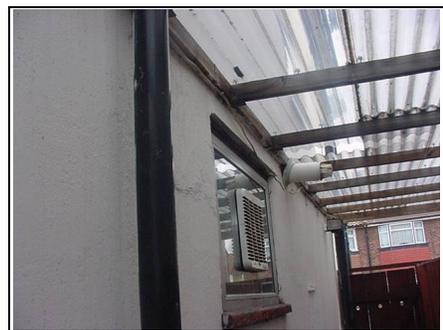
The sides of this appear to discharge water onto the structure which can cause dampness.

A Large amount of Plastic Sheeting on the Roof

**ACTION REQUIRED:** We would class this plastic sheeting as a temporary structure and you need to improve it by replacing with polycarbonate or something of an equivalent quality.

We would at the very least recommend that this is redirected to have a central gutter.

**ANTICIPATED COST:** We would estimate this to be in the region of £1,000 to £2,000 to have this carried out properly. Quotations are required.

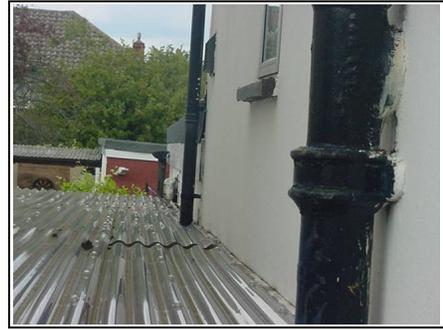
Looking down onto the plastic sheeting

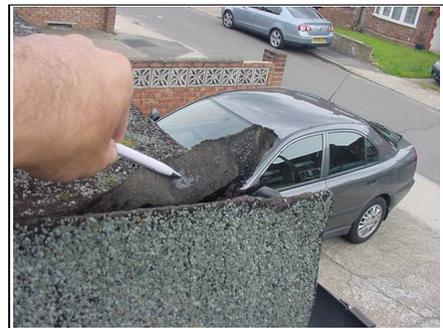
We noted some damage to the front flat roof which is over the entrance porch.

Damage to the front Flat Roof

**ACTION REQUIRED:** We would recommend a "patch repair".

**ANTICIPATED COST:** We would estimate this to be a few hundred pounds. Quotations are required.

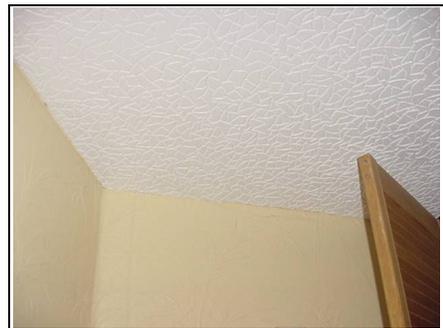
Polystyrene Type Paper to the Ceiling

**ACTION REQUIRED:** We recommend that this is removed as it can be a dangerous hazard if a fire was to break out, dripping plastic onto you.

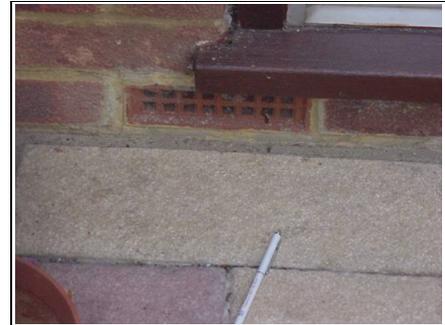
The airbricks are acting as gutters. We do not think that there is a sufficient through flow underneath the floor. Our access was restricted by carpets. We have recently come across a case where there had been a severe outbreak of woodworm, due to lack of airflow and damp conditions.

Airbrick is too low

**ACTION REQUIRED:** We would recommend protecting the gutters to stop water getting in it and we would also recommend that the floor is opened up to check its condition.

**ANTICIPATED COST:** We estimate this to be a few hundred pounds to open up and check the condition of the timber, to check that no wet rot, dry rot or woodworm is occurring. Quotations are required.

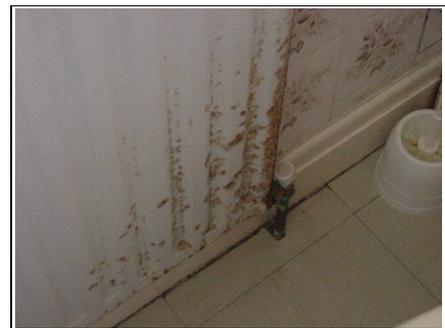
The cloakroom is liable to condensation due to the fact that it is in a relatively cold area and we suspect that the flat roof above it has next to no insulation. This should also be of concern to you with regard to the general heating of the flat roof area.

Rusting Radiator

**ACTION REQUIRED:** We would recommend opening up of the roof to check that there is insulation and adding this if it hasn't. With regard to the radiator, we would recommend that this is changed to ensure that a more efficient one is in place.

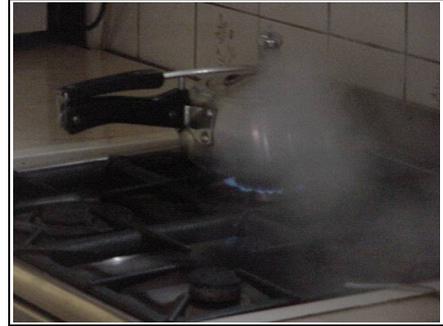
The house currently has some condensation problems, possible due to the lifestyle of the present occupants and also due to the mixture of the older type of construction which has next to no insulation in it and the newer construction that has been added such as the double glazed windows and the insulation in the roof. We see for example, condensation occurring within the bathroom and also as mentioned, within the utilities room. We also noted that steam cooking was taking place without the benefit of opening windows. We have included an article regarding condensation in the Appendices of this Report.

Steam cooking taking place

**ACTION REQUIRED:** We would recommend that the bathroom, cloakroom and kitchen all have extract fans added which are thermostatically controlled.

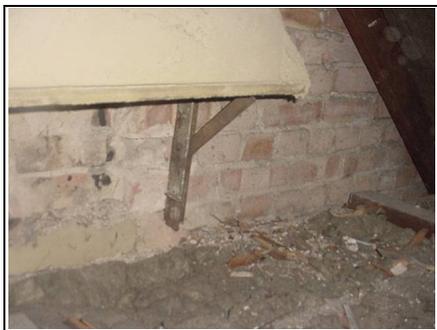
Please see our comments in the Executive Summary with regard to the chimney which has been removed, which is not ideal.

Chimney has been removed

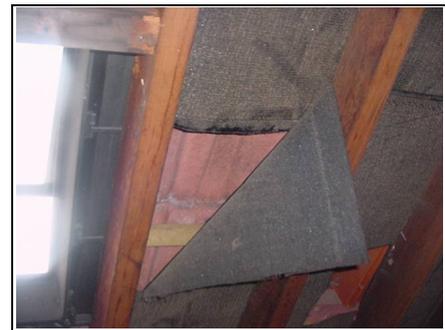
When we inspected the loft space we found a Hessian base Bitumen membrane. This type of membrane has been used since the 1960s. We generally found it to be in average condition, its damaged in a few more places than we normally find.

Protective Under layer

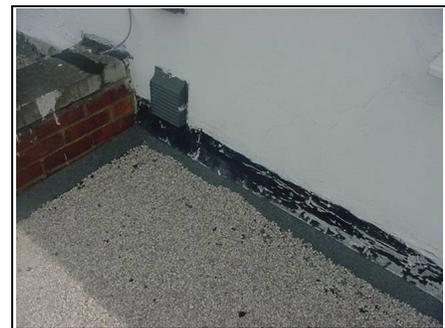
Important areas are the flashings in this case the flashings are a mixture of felt and lead. The area looks to have been bitumen repaired in the past.

Flashing to the roof

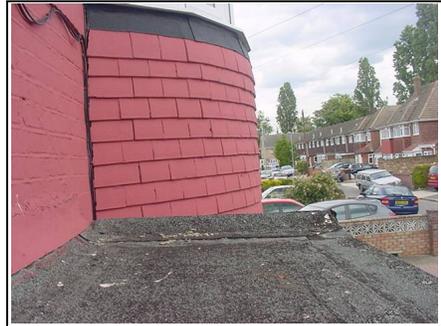
Front Porch Roof

Please see our comments in the Executive Summary with regard to the patch repairing required to this roof.

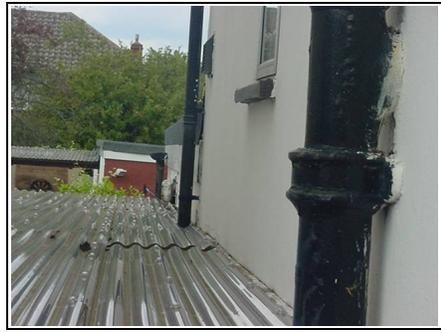
Plastic covered area

Please see our comments with regard to upgrading the plastic covered roof.

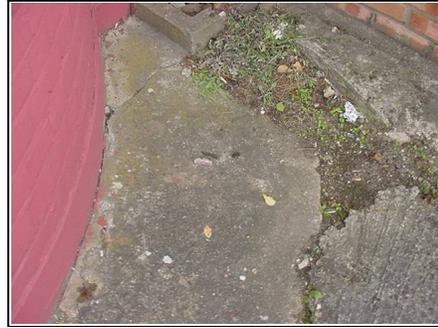
We noted that the ground is uneven in front of the front bay. Often front bays are added without any foundations. It may be relating to movement on this or it may just be poor workmanship when the parking area was put in.

Uneven Ground to the front bay

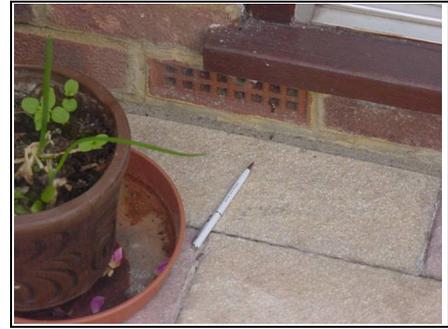
Without opening up the floor we cannot confirm its condition we would be very surprised if the floor did not have some rot.

Airbrick to the rear of the Property

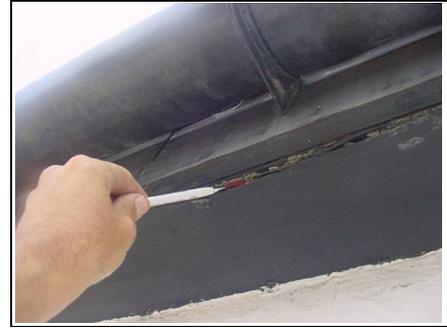
The property has painted timber fascias and soffits although much of the fascia is hidden by the guttering, what we can see looks in average condition, starting to degrade. We were able to have a close inspection to the rear of the property when we were standing on the flat roof. Here you can see where the paint is starting to come away in the adjoining photograph.

Fascias and Soffits

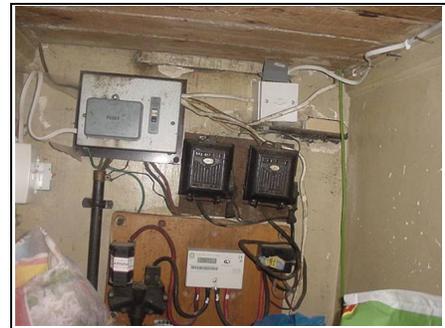
Dated Electrics

**ACTION REQUIRED:** We recommend that the fuse board is replaced and that you arrange to have an Institute of Electrical Engineers test carried out. Please see our comments within the Executive Summary.

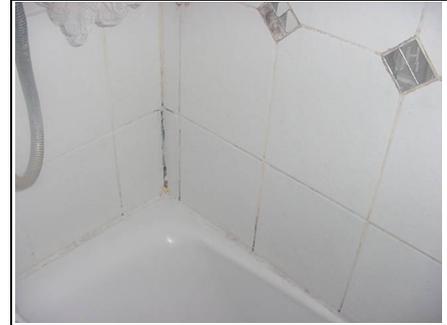
The family bathroom suite, looks in average condition although mould is present. Please see our comments within the Executive Summary.

Condensation present in the Bathroom, causing mould
