RESIDENTIAL BUILDING SURVEY

Hertfordshire, SG12

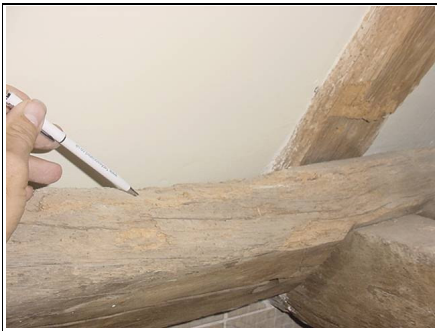
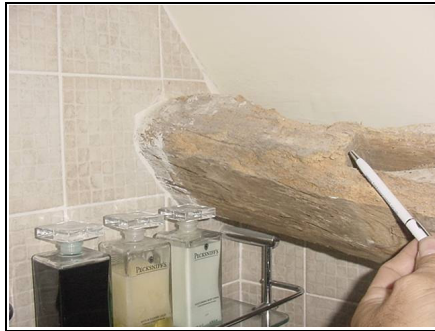
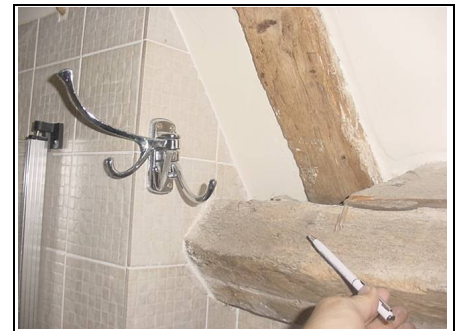
As you would expect in a property that is of this age and is primarily constructed from a timber frame there is woodworm, the question is whether the woodworm is active or not. We would normally look for frass which is the chewed up sawdust in the roof space where it is not regularly disturbed however in this property the roof space has been made into an additional bedroom therefore general use and movement of the property will disturb the frass. From our inspection we believe there is some woodworm activity, however it isn't the best time of year to identify the frass. There are better times such as the breeding season during the spring months where you can establish for certain the extent of the woodworm and whether it is active.

Woodworm to timber on top floor

ACTION REQUIRED: We recommend you set aside the sum of £2,500 - £5,000 for investigation and potential woodworm treatment. We would recommend that the property is re-viewed during the spring, we are more than happy to return. In a property of this type we would not recommend using a Chemical System.

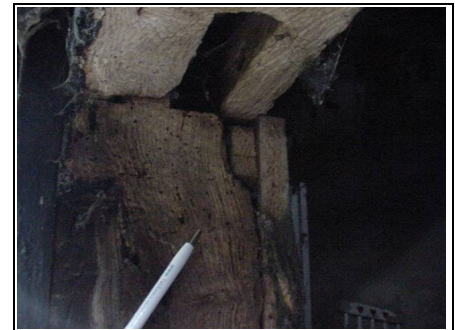
Woodworm in oil shed barn

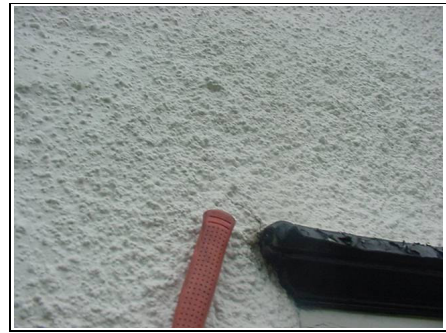
We noticed some minor hairline cracking in the render. In a property such as this the render acts as a waterproof layer and stops dampness getting into the timber frame and causing deterioration which is very important in this type of structure.

Hairline cracking above front window

ACTION REQUIRED: Set aside the sum of £1,000 to seal the render before the winter of 2010. Then we would recommend in the spring of 2011 you look at repair works to the render in general. We can see that repair work has taken place previously due to the mixed different styles of render. Whilst we have carried out a tap test using the back of a hammer to the lower parts of the render you do need to expect in this age of property to have continual repairs to the render and sealing hairline cracks, etc. as a standard maintenance requirement.

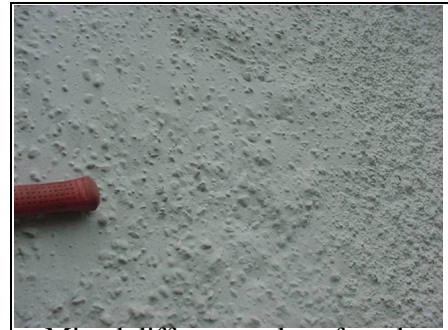
Mixed different styles of render indicating repairs have been carried out in the past.

ANTICIPATED COST: In the region of £1,500 - £2,500; quotations required.

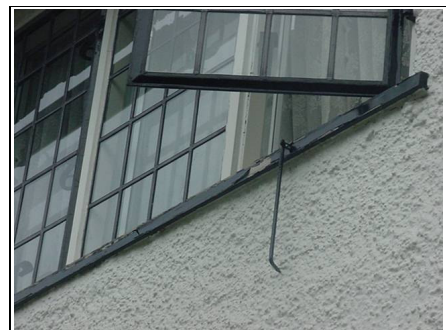
Flaking of paint to windows

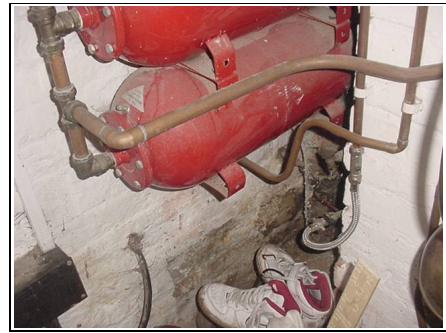
We noted dampness to the lower ground floor as we would expect as the ground levels are below the natural ground levels in some areas. We believe this is due to bridging with the outside earth and we would recommend a French gulley.

Dampness visible just above shoes

ACTION REQUIRED: We would recommend adding a French gulley.

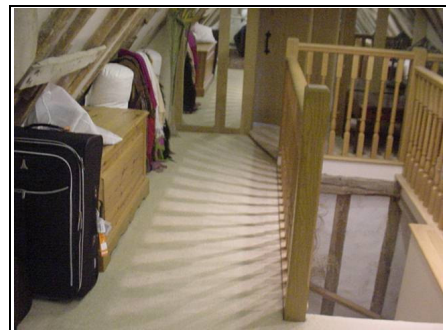
A building of this height would now require fire regulations. Obviously applying this to an old property is very difficult. We therefore suggest that you upgrade the fire alarm system. We would recommend in older properties a wireless fire alarm system (to avoid the cables looking unsightly).

Top floor requires fire regulations

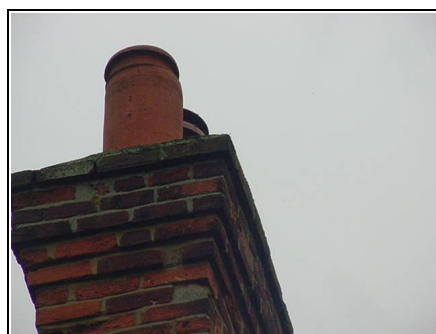
Top of chimney one

This chimney is brick finished with two chimney pots, we could not see the flashings properly so cannot comment. We did however note that there is spalling brickwork which indicates that it has been repaired in the past with cement mortar. The top of the chimney known as the flaunchings we cannot comment on as we were unable to see it.

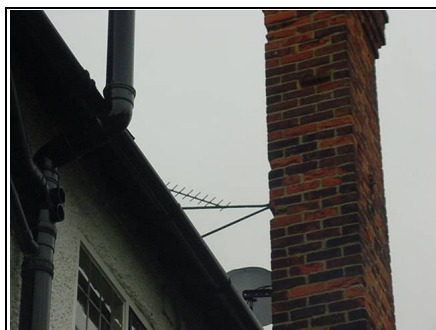
The repairs in the cement mortar will cause damage to this type of softer red brick and indeed already are as you can see by the light areas of brickwork.

Spalling brickwork

ACTION REQUIRED: We would recommend that you repoint in a lime based mortar.

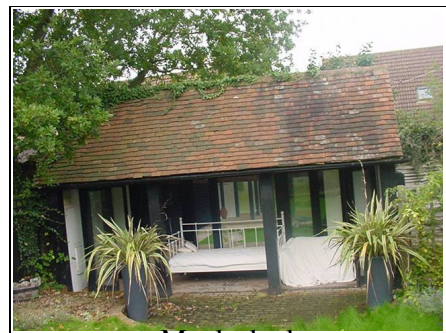
The mock shed to the rear of the property has a plain tile probably nibbed, there are a few tiles displaced. There was ivy growing to the back of it which can cause problems if not cleared.

Mock shed

ACTION REQUIRED: We would recommend that the ivy and vegetation is cut back generally to the roofs and we would recommend a roofer for half a day to reinstate missing and moved tiles.

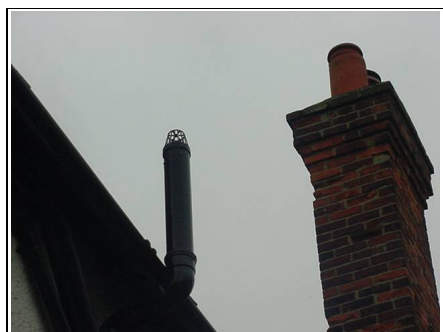
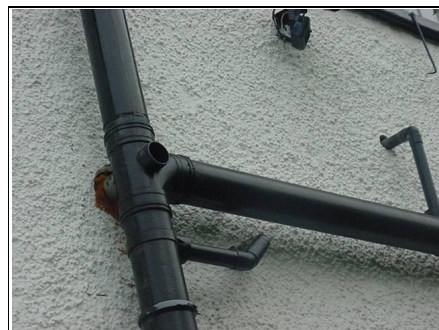
There are plastic soil and vent pipe. We can see it was originally grey and has been repainted in black which is not ideal as the paint comes away and flakes relatively quickly.

Soil and vent pipes

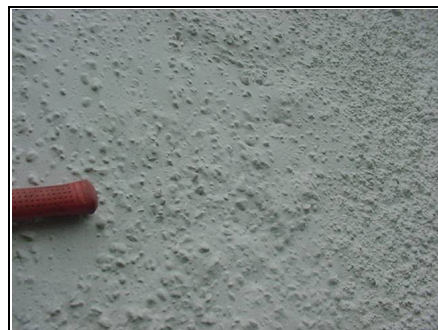
We did note that there are hair line cracks to the render, some of which have been repaired.

Mix of render types indicating repairs to render. With this age of render repairs will get more and more frequent.

ACTION REQUIRED: All cracks need sealing as soon as possible to stop dampness getting in the property. Please see our comments in the Executive Summary.

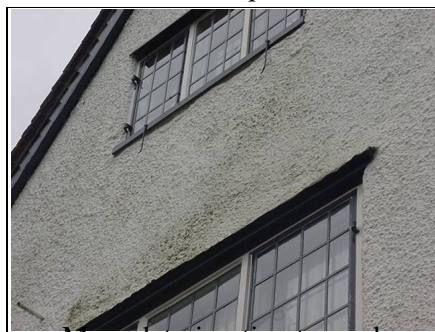
Moss deterioration to render

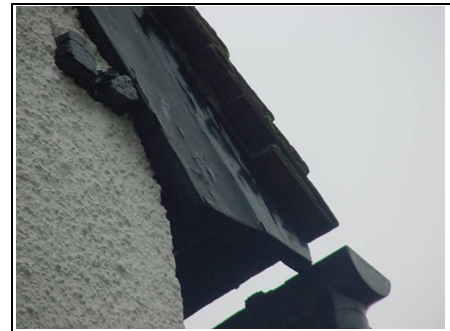
Deterioration to bare board/fascia and soffit boards

ACTION REQUIRED: We recommend repair and redecoration next spring/summer.

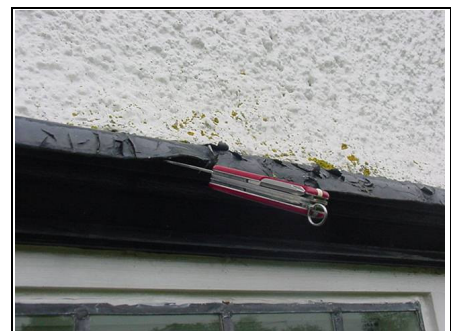
Knife test to windows. Also note moss to the render

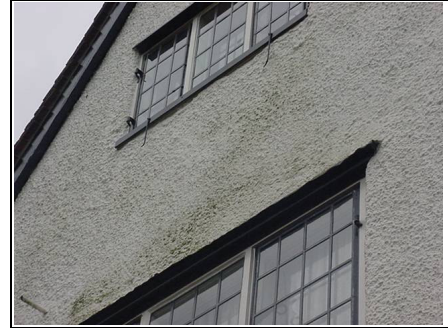
We would comment that the painted render acts as a protective coat to the property. When you redecorate in a few years time it will be fairly expensive, you should not underestimate the importance and cost of re-decorating the render.

Moss growing on the render which needs treatment and redecoration spring/summer 2011

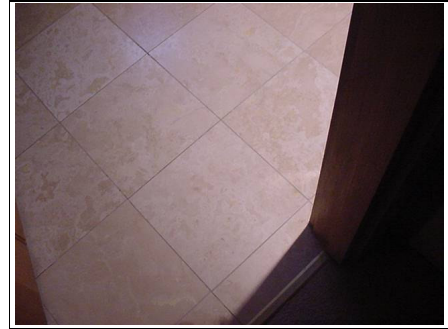
We noted that floor tiles had been used in the bathroom. Where you have a mix of solid materials such as tiles and a flexible structure such as the timber framed structure and the floor it's on, you can get breakages in the grout. We are advised that the bathroom is relatively new so this is something that will happen in years to come.

Floor tiled within the main bathroom

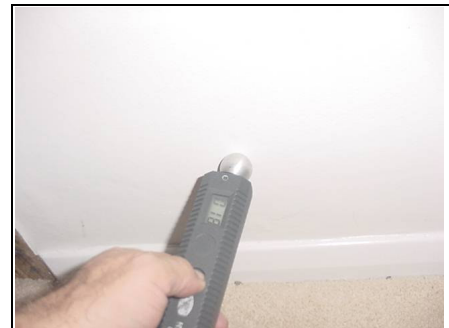
We carried out tests with an electronic damp meter and found average dampness considering the age, type and style of the property.

Checking for rising damp –
reading of 18

ACTION REQUIRED: Please see our comments in the Executive Summary.

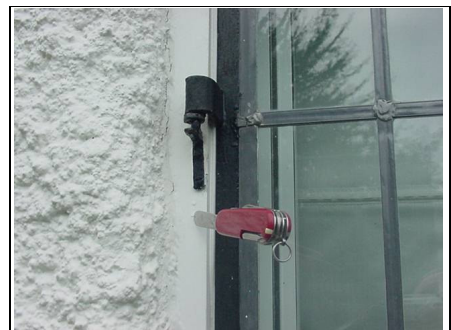
We believe there may be wet rot to the fascias and soffits and the windows as we can see flaking paint and some blistering of paint. We would expect some wet rot to the rafter feet and possibly the common rafters although we were unable to examine these. Please see our comments within the Executive Summary.

Checking windows for wet rot

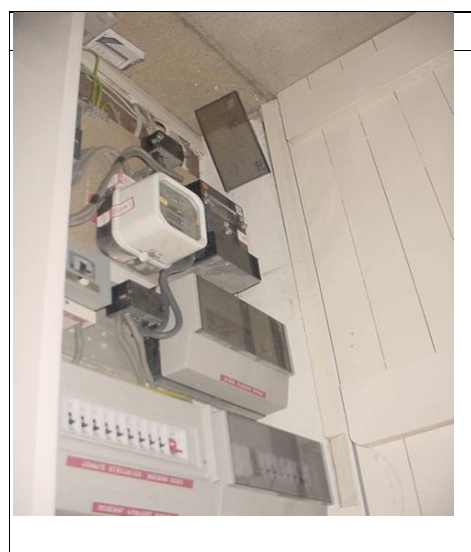
The electric fuses and consumer units were located in the cupboard on the upper ground floor adjacent to the stairs. We would date the fuseboard as being from the 1980's/1990's and, whilst not the best now available, it is reasonable. During our question and answer session the owner advised the electrics have been updated quite recently.

ACTION REQUIRED: We would recommend that you obtain a copy of the latest certificate via your solicitors. If this is not forthcoming then you do need to carry out an electrical test due to the failure of the earth testing that we explain below.

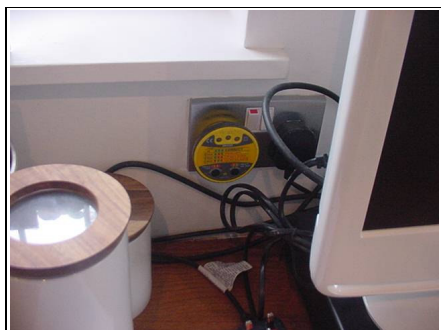
When we carried out the electric earth test it fused the system. During our question and answer session we were advised that kitchen alterations had been carried out. Often these are carried out without using a qualified electrician although in this case they did say that he was. We nevertheless feel that electrical wiring if not to the best standards in a timber framed property can cause all sorts of problems particularly relating to fire. It will depend upon how you use the building, it may well be a stress and strain on the existing system.

Earth test that failed

ACTION REQUIRED: As the property is changing occupancy the Institute of Electrical Engineers (IEE) recommend an NICEIC (or equivalent) registered and approved electrical contractor carry out an inspection, test and report.
