RESIDENTIAL BUILDING SURVEY

Islington, London N1

GEM Associates Limited

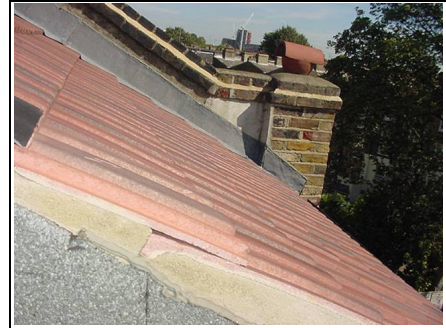
We much prefer a slate roof to be replaced with a slate roof, particularly due to the extra weight that can be put on the roof by concrete tiles. We also consider this particular roof to be poorly detailed, and we would expect a lead valley gutter to the front of the property and work to have been carried out to the parapet walls, especially as we were advised that this work was only carried out a few years ago by the Local Authority Landlord.

Close up of concrete roof tiles

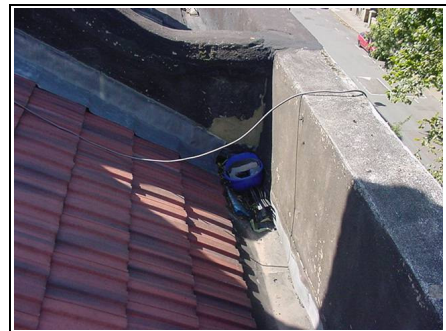
Front box gutter to parapet wall

ACTION REQUIRED: The box guttering needs to be kept clear. It is likely that this is going to leak in the next five to ten years. We also noticed some tiles have been damaged, which need to be repaired

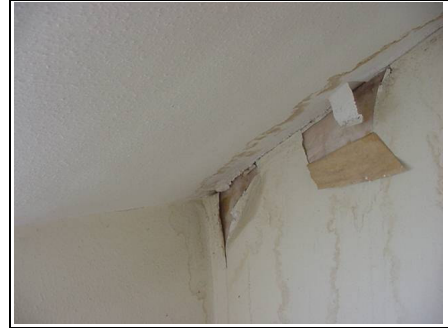
We can see staining to various areas of the property. Some of this we believe relates to old roof leaks, other areas we think dampness could still be getting in via the parapet walls. Having taken a close look at them we can see they have a flashing, which may or may not have been cut in correctly. It is literally not possible to tell without damaging the flashing.

Dampness to the rear of the property on the top floor

We would comment that the roof was probably in a bad way when it was replaced, allowing water in.

ACTION REQUIRED: Unfortunately the only real way to see whether dampness is coming in (unless it is excessive) is to repair and redecorate.

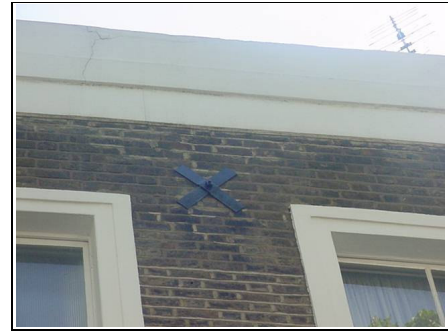
We can see that there has been movement in the property, as we are sure you can with the cracking that can be seen in the walls. We believe this relates to the embedded floor joists that run from the front to the rear of the property, that would have originally given lateral strength to the front and rear walls. These have deteriorated over the years the lateral strength has been reduced. This has resulted in movement in the property.

Tie bar on front of property

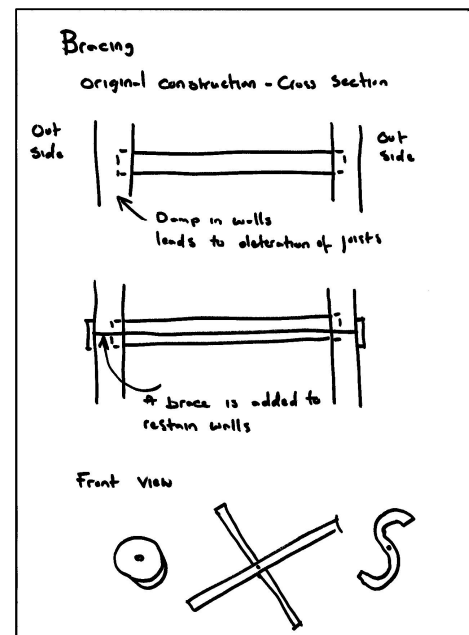
Lots of movement in the structure

Evidence of movement can be seen throughout the property. The cracking relates to the movement of the front and rear walls, which have spread and then been restrained by tie bars, but have obviously had further movement following this, which is why we have recommended that the walls are tied into the main structure to help restrict any further movement. We noticed a similar problem had occurred in the adjoining property. Work may have to be carried out in conjunction with your neighbour.

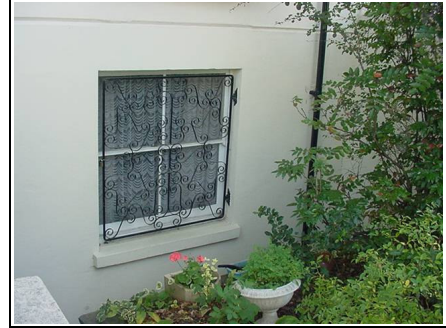
Movement can be seen on the walls

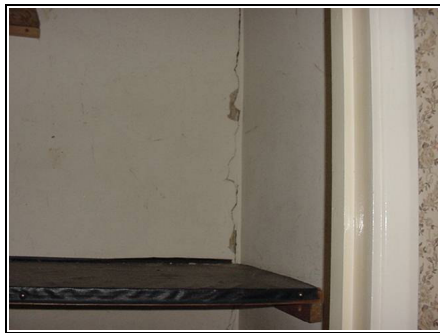
Cracking caused by movement

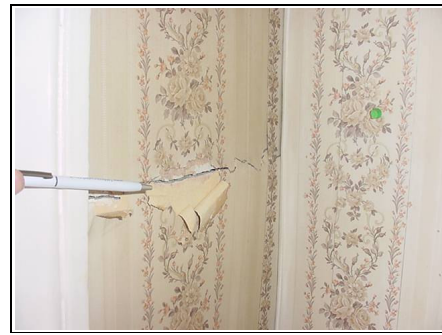
Cracking on wall

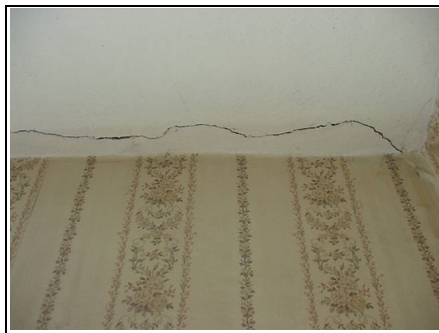
Cracked ceiling

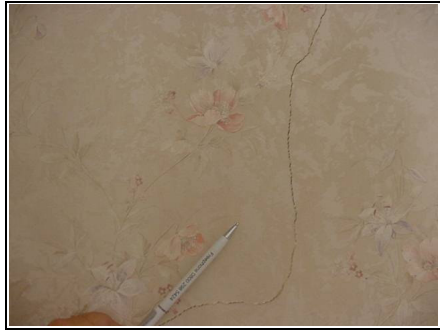
Vertical cracking

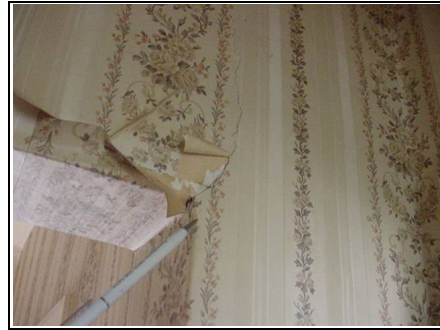
More cracks

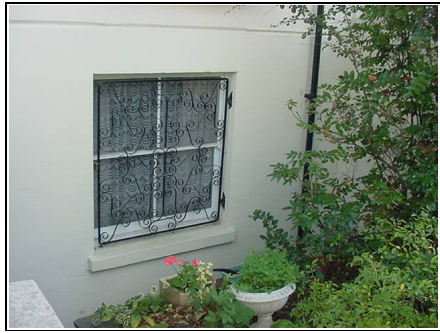
A photo of the basement. Notice the downpipe on the right hand side, which discharges directly onto the ground adjoining the property

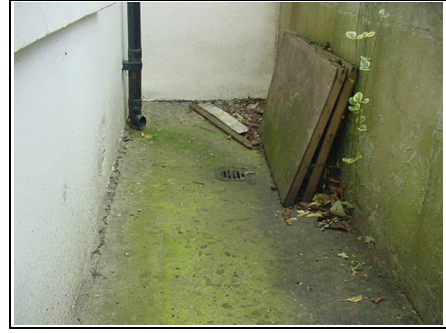
A photo of the downpipe discharging to the base

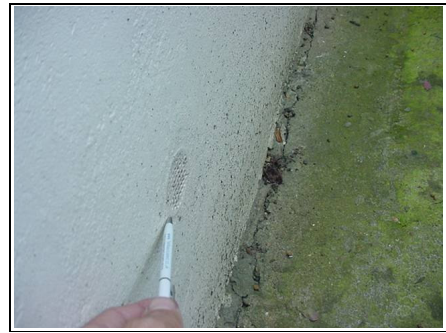
This is an air venting system that does not tend to work. We would recommend that a bell mouth detail is added to the base of the render

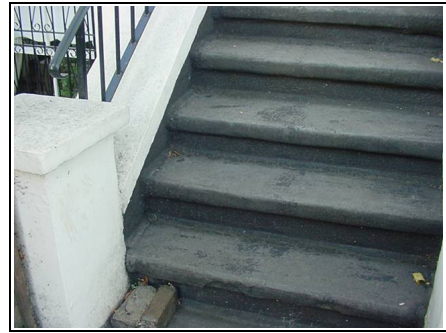
We also noticed that the steps into the property were asphalt covered. We have come across many instances where these allow dampness into a property, albeit that there is normally a cupboard storage space beneath.

Asphalt covered entrance steps

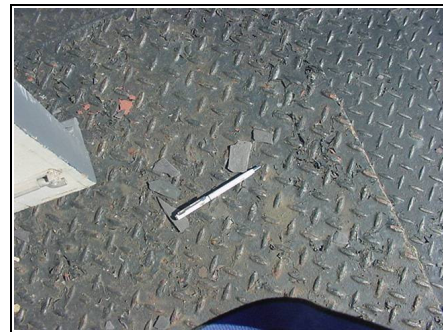
We would comment that the fire exit to the rear is starting to rust and would benefit from redecoration.

Rusting fire escape

ANTICIPATED COST: In the region of £1,000 to £2,000. We assume this is a shared, but your Lease will confirm this.

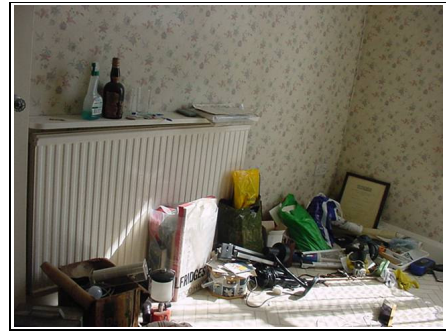
We noted that many of the radiators are internal. As we explained to you, it is traditional to put them under the windows, as this allows air flow and circulation and condensation is more likely if they are not located under the windows.

Internal radiator

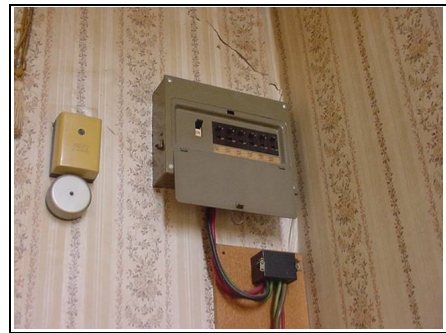
You have a dated electric box in the stair half landing. We recommend that this is replaced, together with it being boxed in with a half hour fire resistant box, as it is an additional fire hazard on the staircase. We also recommend checking the electrical system and possibly increasing the number of socket points.

Dated fuseboard

ACTION REQUIRED: An NICEIC test and report to be carried out to Electrical Engineers (IEE) standards. We would also recommend that additional socket points are added at the same time.

ANTICIPATED COST: In the region of £1,000 to £2,000, depending upon the amount of work required and recommended. Please obtain quotations.

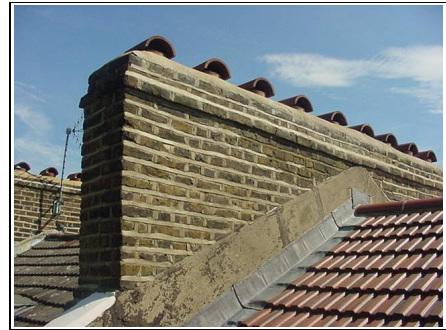
Left hand chimney

This chimney is brick finished with numerous chimney pots. It has a cement and metal flashing, which we believe to be lead. The chimney is in average condition. We can see by the different colour mortars that it has been repointed.

Unfortunately we were unable to see the very top of the chimney known as the flaunchings, we therefore cannot comment upon them.

ACTION REQUIRED: A periodic inspection of the cement flashing needs to be carried out, as these are susceptible to cracking and leaking.

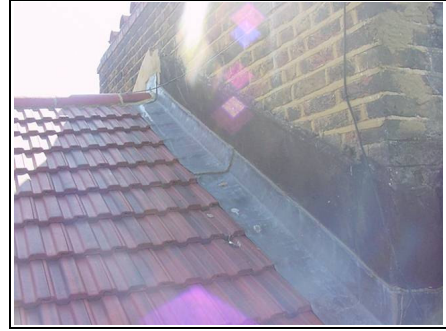
Right hand chimney

We would comment in a similar manner to the previous chimney. Again, we are concerned about the large amount of cement that has been plastered onto the chimney, some of which has been covered in bitumen in this case, which indicates that it has leaked or caused problems in the past. Please see the Report for further comments.

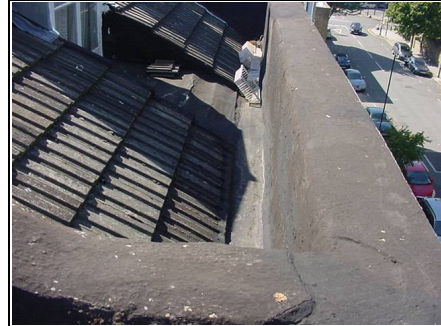
Parapet wall

As often is the case, they have had some repairs over their life and we can also see that bitumen has been used, which tends to be used where they are leaking.

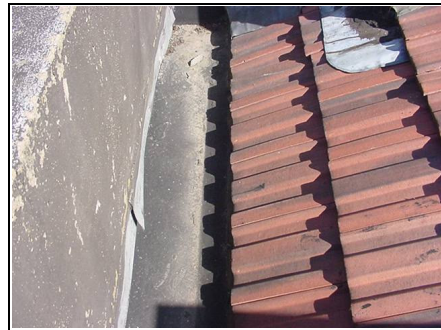
Our main concern is the box gutter that is formed to the front, which we would much prefer to be in lead. They are susceptible to leaking and lead really is the best material (in our opinion). The box gutter is formed with a felt, with a small metal flashing. We believe this is susceptible to blockage and does need to be inspected regularly, particularly to ensure it does not get blocked with leaves, etc.

Close up of box valley gutter.

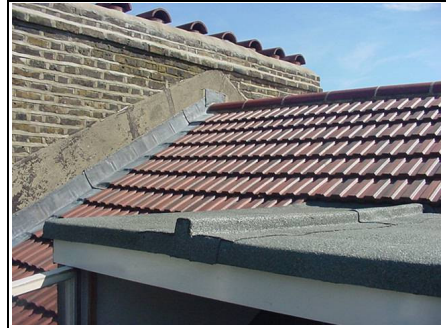
There are two dormer windows to this property; one to the front and one to the rear. We were able to gain access to view the one to the front of the property closely. We could see that the original metal roofs and metal sides have been replaced with a felt, which we do not feel is anywhere near as good.

You can see the felt roof. However, it is relatively new and therefore will last. It is a shame it wasn't carried out in a proper detail, as it was originally in metal

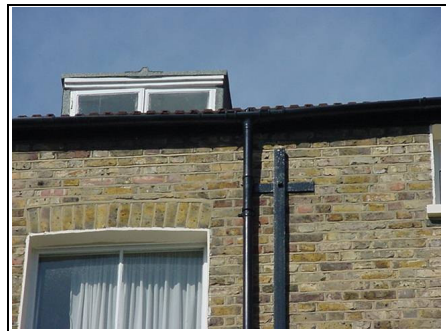
Unfortunately, we had a very poor view of the rear dormer, as you can see in the adjoining photo, and we therefore cannot comment on its condition. We would take an educated guess that it was repaired at the same time as the front dormer.

Dormer window to rear of property

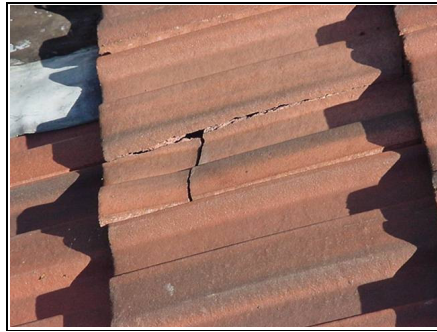
Cracked tile

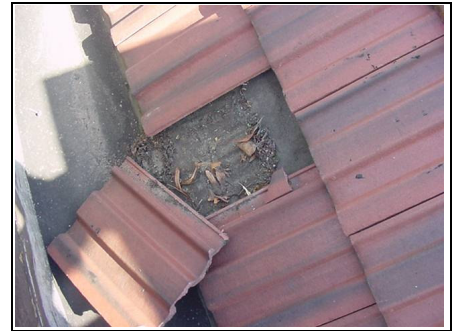
Displaced roof tile
(which we did put back in place)

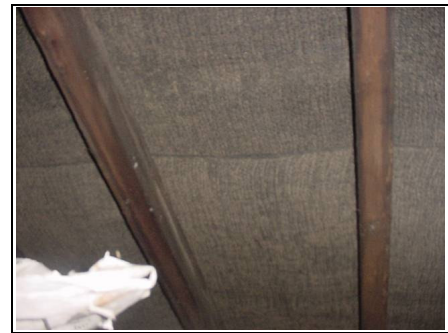
When we inspected the loft space we found a Hessian base bitumen membrane. This type of membrane has been used since the 1960s. We generally found it to be in average condition, it is damaged in a few more places than we normally find.

This photo shows the common rafters (the ones that form the pitch of the roof) and the dark area between is the underlayer.

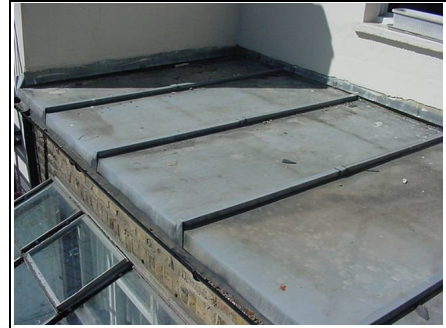
There is a flat roof over the downstairs apartment and is covered in metal, which we do not believe to be lead. We assume, as with the main roof there will be a shared responsibility over this. It looks in average condition, although we cannot ever be certain without inspecting the apartment below, which we cannot do in this instance.

Downstairs flat roof; metal covered

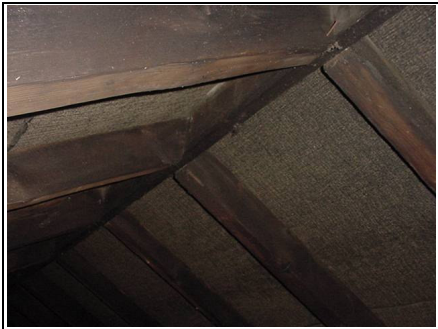
Main roof

We found the roof timbers generally in slightly below average condition considering their age. We found dampness, which we believe to be due to the original poor condition of the roof. We have inspected the roof structure for:

ACTION REQUIRED: We recommend adding ventilation. The only way to be 100 per cent certain is to have the roof cleared and checked. We would recommend adding ventilation to help reduce condensation.

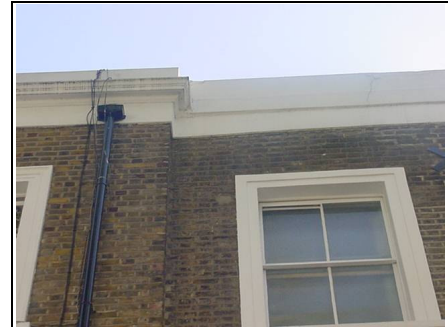
The property's hopper heads and downpipes are fairly typical of what we see and are in average condition. There may be some minor leaks, but we feel most people would be happy to live with these. We do tend to find where there is heavy downpours or rain with this type of roof, of hopper head and downpipe format, that they can overflow.

Rainwater downpipes and hopper head

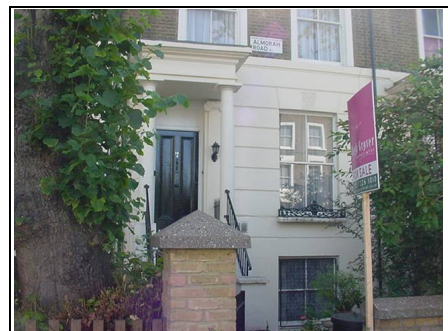
There is painted tender to the lower portion of the front of the property, which is common. It looks in average condition. We mentioned elsewhere within this report about the problems with dampness to the lower portions of the render, which is where we would recommend that a bell mouth detail be added.

Render to lower portion of the front of the property

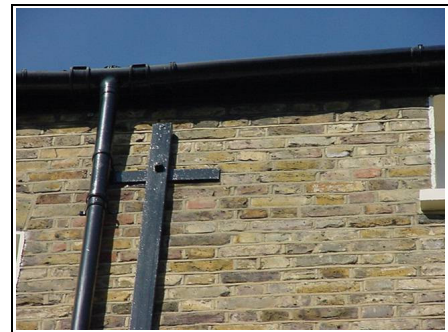
The property has tie bars, these have been added to resist movement in the structure.

Tie bars to rear

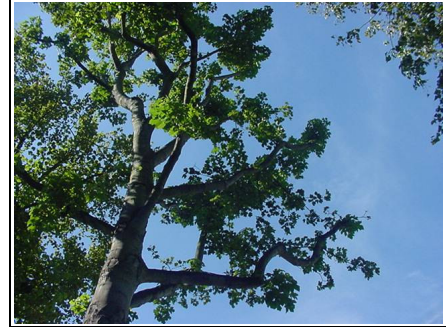
There are some big trees to the front of the property. Damage to foundations and underground services can be caused by trees and shrubs. There are two trees within the vicinity of the building in, what we term within influencing distance, and we believe that these trees may be affecting the property if not suitably maintained.

Big trees to the front

ANTICIPATED COSTS: In the region of a few hundred pounds to keep the trees maintained. We assume this falls within some sort of service charge. Your legal adviser to check and confirm.

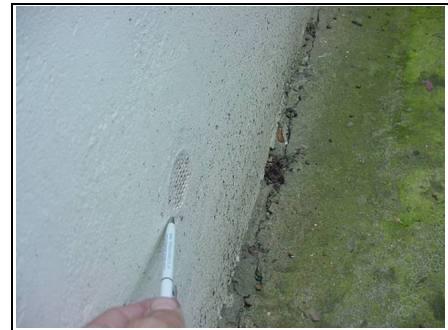
All modern properties should incorporate a damp proof course (DPC) and good building practice dictates that a differential of 150mm (6 inches) should be maintained between the damp proof course and ground levels. In this case, we could see vents on the outside of the building, which is typical of a remedial system that we have seen many times before, although we are still not certain that it works. We would recommend that a bell mouth detail is added.

Air vent

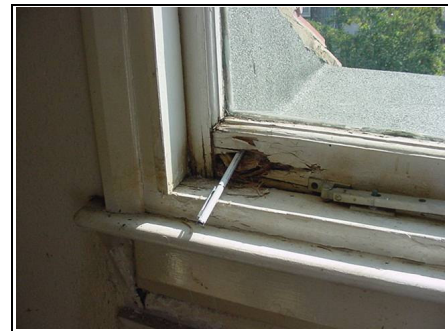
The property predominantly has painted timber sliding sash windows, which are single glazed. They are in below average condition and will need repair work. Some of them may be beyond economical repair, particularly the casement windows to the dormers. We would recommend you do everything possible to ensure that you keep the existing windows as the timber used in them is normally far superior to modern windows (unless you are buying very expensive ones).

Rotten window to the dormer at the front of the property

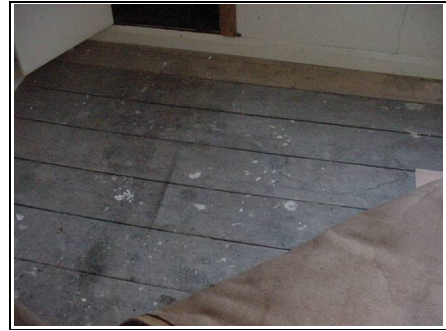
We believe the mortar had embedded timbers, which is why the floor deflects slightly, due to the rot that occurs to the end of the timbers. Also, relatively large openings cut into the floor to allow the staircase, to ensure that these floors always move slightly.

Timber floor

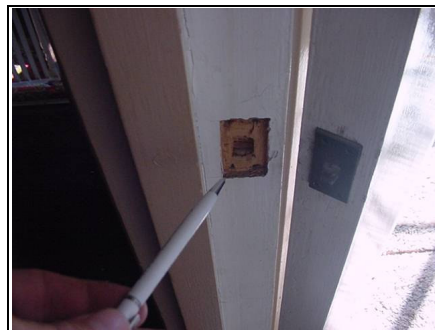
Missing door closer

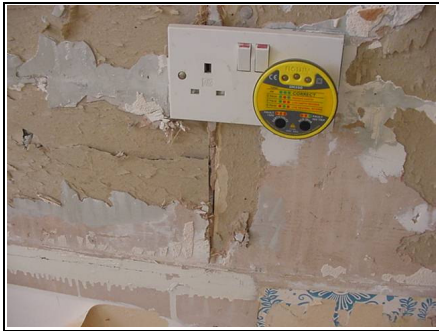
Earth test in kitchen, which failed
