RESIDENTIAL BUILDING SURVEY

London N19

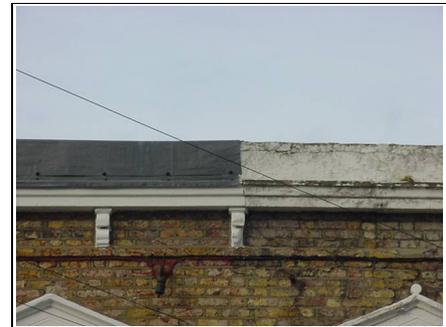
Close up of parapet wall

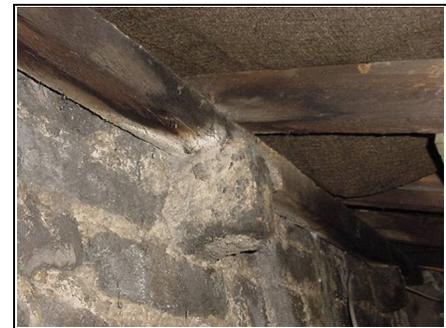
Darkening of timber indicates dampness to the timber

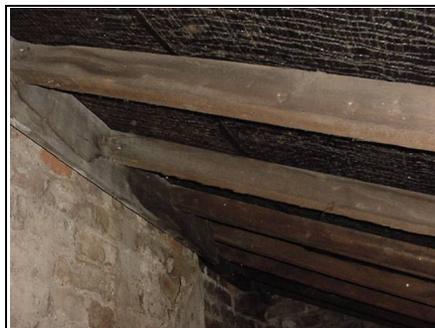
The property has a butterfly roof, these are renowned for being problematic particularly the central valley. From within the roof space (you have two roof spaces to the front butterfly roof and one to the rear roof) we can see that several repairs have been carried out to the valley gutter. We can see in the rear roof the timbers are in a poor condition and in fact additional timbers have been added to help support the roof.

Dampness coming from a leaking parapet wall

ACTION REQUIRED: You need to vent the roofs which have been insulated beyond appropriate for an older property. Condensation is occurring in the rear roof in particular to the condition of the timbers, some of these timbers will need replacing. It is difficult to tell whether the timbers are damp from condensation and/or from dampness coming in via the roof parapet wall or from a leaking valley gutter. We suspect it is a mixture of all of these factors.

ANTICIPATED COST: As mentioned previously we were unable to gain access onto the roof due to the padlocked roof light. We suggest you set aside the sum of £5,000 - £7,000 to carry out this work; quotations required. As this is high level work there may also be some scaffolding necessary.

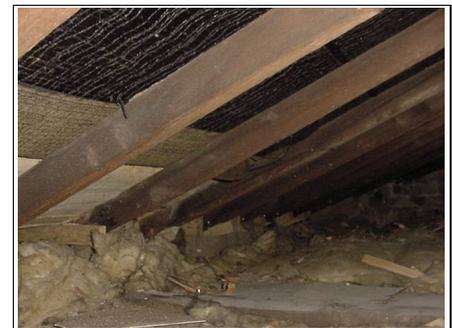
Dampness in the timbers from condensation or a leaking valley gutter

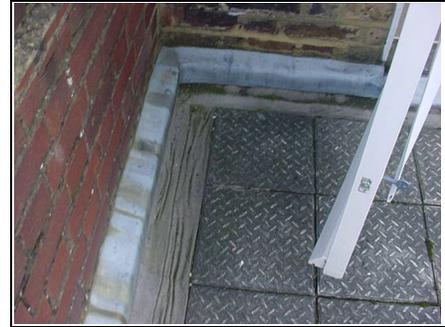
Asphalt is very much the rolls royce of flat roofing. The rear balcony is asphalt covered, we can see this is starting to deteriorate; its life could be extended by having some repairs carried out.

Between the grey lead flashing and the pavier slabs you can see the asphalt is starting to deteriorate

ACTION REQUIRED: General repairs to the asphalt.

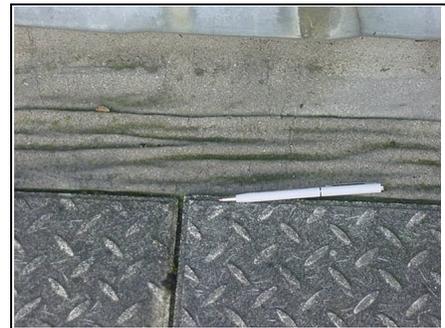
Close up of asphalt

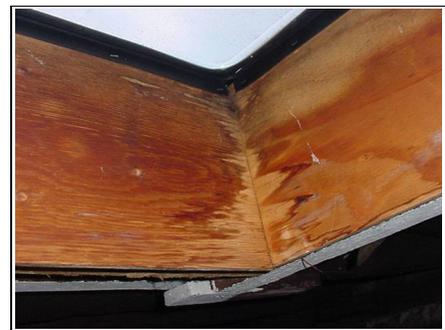
The roof light on the right hand side of the main roof is leaking. This is not a major problem in comparison with the dampness in the timber.

Roof light leaking

ACTION REQUIRED: Replace with a modern double glazed roof light.

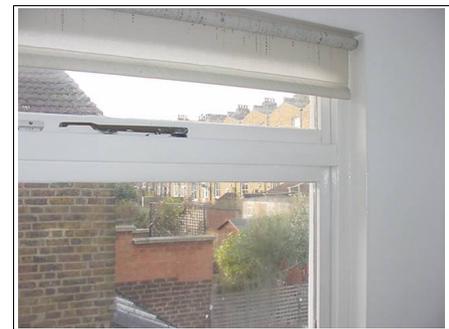
You have a mixture of windows from timber windows to aluminium windows. Many of the double glazed sealed units have misted over meaning that the seal has failed. Some people can live with this, other people cannot; you need to decide. We would also add that we noted the more modern timber windows to the rear of the property in the kitchen area had soft rot which had been painted over.

Lower window misting up

ACTION REQUIRED: Replace the glazed units and also budget to repair, prepare and redecorate the windows in a few years time.

ANTICIPATED COST: We would suggest you set aside the sum of a few hundred pounds per window dependent upon the size of the windows you need to have replaced; quotations required. You may find it more economical to have the whole unit replaced in a plastic unit and then this would avoid cold bridging.

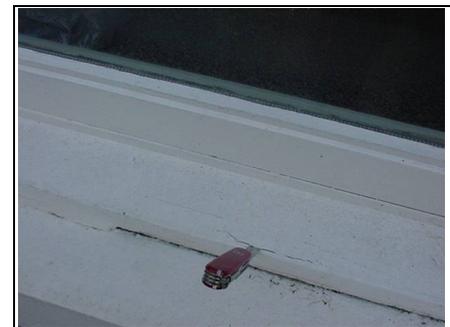
Soft rot in rear window

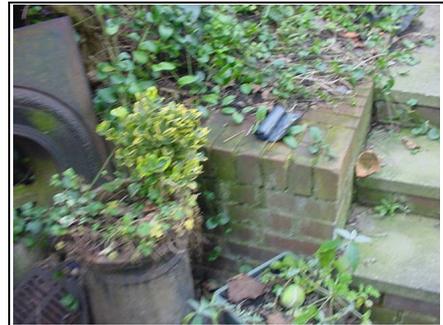
9) Retaining wall within the rear garden

There is a small retaining wall in the rear garden. We noted this didn't have any weep holes. Ultimately this will be damaged by the pressure of the ground water pushing against it.

ACTION REQUIRED: We suggest that you diamond drill some weep holes.

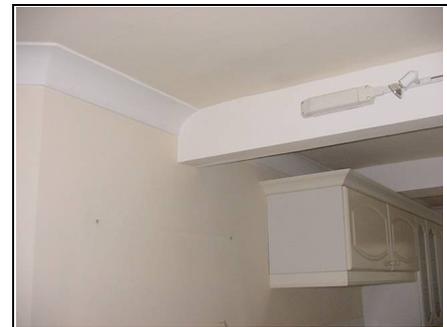
We noted structural supports in the kitchen/breakfast room area which haven't got any piers. It is likely that there is no building regulations approval for them. As they support an extension above you need to get this checked and confirmed.

Structural supports in kitchen/breakfast area with no piers

ACTION REQUIRED: Your solicitor needs to check and confirm whether building regulation approval has been obtained.

ANTICIPATED COST: To obtain retrospective building regulations approval on this is very difficult. Your solicitor may be able to offer insurance against problems relating to this.

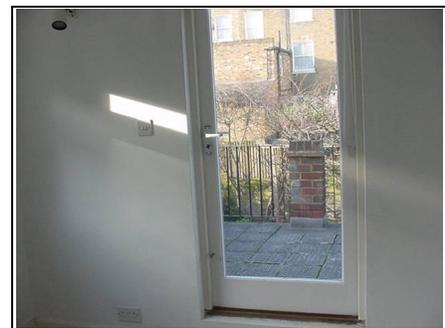
In general we feel the security to the property can be improved in the form of an alarm system and bars to the main entrance door. We also noted that the rear door at first floor level that goes onto the balcony was mainly glass. This may cause a security problem.

Glass rear door

ACTION REQUIRED: Depends on how far you wish to go security wise, it is very much personal issue.

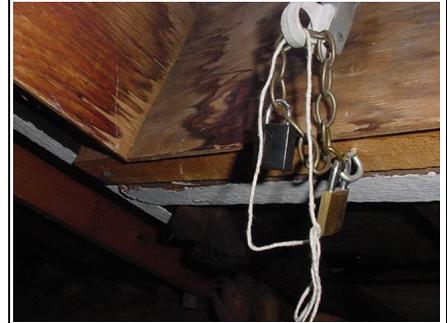
You are only able to see the roof light within the right hand roof. This roof light is leaking as you can see in the adjoining photos. It is also the locked one that would normally give access to the main roof.

Locked roof light

ACTION REQUIRED: We would recommend that this roof light is replaced in its entirety with a modern double glazed unit.

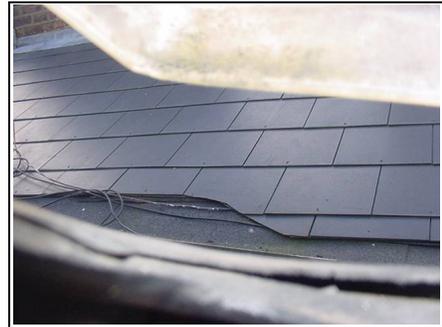
Looking out through the roof light at the manmade slates you can see the unusual cut to the base of the slates to the middle and left hand side of this photo

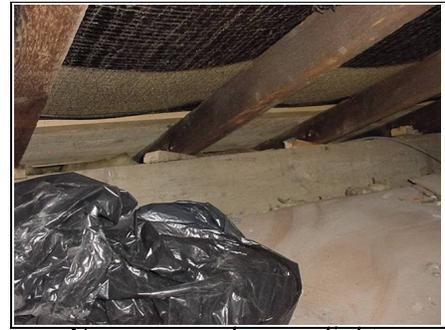
In this instance we have a very limited view of the Valley Gutter from the outside although we could see it internally. Within the roof space we could see that new boarding has been used to the valley itself which could mean in a best case scenario that the Valley has been replaced properly or it could mean in a worst case scenario that it has been temporarily fixed.

You can see the new lighter coloured timber to the base

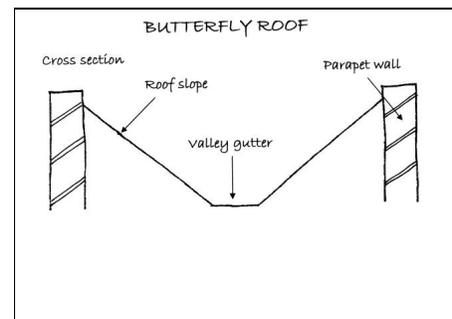
This roof is a poor example of what we typically see but saveable. Typical problems are timbers rotting, brick nibs spalling.

ACTION REQUIRED: When re-roofing the timbers need checking - we showed you the condition of the timbers in the neighbouring property

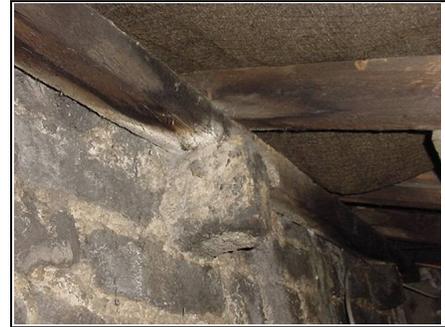
We found dampness in the form of condensation and minor roof leaks via the parapet wall, chimneys and valley gutter. We also believe there is likely to be woodworm in a structure of this age although we couldn't see any active signs of fresh frass.

Dampness in timber

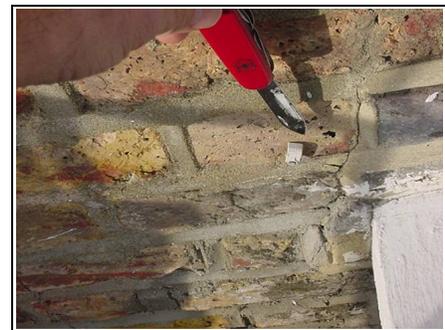
The walls have been inappropriately repointed with a cement mortar which should have been a lime mortar. This will ultimately cause deterioration to the brickwork.

Cement mortar that has been put heavily on brickwork

ACTION REQUIRED: You need to set up a programme of gradual replacement of the cement mortar.

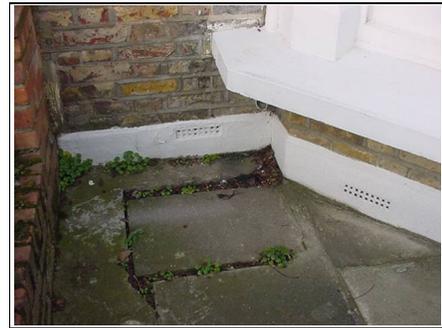
We noted air bricks at the front of the property although some of them are blocked and we noticed one to the rear of the property which we feel would benefit from more air vents. Ideally these need to be placed within the property allowing through air ventilation.

Airbricks to front

ACTION REQUIRED: We recommend that all existing vents are cleaned and additional vents are added. This can be carried out by a vent strip hidden under the stairs or one running along the skirting area. We also recommend the air bricks are kept clear so you have adequate ventilation.

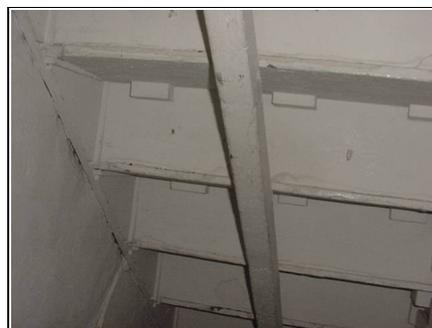
Staircase not lined

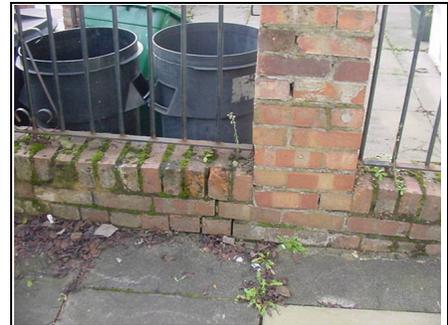
The wall to the front garden would benefit from some work in the not too distant future
