RESIDENTIAL BUILDING SURVEY

Kempston,
Bedford,
Bedfordshire.
MK42 XXX

INDEPENDENT CHARTERED SURVEYORS

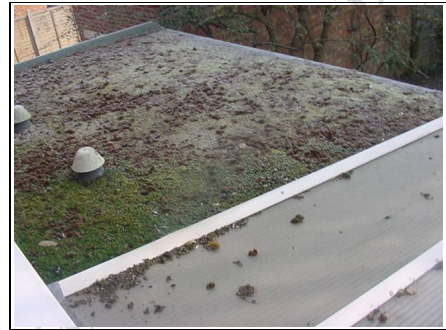
Over the kitchen area and the side area with cloakroom/shower room we feel that there will be a problem in the next few years as there are some signs of cracking and marks in the kitchen area indicating either condensation or that dampness is getting in from the roof.

Rear flat roofs with moss growing

ACTION REQUIRED: Work should be carried out to this area to be better safe than sorry. The owner advised that he would clear the roof and patch and repair the roof as necessary.

We recommend this work is carried out before you purchase the property and checked.

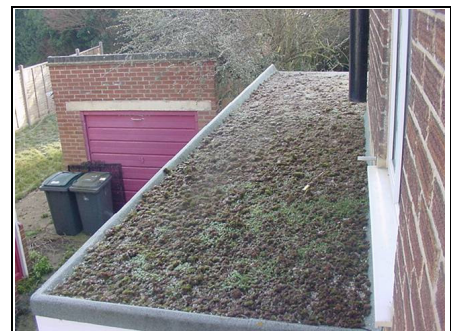
Side flat roof with moss growing

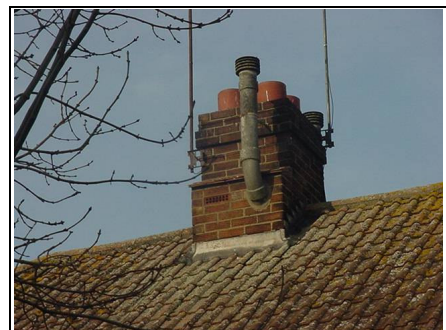
Again the owner advised that he would remove the asbestos flues.

Asbestos flue

We would recommend this is removed prior to you purchasing the property. Please note that we are not asbestos surveyors.

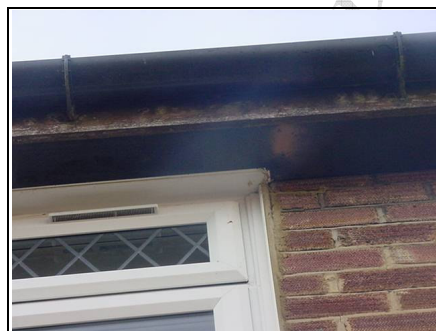
The fascias and soffits are in poor condition we suspect due to old leaking cast iron gutters which have now been replaced with plastic without redecorating the fascias and soffits.

Timber fascias and soffits

ACTION REQUIRED: Redecorate or replace.

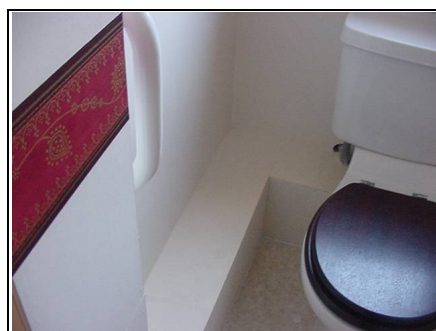
We would also add that the toilet is on a macerator system as some people are unhappy with the noise that these systems generate and they are not as reliable as a gravity fed system.

Cloakroom/shower room macerator system

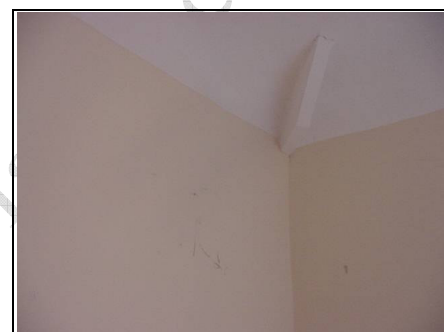
Cold bridging is caused by a colder element in the structure allowing coldness to pass through the structure much quicker when warm moist air is present in the property

Potential cold bridging area where there is part of the roof within the room (where the timber is)

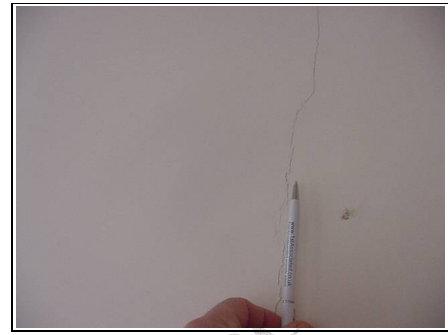
There is hairline cracking in the property which is visible in the ceilings and some of the walls which has come about due to the relatively high moisture content in the house and also what looks to be a skim coat of gypsum plaster to the walls over the original plaster or cement.

Hairline cracking

You need to reduce the humidity and condensation in the house although in our experience this problem will never go due to the incompatibility of modern gypsum plaster with older rendered cement.

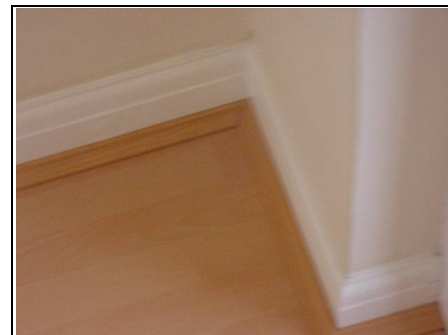
The ground floor flooring is from the cheaper end of the market and is a laminate floor covering. We could see from the way that the corner beads have been used they have not been fitted very well and the floor has a springy feel to it.

Laminate flooring

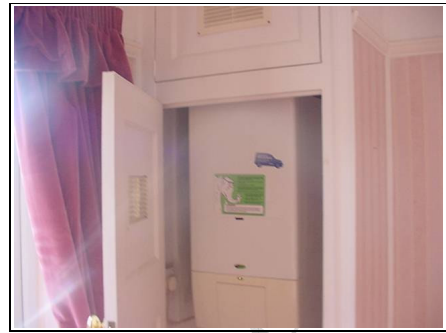
There is a boiler in the rear right hand bedroom which is not an ideal location as many people are unhappy with the noise that a boiler generates which situated in a bedroom.

Boiler in cupboard in bedroom

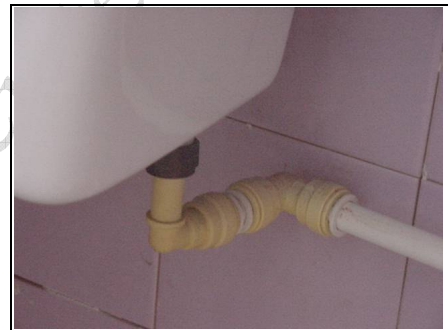
We noticed that water supply pipes in the bathroom on the first floor had been plumbed in with a plastic pipe which is unusual rather than copper pipe. Most plumbers would use copper in their own homes.

Plastic piping under sink in bathroom

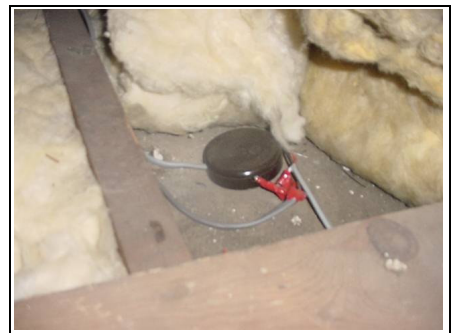
We were advised by the owner that the electrics have been updated however within the roof we found taped over wires which we would not have expected to pass an Institute of Electrical Engineers Test.

Electrics in roof

For the electrics we would recommend an Institute of Electrical Engineers standards (IEE) test and report be carried out by an NICEIC registered and approved electrical contractor or equivalent, which is recommended whenever a property changes occupancy.

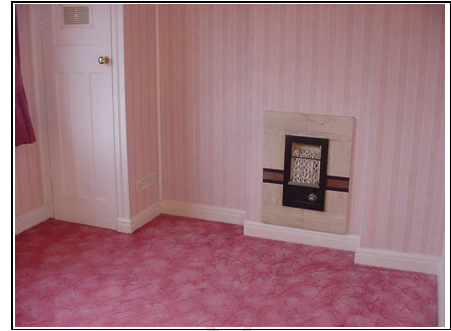
Fire

ACTION REQUIRED: Fires to be checked by a Gas Safe engineer to ensure there are no problems with them.

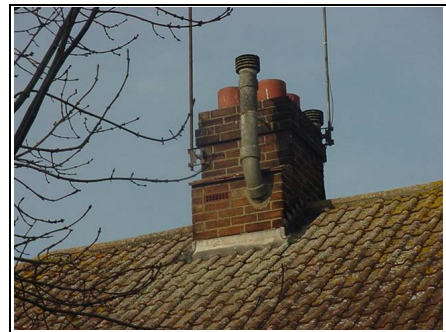
This chimney is brick finished with a lead flashing flashing and several chimney pots, asbestos flues and television aerials. From what we could see from ground level it looked in average condition with the exception of the asbestos flues that have been added considering its age, type and style. Unfortunately we were unable to see the flaunching, we therefore cannot comment upon them.

Chimney with asbestos flue

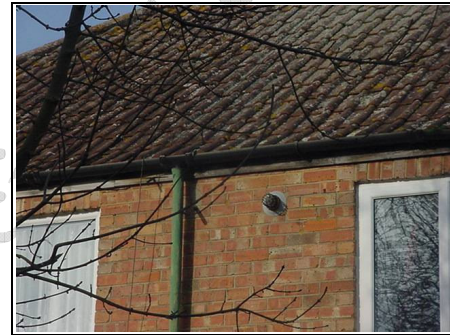
The main roof is hipped and pitched and clad with a concrete tile, and, from ground level, this looks in slightly below average condition considering the roofs age type and style which is because the coating on the tiles looks to be wearing away and there is also some moss on the roof.

Main roof

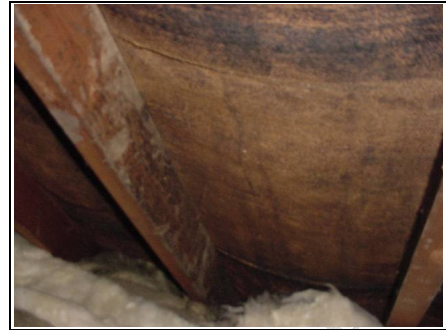
When we inspected the loft space we found a Hessian base Bitumen membrane. This type of membrane has been used since the 1960s. We generally found it to be in average to below average condition, with damage in slightly more areas than we typically find. If you look at the timber in the adjoining photograph you

can see that some dampness is getting through which we often find with these older roofs.

This photo shows the common rafters (the ones that form the pitch of the roof) and the dark area between is the underlayer.

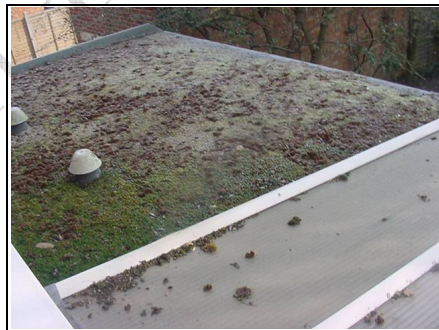
The flat roofs are flat, please see our comments in the Executive Summary, we believe that repair work will be required on these roofs.

Rear flat roof with moss

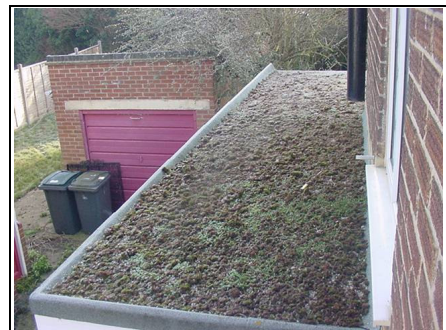
Side flat roof with moss

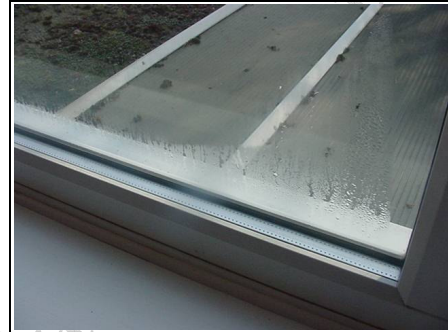
There is a polycarbonate roof to the conservatory to the rear of the property. Polycarbonate roofs are subject to solar gain in the summer months and heat loss in the winter and are prone to leakage.

The average lifespan for this type of roof is fifteen years and some condensation can be seen which does tend to reduce the life of this type of roof.

Conservatory roof

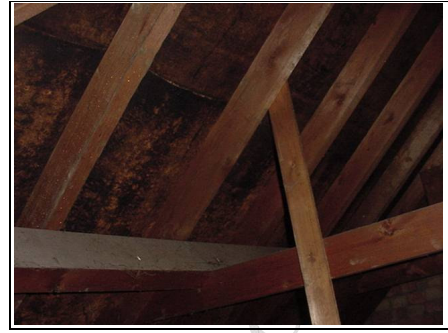
General view of inside of roof

Our examination was limited by the general configuration of the roof and the insulation. What we could see was generally found to be in average to slightly below average condition for its age, type and style as they are slightly damp in some areas. It is, however, feasible that there are problems in the roof that are hidden.

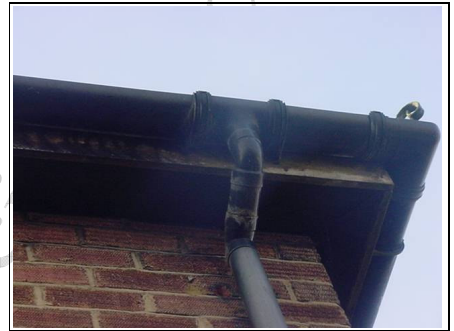
There are signs of guttering leaking as well as some minor leaks but most people would be happy to live with these providing repairs are carried out within the next six to twelve months. We would also add that the rear central downpipe has now been amended due to the extension of the conservatory to the rear.

Leaking gutters

ACTION REQUIRED: We would recommend you stand outside the property next time it rains heavily and see how well the drains cope with the rainwater particularly looking at the guttering and the joints. We would also recommend that the gutters and downpipes are cleaned out, the joints are checked and the alignment checked to ensure that the gutters fall towards the downpipes.

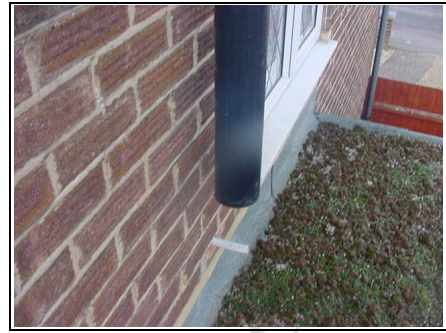
The property has a mixture of cast iron and newer plastic soil and vent pipes which has been disconnected but not removed ideally we would recommend to remove this.

Original cast iron soil and vent pipe disconnected but not removed

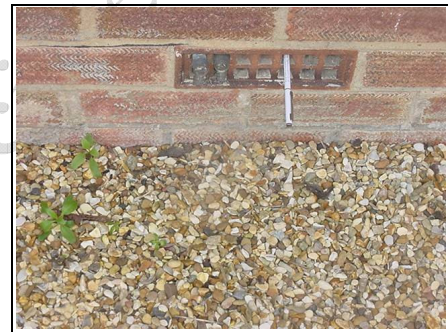
Air brick

Air bricks are essential to have a through flow of air as this helps to reduce the chances of wet rot, dry rot and woodworm. We are concerned that there are not enough airbricks and they may have been blocked by the rear extensions.

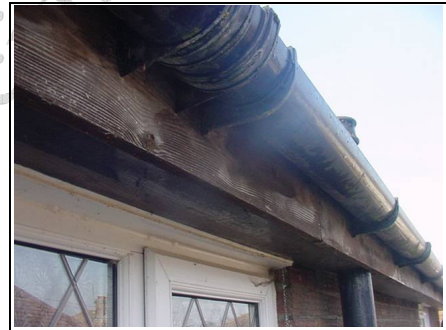
Timber fascias and soffits

ACTION REQUIRED: Please see our comments in the Executive Summary.

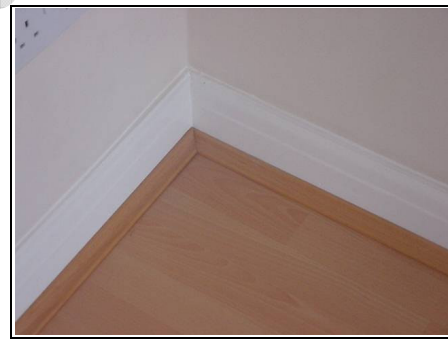
The floors have been covered with a laminate floor covering which is of a below average standard and has some poor quality workmanship.

Laminate floor covering

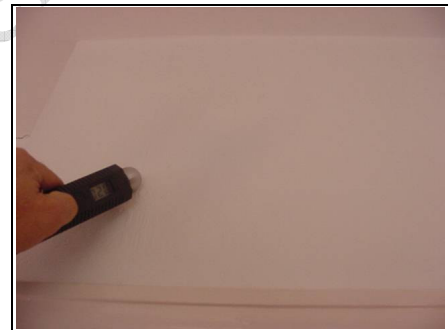
In this particular case we have found no significant rising damp, the minor amounts we did find we believe relates to the property being empty.

Testing for rising damp

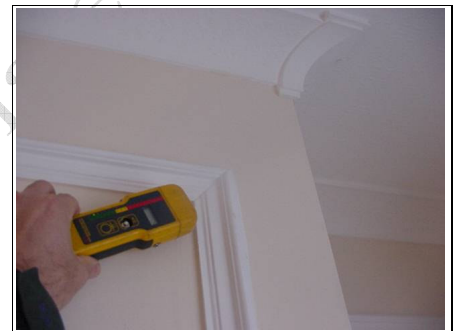
We used a damp meter on the external walls. We have found minor dampness which we believe is due to the property being empty.

Testing for lateral dampness

ACTION REQUIRED: Please see our comments in the Executive Summary.

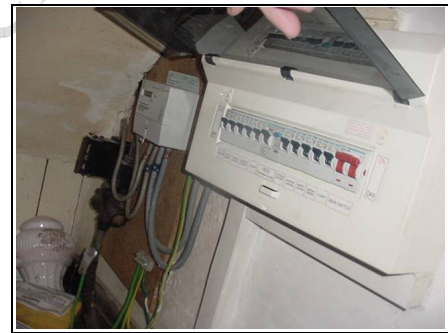
The electric fuses and consumer units were located under the stairs. The fuse board looked newish, from the 1980s or 1990s, possibly.

Fuse Board

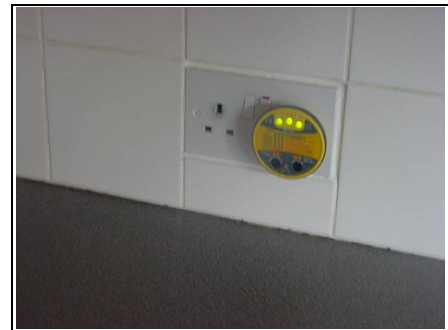
We carried out an earth test in the kitchen area to the socket point that is normally used for the kettle, this proved satisfactory.

Earth Test

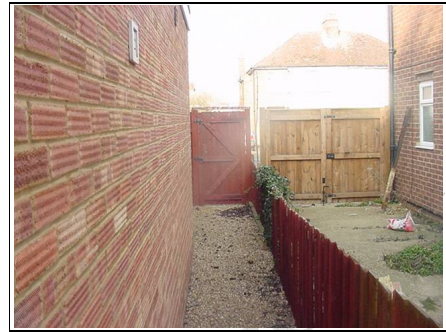
Left hand side low fence that may need to be replaced with a higher fencing.
