RESIDENTIAL BUILDING SURVEY

Kentish Town
London,
NW5 xxx

INDEPENDENT CHARTERED SURVEYORS

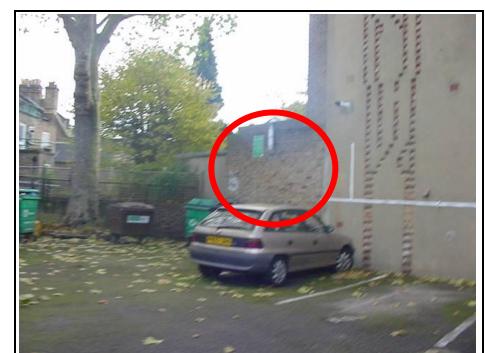
Rear of extension

Your Legal Advisor is strictly correct and without Planning Permission and Building Regulations approval the Local Authority can ask for the rear extension to be removed.

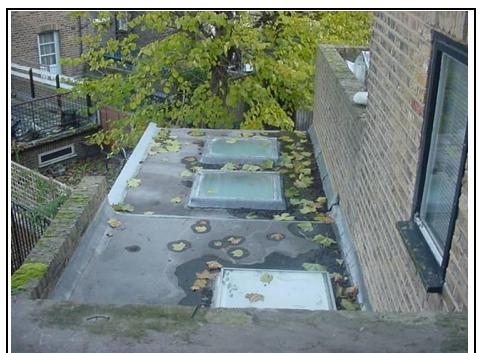
Flat roof on extension

The rear flat roof above the lounge looks to be in average condition. We were pleased to see that it was an asphalt roof.

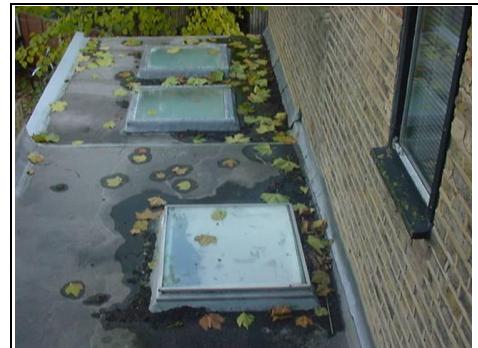
Flat roof with roof windows

We could see some pattern staining down the right hand side indicating that there are flat areas around the roof window and flashing area. In our experience most people forget about the flat roofs until problems occur.

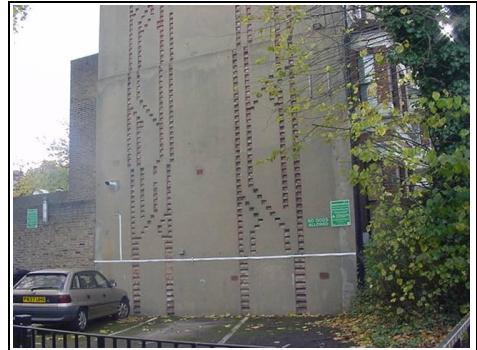
Gable end

The first thing that is notable about this property is that the gable end is partly covered in render and with a brick pattern that outlines the chimney configuration. We were advised by one of the neighbours that this possibly relates to bomb damage and subsequent demolition. This means that the property is now known as an end terraced property and that the old internal wall is now acting as an external wall with render on it.

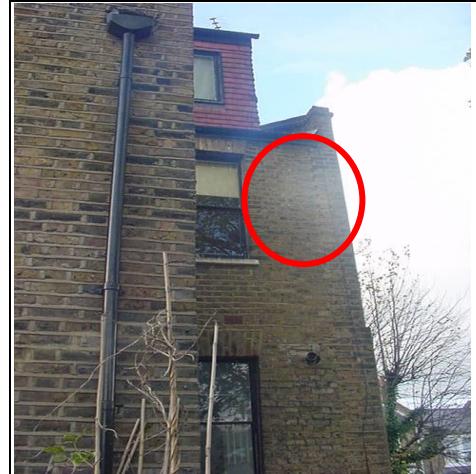
Unfortunately from a one off inspection we cannot be one hundred percent certain that the gable end wall is stable. The Building Research Establishment (BRE) typically recommends that this type of wall is monitored for a year. With the other various other factors that we will discuss we feel this is a medium to high risk purchase.

We are not sure the gable wall is stable as there seems to be movement to the top as highlighted by the red circle

ACTION REQUIRED: The only way we know of to limit your liability would be for the existing owners to place an insurance claim advising that a survey has been carried out and possible movement to the gable end has been noted. If the insurance company confirms in writing that they are willing to monitor the possible movement you can then take over the insurance claim in most cases.

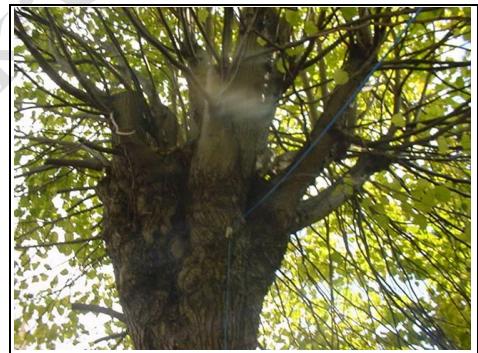
Mature tree

There are mature, substantial trees around the property. These do not look to have been maintained for some time. Whilst, in our experience, older houses can accommodate trees being close to them, providing the trees and houses have been there a long time, in our opinion there are too many trees too close in this particular case.

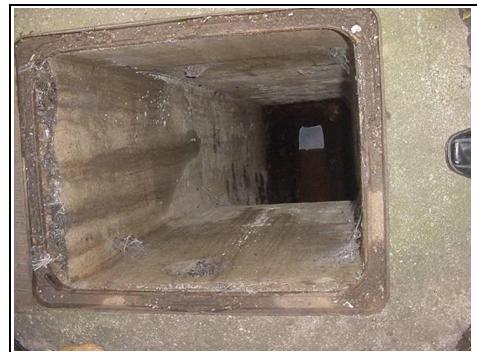
Deep manhole

Another concern that we have with this property is the depth of the manhole that we found to the front of the property. This is unusually deep, together with the fact that it's a concrete manhole. The reason we are highlighting this is that typically for this age of property there would have been a brick manhole which does indicate to us that some alterations and amendments have been carried out to the drainage on the property. Our question and concern is why?

Whilst we have lifted the manhole cover to the front of the property and as we commented we found one of the deepest manholes we have seen. It is also formed with concrete rings indicating it is newer than the building itself.

ACTION REQUIRED: The only true way to find out the condition of the drains is to have a closed circuit TV camera report to establish the condition of the drains. In this age of property there will often have been leaks over the years.

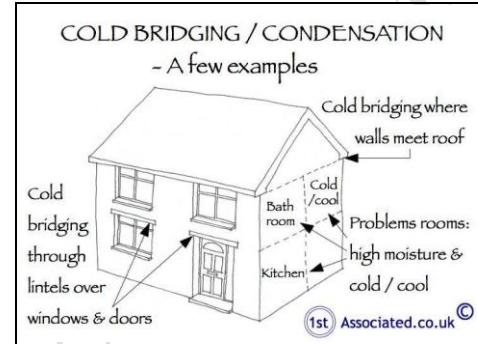
Cold bridging is caused by a colder element in the structure allowing coldness to pass through the structure much quicker when warm moist air is present in the property, often caused by things like having a shower or a bath, cooking or washing, particularly if you are drying washing on the radiators. This is also caused by the general climate which results in condensation on the element.

ACTION REQUIRED: We would recommend that large humidity controlled extract fans are added.

ANTICIPATED COST: £250 to £750 dependent upon the wiring required for the extract fans. We would also add extract fans in any rooms that you intend to carry out the drying of clothes; please obtain quotations.

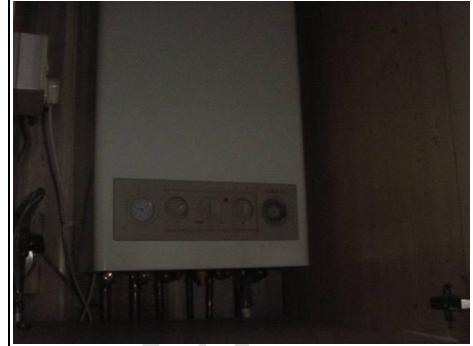
Boiler

The wall mounted boiler is manufactured by Sabre and is a make we rarely come across and as such you may have problems obtaining parts. From the look of it it's quite dated although it has to be said that the apartment was quite warm during the course of the survey. This is possibly because the heating was constantly left on.

The boiler is dated and we would recommend that the system be tested and overhauled before exchange of contracts and that a regular maintenance contract be placed with an approved heating engineer.

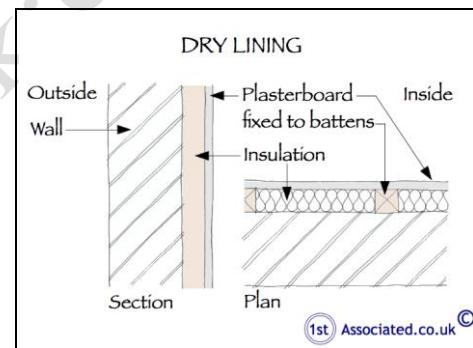
Dry lining

Our thoughts when we find the boiler and heating left on in a property is that there is dampness. We noted to the right hand side wall that there is dry lining, this may be hiding dampness

ACTION REQUIRED: Open up the walls to check their condition to see if there is dampness.

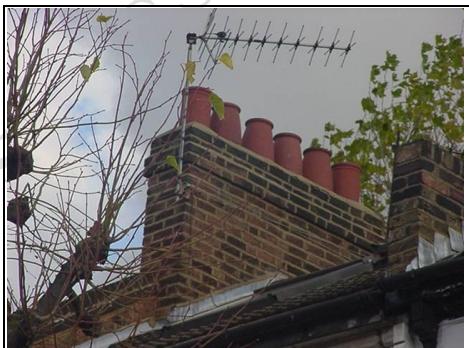
Chimney - left

Our concern would be that we can see the flashing has been cut in to the brickwork rather than following the joints.

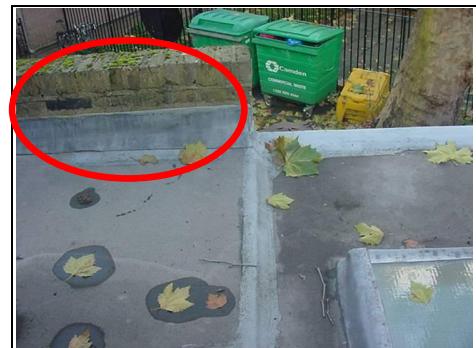
Parapet wall - rear

The rear parapet wall is a brick parapet wall with a lead flashing. We noted some moss to the top of the parapet wall indicating dampness may be coming in down through the parapet wall.

ACTION REQUIRED: We would recommend adding a coping stone to the parapet wall.

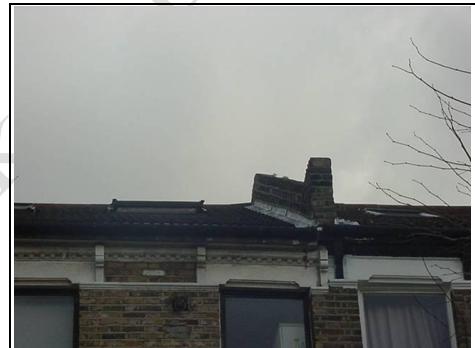
Main roof

Our concern is the shallowness of the pitch of the roof will lead to moss accumulation on it which in turn will fill the gutters and which will then need unblocking.

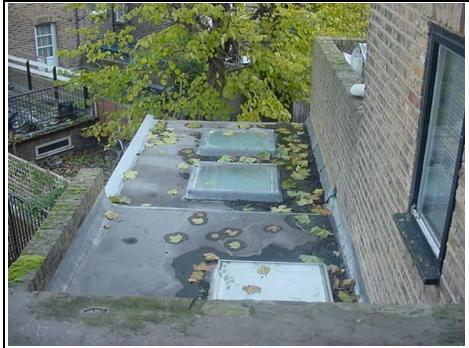
Rear flat roof

There is a flat asphalt roof to the rear of the property. These do tend to be a better type of flat roof. We noticed ponding and leaves on the roof.

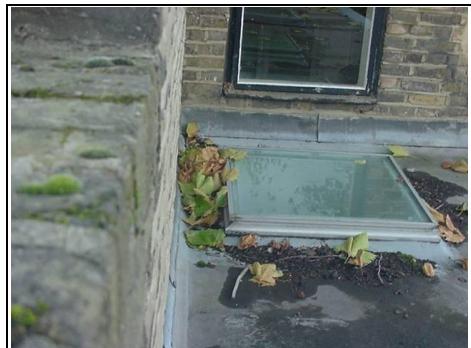
Roof window

One of the windows looks to have been repaired with Flashband which we consider to be a temporary material.

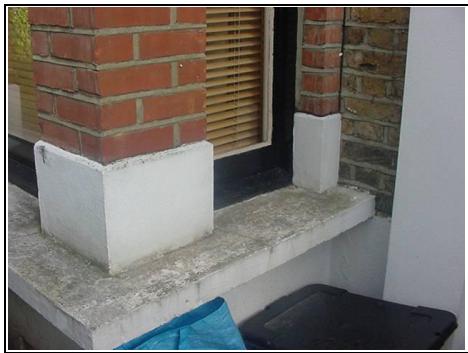
Brickwork repointed in cement mortar

Unfortunately the re-pointing, whilst well meaning, is not appropriate for this type of construction. A cement mortar has been used rather than a lime based mortar. We recommend you use lime mortar in any future repairs regardless of what the builders say! Using lime mortar will limit further damage to the brickwork, which is almost impossible to repair successfully. However, we would add that many, if not most, of the properties that are re-pointed are re-pointed wrongly; it is only in recent years that we have discovered the problems that can occur from it.

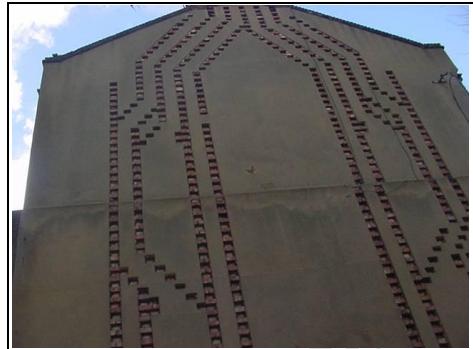
Left hand gable wall

The render on the gable wall to the left hand side of the property, with the openings for the brickwork, is susceptible to dampness. However we did not see any visual signs of dampness at the time of our survey with the exception of the render to the front of the property.

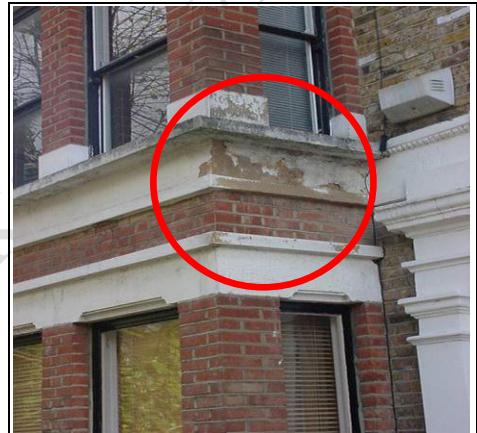
We believe this is coming from a leaking gutter and you will have to stand outside next time it rains heavily to check this.

Dampness to the front of the property

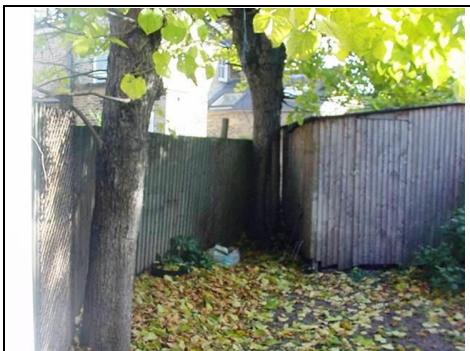
Trees to the rear of the property

There are trees within what insurance companies would term as influencing distance of the property.

ACTION REQUIRED: Seek advice from an Arboriculturalist.
Please see our comments within the Executive Summary.

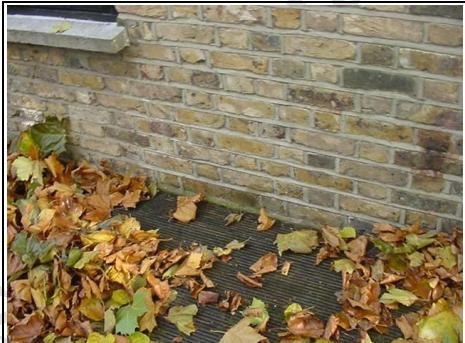
From what we can see there are no airbricks to the rear. These have possibly been blocked by the decking that is present (visible once we cleared the leaves). Also as this is a newer extension, with a possible concrete floor, it may not have been thought about by the builders and simply does not have airflow underneath it.

Air bricks may be blocked
by the decking

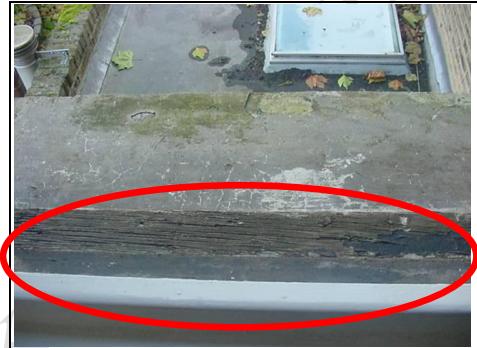
The property was reasonably well painted at the time of the survey with the exception of the render to the front. We also noted the rear kitchen window to the first floor flat was bare timber and is typical of what would be a shared cost. We had a chat with the occupier of the first floor flat who informed us he was leasing the property. We always find where there is an absentee landlord that things take longer to get done.

Bare timber on first floor flat kitchen window

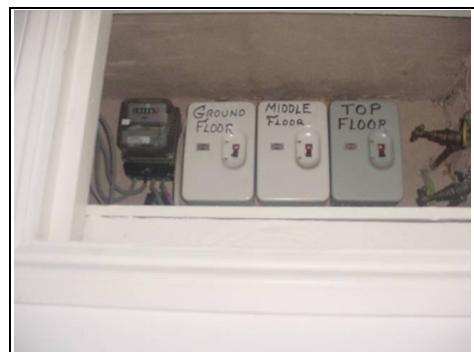
Fuse Board

The electric fuses and consumer units were located in the hallway. The fuse board looked dated, circa 1960's /1970's, and better are now available. In multi occupied properties a defective fuse board can be particularly dangerous.

ACTION REQUIRED: We would recommend changing the fuse board. The electrics should be tested to the Institute of Electrical Engineers (IEE) standards and carried out by an NICEIC registered and approved electrical contractor or equivalent.
