RESIDENTIAL BUILDING SURVEY

Aldwincle, Kettering,
Northamptonshire. NN14 XXX

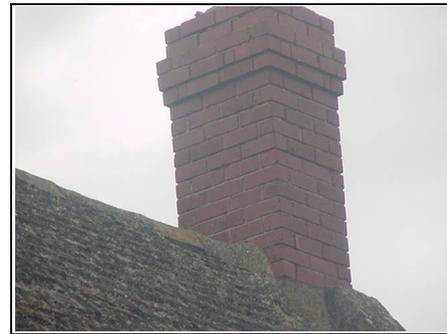
Front right hand side chimney viewed from the front of property

ANTICIPATED COST: Due to being high level work it is likely to require scaffolding, we would expect this to double if not treble the cost. We anticipate the cost to be in the region of £500-£1000; quotations required.

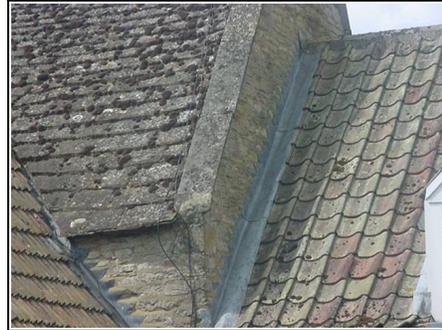
There are parapet walls and up stands to the roof area. The up stand between the two storey property and the storey and a half building is somehow allowing dampness into the structure at high level. We can see this due to the dampness in the timbers internally and at low level an overflowing gutter and hopper head which is allowing an amount of water to discharge into this area.

Leaking junction between main building and the lower building

ACTION REQUIRED: You need to double check the lead flashing is properly bedded and re-point the stonework in an appropriate lime mortar.

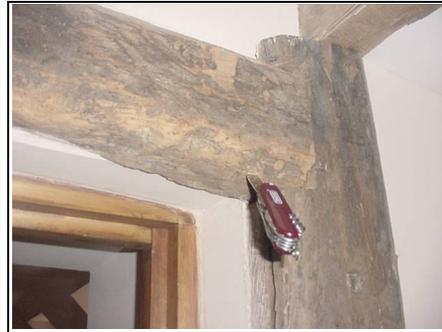
Dampness internally

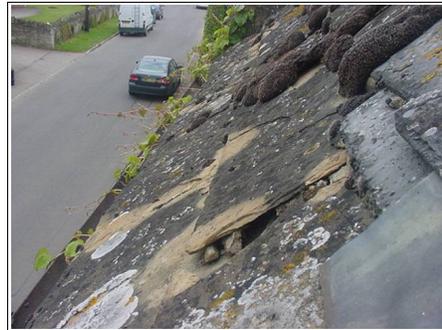
Specifically we noted plants are growing into the gutter system at the front of the property and are blocking the system and need cutting back and clearing. There is also moss on the roof which is filling the gutters.

Ivy in guttering system and moss on roof with displaced tile

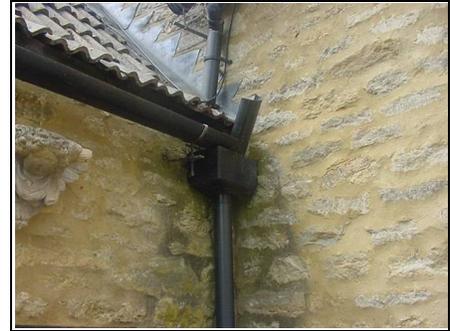
Overflowing gutter and hopper head

ACTION REQUIRED: General maintenance clearing the gutters and cutting back the vegetation. With regard to the low level overflowing of the gutters and downpipe we would suggest that you have a larger hopper head purpose made out of lead.

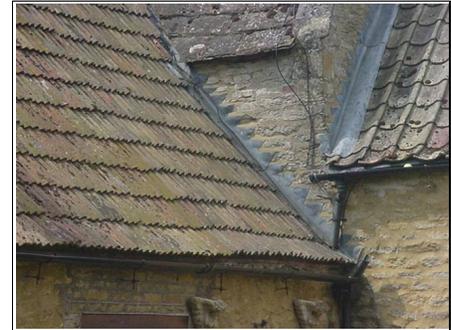
Leaking junction between main building and the lower building

ANTICIPATED COST: Maintenance work to clear gutters and cut back the vegetation considerably; a few hundred pounds. We would also recommend cutting back the front plant life considerably and if at all possible inserting a trellis between the vegetation and the building to stop damage to the walls; quotations required.

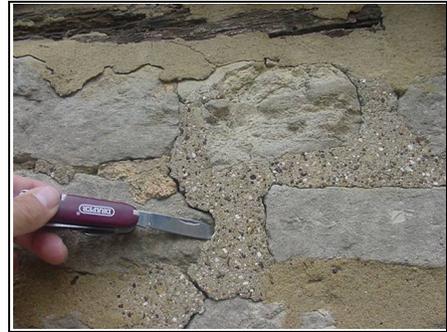
What has happened over the years is that a variety of cement repairs have taken place to the property which has trapped in the moisture as the cement mortar has made the walls less able to cope with getting damp. This when combined with the warm environment we like to live in internally which draws the dampness and the timbers above the windows which form the lintels and also the bounding timbers which were put in this type of structure degrade means that you do have to carry out regular maintenance on the property.

Terrible cement pointing gable end

ACTION REQUIRED: We recommend a programme of re-pointing in an appropriate lime based mortar generally removing and replacing the cement mortar over the next three to four years.

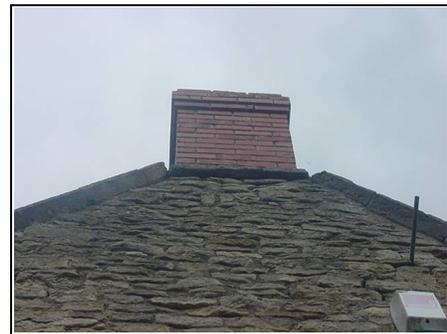
Re-pointing required

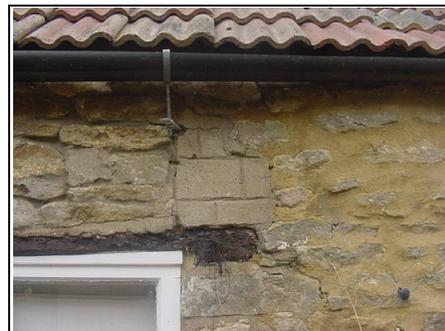
Timber lintel with very poor cement pointing

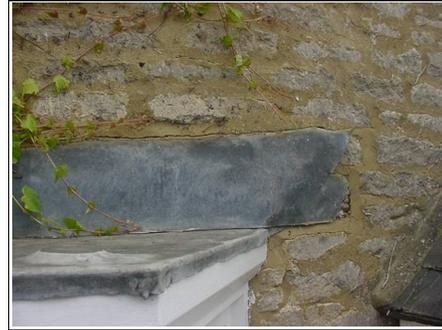
Flashings to front bay coming loose pointed in cement mortar

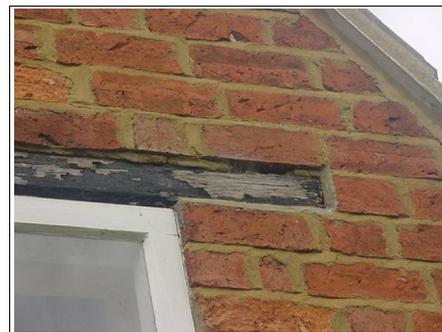
Again this is causing problems with the timber lintels which will ultimately lead to spalling to the surface of the brickwork.

Timber lintel

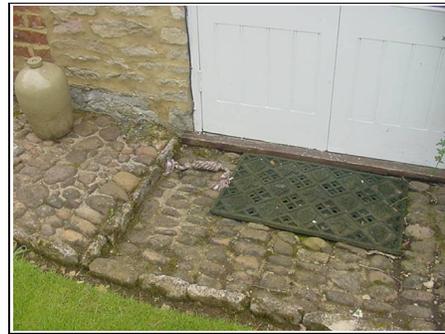
The outside ground level is higher than the inside ground level in many areas which causes dampness both in the form of dampness in the walls and dampness in the floors.

Threshold too low

ACTION REQUIRED: We recommend you live in the property through the winter and we feel that it is likely that you will need to add a French drain around the whole of the property. Before you carry this work out please experience living in the property for a year.

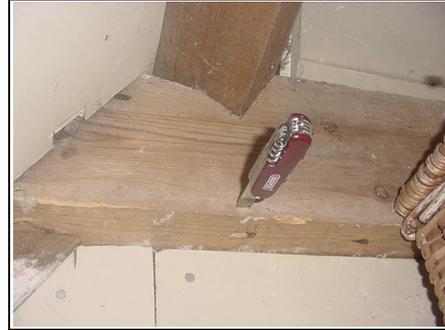
In a property of this age it will no doubt have had woodworm most of which will no longer be active. In this case we found an area which we feel maybe active woodworm which is in the cupboard to the top floor bedroom. We would only comment that during this time of year we would expected to have seen frass (chewed up sawdust) and we could not find any.

Woodworm in top floor cupboard

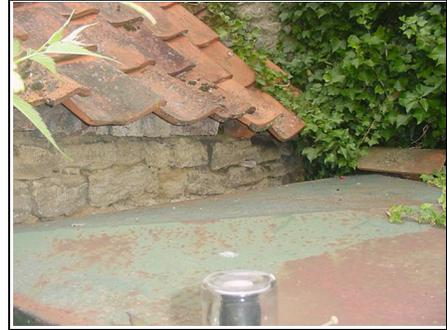
We would comment that the oil storage unit is rusting and does not have a bunged wall to stop any oil escaping.

Rusting oil tank, next door's roof looks like it maybe discharging water onto the rusting oil tank. It would be worth having a chat with next door.

ACTION REQUIRED: Ideally replace with a plastic oil storage unit, these are double lined so therefore this gives additional protection against leaks. Please be aware of the new Regulations with regard to where oil tanks can be located.

ANTICIPATED COST: £3000 - £5000; quotations required.

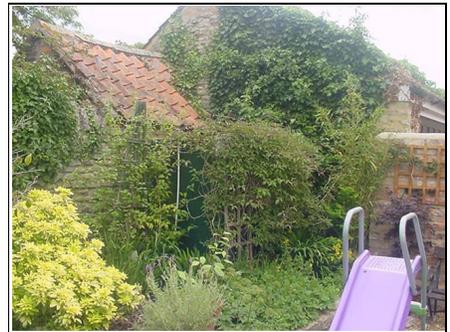
Rusting oil tank hidden by plants.

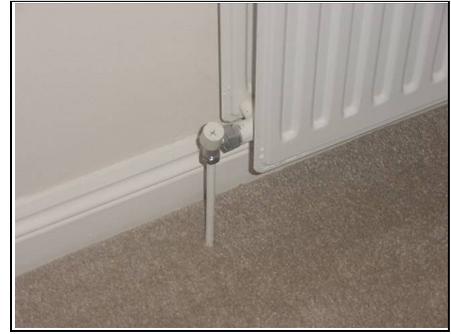
In addition we noted that the central heating system has micro-bored pipes, which is a system we would not recommend as these pipes tend to block up. However these pipes are preferred by plumbers as they are easier to use, bend and store as they come on a roll.

Micro-bored pipe work

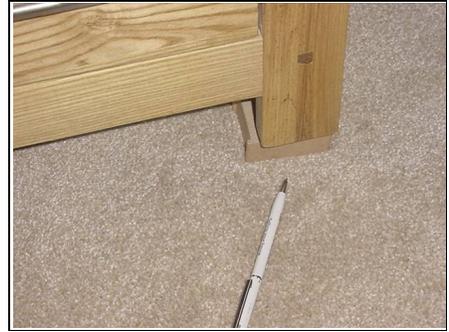
Uneven floors, packing under bedside cabinets on top floor

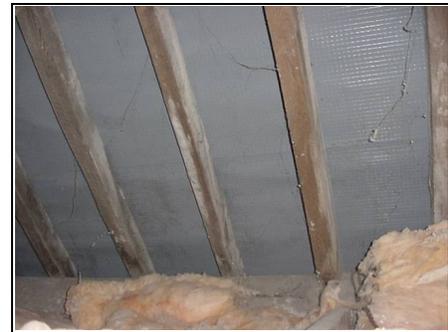
Damp and mould to timbers

ANTICIPATED COST: In the region of £1000-£3000 if access scaffolding is needed it maybe more; quotations required.

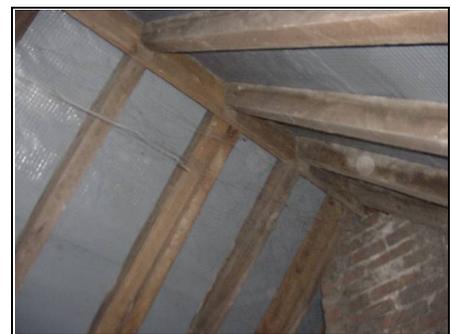
Roof over en suite bathroom in master bedroom plastic under layer with dampness penetrating into the structure

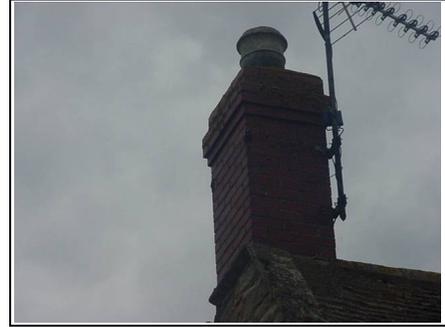
From what we could see it looks to be in better condition than chimney one but nevertheless may benefit from re-pointing which should be checked when re-pointing work is carried out to chimney one. Unfortunately we were unable to see the very top of the chimney known as the flaunchings, we therefore cannot comment upon it. However we would recommend a close up check.

Front left hand side chimney

ACTION REQUIRED: Carry out minor repairs, ideally before the winter of 2012.

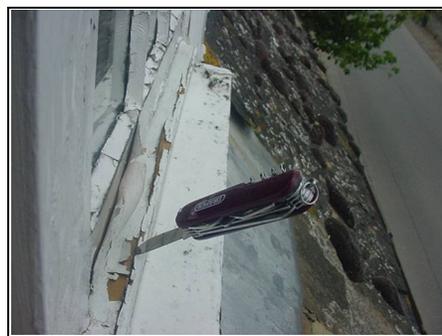
The two at the front are in particularly poor condition, we were able to push a knife into the sills.

Wet rot to Dormer window

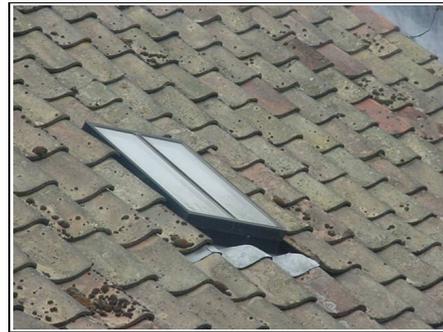
This flat style replicates the older style of roof light, which was generally made up on site and was in reasonable condition, our main concern would be that there is not enough ventilation in this room in general and relying on this window is not ideal.

Old style roof light

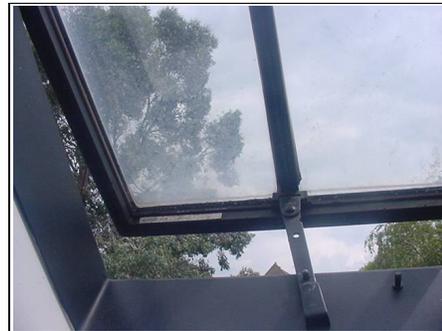
We would say that it seems inevitable with roof lights that they will sooner or later leak. If this doesn't occur then they seem prone to condensation particularly in a bathroom.

Metal roof light within en suite bathroom within master bedroom

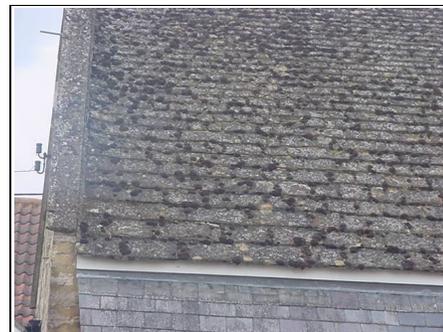
Main stone slate roof

Whilst we noted that some of the stone slates are starting to deteriorate and there is a fair covering of moss, we feel this is average to slightly below average for this age of the property. Our concern is the level of insulation in the roof which can be causing condensation to the fixing points which will lower the life of the roof unless ventilation is added to the roof space. This should be possible to the gable ends of the roof but remember this is a Listed Building and it may be necessary to remove the mass of insulation that has been added inappropriately to this roof.

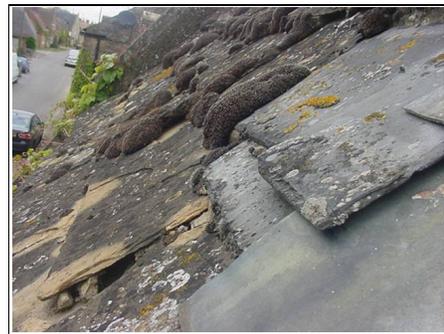
The moss on the stone slates can be causing deterioration, we generally recommend clearing off using a soft brush during the summer period as this causes least damage but you really have to judge for yourself one a small section as to whether it is causing any damage.

Moss sitting on stone slates

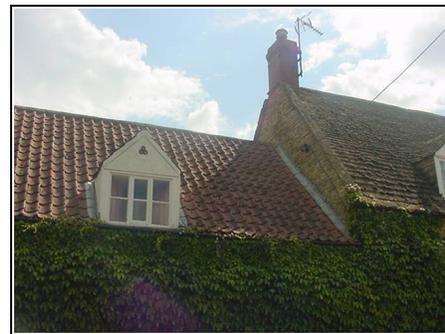
Within this roof we saw a reinforced plastic protective under layer. This type of under layer was used in the 1970s/1980s and its use was generally stopped because it was susceptible to causing condensation unless the roofs are adequately vented, which they are usually not. Unfortunately in this instance the addition of the mass of insulation and also having humidity generating areas underneath it such as your en suite bathrooms and kitchen the lack of ventilation has caused mould to start to occur within the roof timbers. The next stage is likely to be wet rot not unless equally it could activate some old woodworm.

Pantiled roof over the kitchen area where it meets the main building area.

Please see our comments in the Executive Summary. Ideally we would remove all of the Pantiles and re-roof using a modern breathable felt, this would cost in the region of £20,000-£30,000. An alternative which is nowhere near as good is to add ventilation to the roof and we would insist that you add additional extraction to the en suite shower room area controlled by humidity thermostats which switch on automatically when the humidity increases.

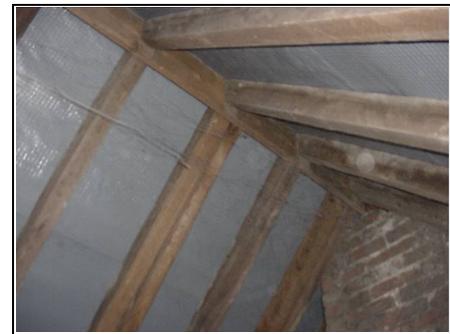
Kitchen area roof with mould and dampness to the timbers

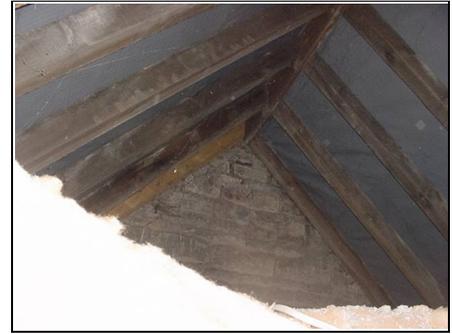
Mass of insulation and mould can be seen in this area.

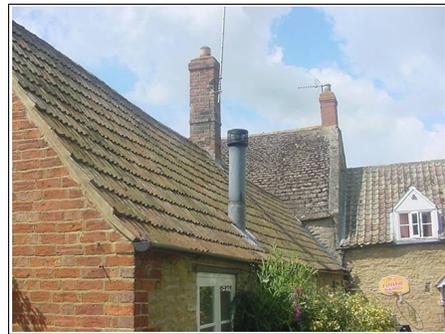
There was a hessian based protective under layer present but also a mass of insulation.

Roman tiled roof

ACTION REQUIRED: Add ventilation

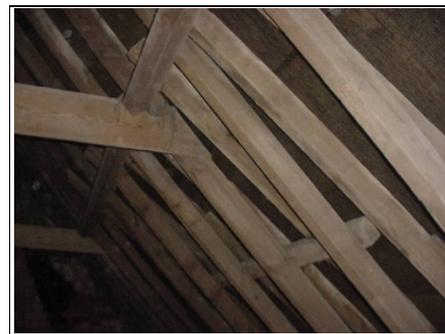
Here we could see a hessian based protective under layer however there was a mass of insulation

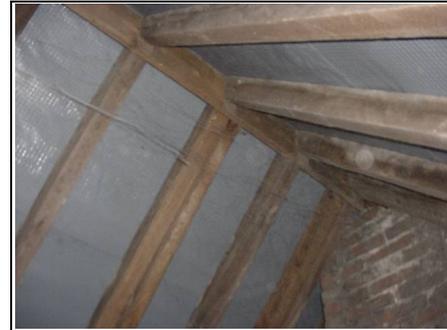
Roof over en suite bathroom to master bedroom with dampness and mould to timbers

Our examination was limited by the general configuration of the roof and the mass of insulation. What we could see was generally presently found to be in below average condition with mould occurring and dampness however if left it could be considerably affected by the condensation and dampness. It is, however, feasible that there are problems in the roof that are hidden.

ACTION REQUIRED: We recommend adding ventilation. The only way to be 100 per cent certain is to have all the roof cleared of insulation and then checked.

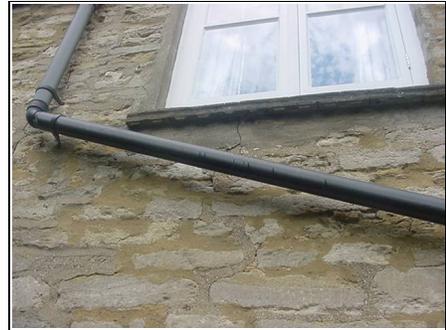
The property has plastic gutters and downpipes, we would much prefer to see a deep flow or wide flow gutter on this property or indeed aluminium gutters or cast iron gutters rather than plastic. We generally find that people installing plastic gutters do not have the knowledge to install them correctly in line or with a fall to the downpipe or even they do not put enough support so that the guttering bends.

Awkward angle to guttering

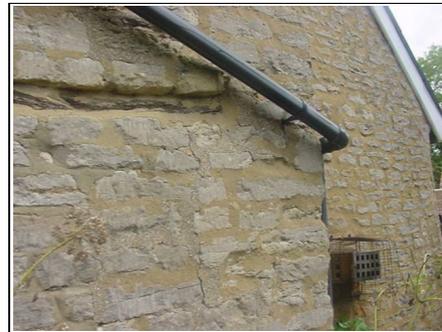
The stonework and pointing is in average condition over all. It has been re-pointed very poorly in a cement mortar however we would add that approximately eighty per cent of all properties we come across have been re-pointed incorrectly in cement mortar. This is just particularly bad and would use the term that it has been smothered in a cement mortar in some areas.

Stone work

ACTION REQUIRED: Carry out ad hoc re-pointing in a lime mortar where appropriate.

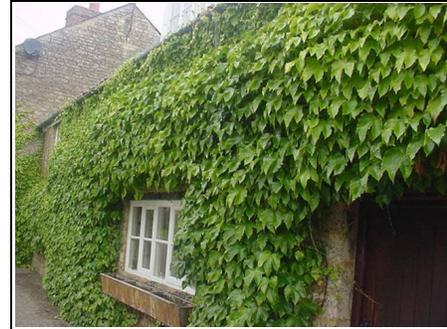
There are no trees within influencing distance of the property. However the ivy needs cutting back and ultimately putting on a trellis work to keep it off the walls

Ivy in need of cutting back

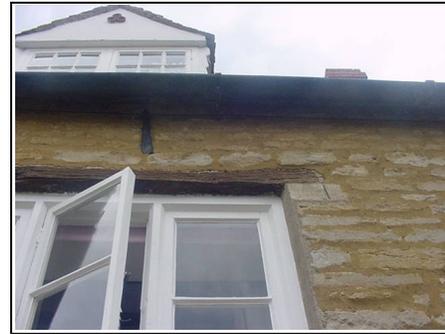
The fascia is hidden behind the guttering in this instance and so we cannot see it. However, it is common for this type of detail to have some deterioration to the timber.

Fascias difficult to view

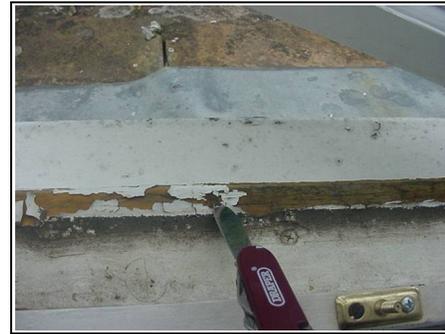
The property predominantly has painted timber casement windows, which are single glazed. Generally we consider the windows in average condition, but, as with any painted timber window, it will require repair and repainting periodically. Specifically we would comment that the dormer and higher level windows are in a poor condition and we noted that the front windows on the ground floor have been carefully repaired and redecorated. Please see adjoining photographs.

Wet rot to windows

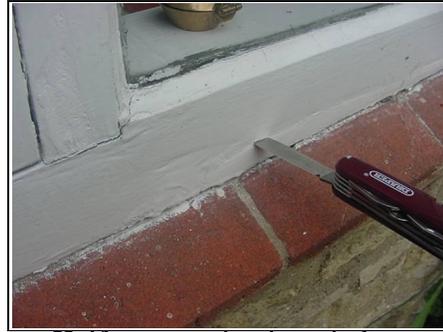
Knife test cutting into timber window

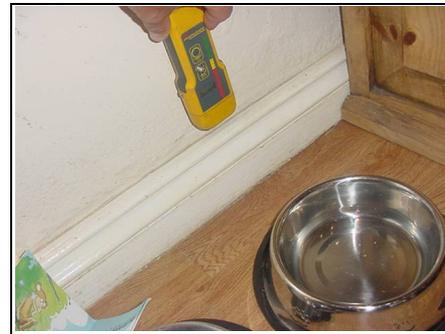
A random visual inspection and tests with a moisture meter have been taken to the perimeter walls and some internal walls. The readings we obtained indicated that there is dampness in the property.

Testing for Rising damp

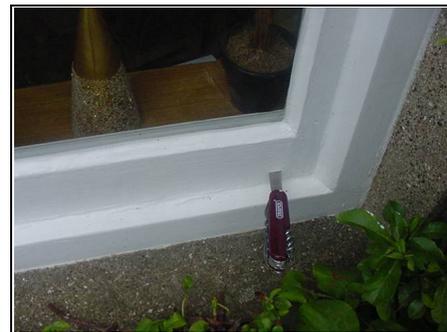
Wet rot to timber window frames

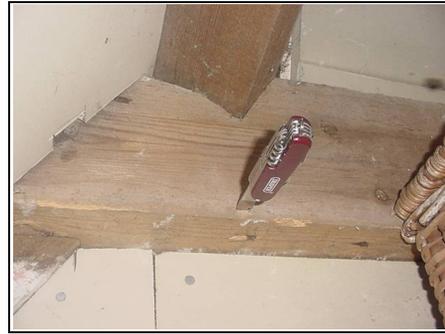
Woodworm found in top floor cupboard

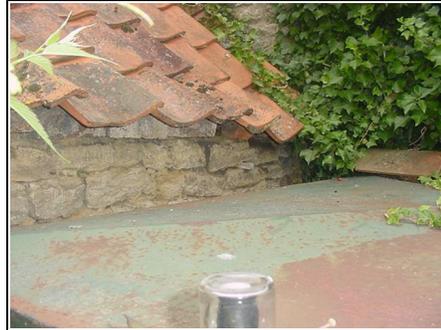
Rusting to oil tank
