RESIDENTIAL BUILDING SURVEY
OF
Edwardian Terraced Property, Letchworth, Hertfordshire,
SG6

FOR
Mr A

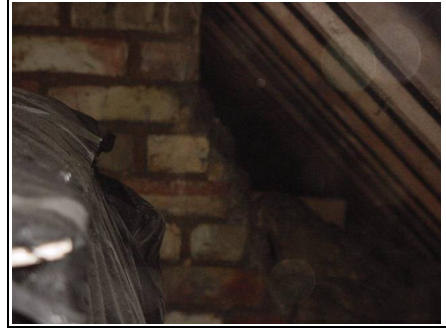
Although difficult to see in the photo the firewall is not complete to the left hand side of the property. This means that should there be a fire in one property it could transfer to the next. It is generally a rule by most mortgage lenders that any firewalls are built up to the roof.

ACTION REQUIRED: Complete the firewall.

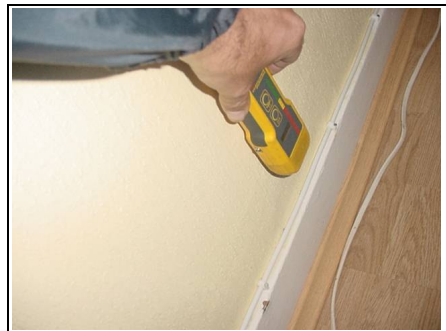
Rising damp was found to the front of the property on the left hand side. It may be elsewhere in the property too, but unfortunately we were unable to get at the wall in the kitchen due to the units.

ACTION REQUIRED: You should instruct a qualified and experienced contractor who is a member of the BWPDA (British Wood Preserving and Damp Proofing Association) issuing a long-term

insurance backed guarantee to carry out a quotation on the property, which should be forwarded to us for comment, and to implement all necessary remedial works. In conjunction with the above, damp affected plaster should be replaced in accordance with the specifications of the specialist contractor; failure to do so may nullify the validity of the guarantee.

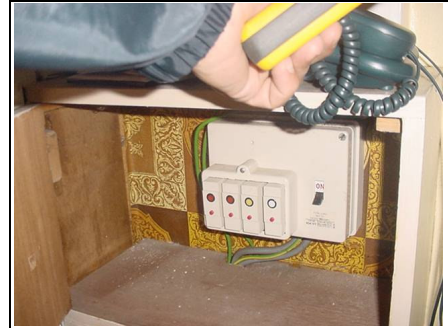
There also looks to be some DIY standard of wiring, or maybe lazy professional wiring, as there is a lot of surface mounted conduit.

ACTION REQUIRED: We would recommend replacement of the consumer board. An NICEIC registered electrician to check the wiring at the same time. You may also wish to add extra socket points.

ANTICIPATED COST: In the region of £250 - £300 for a new fuseboard, plus any recommendations carried out by the electrician.

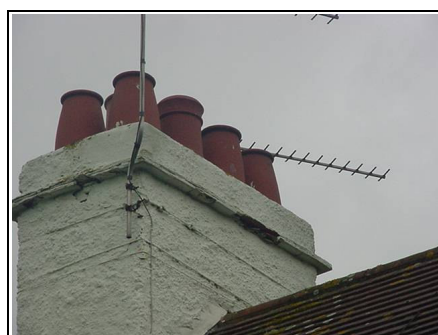
This chimney has a painted render finish with a lead flashing and eight chimney pots. From ground level there looks to be a need for minor repair. This is fairly typical for a chimney of this age. Unfortunately we were unable to see the top of the chimney known as the flaunching.

Your Chimney
Deterioration starting to occur.

ACTION REQUIRED: Carry out minor repairs, ideally within the next five years, but this is nothing to be overly concerned about.

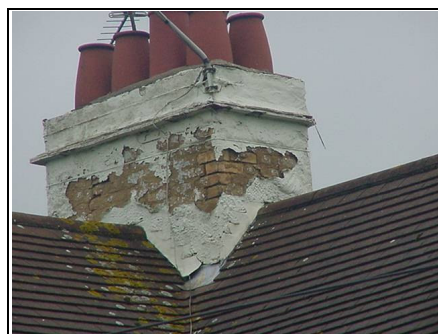
Please see the photo of next door's chimney. You can see how deterioration can occur, and this in turn will cause dampness into the structure.

Next Door's Chimney
This shows why you have to keep chimneys in good order.

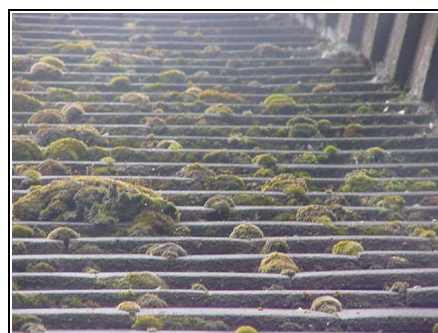
There is moss on the tiles; this can cause problems with damage to the tile surface and / or block gutters.

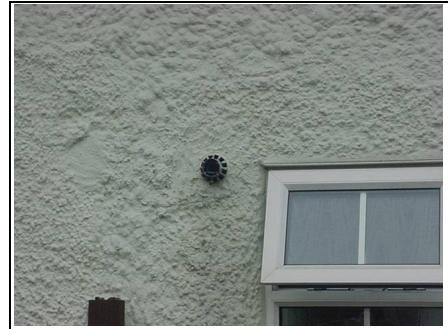
We did note that there have been some hair line cracks to the render, some of which have been repaired. All cracks need sealing as soon as possible to stop dampness getting in the property.

ACTION REQUIRED: Seal cracks.

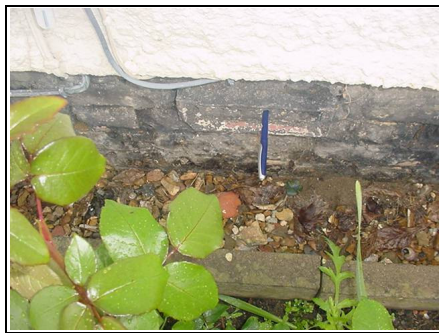
Front Airbrick, indicating a suspended timber floor

ACTION REQUIRED: Airbricks need to be added to give air flow, although this is likely to be difficult. There is likely to be some rot under the floor.

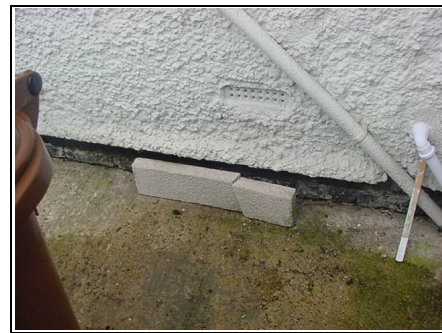
No Airbricks to the rear.

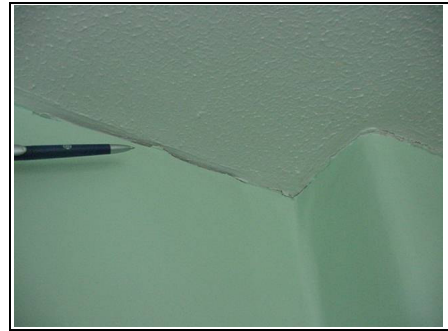
Slight movement where the central studwork partitions are.

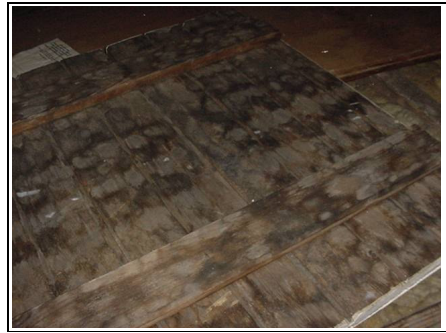
We noticed staining on the back of the loft hatch door, which could indicate that there is condensation occurring within the roof.
