RESIDENTIAL BUILDING SURVEY

London
South East

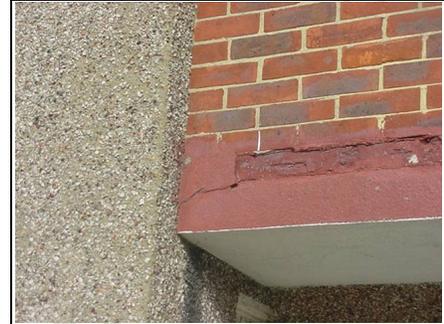
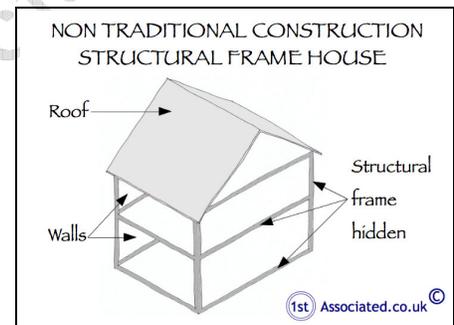
Deterioration to concrete frame

- i) Cracking to the structure as the concrete doesn't accommodate movement very well. Whilst modern structural frame properties incorporate movement joints, in this era they were not usually included.
- ii) Limited mortgages available – many companies will limit the mortgages that they will have available on non-traditional constructed properties such as this. They may even not give you a mortgage on this type of property. You need to check with some mortgage companies to see what the current situation is as this can change.
- iii) Concrete cancer – this is a common term used as a catch all and is a generic term for problems with concrete where accelerators or additives were used, which was relatively common in the after War Years as a way of accelerating the drying times of the construction.

- iv) Reinforcement rusting causing spalling of the concrete and general deterioration.
- v) Limited future sale market. Many people will be put off this type of property once they know it is non-traditional. They will also be put off it because of the lack of mortgage availability on this type of property.

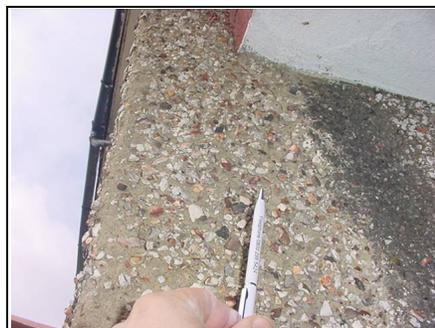
The property is finished with a pebbledash render. We can see hairline cracking in it as well as the cracks that have obviously been repaired over the years, the majority of these are to the rear of the property and are shown in the photos below but there is also hairline cracking to the structure which is almost invisible unless the structure is closely viewed. Based upon the size of the repairs that we can see, the cracking must have been extensive and probably of a structural nature.

Vertical hairline cracking

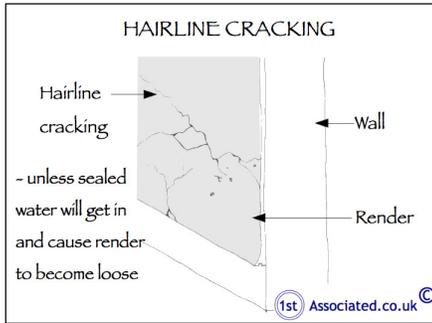
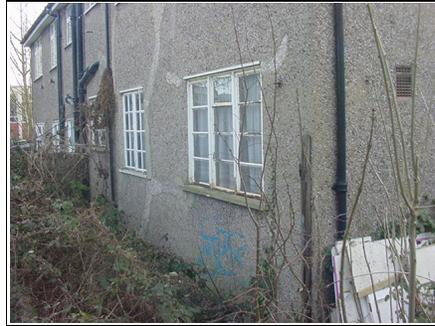
Cracking to render to rear of property

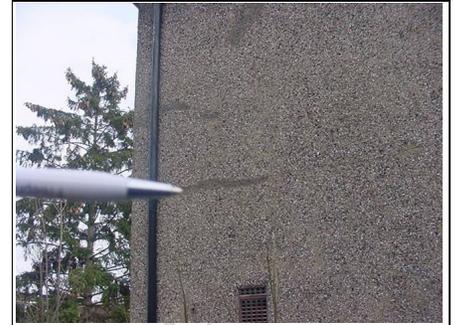
Horizontal cracking

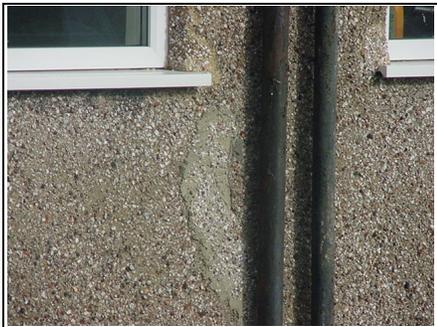
Bad pea shingle repair

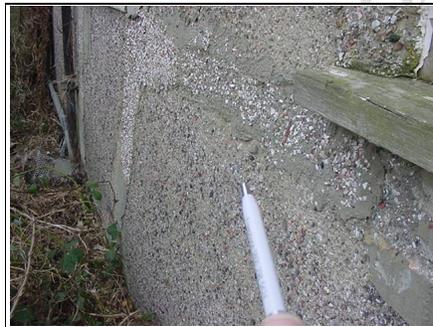
Repair to render

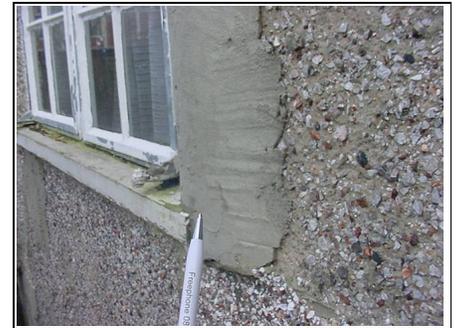
Repair to render

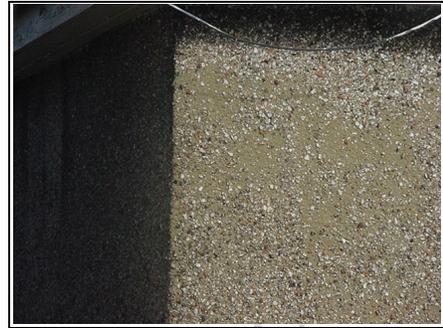
There are also areas where the render has weathered, indicating that there is leaking gutters and that the render is now of an age where it is starting to deteriorate. Unfortunately it is very hard to patch repair render without it being very visible as you can see in the repairs that have been carried out to the cracking.

Render weathering

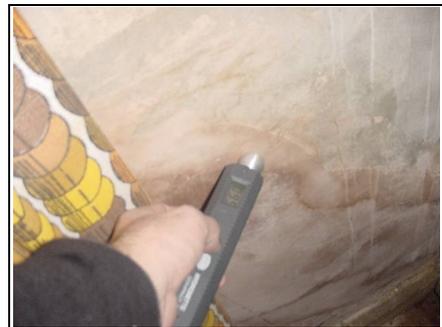
We found dampness to the property, particularly to the rear. This we believe relates to the cracking externally which is allowing water in. We have had a range of readings from the mid to late thirties and early forties that we would expect almost double in some areas, particularly to the rear of the property. This shows dampness

Dampness

is getting in through the render which means that the render repairs that have been carried out aren't sufficient.

ACTION REQUIRED: We would recommend the entirety of the rear of the property is re-rendered once you have established if there is any movement in the property and resolve this if there is.

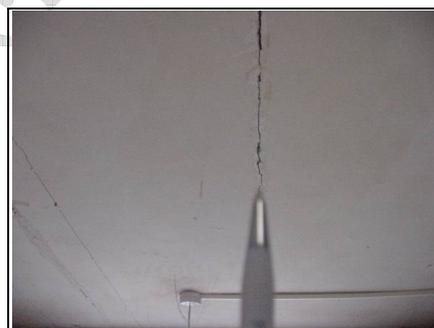
We can see a range of cracks internally. Most of these are due to the structure as a whole moving as explained earlier in this report. There is also ceiling movement at a different rate so you have ceiling board cracking as well. Finally, you also have the cracks associated with the new additions to the electrics. We believe there may also have been a skim-coat of plaster applied to the ceilings.

Cracking to ceiling

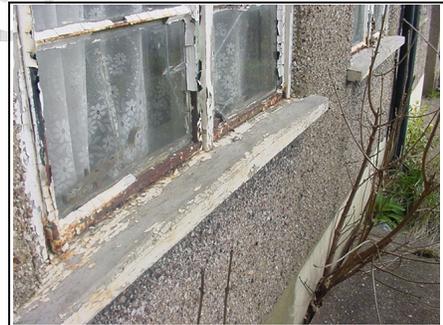
It was common in this Era to have single glazed metal windows. These windows rust and warp and allow condensation as they have in this instance. The windows have many cracked panes as is common with metal windows that are warping and deteriorating.

Rusting to metal windows

ACTION REQUIRED: We would recommend you budget for new double glazed windows.

ANTICIPATED COST: Budget for new double glazed windows, we would anticipate cost in the region of £2,500 - £5,000. The cost really does depend upon the quality of the windows that you choose to have. It may be worth considering enlarging one of the windows and making a patio door to give access to the garden (assuming

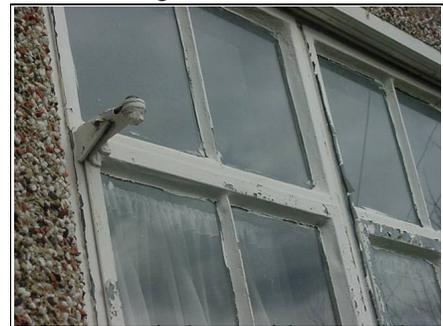
Newer windows with external hinges

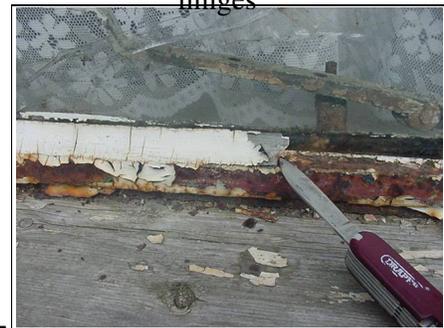
Close up of rusting to windows

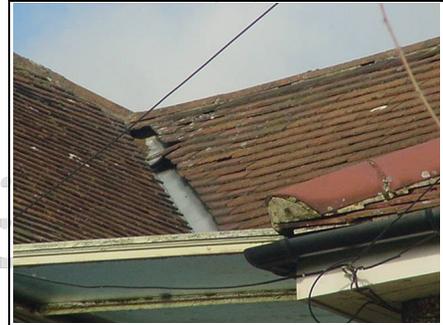
There is some deterioration to the roof tiles to the front of the property. We haven't been able to gain access to the roof (number 13 and number 14 were not in at the time of our inspection) however we did note a nearby property in a similar style have had their roof replaced. You could have a shared cost towards replacing this in years to come.

Slipped tile to hipped roof

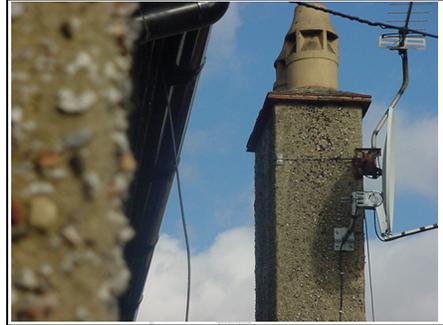
There is a chimney to the left hand side, we assume it is shared. We can see the render on this is deteriorating (the pebbledash surface). We anticipate work will be required in the next few years to stop dampness from getting in. Whilst this may not directly affect your property, but would affect the top floor property, you may have a shared liability for this.

Chimney

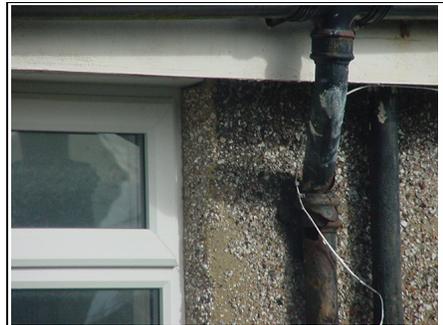
We can see a mixture of plastic and cast iron. Some of the plastic has twisted and is allowing water to discharge down the front of the property. We can see areas where the cast iron has rusted.

Cast iron downpipe rusted

ACTION REQUIRED:
Repair/replace all the gutters and downpipes.

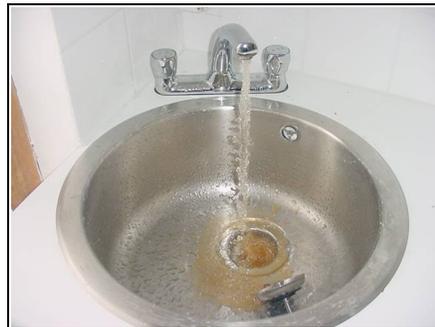
We noted rust when we first ran the kitchen tap. You may have old pipework.

Rust staining from taps

ACTION REQUIRED: You may need to remove old rusting pipes.

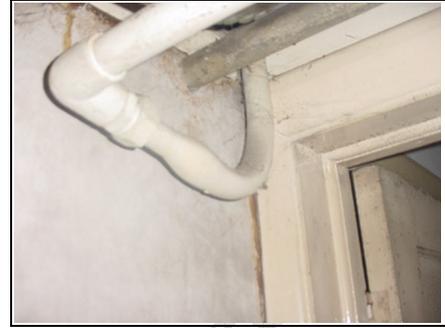
There is danger in older properties of having a lead water supply; we would recommend that you speak to the water company to ask them if they have carried out such replacement, as you will be re-piping much of the water used in the building it gives an ideal opportunity to also check for any remaining lead pipes.

Lead pipe

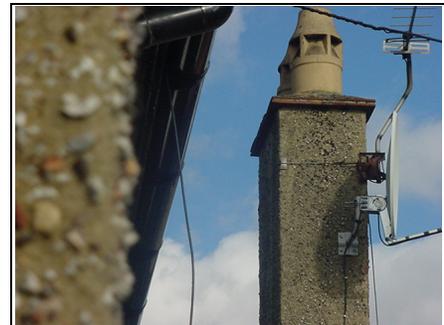
This chimney is finished in a pebbledash render. It was difficult to see whether there was a proper flashing. Often with a render chimney the flashings are hidden by the render (we would recommend a lead flashing if there isn't one). From what we could see the chimney looked in slightly below average condition considering its age, type and style.

Chimney

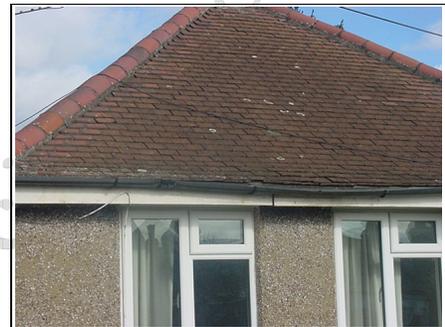
The main roof is hipped, pitched and clad with concrete tiles and, from ground level, this looks in below average condition considering the roofs age, type and style. With this age of roof there will usually be a few missing or displaced tiles, these need repairing/replacing.

Roof tiles

ACTION REQUIRED: Please see our comments in the Executive Summary. Carry out periodic inspections and maintenance of the roof, as required. We would emphasise that we have not had access within this roof which is what we need ideally to establish its condition. We would be more than happy to return and visit to inspect if you can arrange access with the top floor owners.

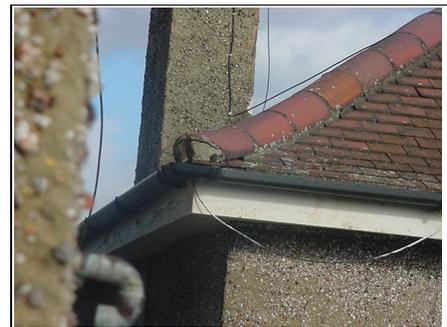
Close up of hipped roof

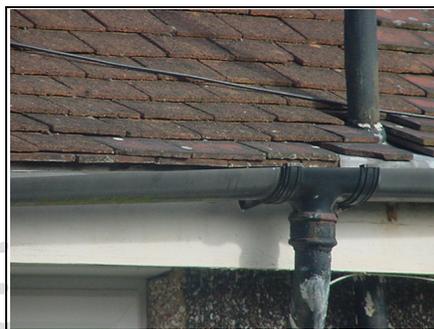
The property has a mixture of the original cast iron and plastic gutters and downpipes. The cast iron is in a poor condition and needs major repair or replacement. The plastic guttering is of the older style which is starting to weather and discolour. It was also sagging in areas indicating they didn't have enough brackets or it was a poor quality gutter.

Cast iron to plastic guttering

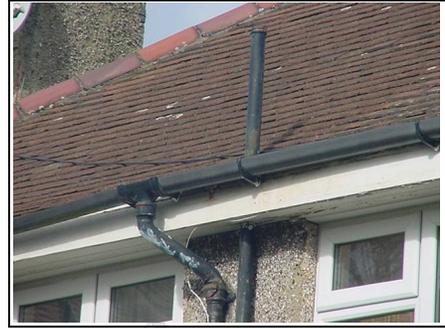
Soil and vent pipe

ACTION REQUIRED: Maintain the soil and vent pipe and/or replace.

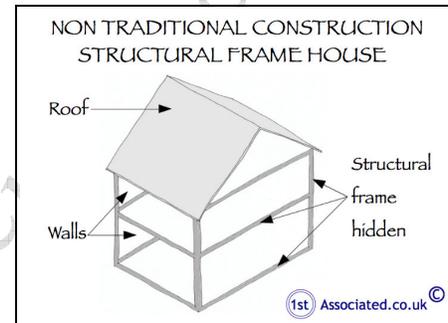
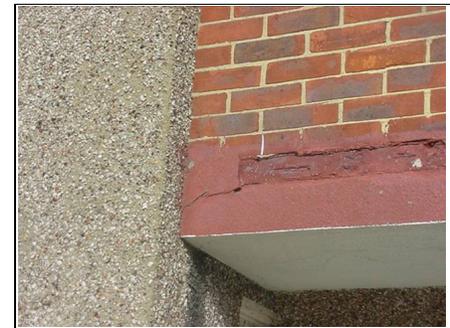
Deterioration to concrete frame

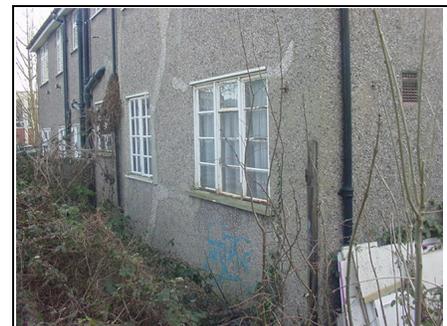
The walls to this property are finished in a pebbledash render. We feel in this instance that the render is in below average condition for its age, type and style.

Cracks to rear of property

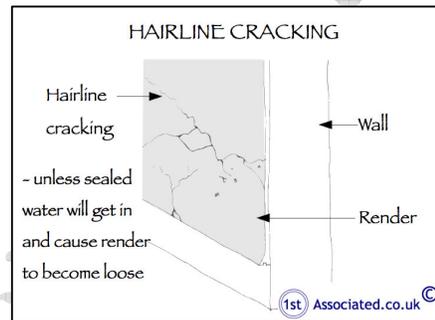
We would divide this into structural cracking and hairline cracking. We feel that the cracking to the rear of the property has potential to be structural cracking however there is also hairline cracking which needs to be sealed as soon as possible to stop dampness and water getting in causing sections of the render to need to be re-rendered.

ACTION REQUIRED: Please see our comments in the Executive Summary.

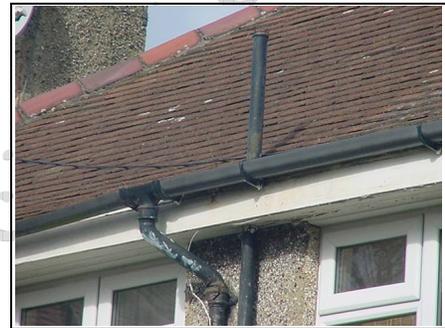
The fascias and soffits are timber. They are painted and we would comment they are in average condition for their age, type and style which is surprising given the condition of the gutters and downpipes.

Painted timber fascias and soffits

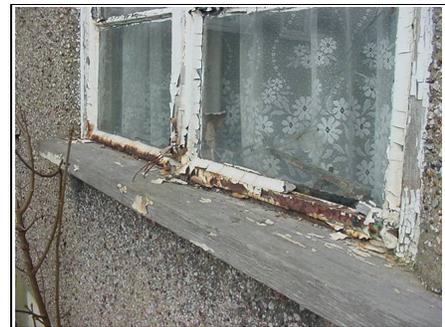
The property has metal windows, some are in timber frames. Metal windows are often known by their generic name of Crittal windows which was one of the main manufacturers. Typically these windows warp and rust and become difficult to close which in turn makes them draughty. In this instance there is lots of rusting and warping to the frames together with cracking of the glass.

Rusting to metal windows

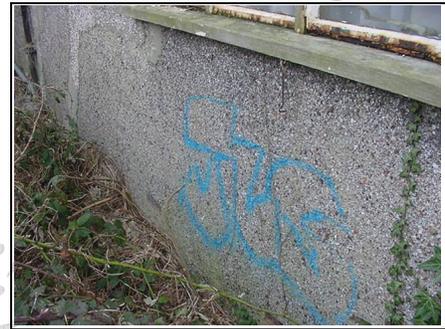
Graffiti

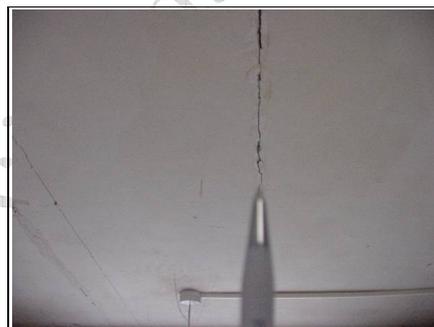
Cracking to ceiling

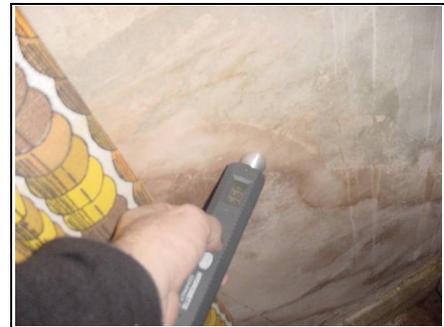
A random visual inspection and tests with a moisture meter have been taken to the perimeter walls. In this particular case we have found rising damp.

Testing for rising damp

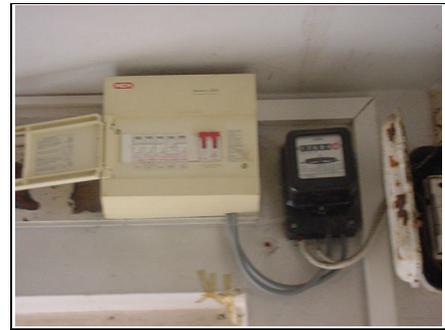
The electric fuses and consumer units were located in the hallway. The fuse board looked dated and better are now available. In multi occupied properties a defective fuse board can be particularly dangerous.

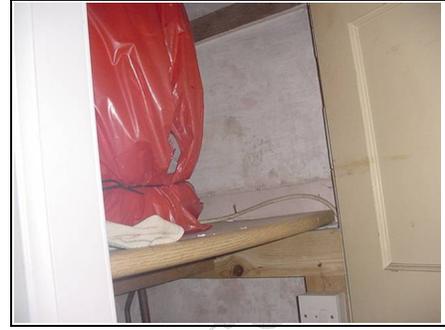
The hot water cylinder is located within the bathroom. This is an older style cylinder which has a separate insulation jacket. Unfortunately this type of cylinder, due to its age, can leak without warning.
