JOB REFERENCE: XXXX

RESIDENTIAL BUILDING SURVEY

XXXX
Lewisham
London
SE13 XXX

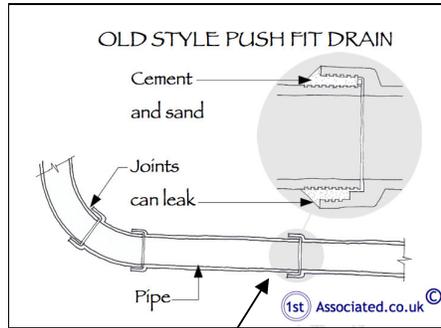
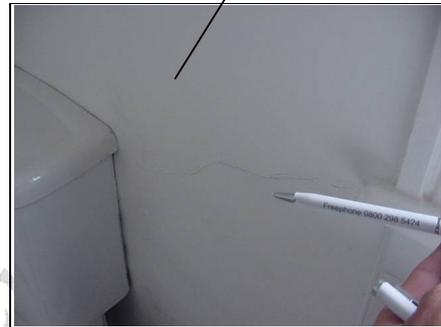
There is a crack in the bathroom (the current owners advised us verbally that they were not aware of any other cracks), this crack appears to be a settlement crack caused by leaking drains which is fairly typical on a Victorian property; this is because the original drains are push fit. Unfortunately we were not able to open up the drains to check their condition as there were no drains within the boundary of the property as far as we could see or the present owners were aware.

Crack in bathroom

ACTION REQUIRED: You need to monitor this cracking.

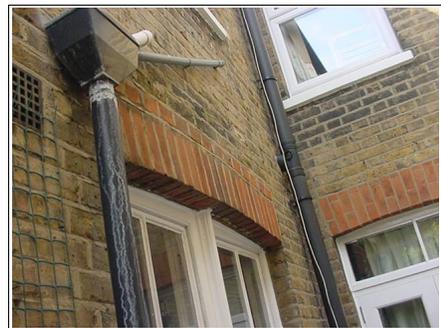
There is a soil and vent pipe that runs at the corner junction which limits are view in this area typically where any additional cracking would be outside.

Soil and vent pipe

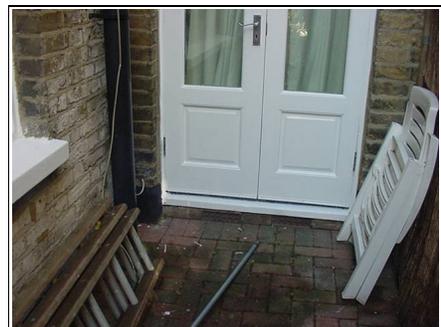
We would normally expect to find a manhole to the rear left hand side (all directions given as you face the property) in this type of house but there is not one present. We spoke to the current owners about the lack of a manhole during our question and answer session and they advised that the brick pavers path to the side of the

Brick pavers to the left hand side (all directions given as you face the property) where there would normally be a drain

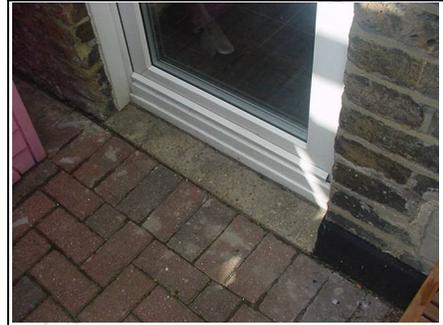
The brick pavers to the rear of the property have been added over the old ground level and as such causes a situation where dampness can get into the property. Ideally all the pavers should be lowered but this is a big task.

Brick pavers at threshold same level as ground level

ACTION REQUIRED: The pavers are surrounding mainly the kitchen area and we would suggest that if problems do occur with dampness (this is most likely to happen in the winter months) you remove the brick pavers directly next to the property perimeter. You will then need to dig down lowering the ground level and replace the pavers with a pea shingle that will allow any water that gets to this area to drain away and is what is known as a French drain. Have a look outside next time it rains heavily to see how the rainwater is around the property.

ANTICIPATED COST: £1,000 to £3,000 to have a proper French drain installed and of course you would have to find the drains; please obtain quotations.

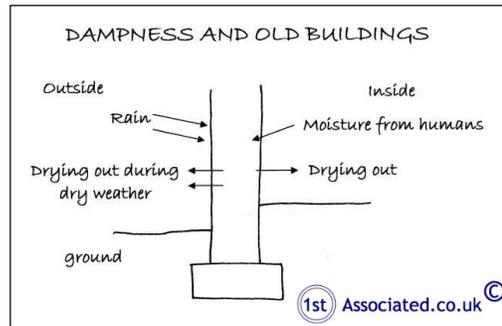
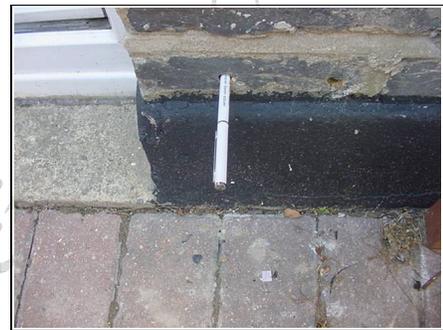
Signs of damp proof course being added to the rear of the property

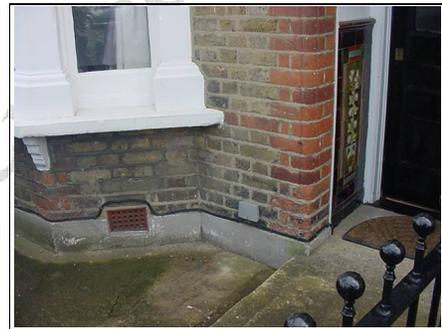
We noted that you have a suspended timber floor to the property, as is common, we could see airbricks to the front of the property and we were pleased to see that these were double the normal size. In addition you do need to have airbricks to the rear; we could only see two airbricks to the rear underneath the French doors but you really should have more in the step to the kitchen to allow a through flow of air.

Airbricks to the front of the property

ACTION REQUIRED: Check the airbricks are clear and add additional airbricks to the step in the floor in the kitchen.

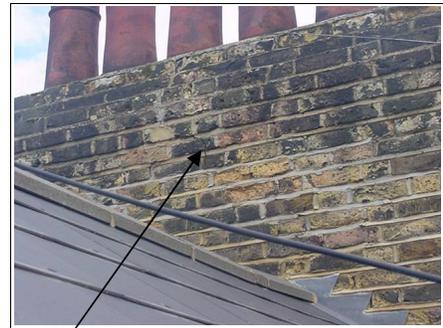
The other issue we would draw to your attention is cracking that is noted in the photograph below, this ultimately will need repair and would we suggest in the next three years.

Crack in chimney in the centre of the chimney underneath the middle chimney pot five bricks down

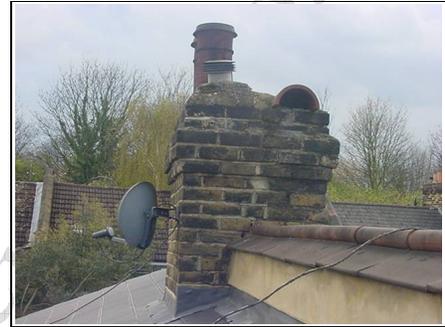
When these properties were built originally they would have had all the rooms heated via a chimney and they would normally have a chimney to the rear of the property. In this case we were pleased to see that the rear chimney was in place and we could view this chimney from the roof light within the attic space. The chimney is brick built and we can see that the chimney has been re-pointed and are pleased to see a lead flashing although we are not too keen on satellite dishes that are fixed in one point such as the one that is present as this can cause damage to the chimney.

Rear Chimney

ACTION REQUIRED: Periodically inspect the chimney.

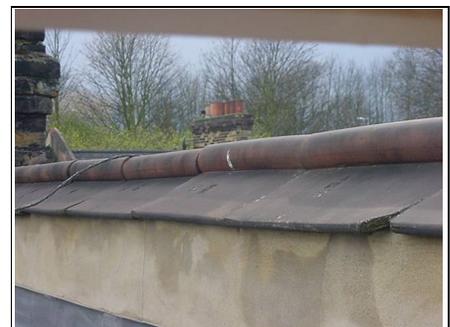
Tiles to parapet wall on right hand side to the rear do not look to have been bedded properly and almost look as if the job ran out of money!

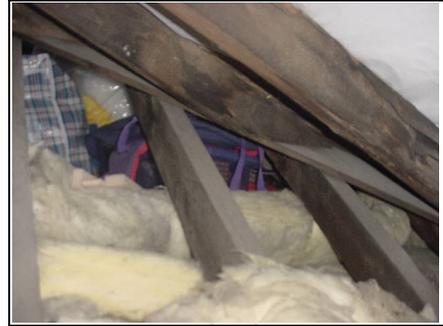
We could see some staining to the timbers below the valley gutters where the main front roof meets the main rear roof which indicates to us that there is dampness coming through however when we discussed this with the current owner and he advised that the old concrete tiled roof was in such a poor state that the valley gutters were leaking and these stains may remain from this.

Dampness to timbers beneath valley gutters

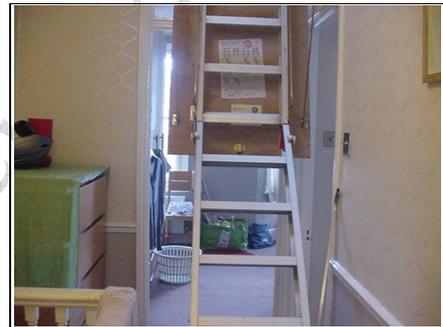
The main roof is accessed via the loft hatch located landing. There is the most bendy loft ladder that we have ever seen (we are surprised they managed to sell these), there is electric light and secured floorboards. We recommend a new loft ladder!

Bendy ladder to loft space which would be high on our list of things to replace as to be honest we were surprised that this wobbly type are ever sold!

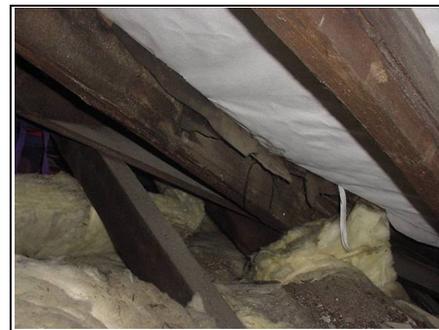
Our examination was limited by the general configuration of the roof, the insulation and mass of stored items. What we could see was generally found to be in average to below average condition for its age, type and style. It is, however, feasible that the staining we could see was formed many years ago prior to the property being re-roofed.

Dampness in timbers

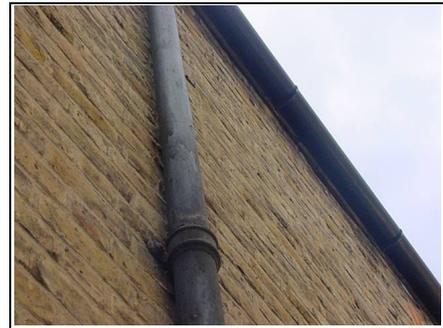
The property has a mixture of older cast iron and modern plastic gutters and downpipes. The condition is fairly typical of what we see; the plastic gutters and downpipes are in average condition and the cast iron ones are starting to rust and would benefit from a rust stop agent and redecoration.

Cast iron gutter and downpipe to the rear of the property

ACTION REQUIRED: We would recommend you stand outside the property next time it rains heavily and see how well the drains cope with the rainwater particularly looking at the guttering and the joints. We would also recommend that the gutters and downpipes are cleaned out, the joints are checked and the alignment checked to ensure that the gutters fall towards the downpipes.

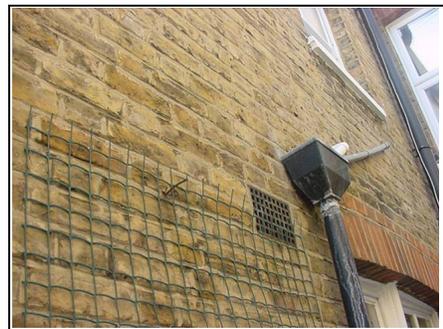
Leaking hopperhead to the rear of the property 36

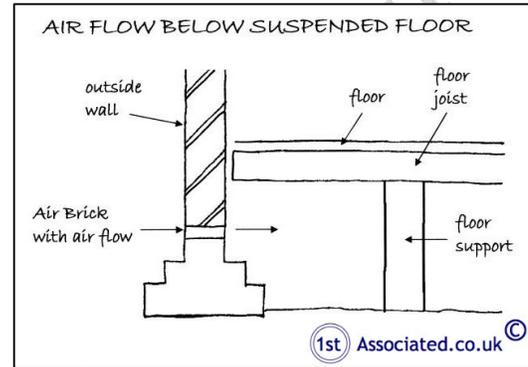
Drafts coming under the floor

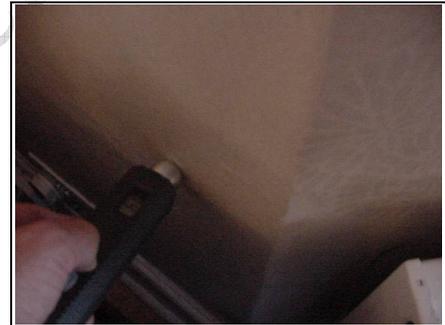
A random visual inspection and tests with a moisture meter have been taken to the perimeter walls. In this particular case we have found some minor damp but could be condensation.

Testing for rising damp

ACTION REQUIRED: Please see the Executive Summary regarding dampness to the rear of the property.

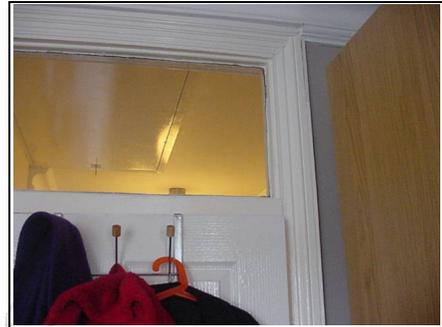
Modern door to master bedroom
you may wish to replace

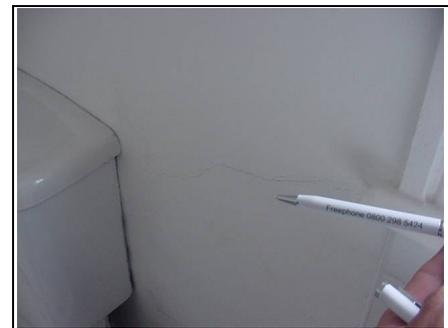
Crack in the bathroom

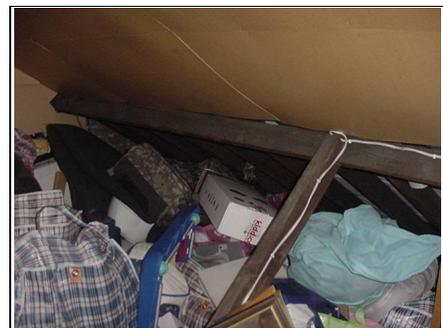
Mass of stored items in the roof space
