# RESIDENTIAL BUILDING SURVEY

OF  
Luton, Bedfordshire, LU2

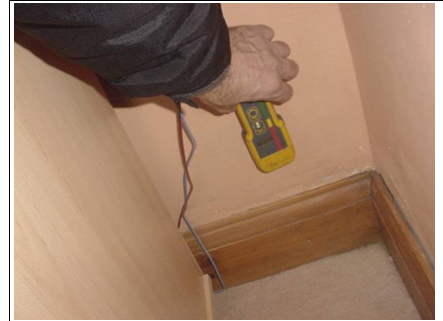
We found rising damp to the chimney on the left hand side (all directions given as you face the property from the front) within the rear lounge and also on the adjoining walls. We believe this is to do with the meeting of the suspended timber floor with the rear concrete floor which can often have areas of dampness.

Checking for dampness

You need to stop the water from getting into the airbricks, we suggest a French gully. Also ideally you need to open up the floor around the chimney to check it does specifically relate to this problem. There is also the possibility that it relates to a defective damp proof course in case you need to add a new damp proof course.

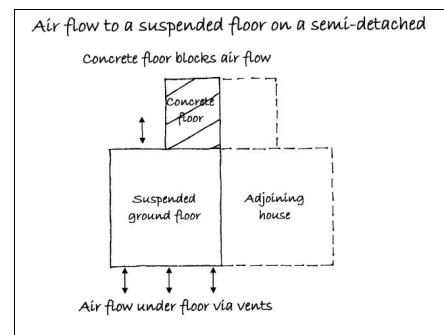
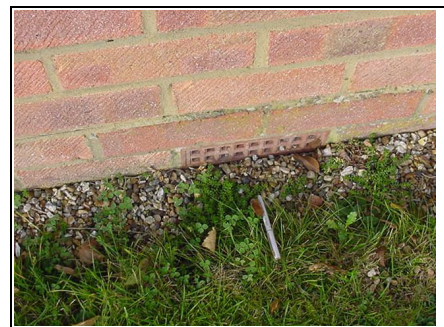
In this particular instance we also think that an additional factor is that the airbricks are acting as gutters allowing water to discharge into this area as there is a slight slope to the rear garden towards the house and we can see that running gulleys have been added by the owner to stop some of the water issues.

Airbricks acting as gutleys

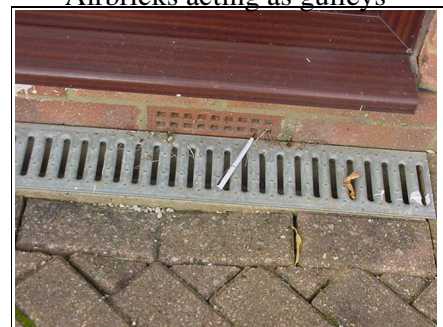
Running gully

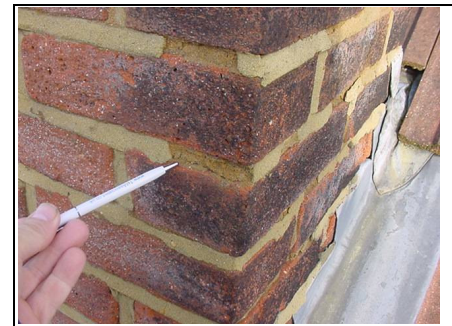
We noted to the front right hand chimney that you have condensation, also possibly dampness coming from the chimney itself. We found hollow and blown plaster in this area. Please note our comments with regard to repointing of the chimneys.

Repointing of chimney

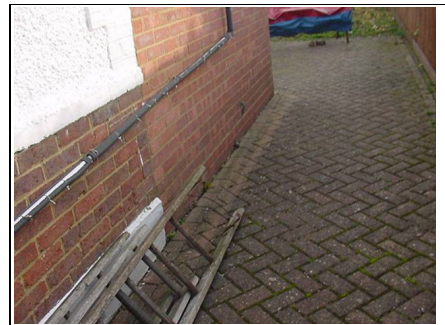
As rainwater is travelling from the rear of the property to the front of the property rain is gathering around the base of the bungalow. Running gulleys will help prevent this as will French gulleys which we have recommended to the rear of the property. It may also be worth adding a French gulley to the side of the property as well. You really have to see it when it is

The path that the water travels

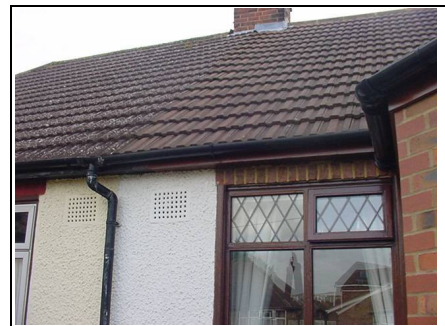
As with many roofs that are re-roofed there is no tilting fillet to the edge detail. This can cause problems with water discharging onto the painted render beneath it.

No tilting fillet

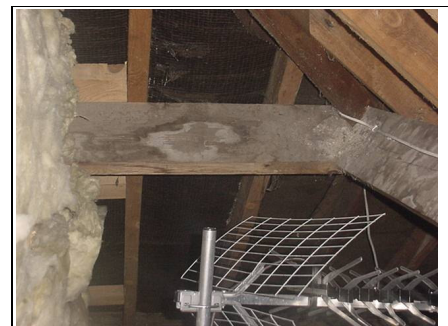
Within the roof space we can see that dampness had got in. On the day of the survey there was a very strong prevailing wind. It may have been wind driven rain that got in this area. We note that repairs have been carried out to the ridge tile in this area although it is difficult to be certain that dampness is still getting in?

Dampness getting into timber on ridge which has been replaced

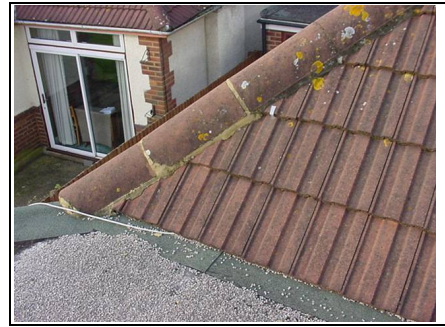
Repairs to the ridge

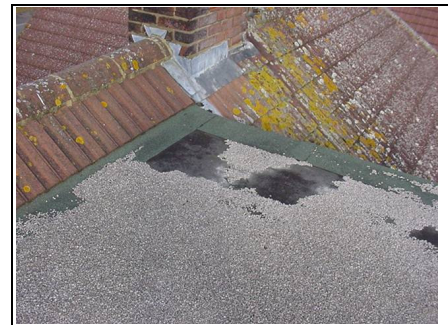
Protective shingle layer coming away

redistributed. It would be advisable to remove all the chippings that have landed in the gutter as they will be blocking it sooner or later.

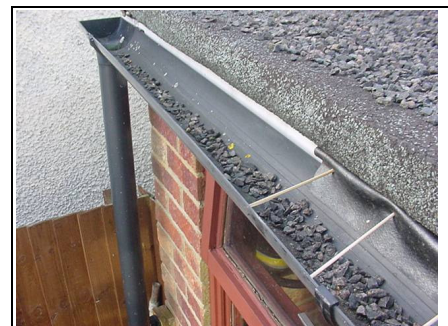
Chippings in the gutter of the garage roof – there were far more in the rear roof

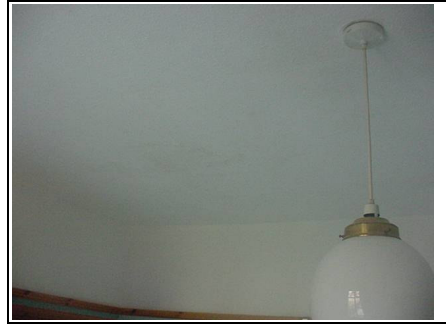
We noted some staining to the ceiling, almost like damp stains or like smoke nicotine stains. We spoke to the owners about this specifically and they advised that it was a poor quality tin of paint that they used from B & Q which they complained about at the time and never got round to painting over. Unfortunately we haven't been able to get into this part of the roof as the first floor room is formed in the way of it. It could be a range of things from wind driven rain that happens occasionally to condensation which can happen in some roofs if not vented property.

Staining to ceiling

**ACTION REQUIRED:** We recommend that the dark patches are painted over to see if they reappear over the winter months. However unfortunately if it is wind driven rain there is very little that can be done without major cost.

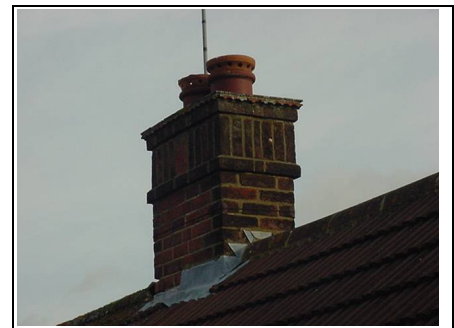
Middle chimney

This chimney is brick finished with two chimney pots. If you look at the base of it you can see that there is a metal flashing which we believe to be lead. This looks to have been replaced with a larger flashing. We could see the top of the chimney in this instance which have been finished with a tile which looked in reasonable condition.

**ACTION REQUIRED:** Carry out repointing as soon as possible and check the flashing.

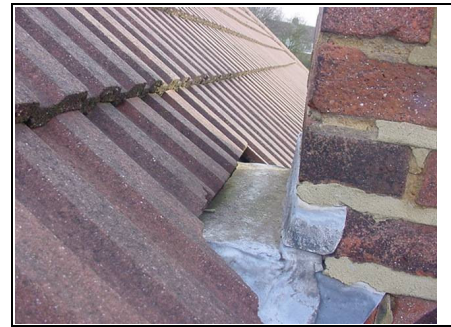
This chimney is built in brick with a lead flashing and one chimney pot. From what we could see the chimney needs repointing and the flashing needs checking/ replacing. The flaunching wasn't in bad condition.

Please see lead flashing to the rear

**ACTION REQUIRED:** Carry out repointing, the sooner the better, ideally in the summer of 2010. You need to check flashing immediately and replace with lead in the long term.

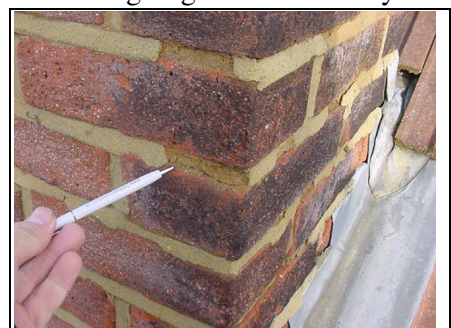
This chimney is also brick built with a lead flashing. The chimney would benefit from being repointed (as would some of the rest of the property)

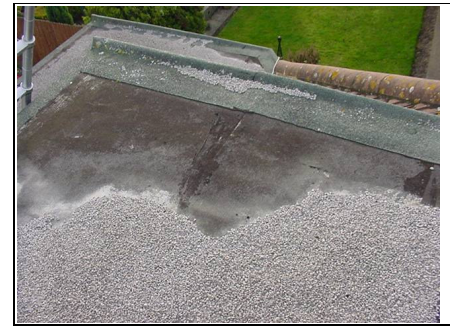
There is one dormer window to the rear of the property to form the ceiling height within the first floor bedroom. The roof is clad with felt which we managed to get onto and the cheeks/sides are in vertical tiling. The roof as you can see in the adjoining picture is in reasonable condition with a mineral felt edging. It should have had a protective chipping all over it but this was missing in some areas. We believe this relates to the high wind. It is going to be a continuing problem due to the high wind levels in this area.

Chippings missing from dormer roof

**ACTION REQUIRED:** You do need to redistribute the chippings to offer a protective coating against the effects of solar deterioration and the frost thaw cycle.

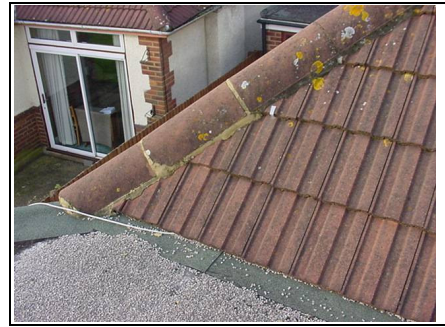
Please see our comments in the Executive Summary with regards to dampness that we can see getting into the structure. Here we can see in the photo the hog back tiles are in a new light colour cement mortar which indicates that they have been replaced. We also can assume that some water can get in at the junction where the flat roof meets the pitched roof.

Tiles that have been replaced

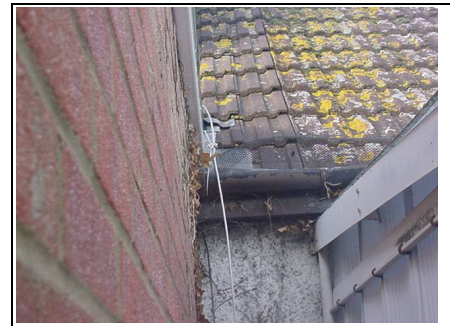
A tricky aspect where properties have been re-roofed which is where they join together. There can be a difficulty in getting a watertight joint. Unfortunately this area is hidden from us because the room has been formed in the roof.

Note the joint between yours and next doors roofs

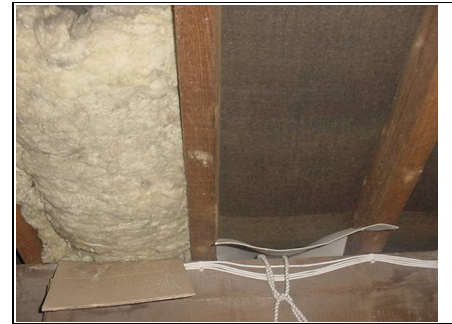
We had a very limited view of the loft space. Where we could see it we found a Hessian base Bitumen membrane. This type of membrane has been used since the 1960s. We generally found it to be in average condition, it is damaged in a few more places than we normally find.

Hessian backed felt

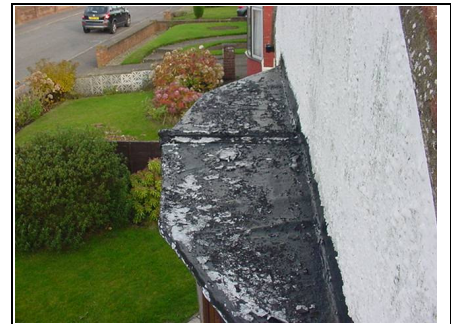
The bay window roof is a lead roof which is rather unusual and it has been tarred indicating that there have been problems in the past. From our visual inspection we couldn't see any water damage.

Front bay window roof tarred over

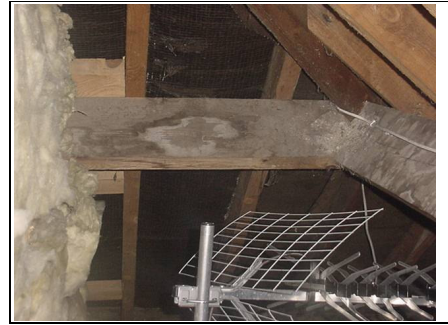
We had a limited view of the roof timbers, we could see that there had been some staining to some of the timbers indicating dampness getting into the roof one way or the other. We have inspected the roof structure for:

Staining to the purling which is the horizontal timber

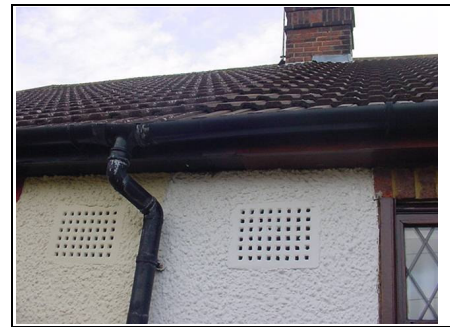
From ground level the gutters and downpipes looked to be plastic and appeared in average condition. There are a few repairs.

Gutters and downpipes

**ACTION REQUIRED:** We have commented elsewhere within this report about the amount of stone chippings from the flat roofs in the gutters. These need clearing and also redistributing on the flat roof. We would also recommend that the gutters and downpipes are cleaned out, the joints are checked and the alignment checked to ensure that the gutters fall towards the downpipes.

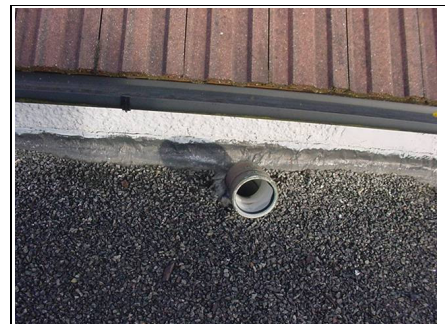
The new section is plastic with the old section being cast iron at lower level which is what we commonly find. It should really terminate higher above roof level approximately a meter. We suggest a pipe is added and a birdcage to the top.

Soil and vent pipe from the shower room

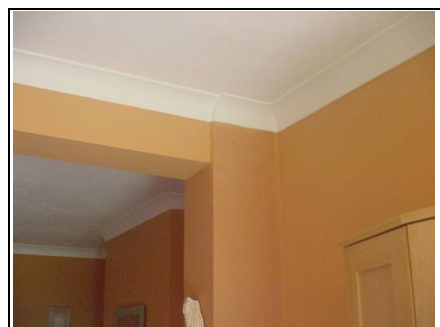
Crack in rear reception room

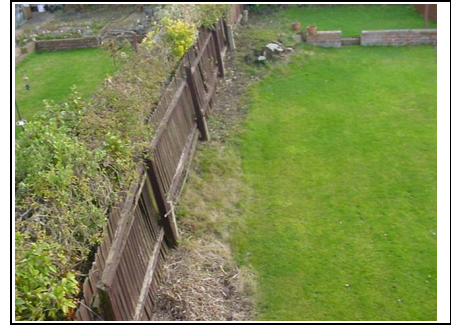
Fence that needs repairing
